RECEIVED: 25/02/2026

Appendix 7.2

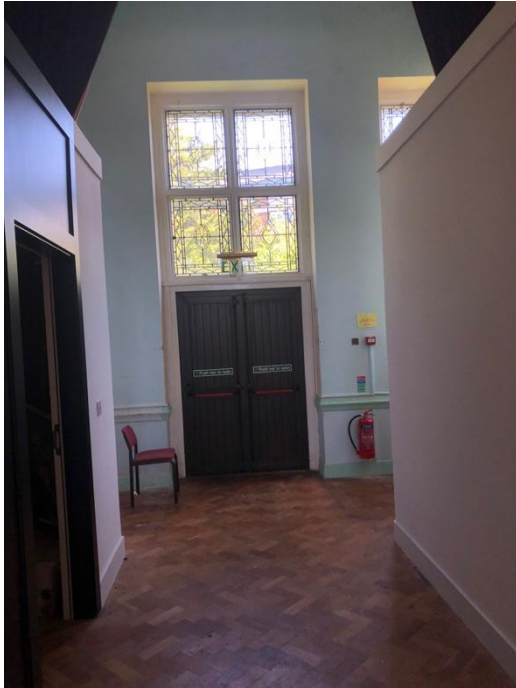
Plate 325: External doors with leaded lights over.
