# Arboricultural Report

Tree Survey,  
Arboricultural Impact Assessment &  
Arboricultural Method Statement

**Mooretown Phase 2**

**250919-PD-11-A**

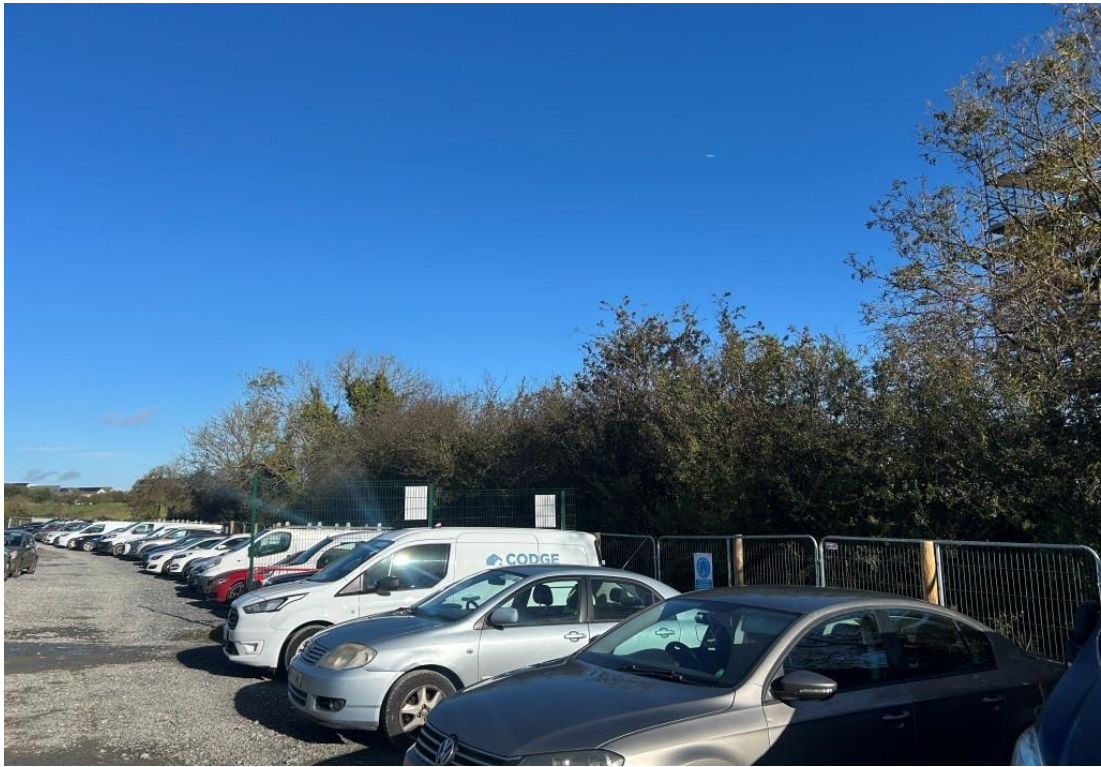
**Image 1:** View of the native hedgerow H16 located along the eastern boundary in the northern section of the Site.

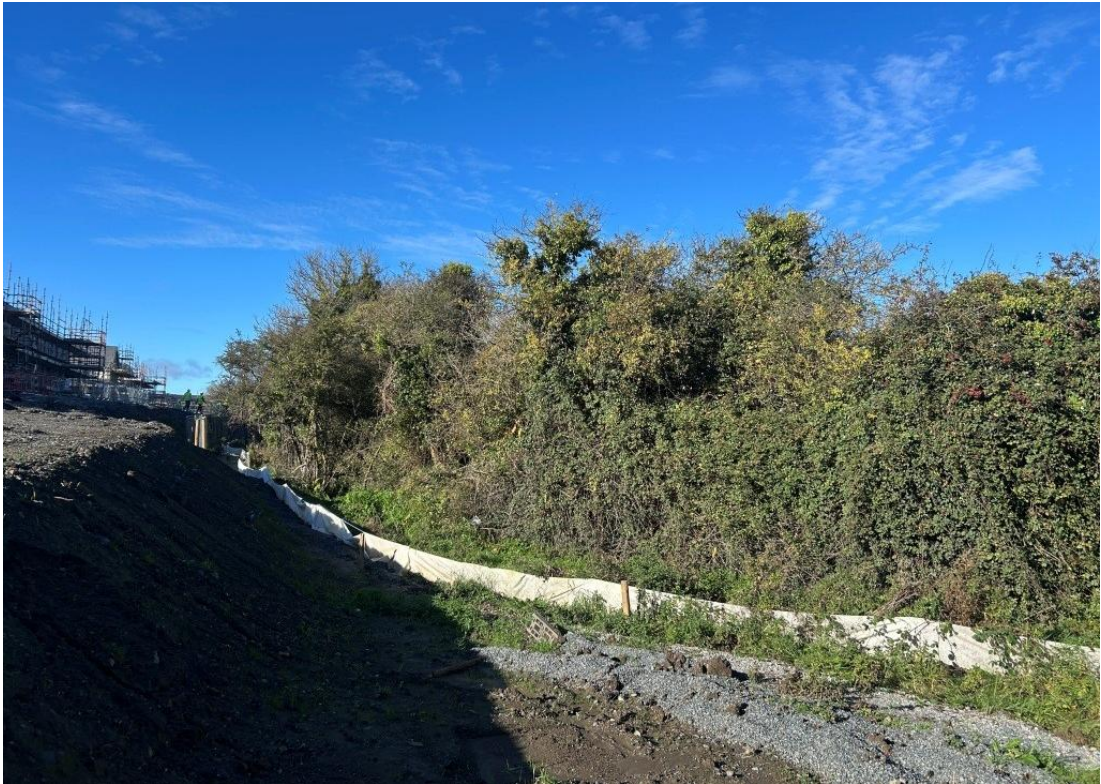
**Image 2:** Second view of the native hedgerow H16 from the southern side.

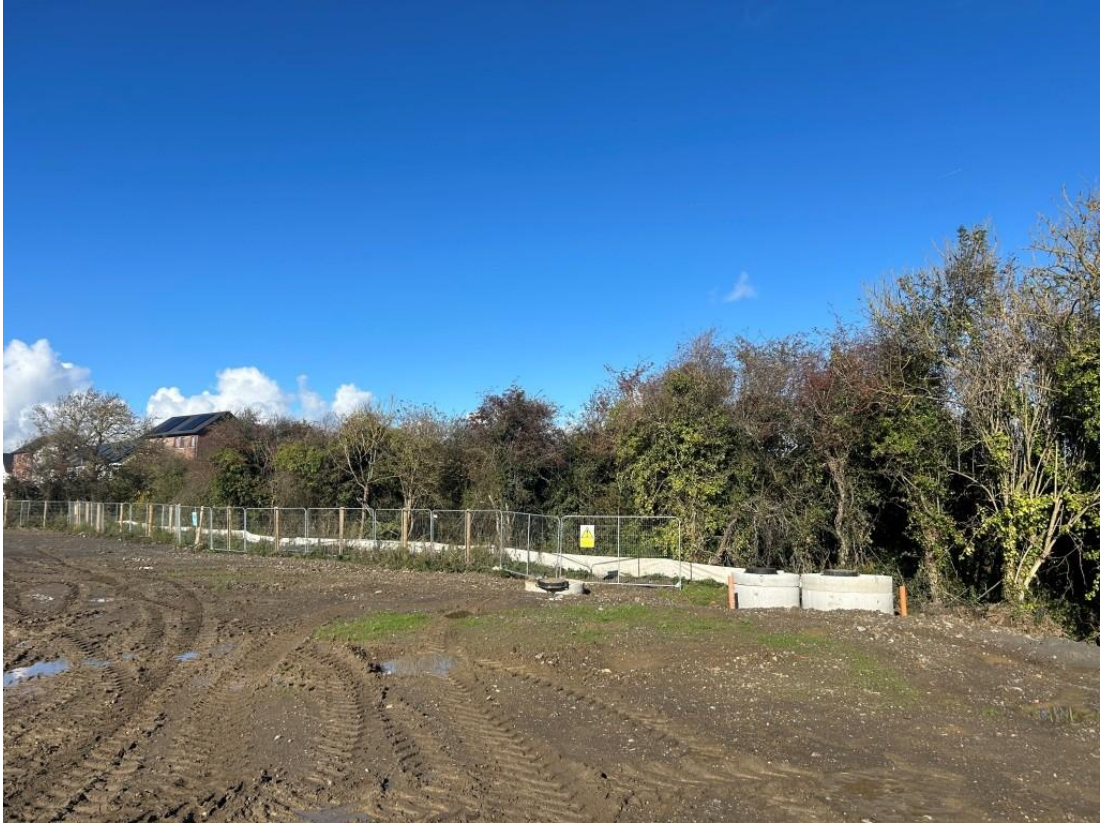
**Image 3:** View of the native hedgerow H7 located along the southern boundary in the northern section of the Site. Image taken from the southern side of the hedgerow.

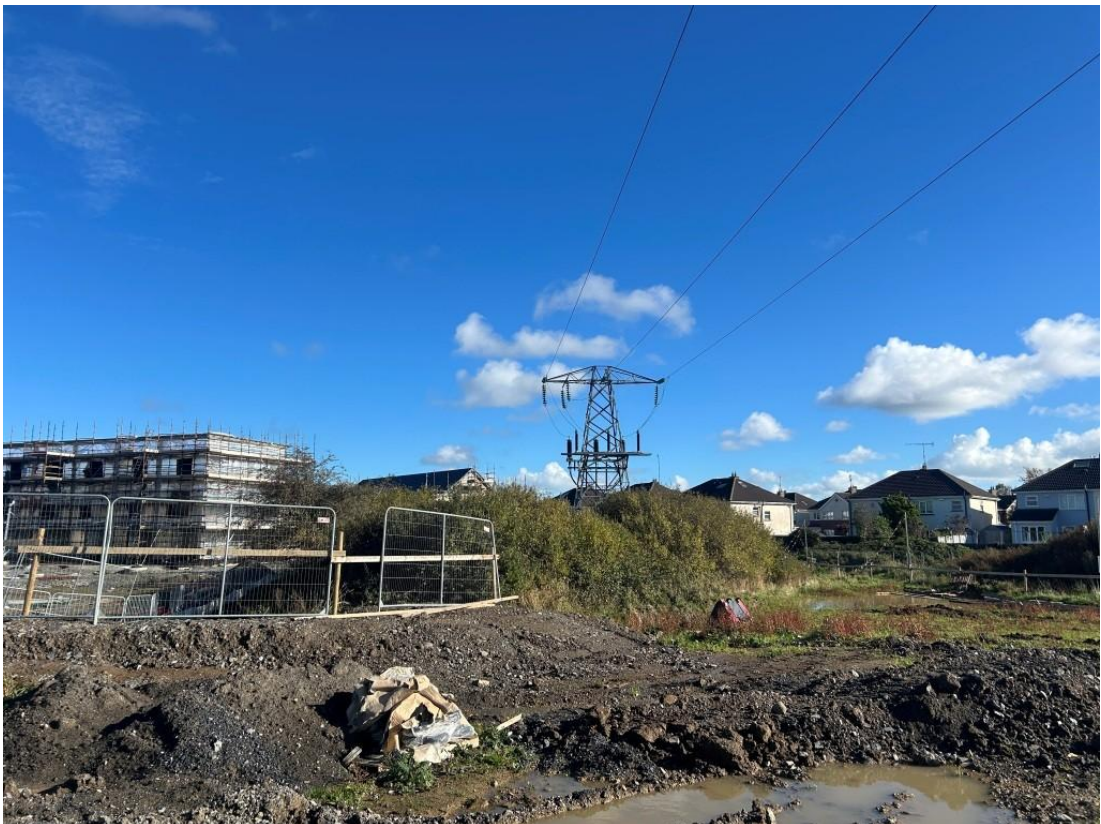
**Image 4:** View of the overgrown group of blackthorn G19.

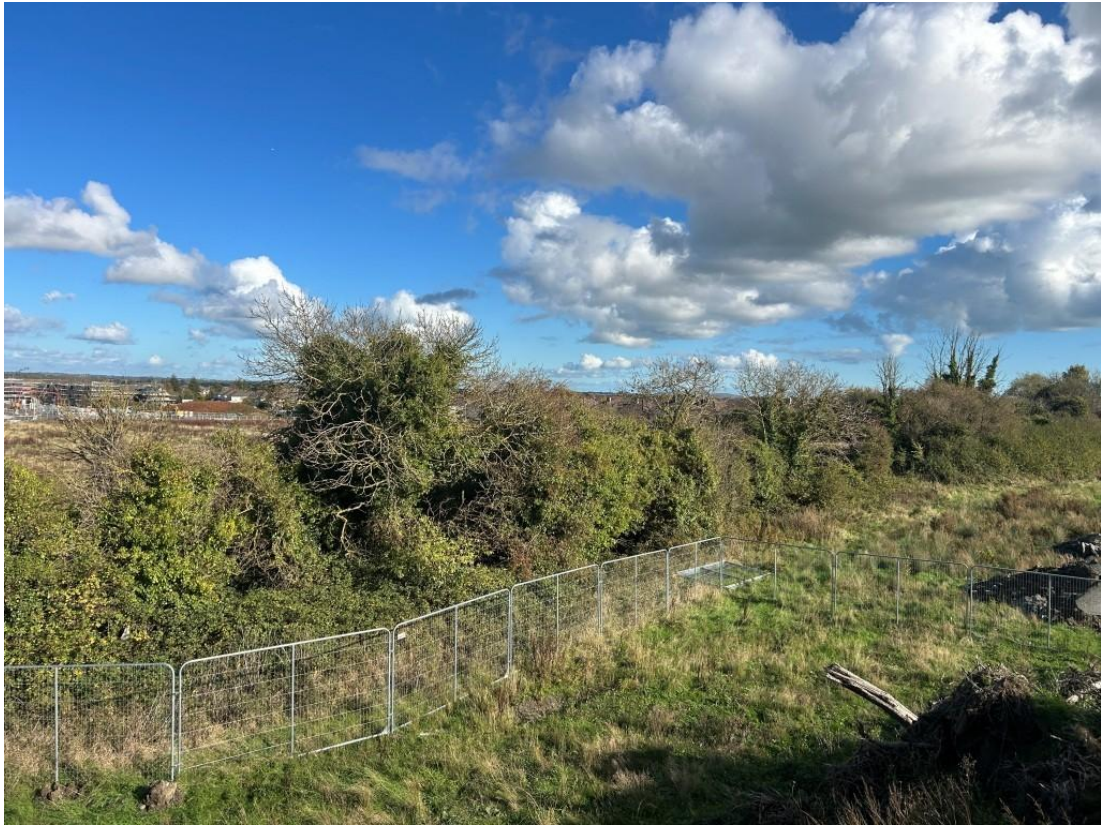
**Image 5:** View of the native hedgerow H64 located within the centre of the southern Site.

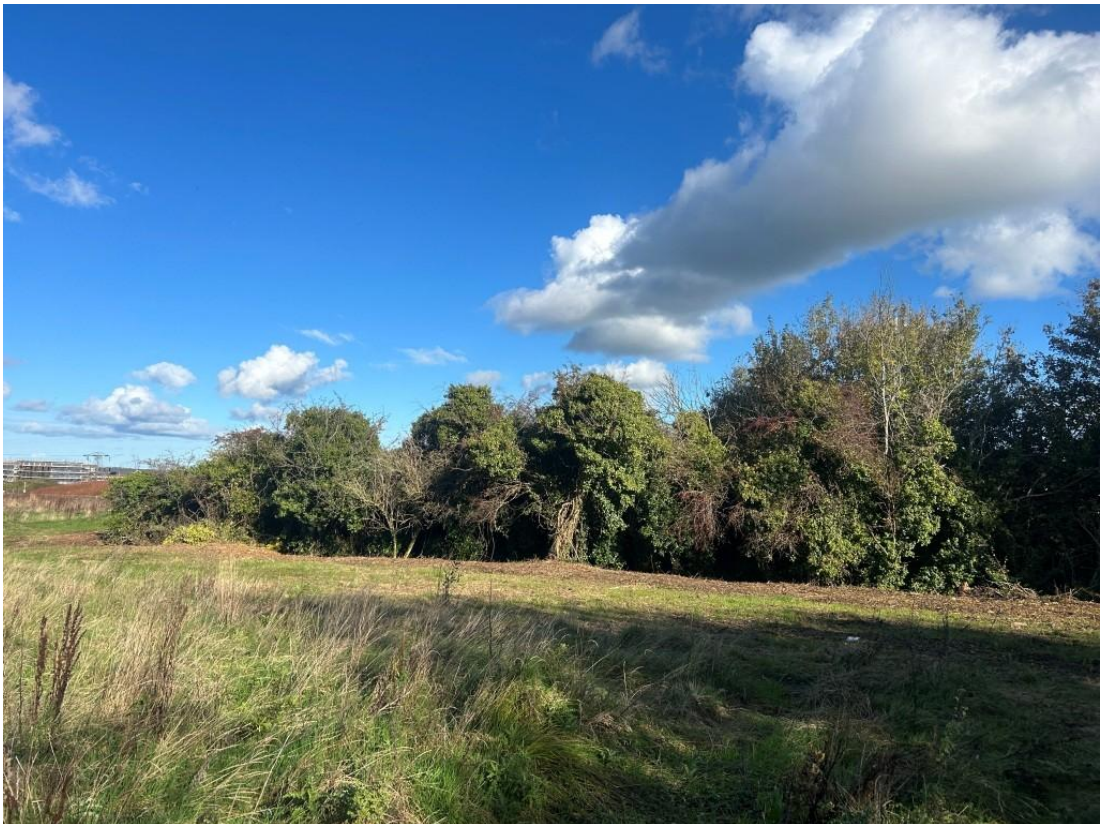
**Image 6:** Second view of the native hedgerow H64 located within the centre of the southern Site.

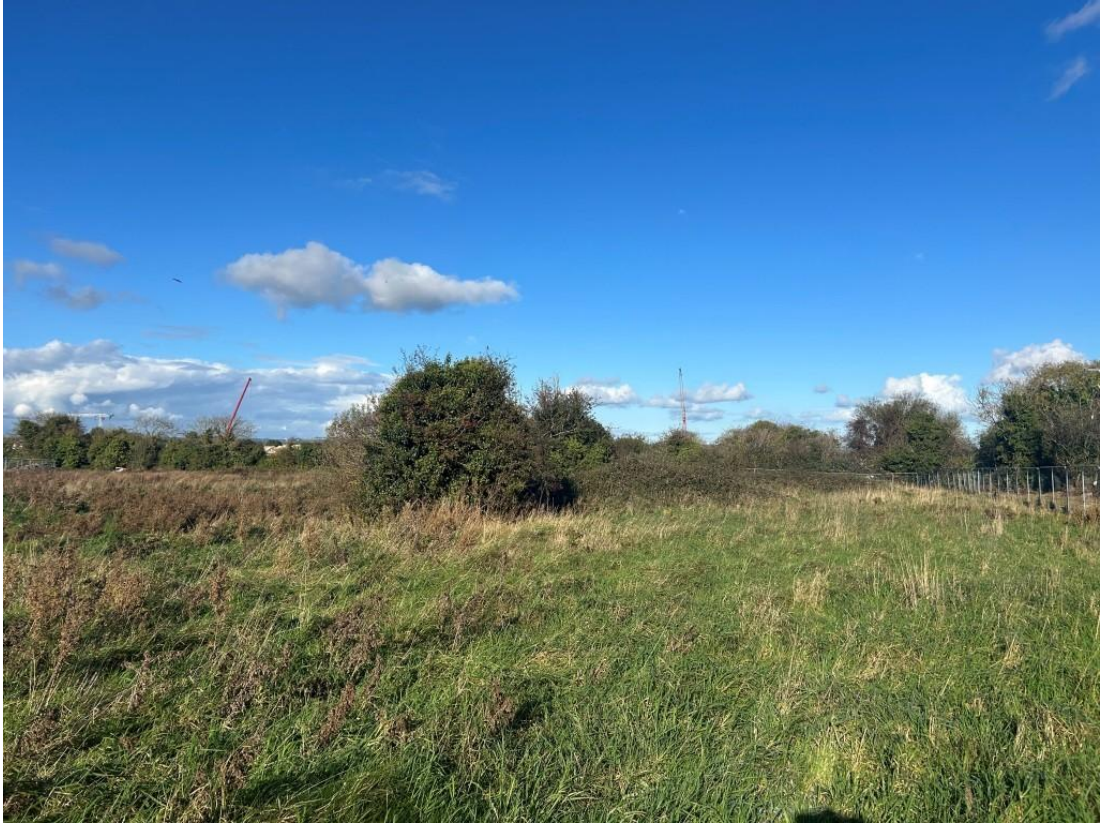
**Image 7:** View of the hawthorn and goat willow trees located within the centre of the southern Site.

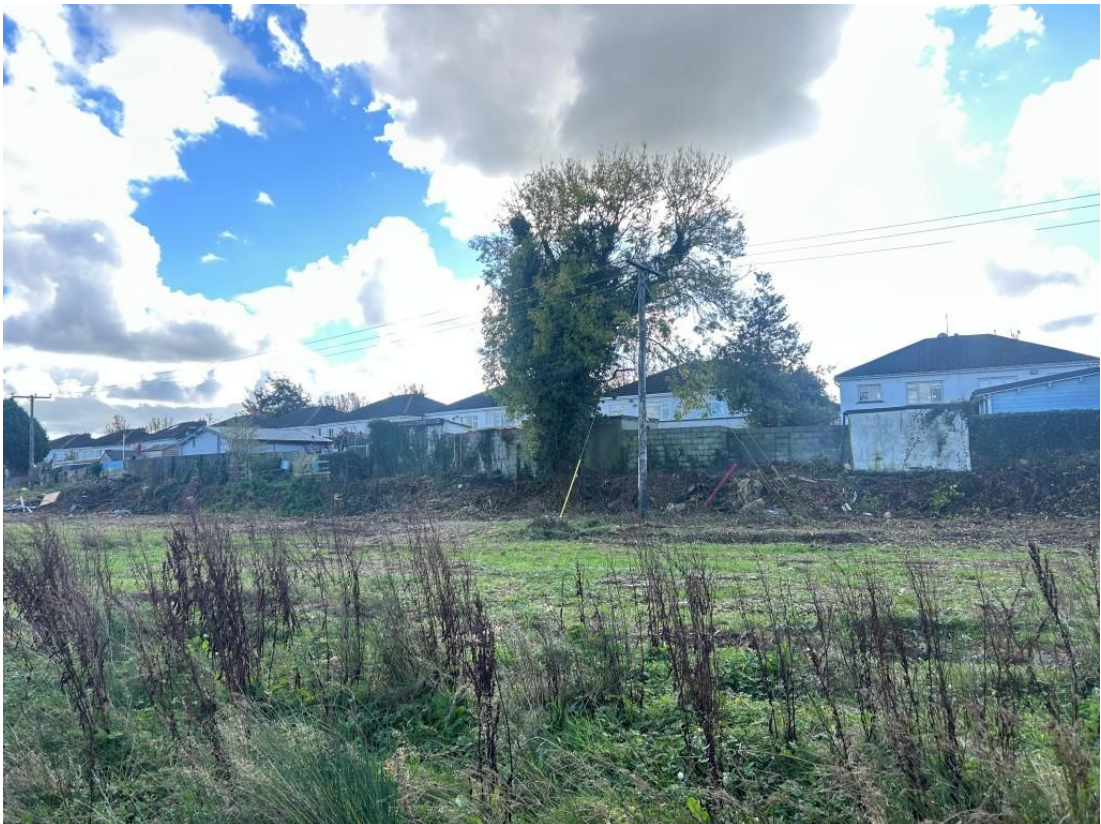
**Image 8:** View of the ash T43 located along the southern boundary of the Site.
