Chapter 15

Architectural Heritage

This report has been produced as an assessment of the potential effects of the N5 Ballaghaderreen to Scramoge Proposed Road Development on built heritage.

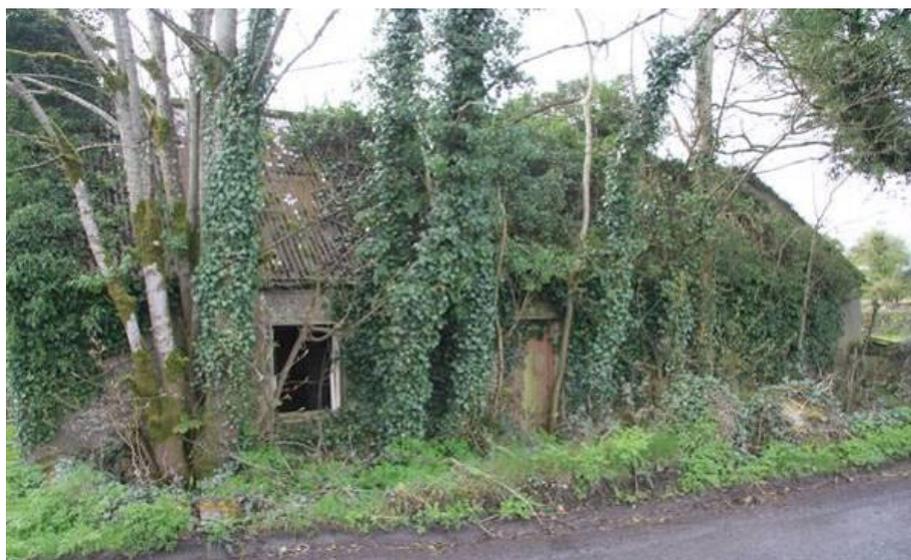
Plate 15.17 House at Lugboy

Single-storey, four-bay, stone-built, three-roomed house on southern side of local road. Façade is rendered with sand and cement. Windows are largely missing, but surviving remnants are of two-over-two timber sashes with quadrant horns. Window opes have moulded timber architraves, as have doorways. Original roof structure largely survives and is of paired rafters and collars in the round, supporting purlins and runners in the round, on which is straw thatch. Roof has been reconstructed at one end with sawn timber rafters, collars and purlins. Main hearth has large hearth and a chimneypiece of brick and tile; other 2 hearths have cast iron hob grates and remnants of timber chimneypieces.

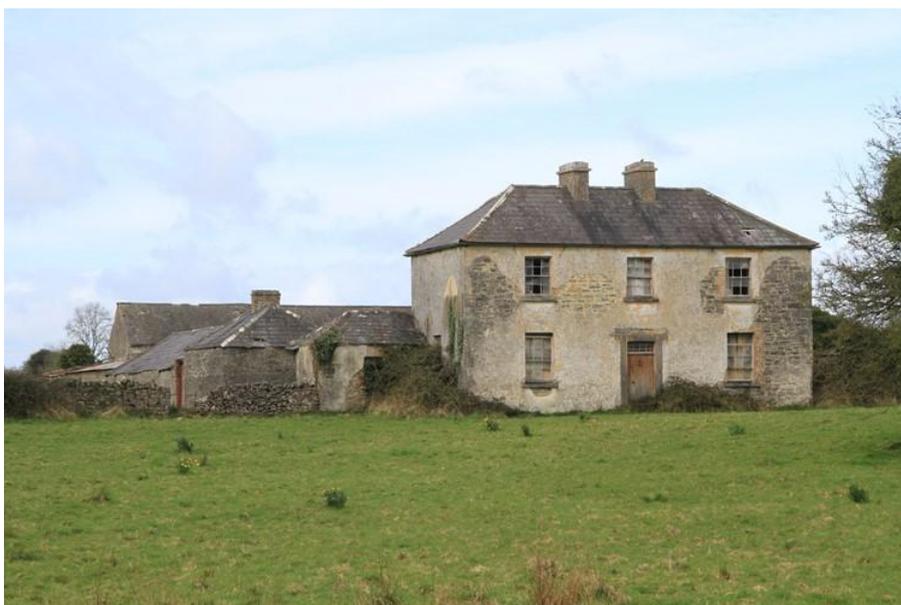
Plate 15.18 Farm House and Outbuildings at Lugboy

This farm complex had not been built at the time of the first edition Ordnance Survey six-inch map in 1837 and it was probably constructed around 1860. The house is vacant and in poor condition, though capable of being refurbished. The farm outbuildings are in use, though also in poor condition.

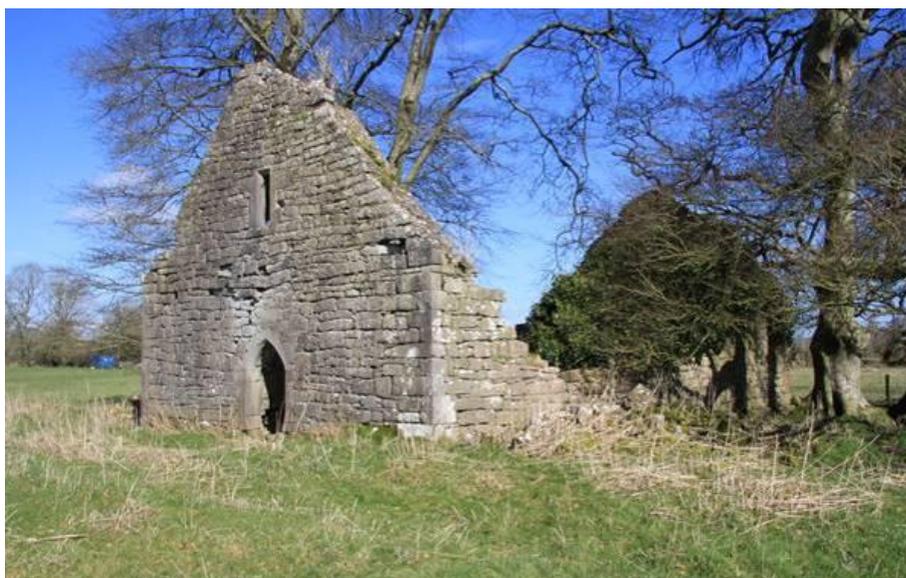
Plate 15.45 Urney Church

Urney Church survives as a ruin, with the two gable ends and much of one long wall standing, while the other long wall has collapsed. The building is in a very precarious state; at the eastern end a section of the inner face of the gable wall has collapsed and a significant area appears to be on the point of falling. A similar situation pertains at the western gable, where an area of the inner face below the high-level window has collapsed. On the outer face of the church this is expressed as an outward bulge in the masonry, with significant levels of cracking.

Mitigation – A condition survey and vibration analysis of the structure has been undertaken which concluded that the church is deemed to be located at a sufficient distance from the proposed road development that the levels of vibration associated with the likely construction works will be orders of magnitudes below the levels appropriate for the protection of vibration sensitive structures (See Appendix 15.1 for further details). A thorough engineering inspection of the structure shall be undertaken immediately prior to construction (subject to the landowner’s consent). A programme of monitoring will be implemented to ensure that condition limits are not exceeded and that all the relevant recommendations are met.

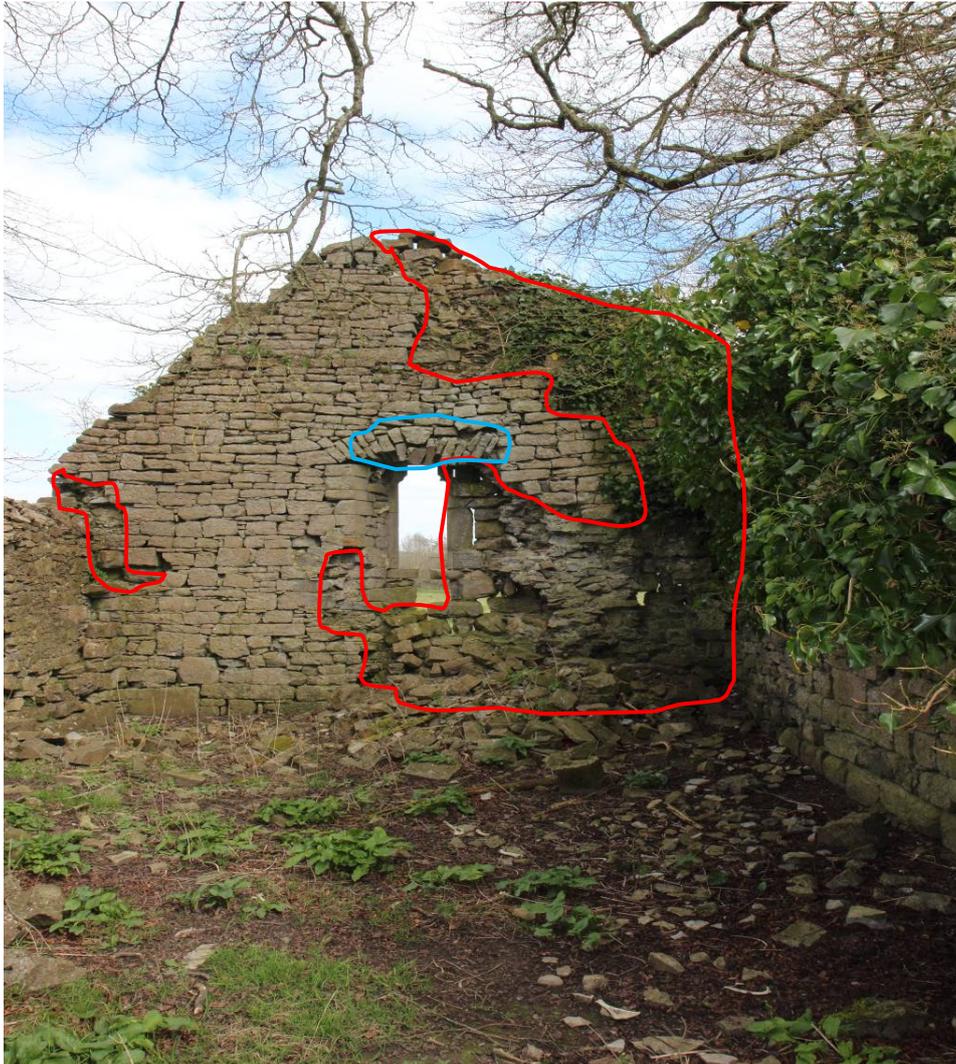
Photograph 4 East Gable Inner face

The inner face has collapsed with the loss of part of the window reveal (red line photograph 4). The stone arch (blue line in Photograph 4) over the window is collapsing. The stone is on the ground at the base of the wall.

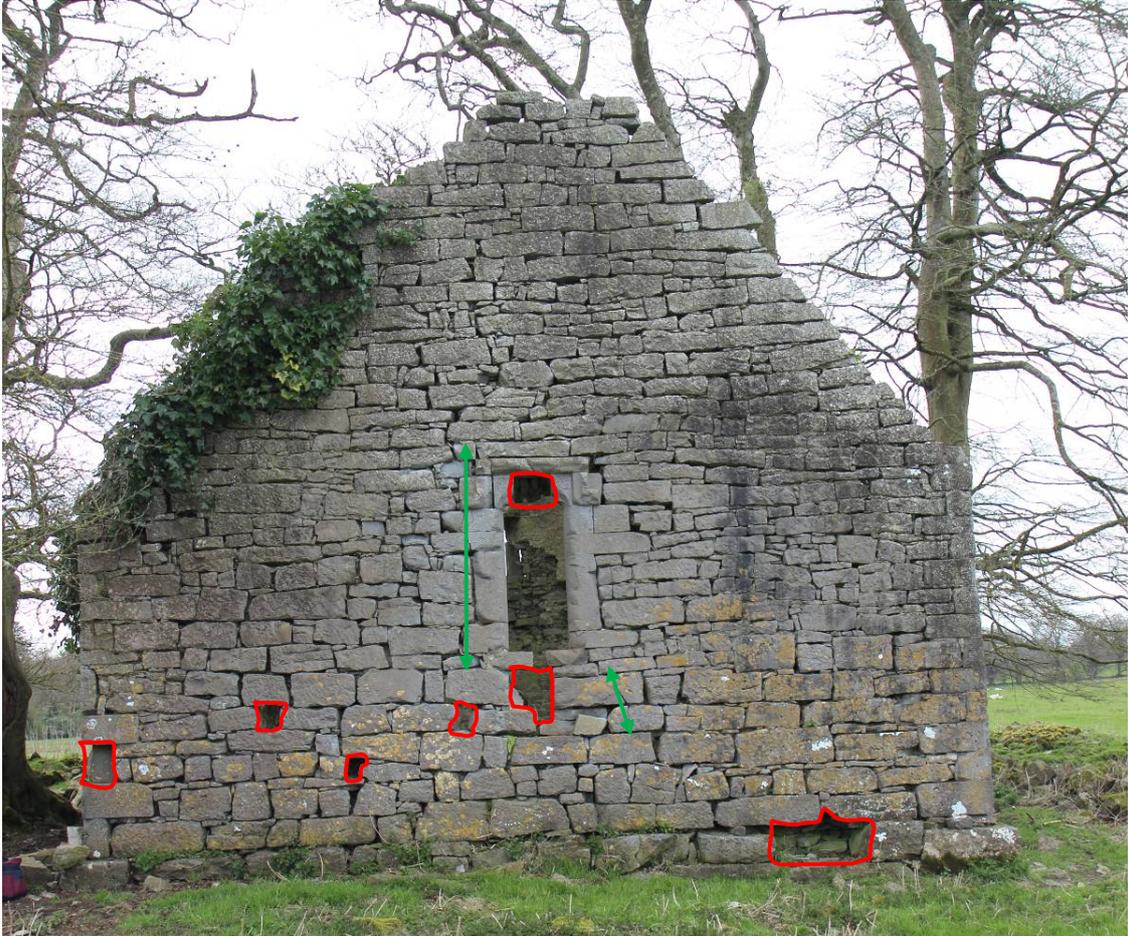
Photograph 5 East gable outer face

The wall top has ivy growth and water is ingressing into the fabric resulting in washing out of fines and mortar and also frost heave.

It was not possible to assess the wall top but it is likely that this is in need of significant repairs to prevent water ingress into the gable.

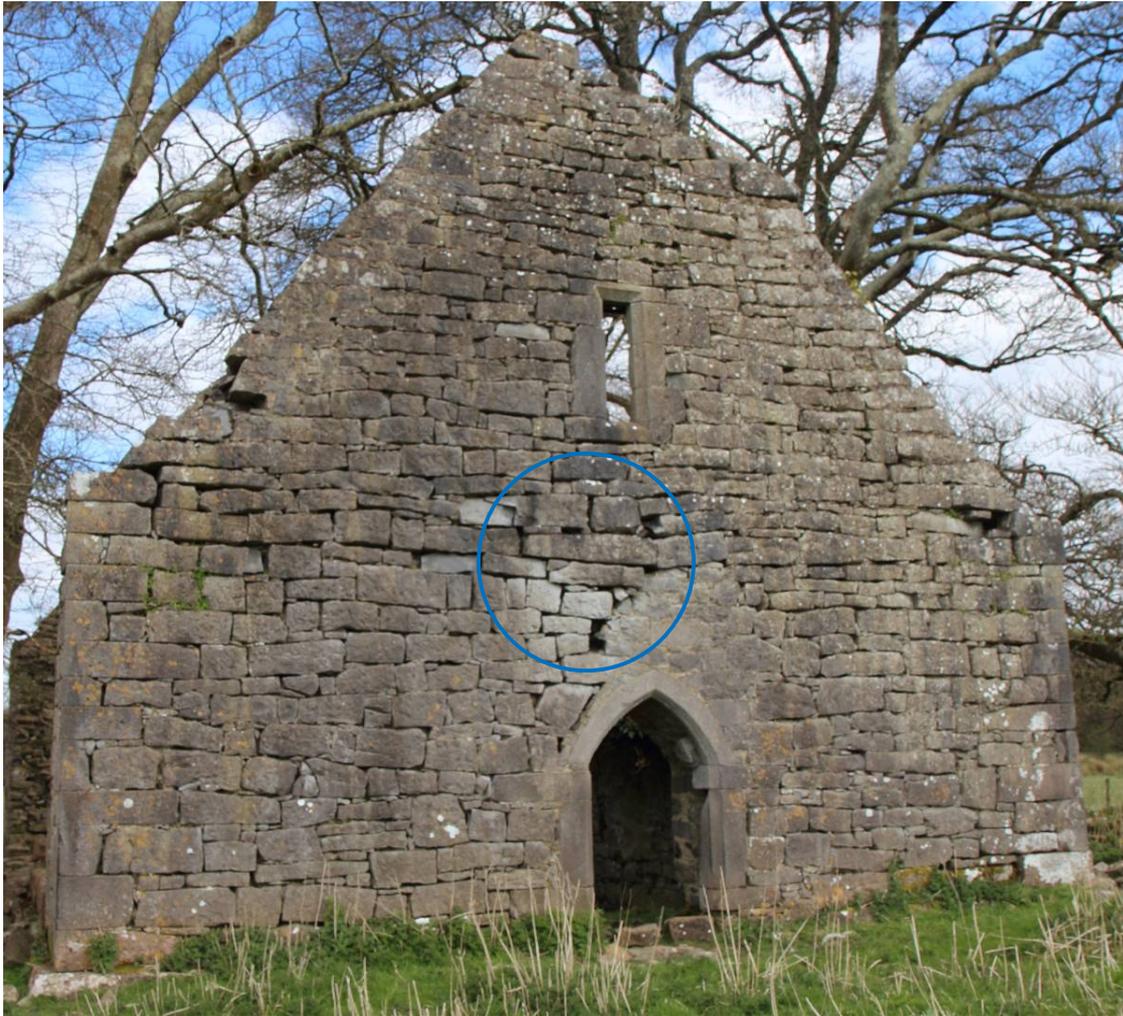
Photograph 10 West Gable Outer Face

There is a significant bulge (photographs 10 & 11) on the outer face to the left of the door opening below the window – in line with the inner collapse. It was not possible to assess the wall top but it is likely that this is in need of significant repairs to prevent water ingress into the gable.

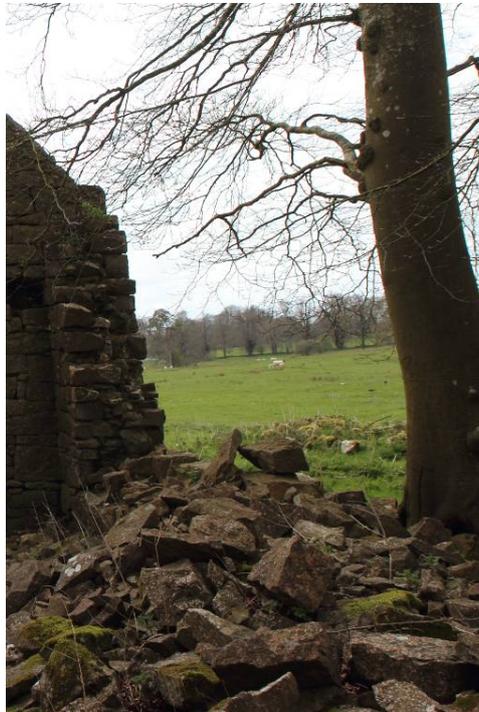
Photograph 12 West Section of North wall

The north wall is almost completely collapsed with the stone on the ground. There is no evidence of any architectural features remaining. The eastern section looks to have been rebuilt at some point. The wall ends are acting as buttresses for both gables. The presence of the trees adjacent to the wall has caused damage to the upstanding wall.

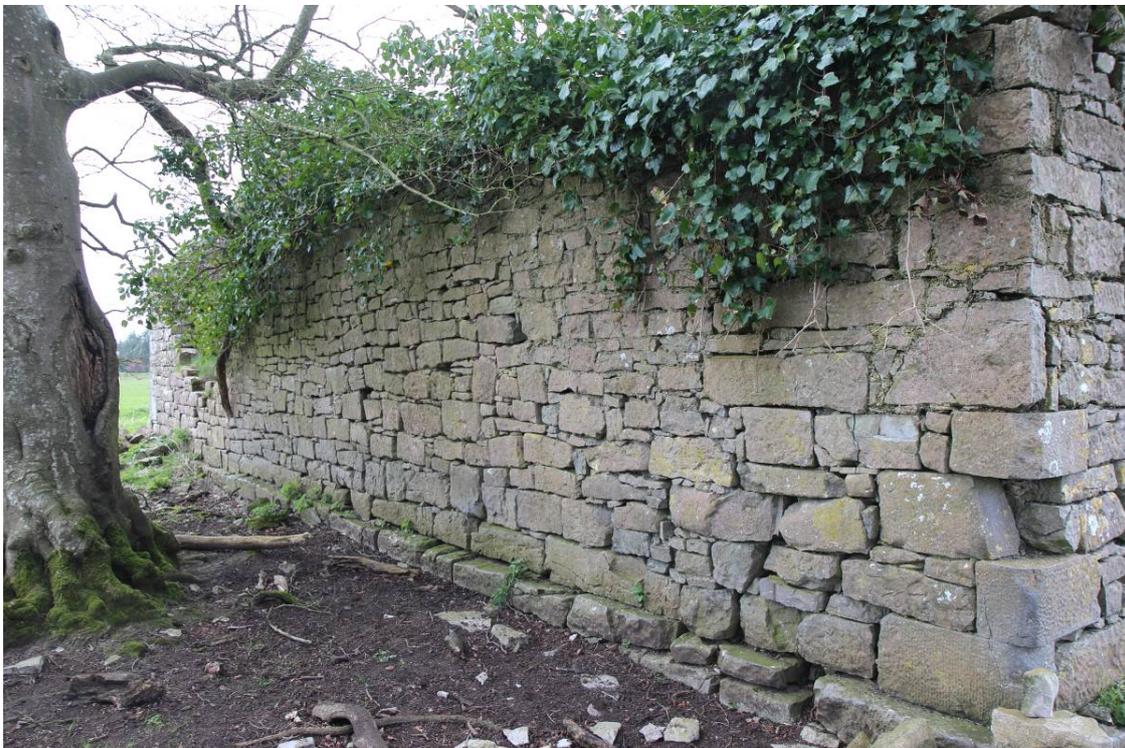
Photograph 15 South Wall for East

The south wall is extensively covered in ivy and apart from the wall top and a collapsed section at the western end the wall is insitu. The ivy may be covering problems but the outer face indicates that the wall is in poor to fair condition. There is no evidence of any architectural features remaining. The wall ends are acting as buttresses for both gables. The presence of the trees adjacent to the wall has caused damage to the upstanding wall.
