Parnell Square Cultural Quarter

New Dublin City Library Project

Protected Structures Impact Statement

October 2018

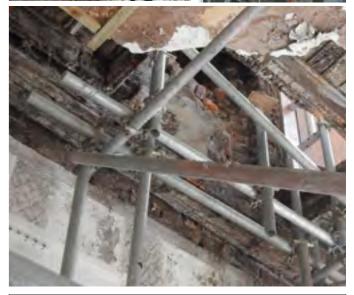
Figs 3.2; 3.3; 3.4: bove: No 28 damagee caused by water ingress and where fireplace hearth has fallen through damaging staircase below.

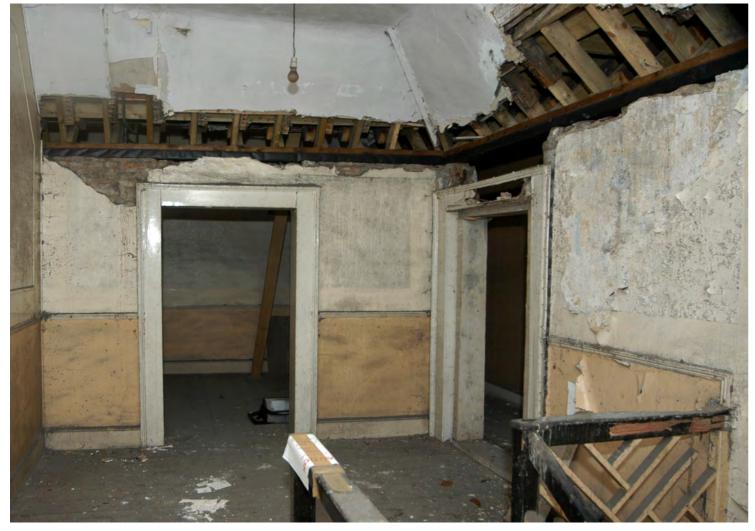
Fig 3.5: No 23 third floor showing typical areas of decay - temporary repairs carried out to exposed rafter ends)

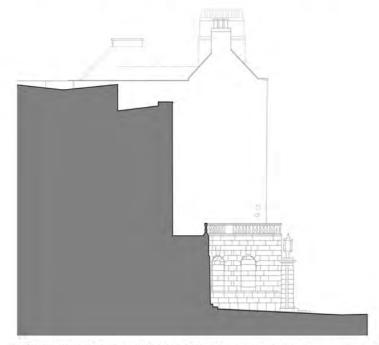
WEST, GABLE, ELEVATION NO 21 - proposal is to remove cement render and repair underlying historic brick, or re-render in lime. Final decision will be based on condition of brickwork following removal of render.
