### TREE & HEDGEROW ASSESSMENT REPORT

**CREAGH, GOREY**

February 2019

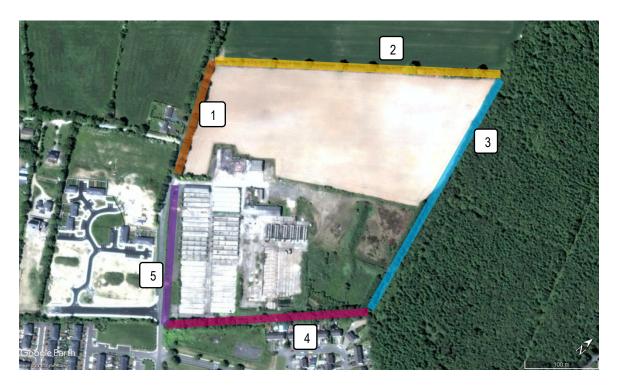
**Figure 3.** Map showing locations of surveyed Hedgerows. See Appendix 1 Tree and Hedgerow Survey Tables for details.

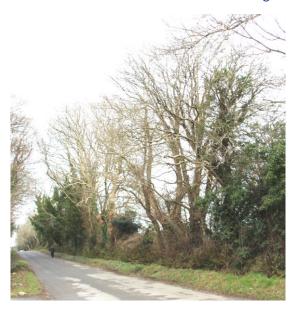
Figure 7. Specimens of matured Ash and Oak to east of Front Road (located west of site – Hedge no. 1)

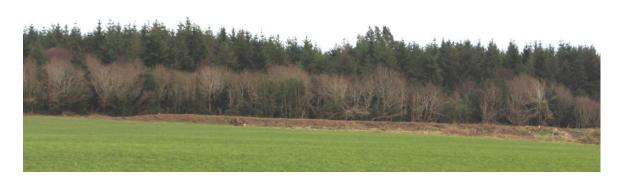
**Figure 10.** North-east Oak hedge (deciduous trees in the foreground - Hedge no. 3). Ramsfort Park in the background (evergreen trees).

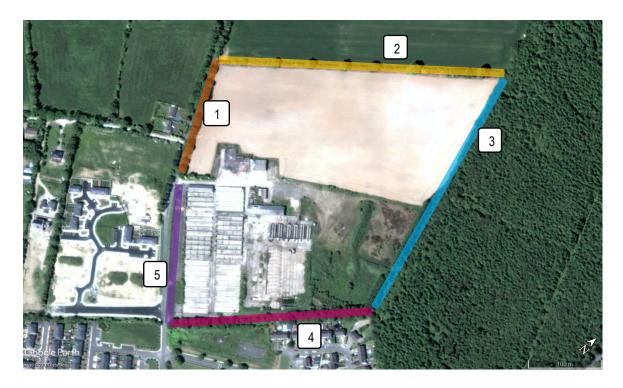
**Figure 14.** Map showing locations of surveyed Hedgerows. See Appendix 1 Tree and Hedgerow Survey Tables for details.
