TREE & HEDGEROW ASSESSMENT REPORT

CREAGH, GOREY

November 2018

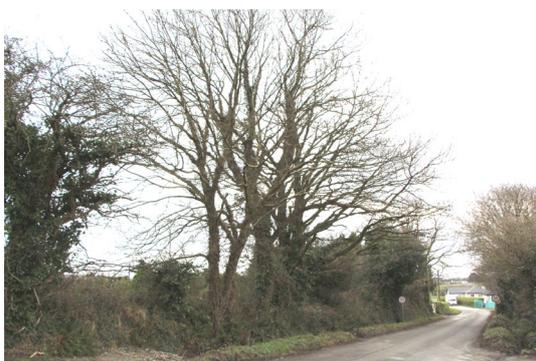
- 1) The first hedge surveyed is located adjacent to Fort Road, west of the site (Fig. 4 and 5 - Hedge no. 1), which is formed by a large continuous earth embankment, over 2.00m high running almost parallel to the road, where mature trees are growing close together along approximately 150 meters. All its vegetation has been neglected for some time, with resultant uneven tree growth, densely overgrown understorey areas and some large gaps in the fabric of the hedge. Generally, it is composed of several mature specimens of Ash (*Fraxinus excelsior*) and Oak (*Quercus robur*) all of which are mostly covered in Ivy and Bramble. Bracken (*Pteridium aquilinum*), Bramble (*Rubus sp.*), Gorse (*Ulex europaeus*), Hawthorn (*Crataegus monogyna*), Holly (*Ilex aquifolium*) and Ivy (*Hedera helix hibernica*) form what is left any past hedge boundary, although these species are very scattered. The main boundary is ostensibly the earth embankment with associated cover of Bramble and Ivy. The Ivy is frequently found covering trees impeding an appropriate tree visual assessment. It is considered that due to the form of the existing embankment that the roots of existing trees that are on top of the embankment do not extend into the field. The field has also been harrowed and ploughed over time, which also further restricts root growth into the field.

Figure 4. Hedge embankment, east facing Front Road (located West of the site – Hedge no. 1a)

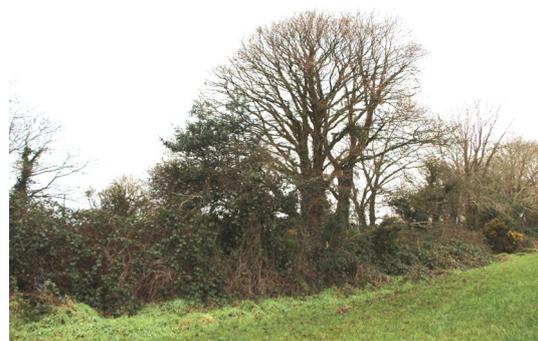
Figure 5. Overgrown hedge, adjacent to Front Road, facing opened field (West of the site – Hedge no. 1a)

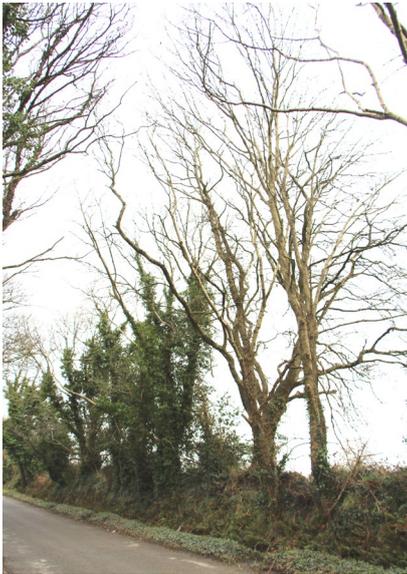
Figure 6. Specimens of matured Ash to east of Front Road (located west of site – Hedge no. 1)

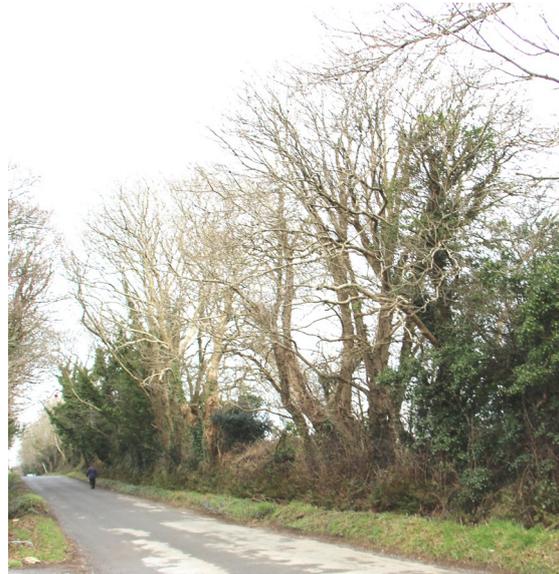
Figure 7. Specimens of matured Ash and Oak to east of Front Road (located west of site – Hedge no. 1)

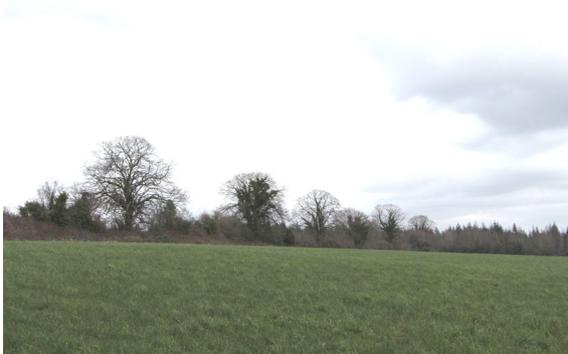
Figure 8. Hedge embankment, east facing Front Road (located west of the site – Hedge no. 2)

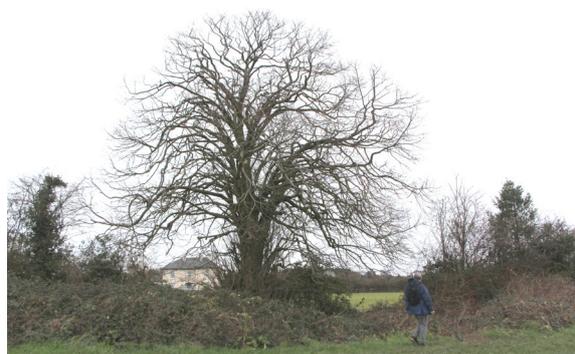
Figure 9. Specimen Lime to north

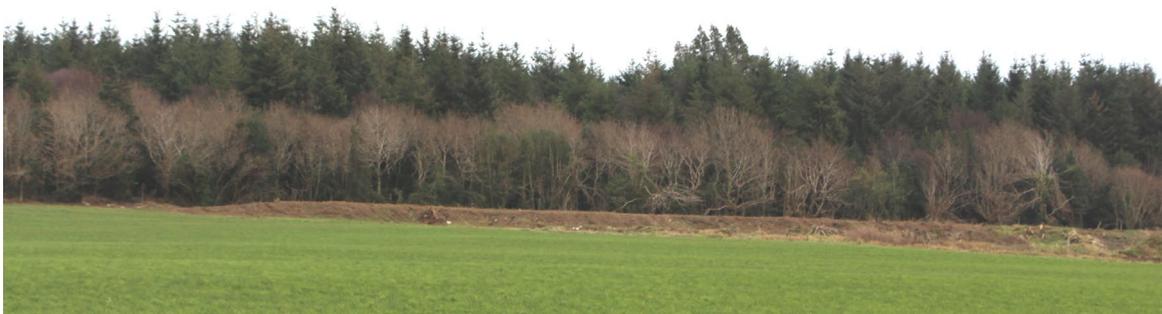
- 3) The boundary with the Coillte lands of Ramsfort Park Forest consists of young recently planted oaks (*Quercus robur*), no higher than 10 meters, and a concrete post with chain-link fence located north-east of the site with low height Ivy and Bracken, extending for over 380 meters. These oaks are to be found outside the boundary of the future development area and establishing a transition between the site and Ramsfort Park (Fig. 9 - Hedge no. 3). The Oaks were planted close together, however upon visual inspection, all have a healthy appearance with no signs of crown malformation (which can be caused by competition with neighbouring trees), even apical growth and balanced canopy.

Figure 10. North-east Oak hedge (deciduous trees in the foreground - Hedge no. 3). Ramsfort Park in the background (evergreen trees).

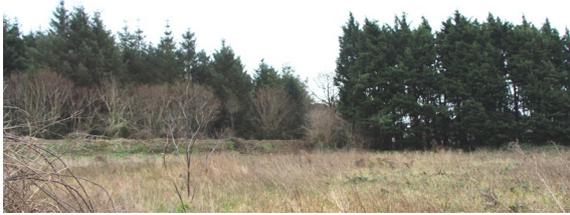
- 4) In the south-east boundary, the hedge is mostly composed of mature *Cupressus sp.* (dominant species in this hedge) with approximate 18 meters high, extending for over 280 meters. Multi-stemmed Alder (*Alnus glutinosa*), Bracken (*Pteridium aquilinum*), Bramble (*Rubus sp.*) compose the lower layer of this boundary. Because of the deep embankment located east

of the boundary and overgrown shrubs and ferns to the South, the trees were inaccessible, hindering the survey (Fig. 10 and 11 - Hedge no. 4);

Figure 11. South-east Conifers hedge (evergreen trees – Hedge no.3/4)

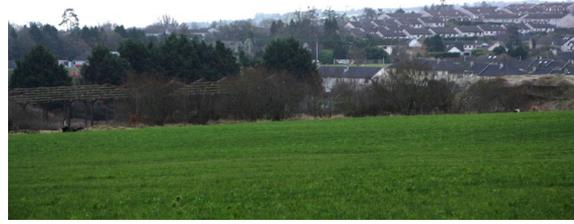
Figure 12. South-east Conifers hedge (Hedge no. 4). Gorey Corporation Housing in the background.

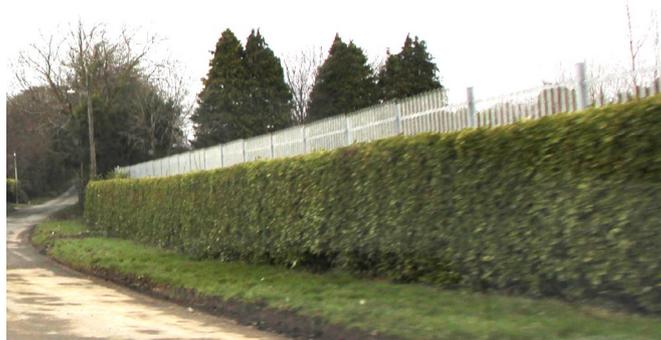
- 5) South-west of the site is a medium sized, under maintenance *Griselina* (*Griselina littoralis*) hedge of approximately 2.00m high and palisade fence that extends over approximately 200 meters from the old mushroom farm gate to the conifers hedge (Fig. 12 - Hedge no. 5).

Figure 13. South-west Griselinia hedge with palisade fence (Hedge no. 5)
