5.0 ARCHITECTURAL HERITAGE

5.1 INTRODUCTION

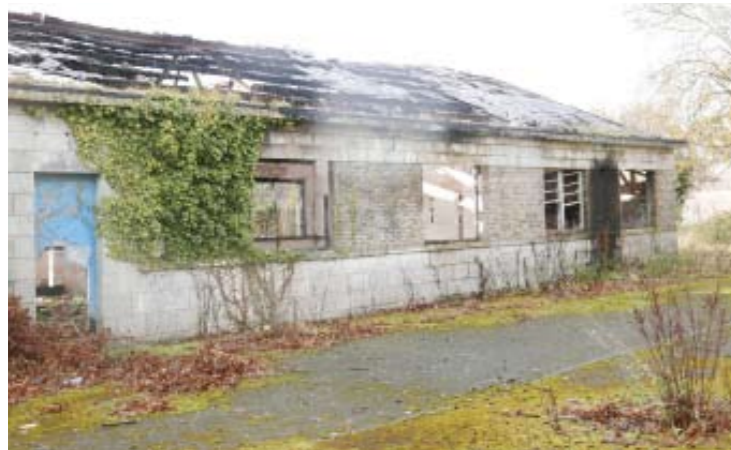
Picture 8: Building 1, NCO's mess. The west end of which is burnt out

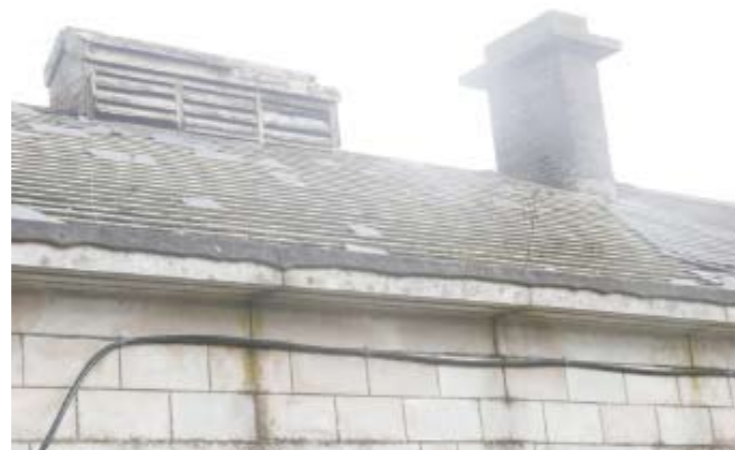
Picture 9: Lantern to Building 1

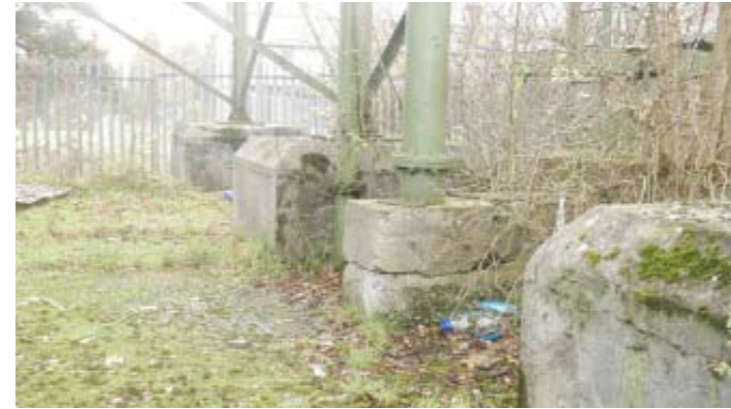
Picture 23: Building 4, foundations

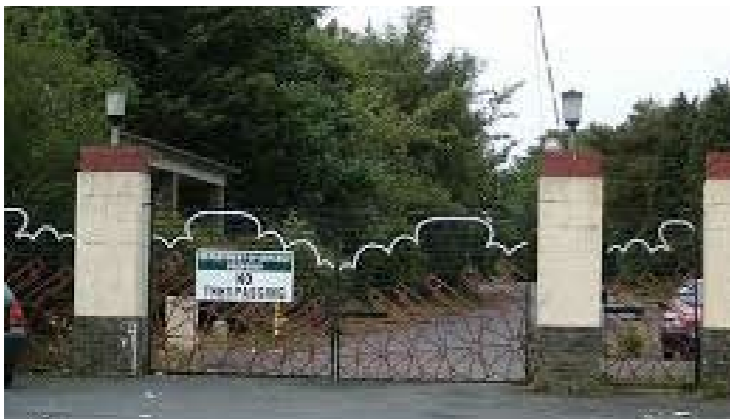
Picture 24: Original gates to be returned to entrance as above historic photo

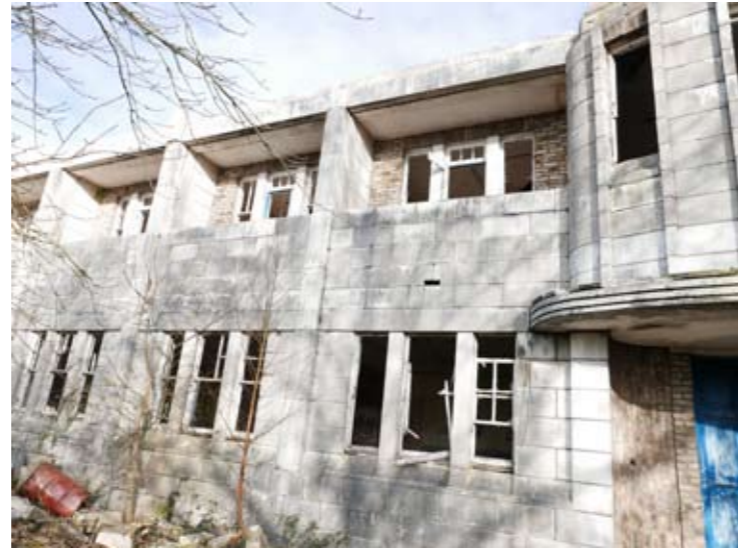
Picture 33: Building 9. The South elevation of the former Officer's Mess. It has deteriorated significantly and many of the openings having been badly damaged or destroyed

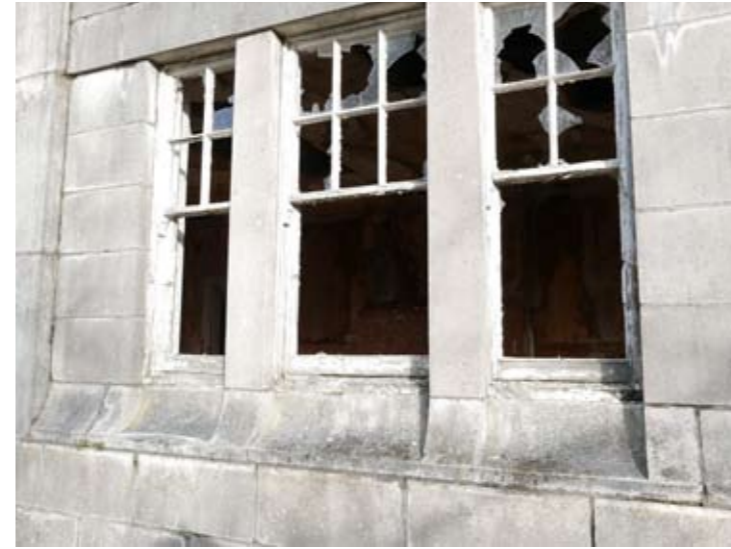
Picture 34: Building 9:

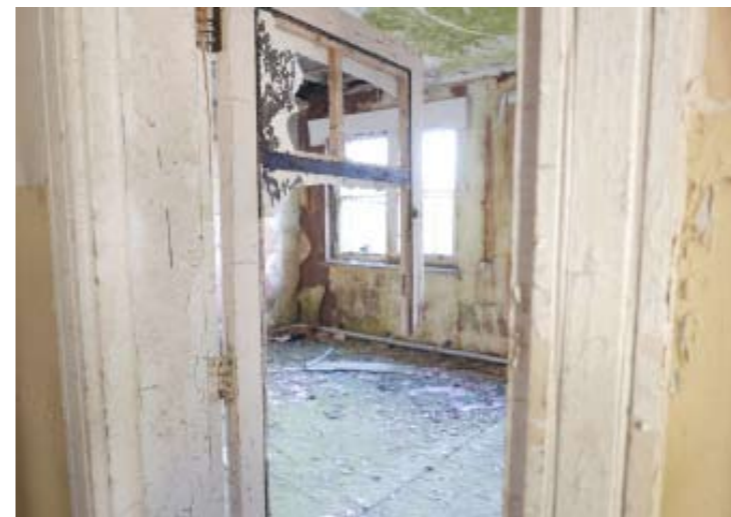
Picture 74: Building 13. The interior contains no features of note and is in poor condition

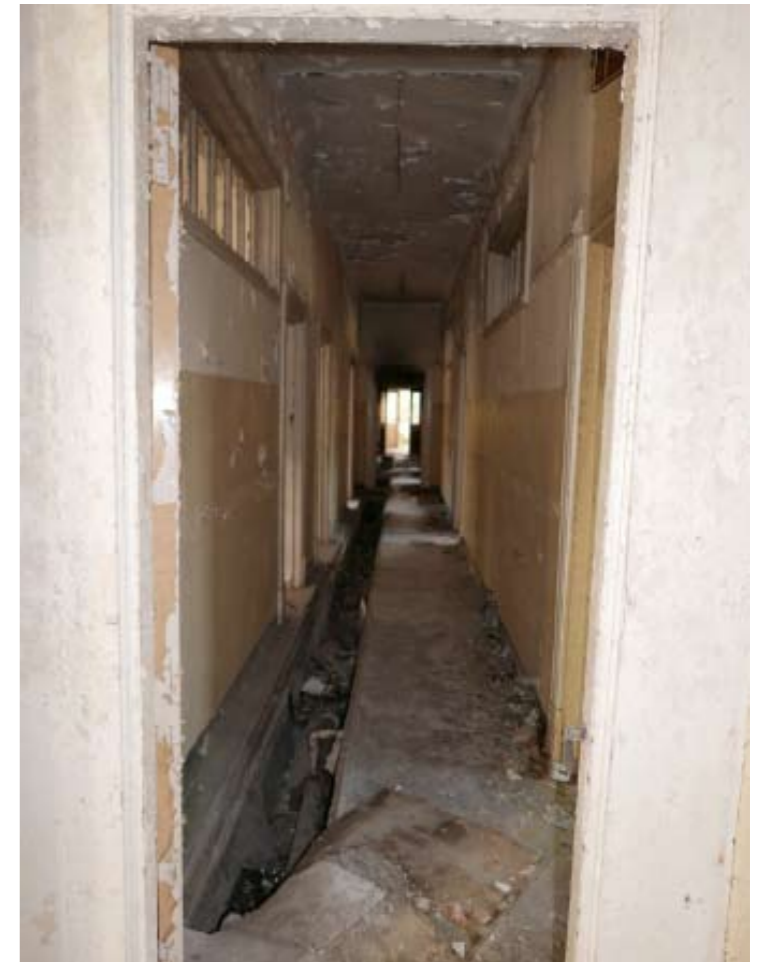
Picture 75: Building 13

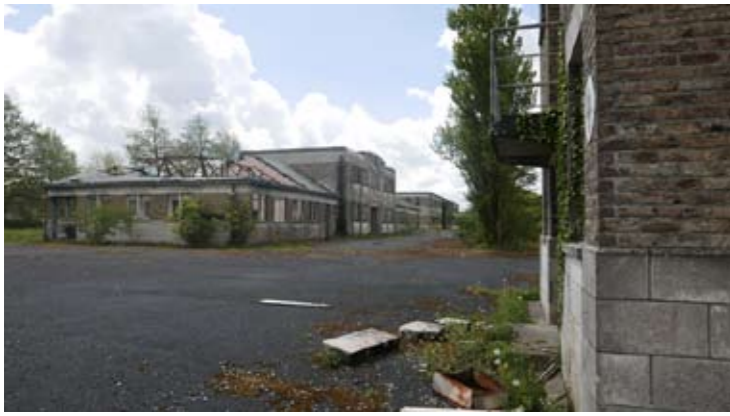
Picture 76: Building 14 with building 13 beyond and the corner of building 18 in the foreground. The buildings are located on the east side of the barrack square. Building 14 has been burnt out and the roof is gone on one of the wings.

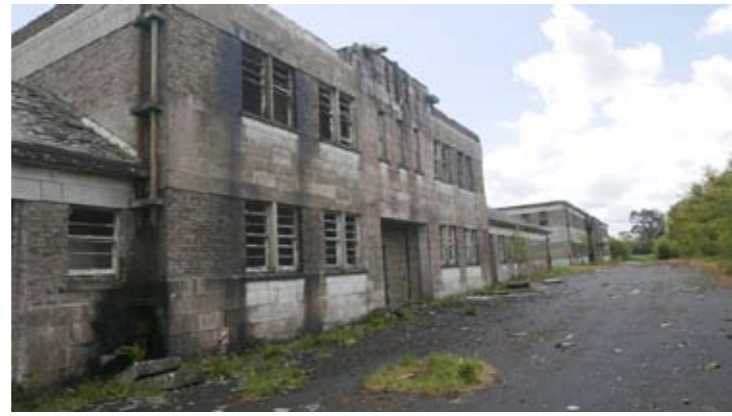
Picture 77: Building 14 with building 13 beyond
