Tree & Hedgerow Survey and Arboricultural Impact Assessment

Magee Barracks
Kildare Town
Co. Kildare

21 July 2019

DOCUMENT:
6362 – Tree Survey Report

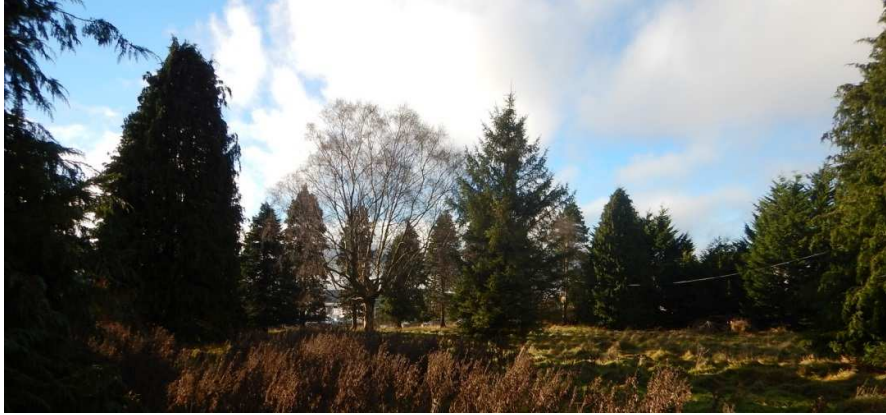
Photo 1. Mixed conifers and Birch trees north-west of the main entrance

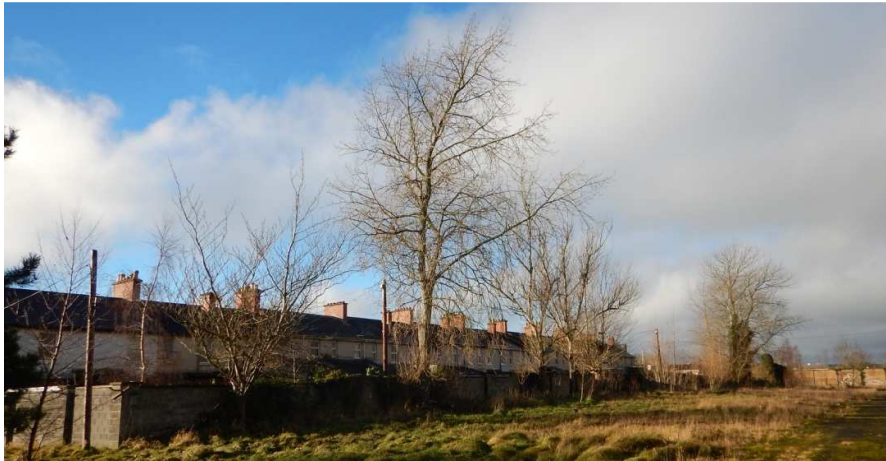
Photo 2. Row of trees (Poplars and Cherry 337-344) along the south-west boundary wall with neighbouring houses

344	Hybrid Black Poplar	<i>Populus serotina</i>	EM	450	1	18	1	8	4	3	3	U	<10	Poor. Low vitality. Ivy on stem. Bacterial canker on stem/branches.	Fell.	5.4
345	Sycamore	<i>Acer pseudoplatanus</i>	M	800	1	14	1.5	7	6	5	6	B2	20+	Fair. Average vitality. Attractive multistem pollard from 3m. some recent removal of lower branches.	Target prune damaged branches.	9.6
346	Beech	<i>Fagus sylvatica</i>	EM	500	1	14	1.5	4	4	4	4	C2	10+	Fair. Average vitality. Tree surrounded by tarmac surfacing. Stem divides above 1.5m. Poor historic pruning.	No work needed.	6
347	Whitebeam	<i>Sorbus aria</i>	EM	325	1	7	1	4.5	3	2	4.5	U	<10	Poor. Average vitality. Poor shape & form. Tree surrounded by tarmac surfacing. Recent fire damage and branch removal - some poor historic pruning.	Fell.	3.9
348	Beech	<i>Fagus sylvatica</i>	M	600	1	11.5	2	4	4	3	2.5	C2	10+	Poor. Average vitality. Tree surrounded by tarmac. Recent and historic branch removal - some vandalism to tree, many lower branches removed. Long linear cracking of tarmac from tree base to the east - likely to be a major root.	Prevent further vandalism.	7.2

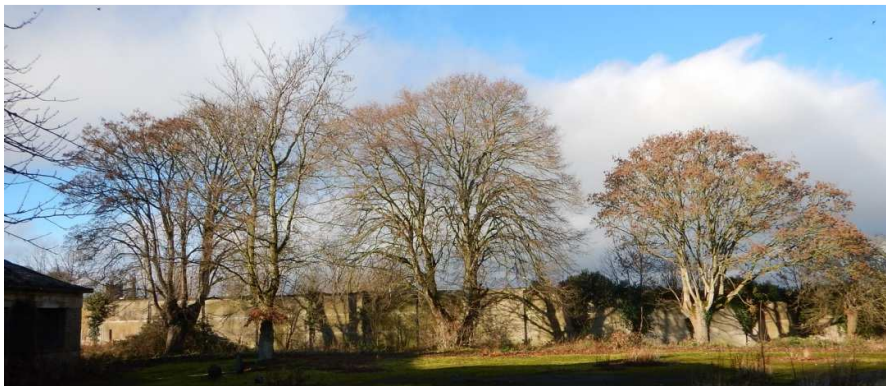
Photo 3. Mature pollards of Sycamore, Lime and Horse Chestnut (345,346, 349-351) along the western boundary

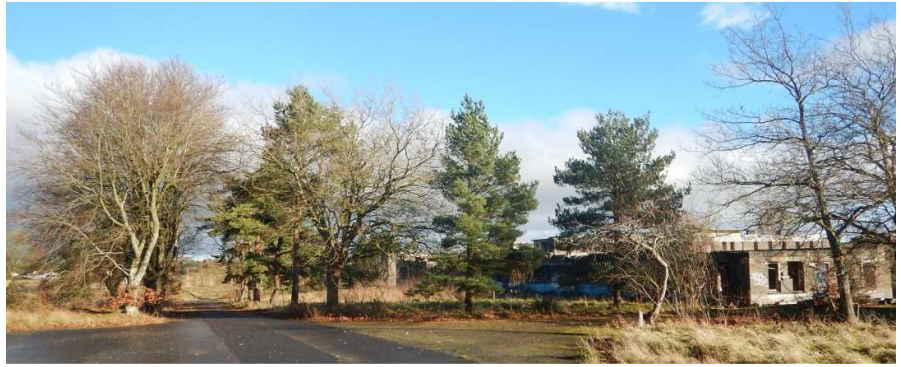
Many trees around the property have been subject to branch damage from machinery or branch removal by trespassers over recent years. The avenue of trees along the main driveway through the barracks has had branches ripped off along the roadside, possibly by excavation machinery. A significant number of trees all over the site have also been subject to lower branch removal by saw; a practice that is ongoing. Several trees have also been felled to stump.

Photo 4. Mixed species avenue of trees (373-375, 380-389) along central driveway

375	Beech	<i>Fagus sylvatica</i>	EM	450	1	14.5	1	5	5	5	5	B2	20+	Fair. Average vitality. Some bark wounds to stem base. Recent removal of large limb at 1.5m. Branching damaged over roadway. Tight union on main stem at 2m; fork appears stable at present.	Crown clean.	5.4
376	Hybrid Black Poplar	<i>Populus serotina</i>	M	500	1	23	2	4	6	5	4	C2	10+	Fair. Average vitality. Large tree of upright form.	No work needed.	6
377	Hybrid Black Poplar	<i>Populus serotina</i>	M	700	1	18	2	4	5	5	4	U	<10	Poor. Declining. Poor shape & form. Compression fork on main stem. Diseased branches in crown. Bacterial canker on stem/branches.	Fell.	8.4

The Scots Pine and Lime trees tagged T378-T380 will be retained from the linear groups established along the main avenue of the barracks and incorporated into a new open space.

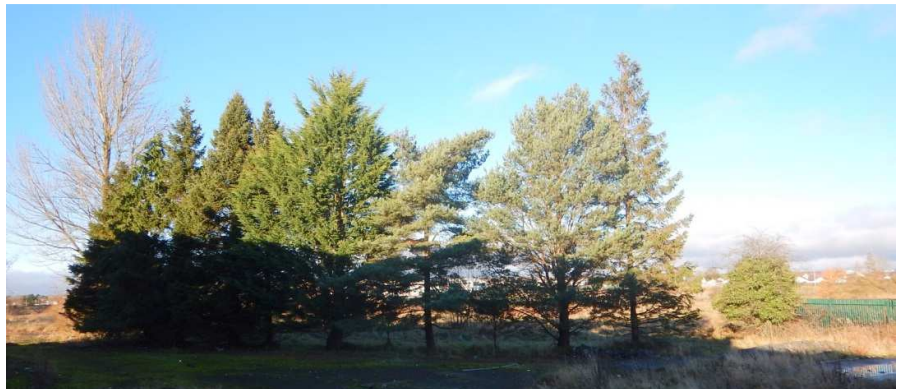
Photo 5. Mixed conifer tree group G6 viewed from the south-east

Tree group G6 could also be considered for retention; this group is made up of relatively low value individuals but could be considered to be of moderate (category B) collectively on the basis of the good health of the trees and the landscape screen that the group provides.

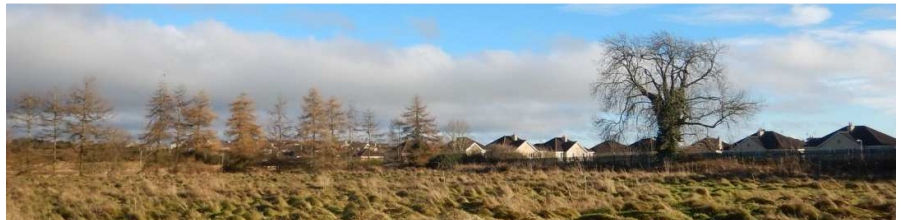
Photo 6. Tree group G7 and untagged mature Ash tree outside fence viewed from the west

Type	No	Species	Botanical Name	Age	Dbh	Ht	Spread	Cat	ULE	Condition/Comments	Preliminary Management Recommendations	RPA
G	7	European Larch Crack Willow	<i>Larix decidua</i> <i>Salix fragilis</i>	EM	200 to 300	8 to 12	6	C2	10+	Fair. Row of Larch trees of upright form at 2-3m spacing between 2 fields. Mostly low vitality. Occasional self-sown Willow along line.	No urgent work needed.	3
G	8	Hawthorn Elder	<i>Crataegus monogyna</i> <i>Sambucus nigra</i>	M	250	4 to 5	3	C2	10+	Fair. Low vitality. Scattered bushes growing on sloping ground in the north-east boundary area of site.	No significant works needed; I would recommend some re-enforcement planting of mixed tree species (Hazel, Oak, Pine etc.) along slope protected by stock-proof fencing.	3
G	9	Horse Chestnut Rowan	<i>Aesculus hippocastanum</i> <i>Sorbus aucuparia</i>	SM	100 to 250	4 to 5	6	C2 U	<10	Poor/Fair. Small plantation of 5x Chestnuts suffering from Bleeding Canker, 3x smaller Rowan in fair condition.	Monitor progress of Bleeding Cank in Chestnuts; I would recommend their removal and replacement.	3

The untagged mature Ash tree (shown in photo 6 below) located just outside the fence-line on the eastern boundary should be subject to more detailed inspection and considered during the planning/design process for the re-development of the site.

The large mature Ash tree (untagged) on the fence-line adjacent to the Ruanbeg Estate on the north-eastern edge of the site will also be retained.

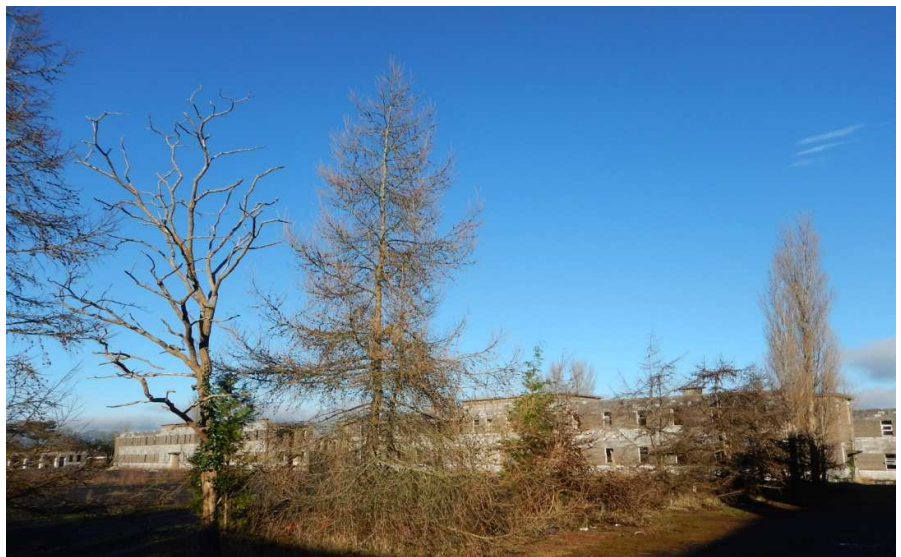
Photo 8. Tree group G10 viewed from the south

G	10	Larch Lombardy Poplar Locust Tree	<i>Larix spp.</i> <i>Populus nigra 'Italica'</i> <i>Robinia pseudoacacia</i>	SM EM M	<100 to 300	4 to 16	4 to 6	C2 U	<10	Poor/Fair. Row of trees established along a thin landscape bed at the eastern side of the large courtyard in the eastern half of the site. Mostly Larch with some Locust trees in mostly poor condition or dead. 2x bigger Poplars in fair condition at northern end of group.	Trees of very limited value; Poplar roots are disrupting the surrounding tarmac and the restricted growing environment is retarding proper growth and development of all of the trees. I would recommend removal of all trees.	3.6
G	11	Horse Chestnut Silver Birch Sycamore	<i>Aesculus hippocastanum</i> <i>Betula pendula</i> <i>Acer pseudoplatanus</i>	SM EM	200 to 300	8 to 10	4 to 8	C2 U	10	Fair/Poor. Short row of mostly multi-stem trees. Some bark wounding to lower stems and possible root damage, overgrown with brambles etc. Trees obviously unmanaged for some time; relatively low value.	Clear brambles and review in full leaf.	3.6

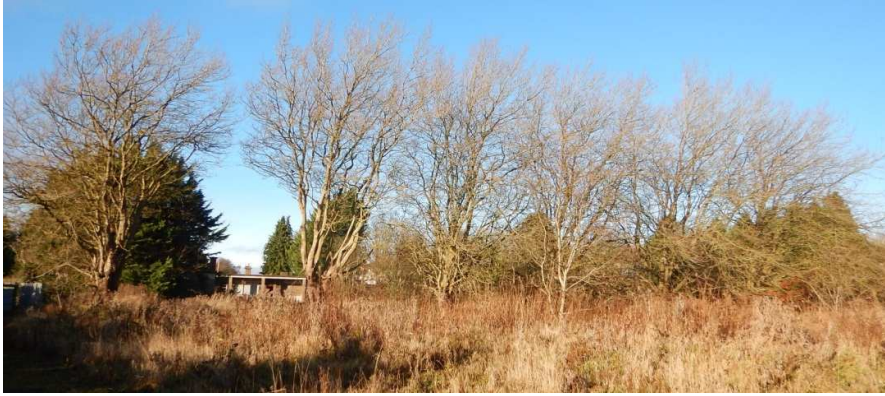
Photo 10. London Plane trees 425-430 viewed from the south-east

Tag	Species	Botanical name	Age	Dbh	St	Ht	Cl	N	S	E	W	Cat	ULE	Conditions/Comments	Recommendations	RPA
429	London Plane	<i>Platanus X hispanica</i>	M	650	1	15	2	7	5	7	6	B2	20+	Fair. Average vitality. Part of linear group. Some historic root damage likely. Several lower branches ripped off on lower south and western side of stem.	Prune to re-shape\balance crown. Target prune damaged branches. Monitor tree condition.	7.8
430	London Plane	<i>Platanus X hispanica</i>	M	700	1	14	0.5	6	7	6.5	7	C2	10+	Poor. Low vitality. Some historic root damage likely. Branching ripped off northern and eastern side of tree; including co-dominant stem from main leader at 3m to leave large wound. Spoil built up close to west of tree stem.	Prune to re-shape\balance crown. Crown reduce 30%. Reduce extended limbs. Consider pollarding. Carefully remove spoil.	8.4
431	Flowering Cherry	<i>Prunus spp.</i>	EM	219	2	5	1.5	3.5	2.5	2	3	C2	10+	Fair. Good vitality. Smaller specimen.	No work needed.	2.6

The southern-most three London Plane trees (tagged T428, T429 and T430) from the existing linear group of six trees will be retained within the small landscape area to the west of the proposed new entrance drive into the development. This will retain at least part of the original feature and contribute some landscape maturity and amenity value to the road frontage area of the development.
