Arboricultural Report

Tree Survey,
Arboricultural Impact Assessment &
Arboricultural Method Statement

**Colp West
Drogheda
Co. Meath**

October 2019

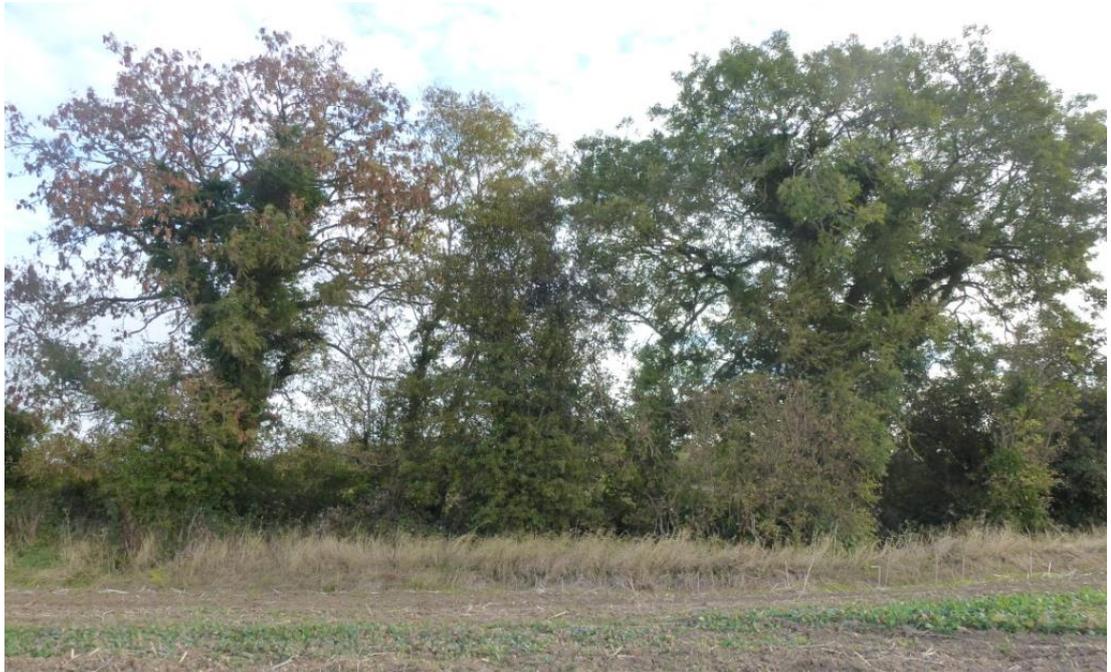
Photo 1 (CM / Oct '18): View of the mature ash trees T613 & T618 and the boundary hedgerow H616.

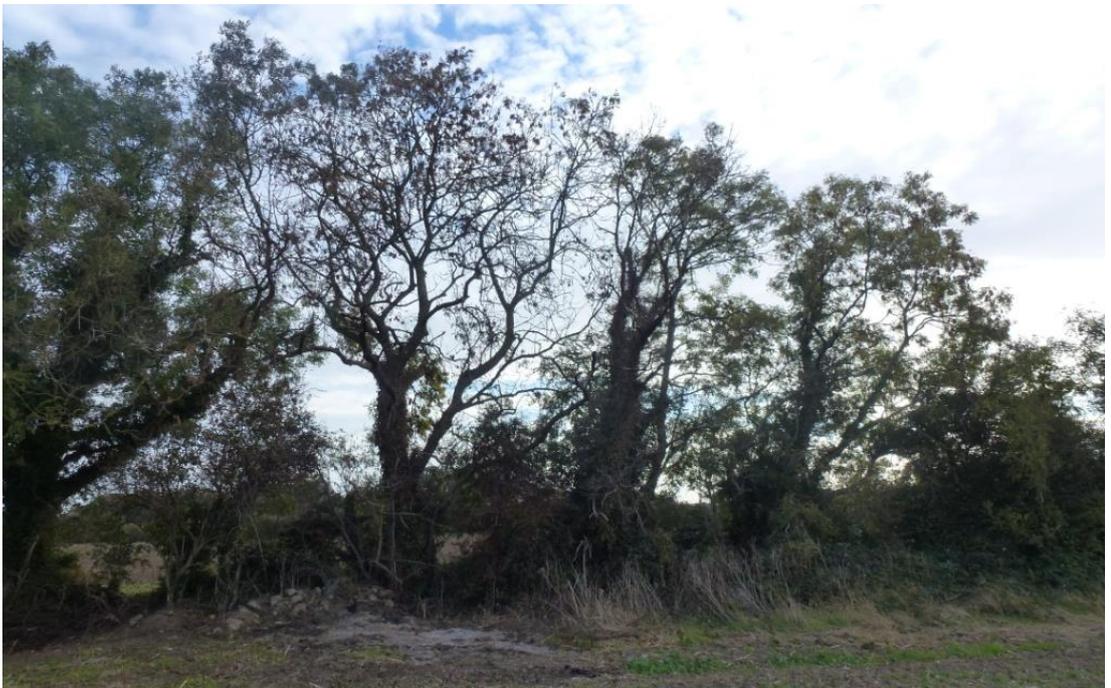
Photo 2 (CM / Oct '18): View of ash trees T614, T615 & T616. The trees are in poor condition as a result of fire damage and have a limited future life expectancy.

Tree T615	1 Fraxinus excelsior (Ash)	13.0	65	1		6.0		6.0		6.0		2.0	2.0		Mature	Structural condition Poor. Physiological condition Poor. Access to inspect base - Not possible. Competition - Adjacent trees. Decline - Evident / observed. Deadwood - Major. Fire damage - Crown. Ivy or climbing plant. Multi-stemmed. Tree located on opposite side of ditch. Unable to inspect tree closely due to ivy cover. Tree is not tagged as access to stem is restricted Unable to inspect tree closely due to dense scrub.	01/10/2018	191.1	7.8	0-10	U

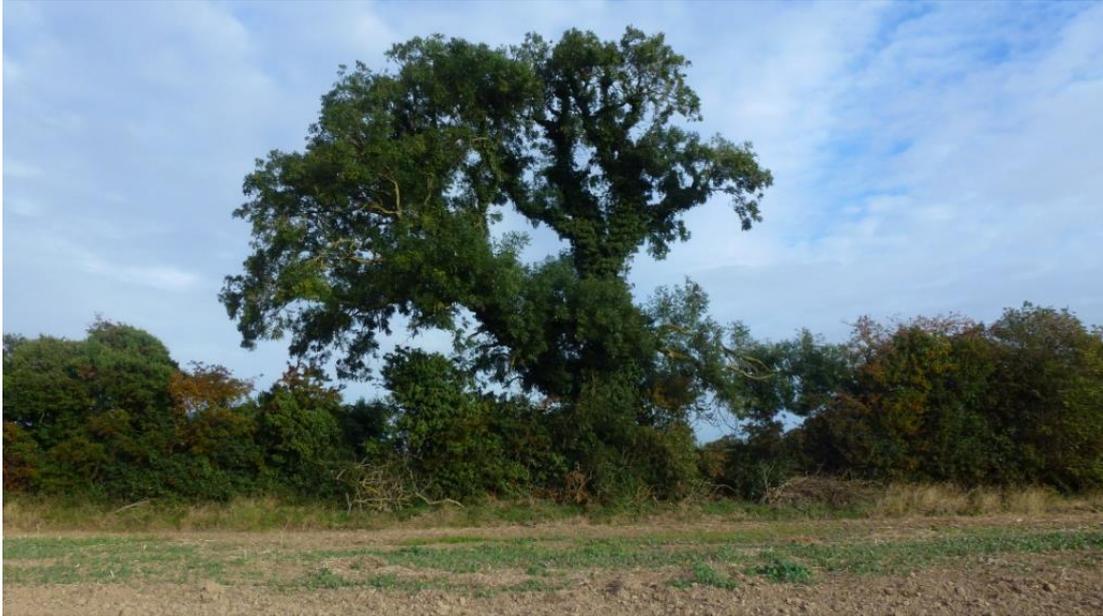
Photo 3 (CM / Oct '18): View of the mature ash tree T944 and the boundary hedgerow H945.

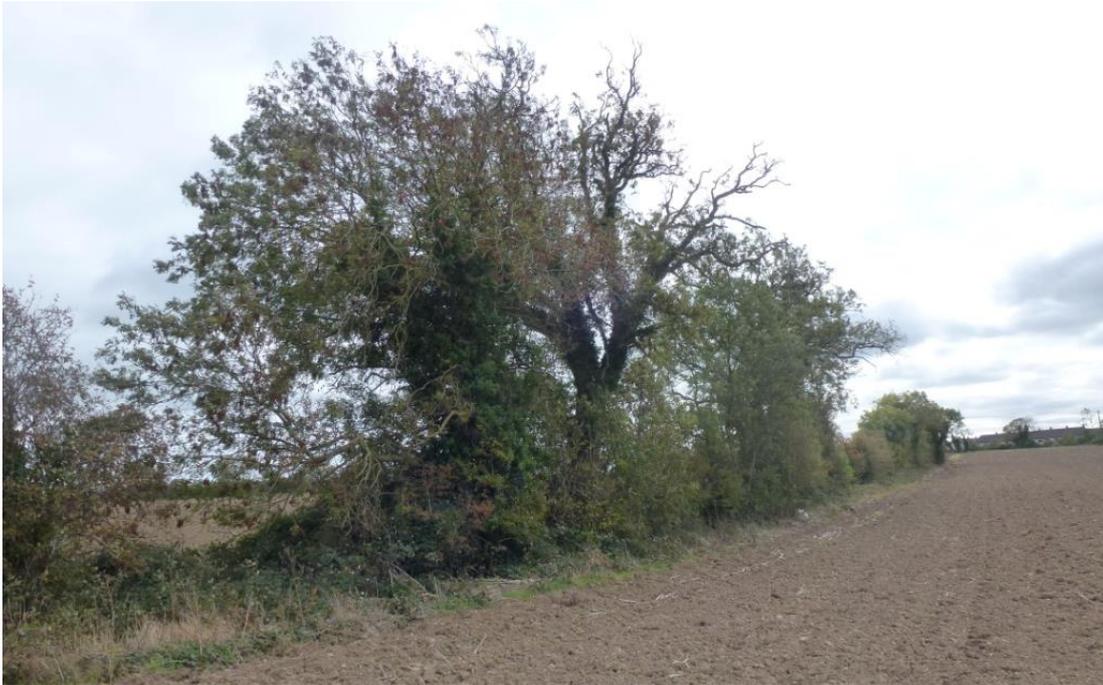
Photo 4 (CM / Oct '18): View of the mature trees and hedgerow (T622 to T644) growing within the centre of the site.

Tree T622	1 Fraxinus excelsior (Ash)	20.0	80	1	9.0		7.0		4.0		8.0			Mature	Structural condition Poor. Physiological condition Fair. Access to inspect base - Restricted / obscured. Branch - Broken. Competition - Adjacent trees. Decay / structural defect in crown limb / limbs - Extensive. Deadwood - Minor. Decay / structural defect - Suspected. Epicormic growth - Base. Fungal fruiting body - structural decay suspected. Unbalanced crown - Minor. Inonotus hispidus on dead branch close to stem on northern side of the canopy at 6m and on western side of stem at 2m. Unable to inspect tree closely due to epicormic growth. Bacterial canker of Ash within crown structure – suspected weak live growth.	01/10/2018	289.5	9.6	0-10	U	
Tree T623	1 Fraxinus excelsior (Ash)	21.0	95	1	4.0		7.5		5.5		8.5			Mature	Structural condition Fair. Physiological condition Fair. Access to inspect base - Restricted / obscured. Branch - Broken. Competition - Adjacent trees. Decay entry points. Deadwood - Minor. Unable to inspect tree closely due to ivy cover. Major limb broken off stem at 2.5m east - suspected machine damage rather than failure.	01/10/2018	408.3	11.4	10-20	C2

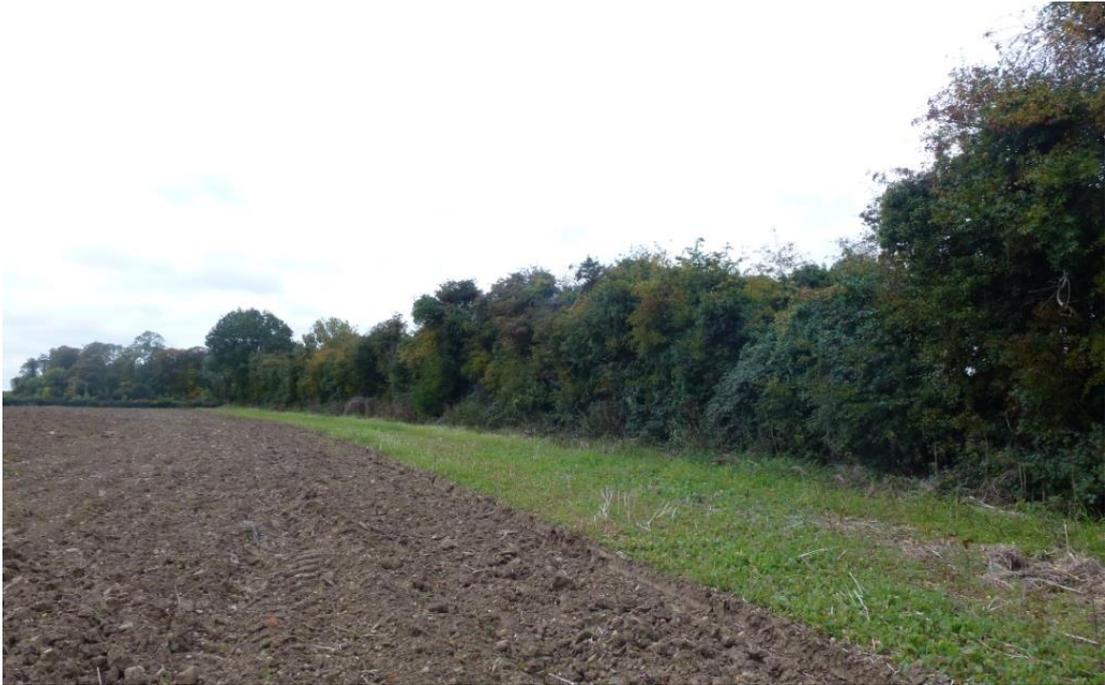
Photo 5 (CM / Oct '18): View of the boundary hedgerow H670.

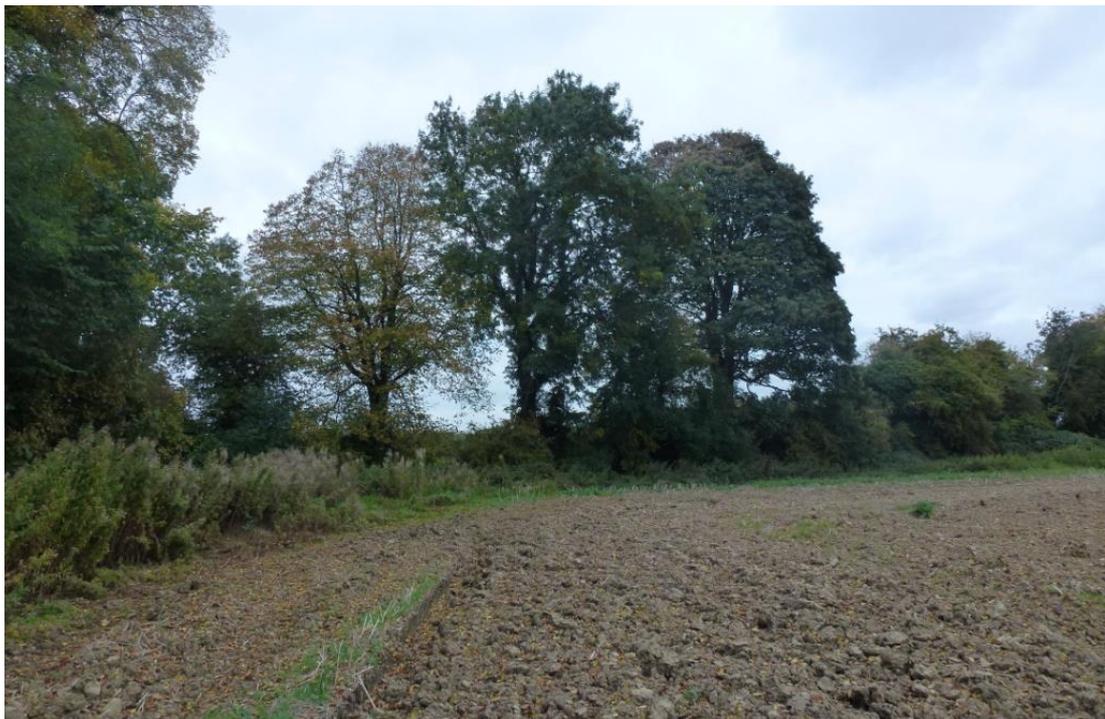
Photo 6 (CM / Oct '18): View of the mature boundary trees T650 to T652.

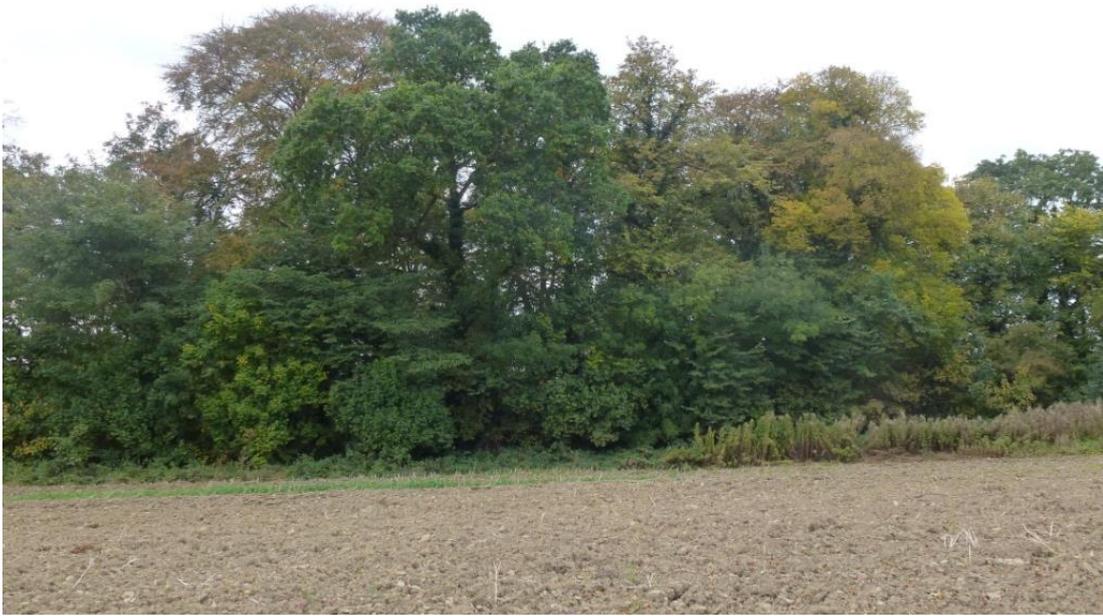
Photo 7 (CM / Oct '18): View of the mature woodland W669 located between the site and the railway line.

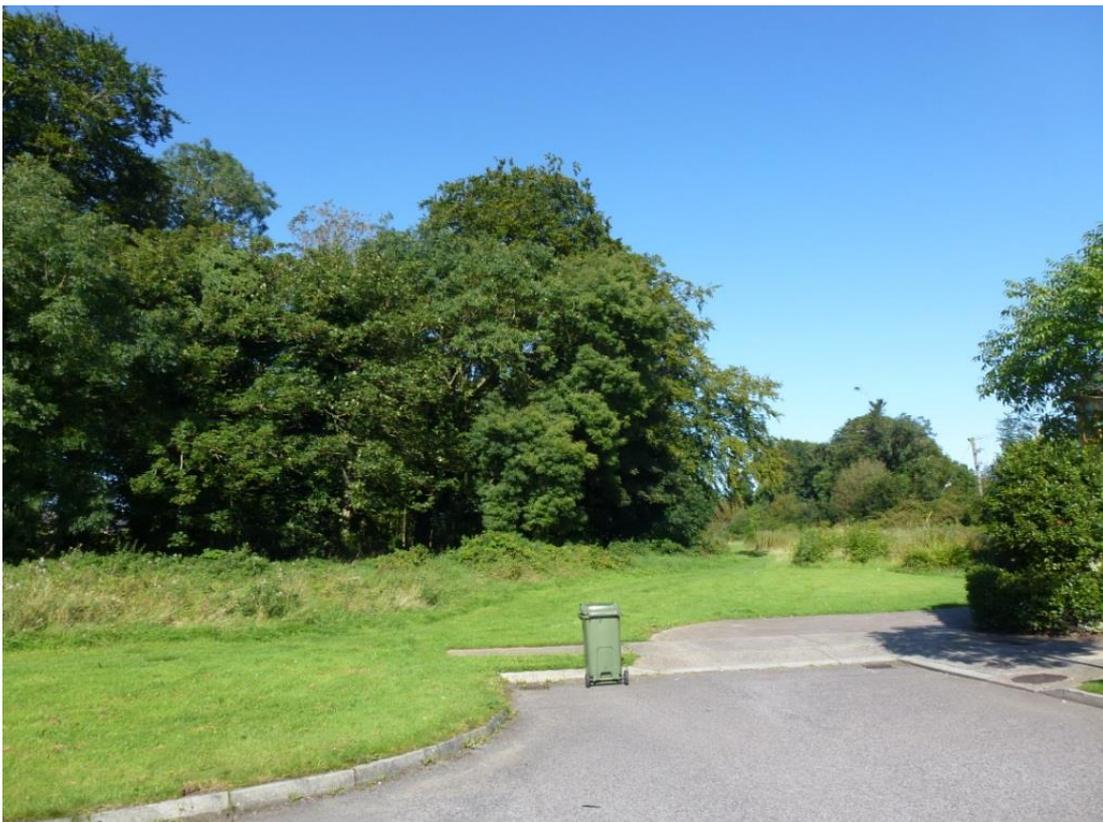
Photo 8 (CM / Aug '19): View of the mature woodland W495 located to the west of the existing railway line and adjacent to the proposed footpath and footbridge.
