Re: An Arboricultural Assessment of the Trees on the Site Area at 'Shanganagh Castle', Shankill, Co. Dublin.

An Arboricultural Assessment of the Trees on the Site Area at 'Shanganagh Castle', Shankill, Co. Dublin.

Prepared for: Dùn -Laoghaire Rathdown County Council

Date: 21st January 2020

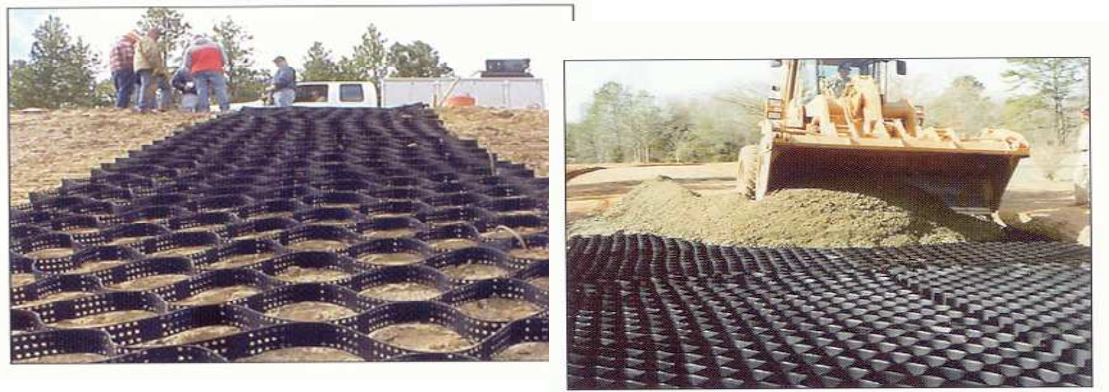
Pictures show the Cell Web being installed on the ground.

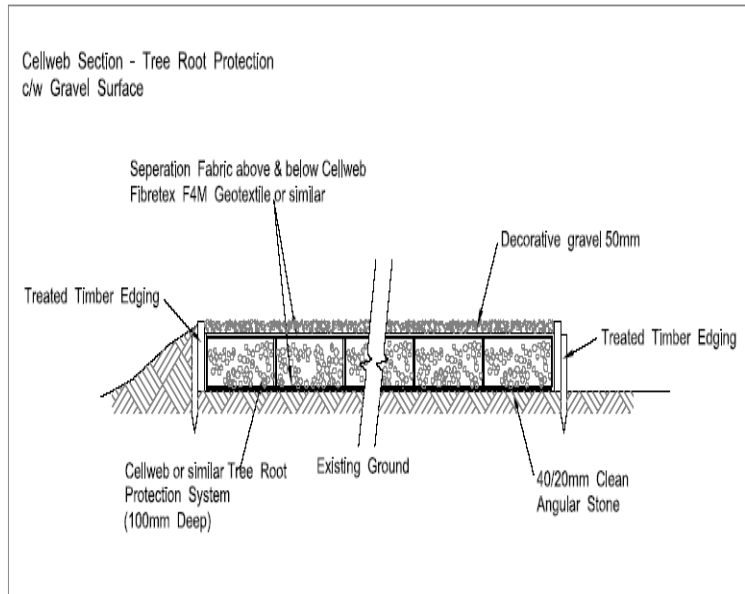
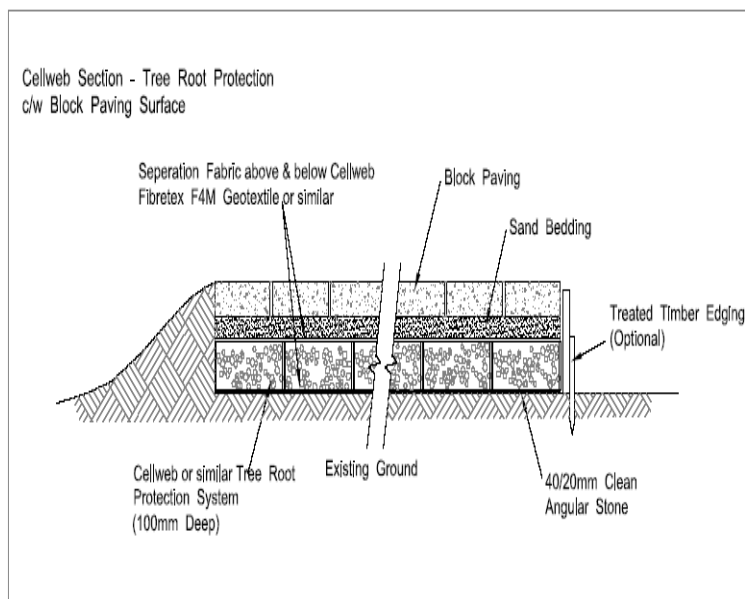
The below diagram shows how the Cellular confinement system should be installed.

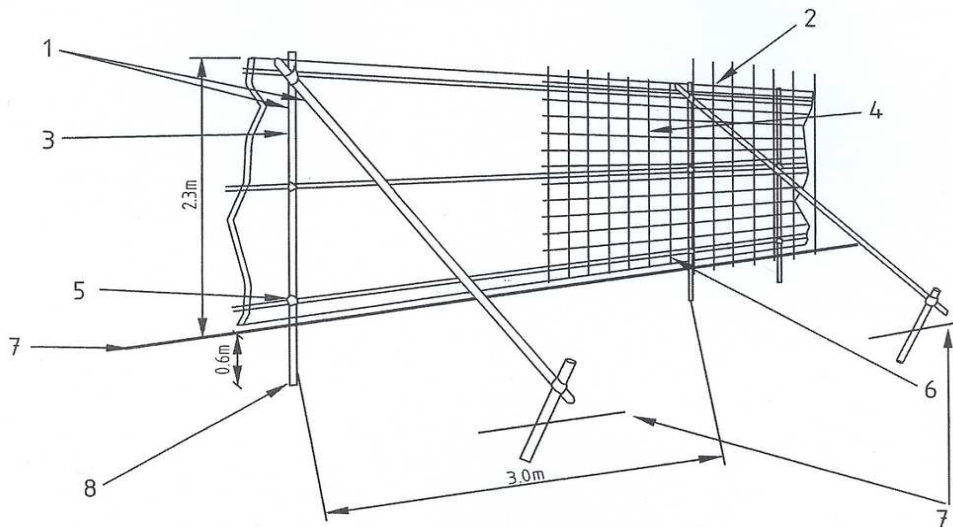
Figure 2. – Protective fencing for RPA

Sample of Temporary Tree Protection Fencing Detail.
