Castlebanny Wind Farm Peat Stability Risk Assessment

DATE 12th January 2021 DOCUMENT P20_021_RP001 REVISION P04 S4

Report prepared for: **TOBIN Consulting Engineers,** Block 10-4, Blanchardstown Corporate Park, Dublin 15, Ireland. Report prepared by: Ciaran Reilly & Associates Consulting Geotechnical Engineers, Maynooth, Co. Kildare, Ireland. This report is for the private and confidential use of the named client who commissioned the report and is not to be reproduced in whole or in part or relied upon by any third party for any purpose without the express and written authority of Ciaran Reilly & Associates. Any liability arising out of the use of this report by a third party shall be the responsibility of that party, who shall indemnify Ciaran Reilly & Associates against all claims, costs, damages, or losses arising out of such use. This report has been prepared for the titled project by Ciaran Reilly & Associates with all reasonable skill, care, and diligence, and taking account of the manpower and resources devoted to it by agreement with the client.

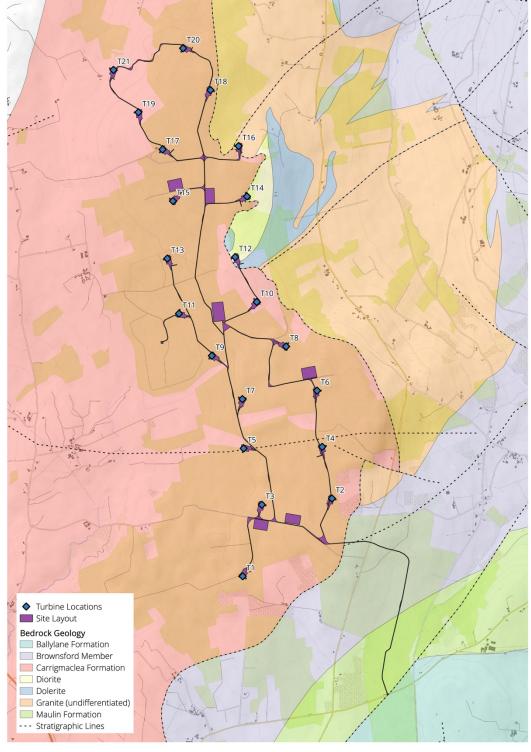
Figure 1 - Bedrock (Source: GSI 1:100,000 bedrock mapping)

Geological Survey Ireland bedrock mapping, shown in Figure 1, indicates that the proposed wind farm access road from the R704 to the south of the site is underlain by the Maulin Formation of dark blue-grey slate, phyllite and schist and the Brownsford Formation of dark grey semi-pelitic, psammitic schist.

The mapping shows that the majority of the site is underlain by the Carrigmaclea Formation of red and brown conglomerate and sandstone, with Turbine 16 potentially being underlain by undifferentiated Granite and Turbine 12 and Turbine 14 being underlain by Diorite. An unconformity between the Carrigmaclea Formation and the other formations to the west, shear zones, and a fold which have been mapped by the GSI are also shown in Figure 1.

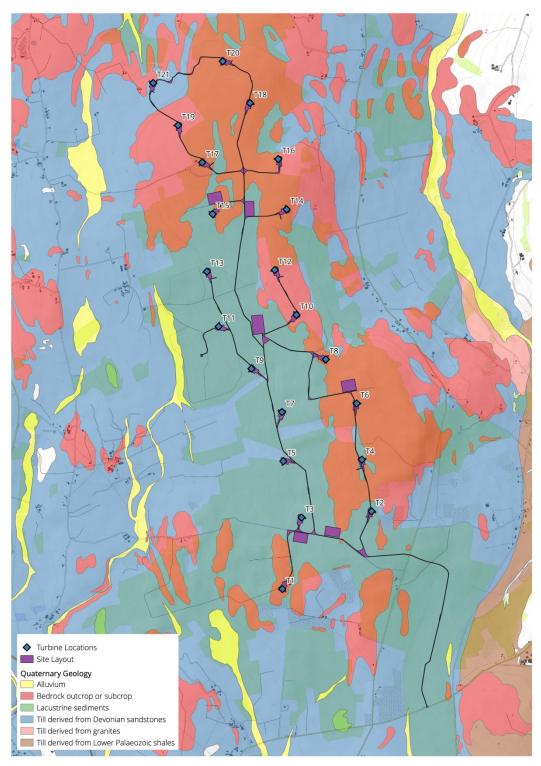
Figure 2 - Quaternary sediments (Source: GSI Quaternary mapping, 2016)

The nearest historical borehole contained in the GSI database of verified borehole logs is greater than 12 km from the wind farm development area and is not considered here. GSI quaternary mapping, indicating the likely subsoil conditions over the top one metre of the soil column, is shown in Figure 2. This mapping indicates that the site is predominantly underlain by "till derived from Devonian sandstones" with areas of "bedrock outcrop or subcrop". No peat, alluvium, or lacustrine sediments are mapped within the wind farm development area.

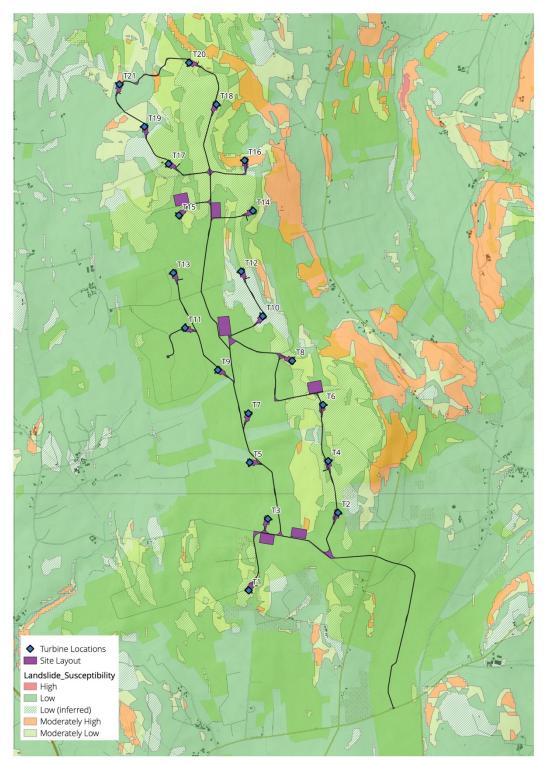
Figure 3 - Landslide susceptibility (Source: GSI National Landslide Susceptibility Mapping, 2018)

The majority of the site is designated as "Low", "Low (inferred)", or "Moderately Low" susceptibility. Turbine 16, Turbine 21, and the access road between Turbine 20 and Turbine 21 are in areas designated as "Moderately High" susceptibility. It should be noted that the GSI risk assessment only accounts for the current site topographic and hydrological conditions. The development of a wind farm can alter these parameters in the temporary and/or permanent case. There is an area which is mapped as being of "High" susceptibility, but it is 1.8km from the site.

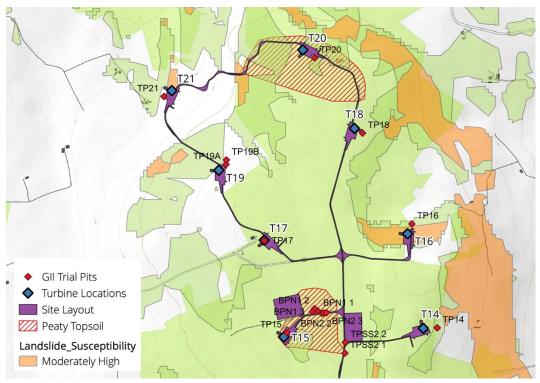
Figure 4 - Areas where peaty or organic topsoil identified during walkover survey and areas of "moderately high" landslide susceptibility (GSI, 2018a)

The walkover study carried out in August 2020 found limited evidence of peaty and organic topsoil within the site boundary, particularly to the north of the scheme. It is considered that some of this material identified as "peaty" may be recent decomposed forest floor material. The depth of this peaty or organic topsoil was less than 500mm in all cases encountered during the walkover and mostly less than 150mm. The areas where this peaty and organic topsoil was identified are shown in Figure 4, along with nearby areas of "moderately high" landslide susceptibility as identified by GSI.

There is one area where "moderately high" landslide susceptibility was identified in conjunction with peaty topsoil, between Turbine 20 and Turbine 21, however the walkover study found less than 0.15m of peaty topsoil in this location and hence it is considered that the risk of peat instability is "negligible" at this location, subject to normal design and control measures during construction.

"Moderately high" landslide susceptibility was identified at the locations of Turbine 16 and Turbine 21. On review of trial pits TP16 and TP21 and based on the site walkover, no peat was found near Turbine 16 or Turbine 21. Hence, and on further study, the risk of peat instability is considered "negligible" at these locations subject to normal design and control measures during construction. The risk of instability in soft CLAY and SILT can be managed effectively through normal design and construction mitigations and controls to secure the short- and long-term stability of the proposed earthworks.
