**Arboricultural Report
Trees at Proposed Site at
Cookstown Road
Enniskerry
Co Wicklow**

April 2021

**The Tree File Ltd
Consulting Arborists
Ashgrove House
Kill Avenue
Dun Laoghaire
Co Dublin
01-2804839**

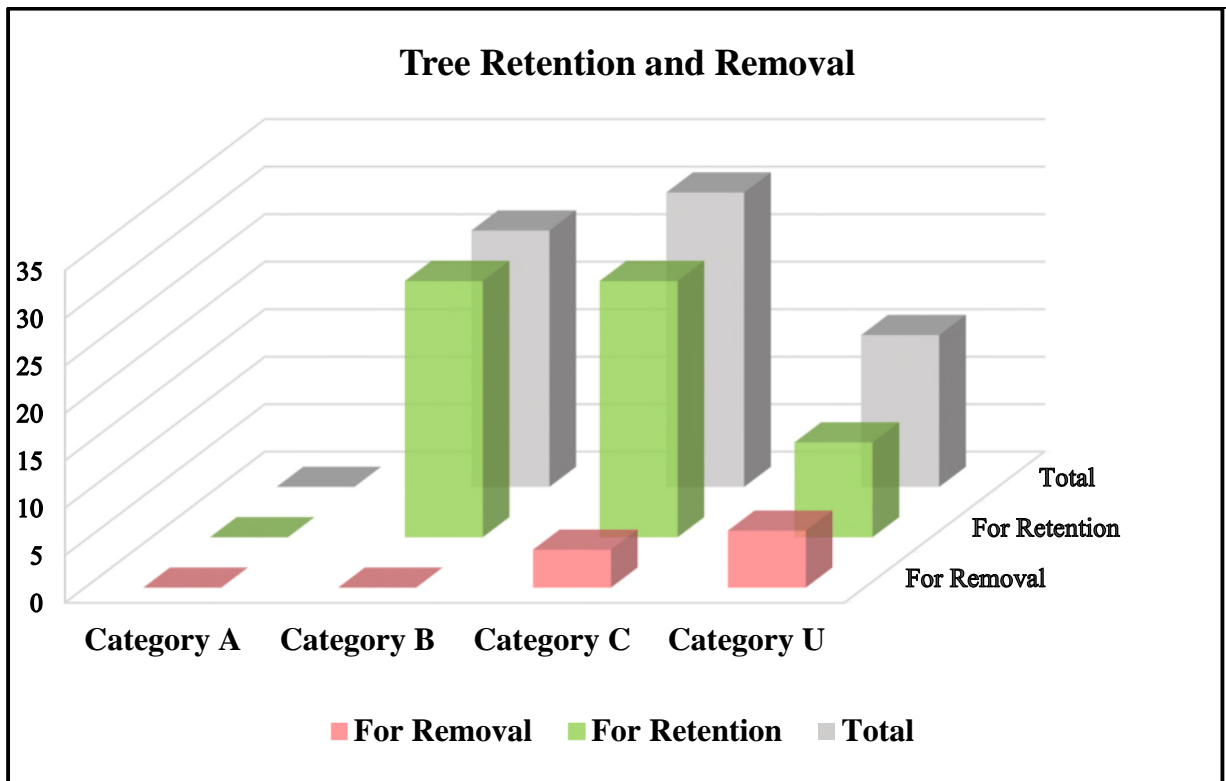
Fig 5 Graphic Representation of Tree Loss/Retention Scenario

11.7 Total development related tree loss - 13 Trees/tree groups
