Re: An Arboricultural Assessment of the Tree Vegetation on the Site Area at 'Charlestown Place SHD', Finglas, Dublin 11.

An Arboricultural Assessment of the Tree Vegetation on the Site Area at 'Charlestown Place SHD', Finglas, Dublin 11.

Prepared for: BMA Planning.

Date: 14th July 2020

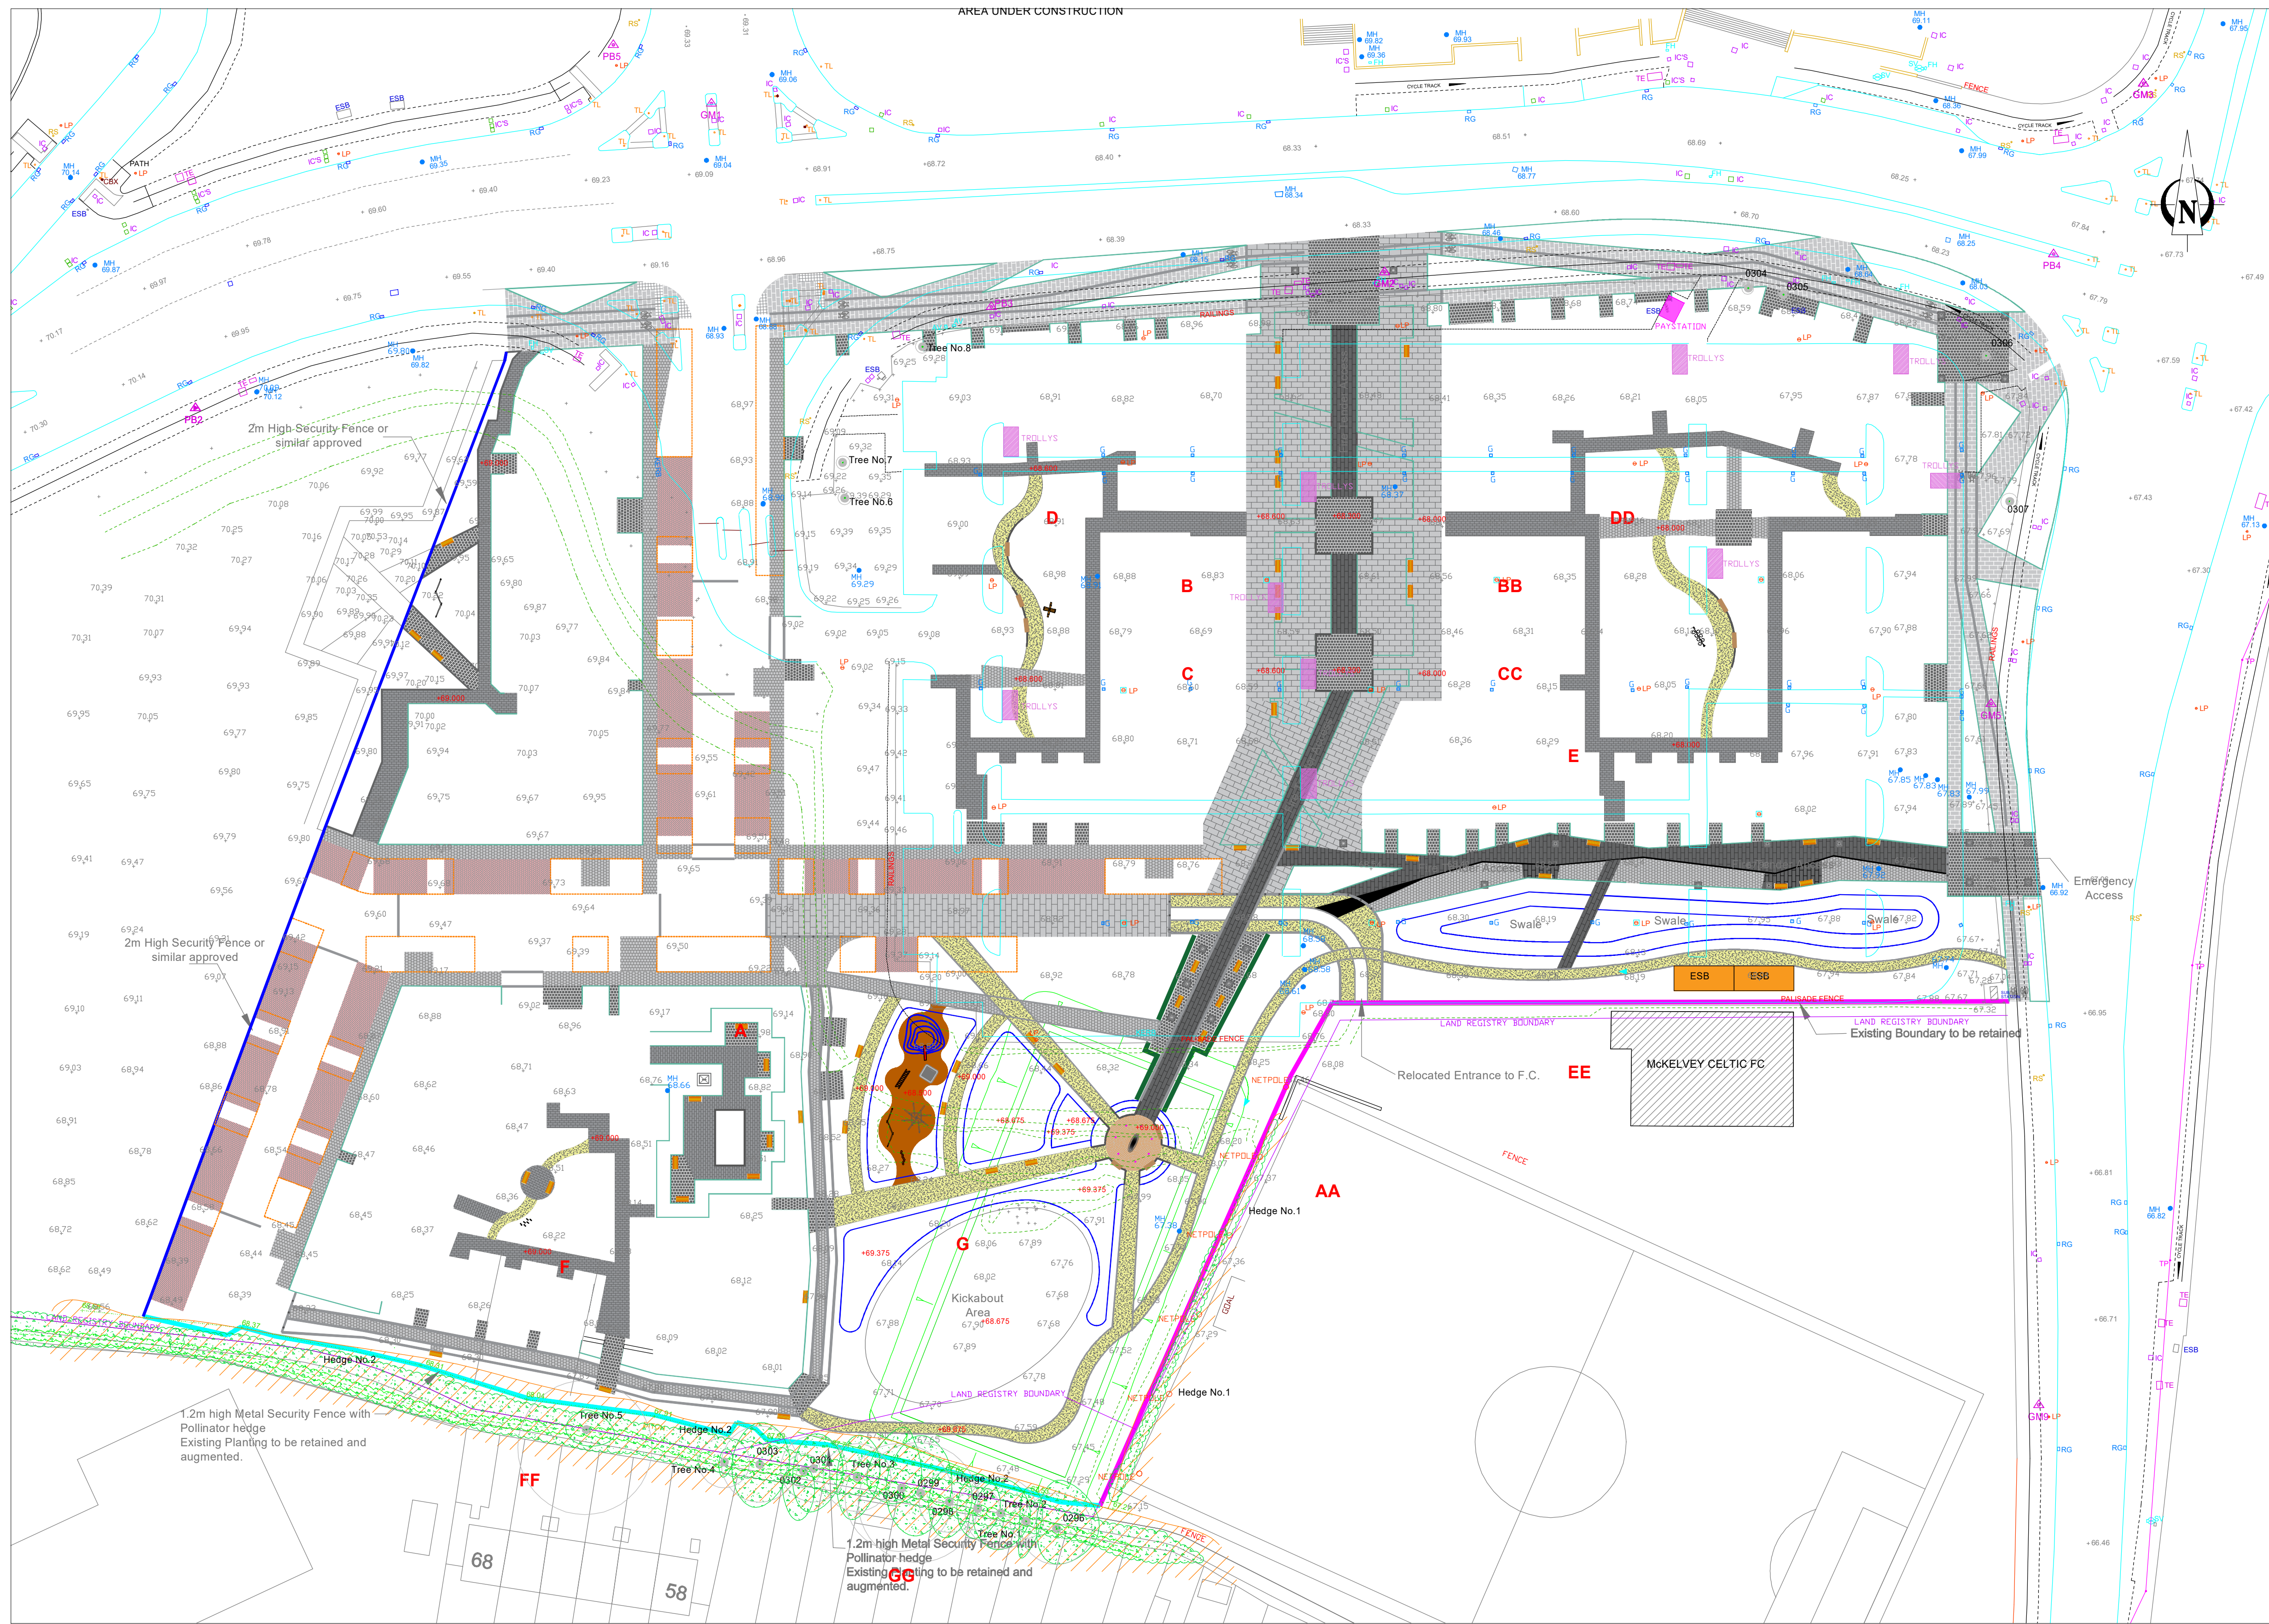
DATE: Dwg No. CLP002 Scale 1:500 © A1

- 5.2 It is proposed to develop these lands for a new residential scheme and it will be necessary to allow for infrastructural works such as services. On drawing (No.CLP002), I have shown the tree vegetation for removal due to the proposed development layout and condition/management with 'Red Hatched' crown spreads and those to be retained with a 'Green Hatched' crown spread.

- 5.3 On this drawing (No.CLP002), I have also shown the position of any necessary tree protection measures in order to protect the root zone of the tree and hedge vegetation being retained within the vicinity of where the construction works will occur. These work exclusion zones are shown on this drawing using 'Orange Hatching' and these areas will need to be cordoned off by the erection of fencing or other means such as ground protection at the start of the works and this will need to be maintained in place until all works are completed.

To facilitate the proposed development, it will be necessary to remove Tree Nos. 6, 7, 8, 0304, 0305, 0306 & 0307 all young Birch trees planted into linear grass verges as part of the landscaping around the existing surface car parking. These trees are of a small size and their loss to the treescape of the surrounding area is negligible and their loss can be easily mitigated within the completed landscaped development with new tree, shrub and hedge planting.

The tree protection fencing is to be erected enclosing the root protection areas around the trees being retained as shown on this drawing and appendix 1 in some areas, the site hoarding may be sufficient to act as the protective fencing if the tree and its root zone are positioned outside and no works are envisaged within the area outside the site hoarding. This will need to be discussed and agreed at the initial site meeting.

Where tree protection fencing is needed, this will need to be 2.3m high and constructed in accordance with figure 2 of BS 5837 2012 (see detail on drawing & appendix 1) using vertical and horizontal scaffold bars or similar well braced together with the verticals spaced out at a maximum of 3m centres. Onto this, weld mesh panels (harris fence panels) are to be securely fixed with wire or scaffold clamps.

Signs are to be attached to these fences warning people that this is a protective area and that the fencing must be maintained in good condition in accordance with the approved plans and drawings for this development.

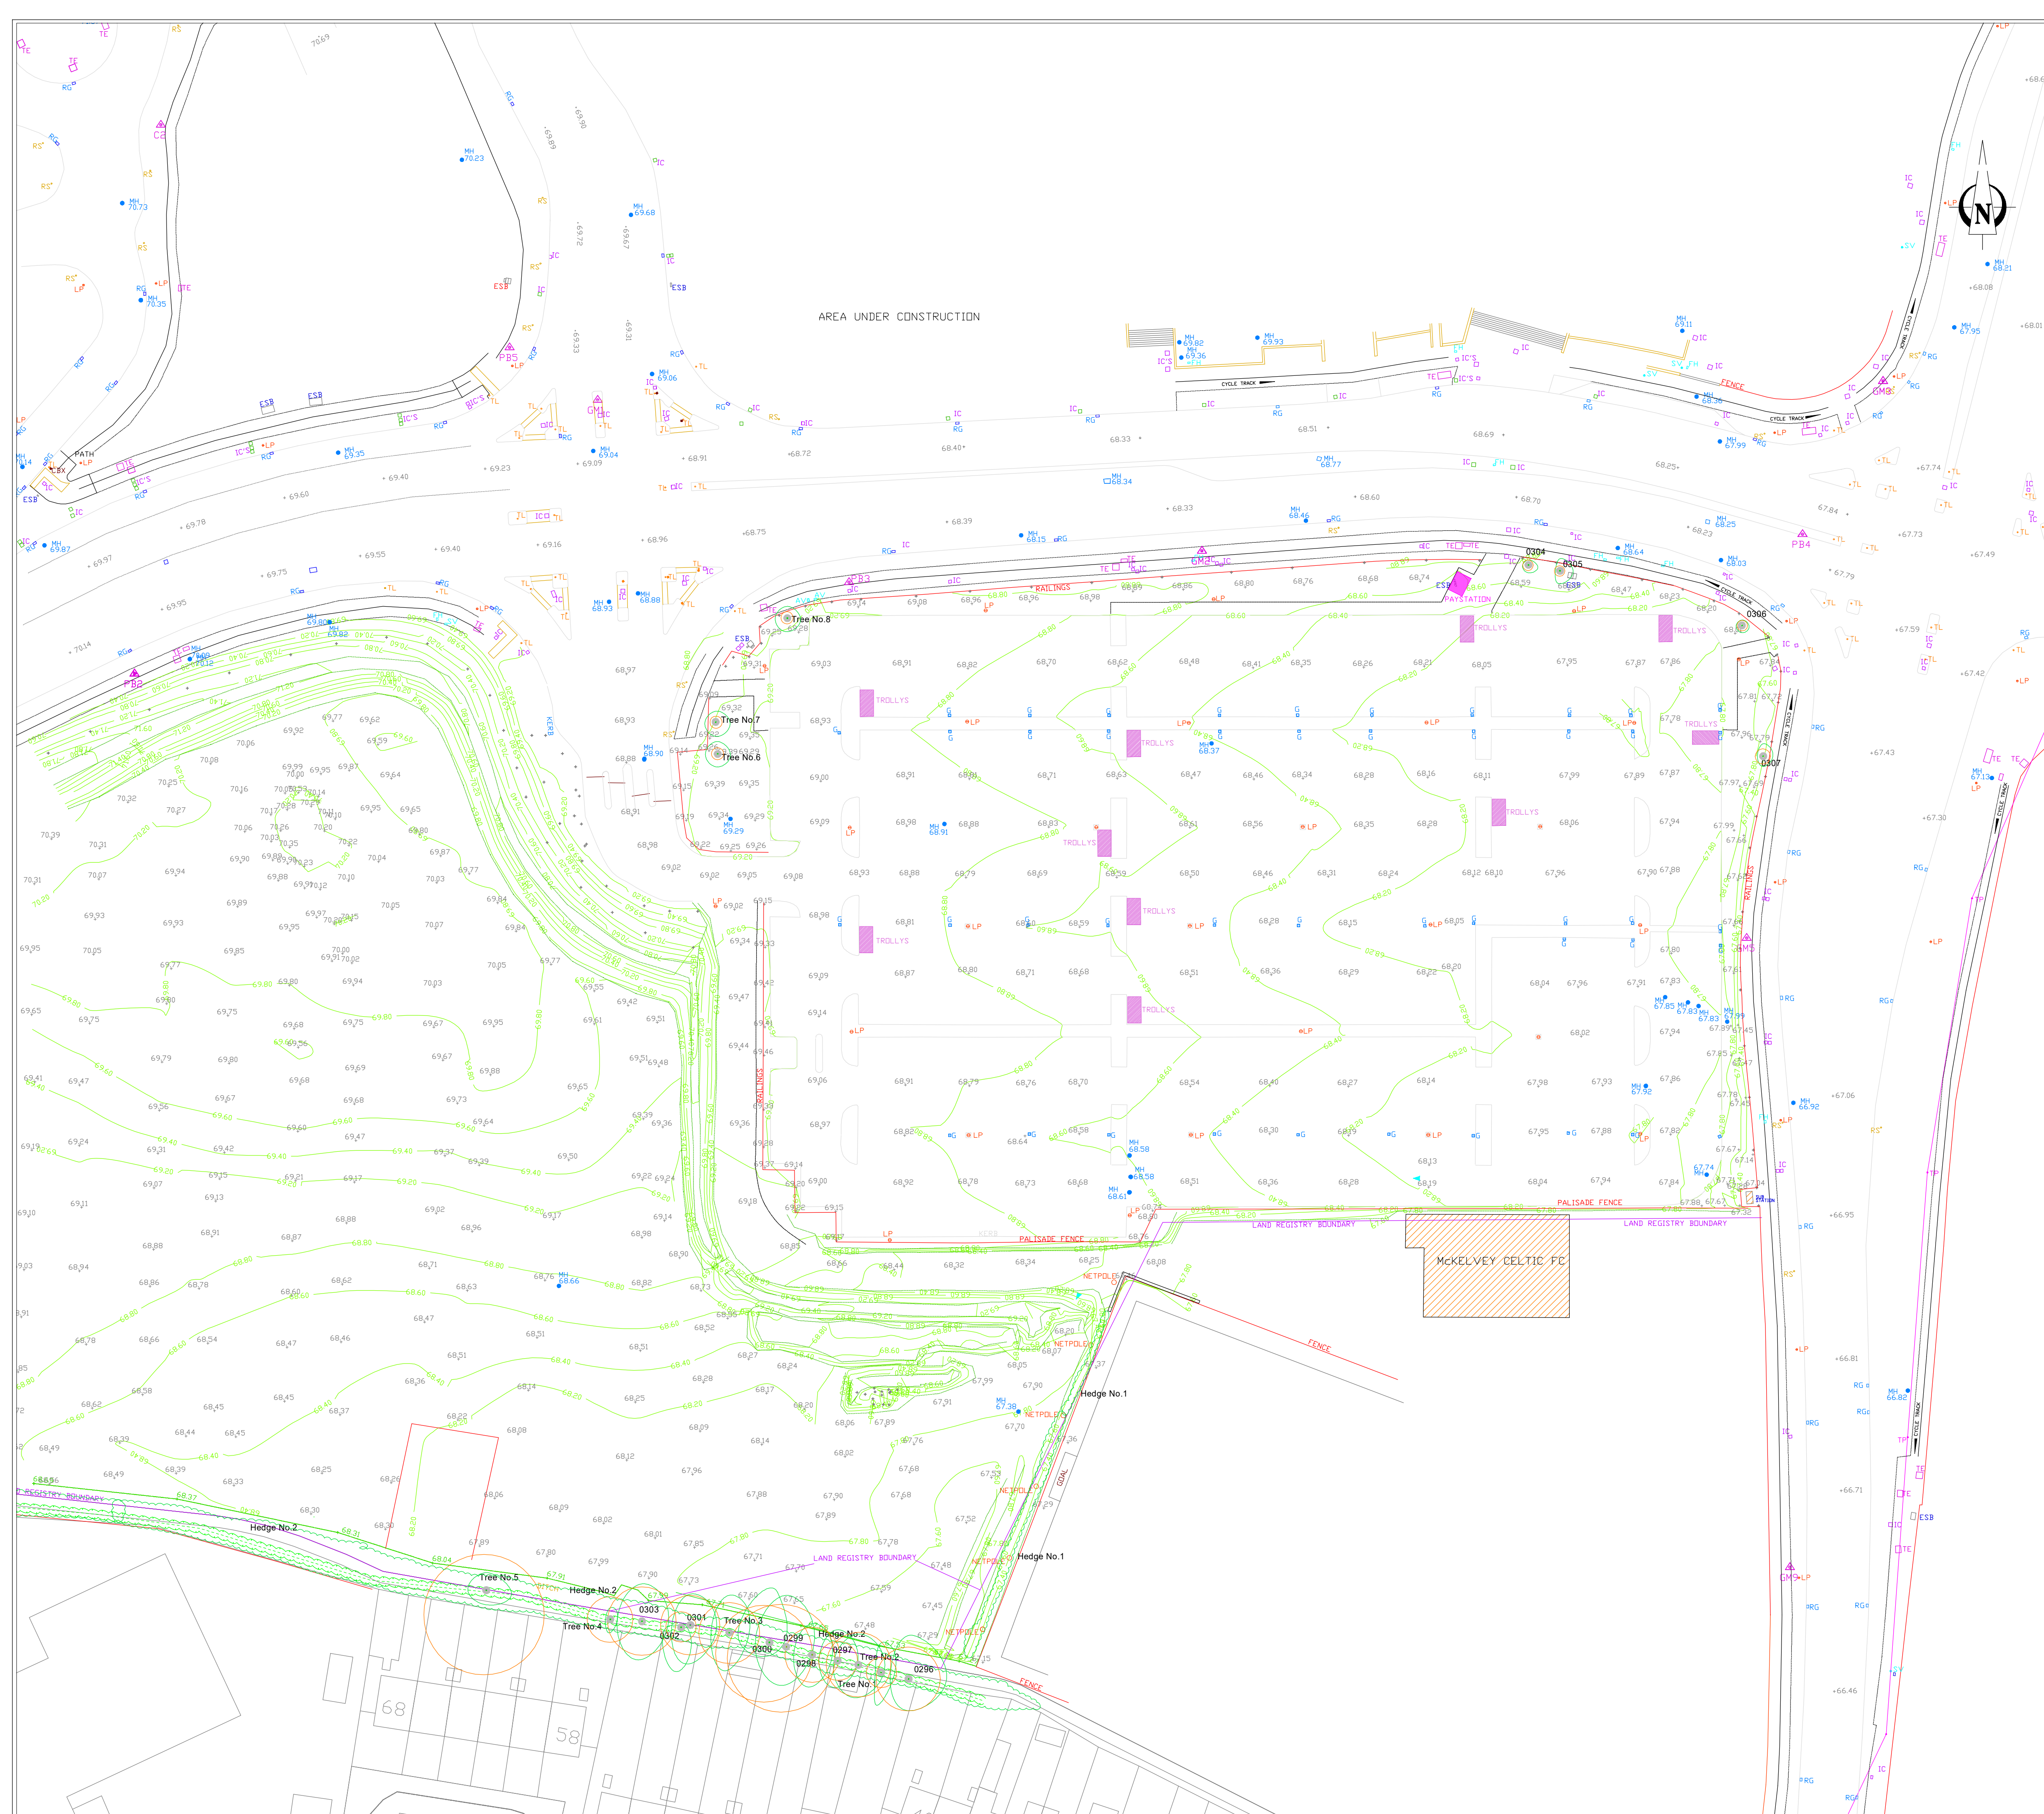
TITLE: Tree Constraints Plan

Any category ‘U’ trees identified have been shown on our drawings (Nos.CLP001 & CLP002) with a ‘Red’ donut around their

Any category 'C' trees within this site area have been identified on our drawings (Nos.CLP001 & CLP002) with a 'Grey' donut around their trunk positions. These trees would be seen as having the potential to provide tree cover for the short to medium term and they should not be seen as a considerable constraint on the development of these lands. Where viable, they should be retained.

- 3.5 The bulk of the trees have been plotted onto the attached drawing (Dwg. No.CLP001) by a land survey company and where they had not been plotted, their positions have been plotted visually to the best of our ability and will need to be checked by a land survey company. The tree reference numbers referred to in the condition tree report have been shown on this drawing along with their crown spreads and their retention category colour coded as detailed above and recommended by BS 5837 2012.

The constraints for each tree were worked out as per the formulas in BS5837 2012 and have been shown on this drawing using an 'Orange Circle' to aid the design team in their final development layout to ensure tree vegetation proposed for retention is retained successfully. The Root Protection Area (RPA) is the minimum area around individual trees to be protected from disturbance during construction works and is expressed as a radius in meters measured from the tree stem. Any deviation in the RPA from the original circular plot takes account of the following factors whilst still providing adequate protection for the root system:
