# Arboricultural Assessment, Arboricultural Impact and Tree Protection Strategy Report

White Pines Central,  
Stocking Avenue,  
Rathfarnham,  
Dublin 16

Project No.	TSTO005	Date	27/05/21
Project Name	White Pines Central	Revision	-

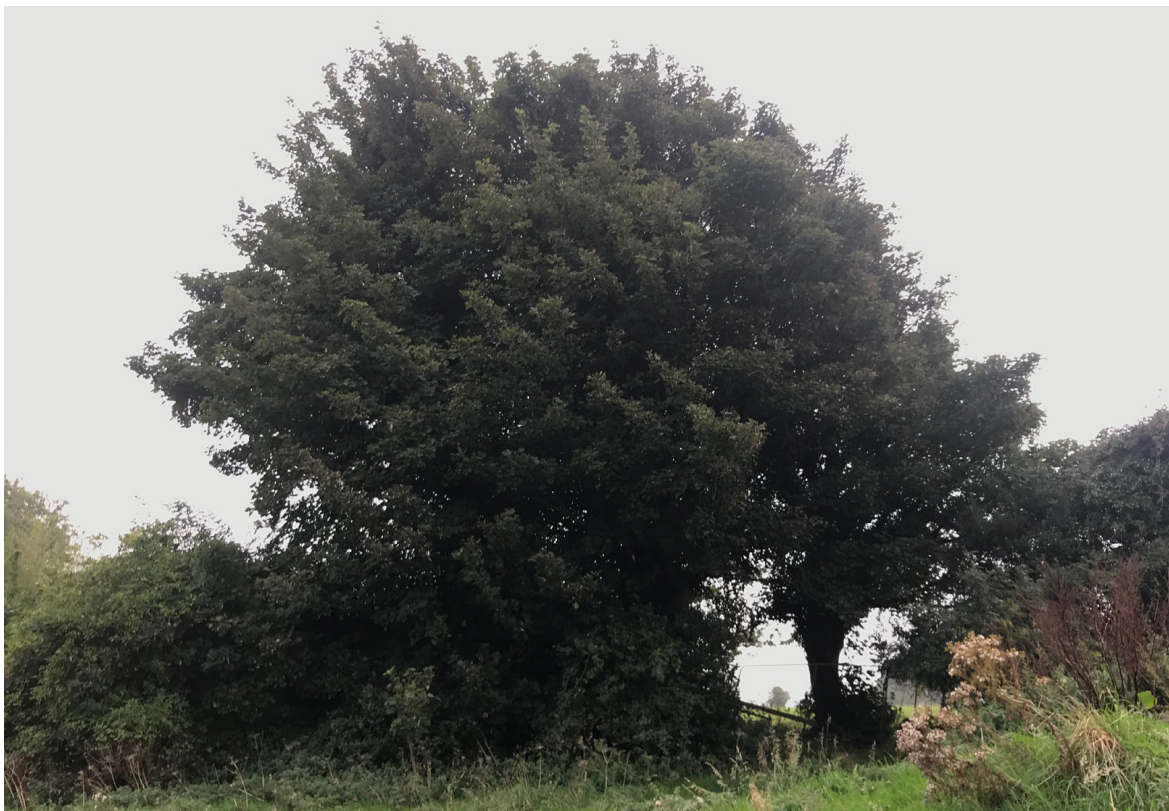
Image 2. Mature sycamore (#1172,1170 & 1169).

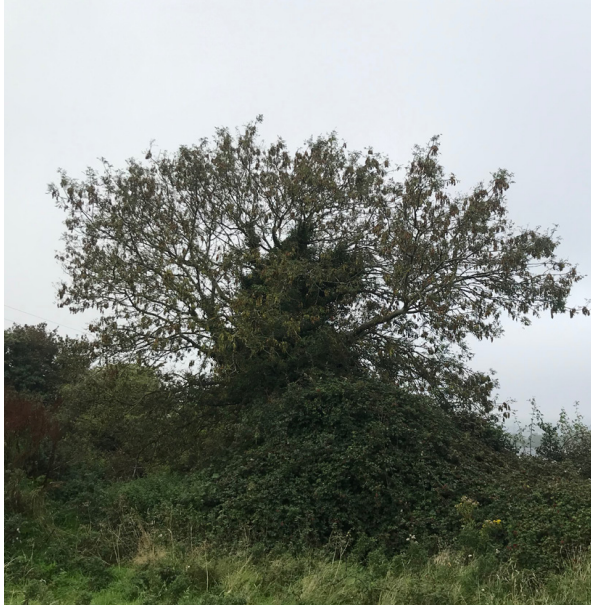
Image 2. Mature ash (#2260) in a state of decline.

Tag Number	Species	Vigour	Age class	Category	Comments	Recommendations	Long Term Potential	DBH (mm)	Height (metre)	Clear Stem (Metre)	Crown spread NESW (Metre)
2660	Ash <i>Fraxinus excelsior</i>	Poor	Mature	C2	Light suppressed deadwood in crown. Slowing signs of indicative of decline. Very heavy ivy growth obscuring view for assessment.	Cut ivy and re-assess	10	520	13	4n	5;5;5;5
1170	Sycamore <i>Acer pseudoplatanus</i>	Good	Mature	B2	Located on the southern site boundary. Dominant in neighbouring tree group. Trunk co- dominant at 1.5m with a sound union present and straight vertical stems. Light ivy covering that has been partly removed recently. No visible defects.	No action necessary	40	1050	17.5	4w	7;4;7;8
1172	Sycamore <i>Acer pseudoplatanus</i>	Good	Mature	B2	Located on the southern site boundary. Subdominant to neighbouring tree 3m west. Canopy extended east as a result. Should only be retained as part of group. No visible defects.	No action necessary	40	680	16.5	4.5n	6;6;6;2

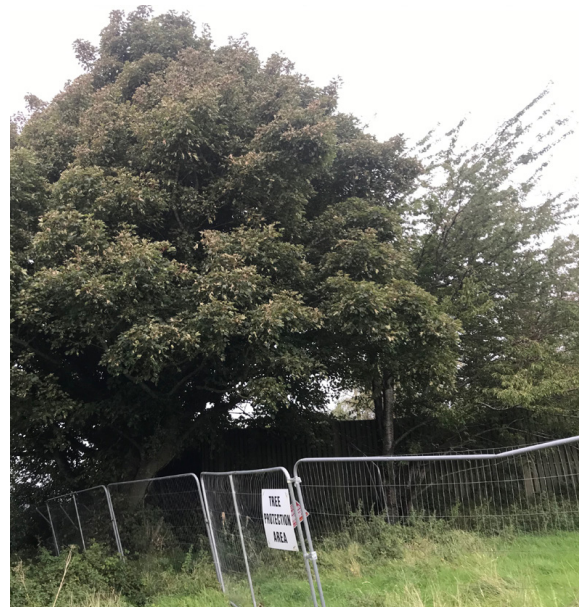
Image 3. Sycamore (#1169) and cherry (#1171) outside of the southern site boundary.

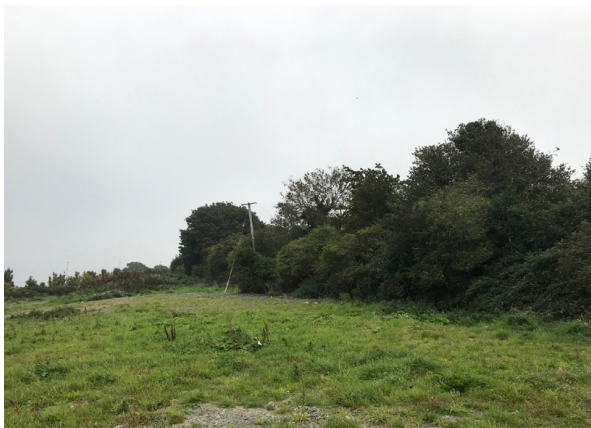
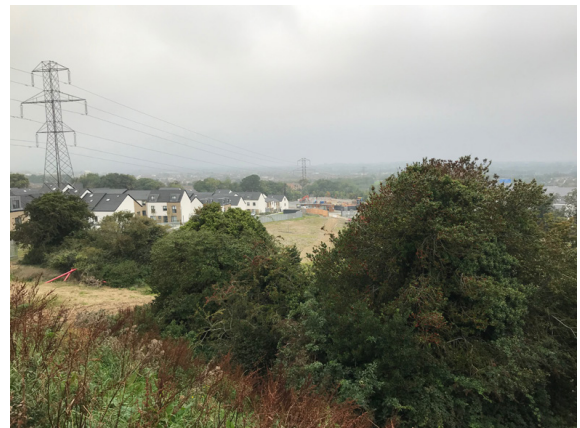
The hedgerow runs east-west on the southern site boundary (images 4-5). In addition to the mature hawthorn and standard trees it contains occasional elder *Sambucus nigra* and a single juvenile self-seeded ash and sycamore (image 7).

Images 4 & 5. Hawthorn hedgerow (#H01) on the southern site boundary.

H01	Hawthorn <i>Crataegus</i> Elder <i>Sambucus nigra</i>	Good	Mature	B2	Located on the southern site boundary. A n unmanaged occasional elder. A juvenile self-seeded ash and sycamore a located on its southern side.	No action necessary	30	N/A	3-6	N/A	6;6;6;6
These trees were located to the south of the red-line boundary with RPA intruding within site.											
1169	Sycamore <i>Acer pseudoplatanus</i>	Good	Mature	B2	Located 2m south of redline boundary. Subdominant to neighbouring tree east. Growth extended west as a result. Deadwood north at 5m due to light suppression. Ivy has encroached into areas of deadwood and throughout lower canopy.	Remove deadwood north.	30-40	700	17	3w	3;1;8;6
1171	Cherry <i>Prunus acium</i>	Good	Early Mature	B2	Located 7m south of the redline boundary. Canopy suppressed north due to neighbouring tree group. No visible defects.	No action necessary	20-30	410	10	2.5e	1;7;6;4

A total of 1 tree and western part of hedgerow (H01) (approximately 90m) are to be removed to facilitate works. This impact represents a loss of ecosystem services in the form of habitat reduction.

The remaining 40m section of hedgerow H01 (refer to drawing TSTO005 102) will provide a potential shelter for existing biodiversity and give a benefit of seeding the proposed woodland planting area.

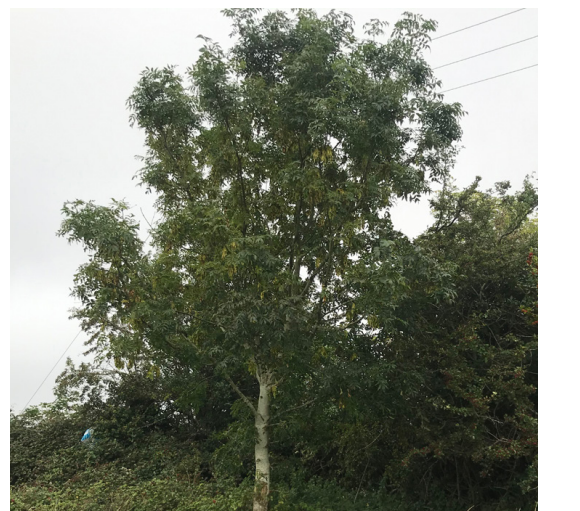
Image 7. Juvenile ash within hedgerow H01.
