**Residential Development, Cornelscourt, Dublin 18**

**Preliminary Design Stage Quality Audit**

**Cornel Living Ltd.**

**DBFL CONSULTING ENGINEERS**

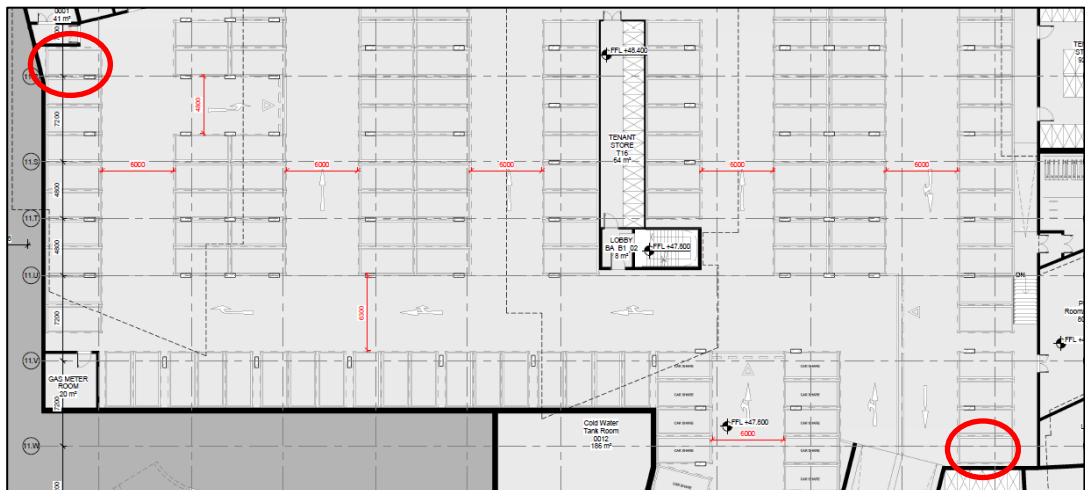
It is unclear to the audit team if all of the parking bays within the residential development are accessible when the car parking spaces adjacent and perpendicular are occupied by vehicles. Failure to provide adequately sized parking bays with aisles of sufficient width could result in material damage incidents as vehicle drivers try to manoeuvre into/out of parking bays.

A tracking analysis should be undertaken to determine if all spaces are accessible. Sufficient side clearance to structures should be provided.

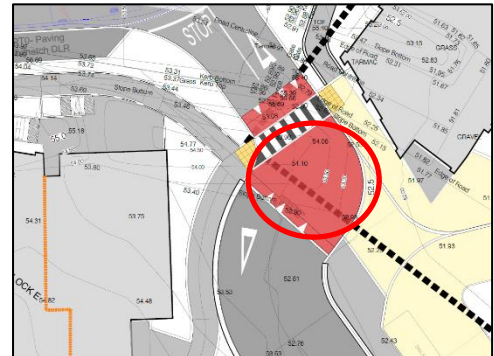
Due to the sharp bend on the vehicle access route to the basement car park the auditors are concerned that there may not be sufficient space for a vehicles to pass at the same time leading to potential conflict. There is a risk that when two vehicles pass that side-swipe collisions may occur.

The design team should confirm that vehicles accessing and egressing the development can pass at the sharp bend. A tracking analysis should be undertaken for the largest vehicles expected to use the carpark. The auditors recommend that typical Zebra Crossing road markings (transversers and zig zag lines) are provided as per TSM, which should aid in outlining the most appropriate vehicular route through the bend, to minimise potential side-swipe collisions.

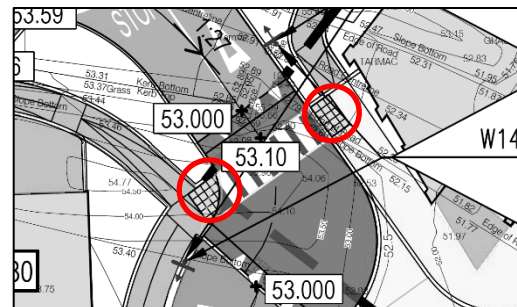
The audit team have noted the use of zebra crossing road markings with buff coloured tactile paving. The zebra crossing road marking indicate that pedestrians have priority at the crossing and vehicle drivers must stop. However,

the use of buff tactile paving (and the associated configuration) indicates that the crossing is an uncontrolled crossing. The use of the zebra road markings with buff tactile may cause confusion to both pedestrians and vehicle drivers as to who has priority, there is potential for pedestrian and vehicle conflict.

It is recommended that the zebra markings with illuminated beacons are supplemented with the appropriate red tactile (and the associated configuration) and the regulatory lines (transverse & zig zag) in accordance with the requirements of the Traffic Signs Manual.

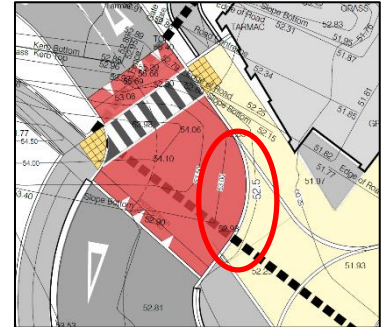
It is unclear to the auditors whether a kerb is proposed between the ramp and the ‘shared surface’ towards the podium area. If no kerbing is provided, the shared area will exit directly onto the road carriageway without any warning being provided to visually impaired pedestrians. Accordingly, pedestrians could find themselves continuing to walk from the ‘shared surface’ out into the path of moving vehicles accessing/exiting the basement car park.

It is recommended that a 50mm kerb is provided which will warn visually impaired pedestrians walking from the shared surface onto the road carriageway. Alternatively, tactile ‘warning’ paving could be provided at the transition from the ‘shared area’ to/from the road carriageway. This will ensure that visually impaired pedestrians are provided with the necessary warning of ‘to proceed with caution’ or direct them along the footpath to the neighbouring zebra crossing facilities.

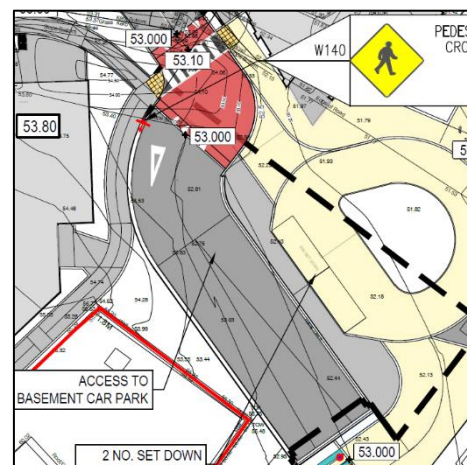
Parking restrictions (barrier or bollards) to the basement, to prevent access for non-residents have not been provided. During the site visit it was observed that cars were parked haphazardly on the southern side of the access. The auditors are concerned that non-residents such as AIB customers may park (i) in the basement or (ii) at the podium level courtyard. Such practices could result in residents having to park haphazardly on the surface level footpaths/shared surface, which could lead to vulnerable road users having to enter the carriageway leading to greater likelihood of conflict with motorised vehicles or could lead to slip and fall as pedestrians mount/dismount kerbs or walk through grassed area.

Ensure appropriate self-enforcing measures are put in place to prevent non-residential vehicles from accessing the basement car park and central podium level 'shared' courtyard area.

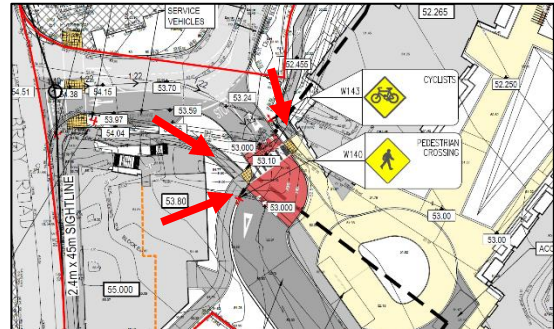
The auditors are unsure if the three paths approaching the zebra crossing are pedestrian footpaths or shared pedestrian/cycle routes? The cyclist warning sign (W143) prior to the crossing, would give the impression that they are shared

pedestrian/cycle routes. If these are shared pedestrian/cycle routes, they appear to be of inadequate width. These shared pedestrian/cycle routes could result in pedestrians/cyclists competing for space and increase the risk of pedestrian/cyclist collisions.

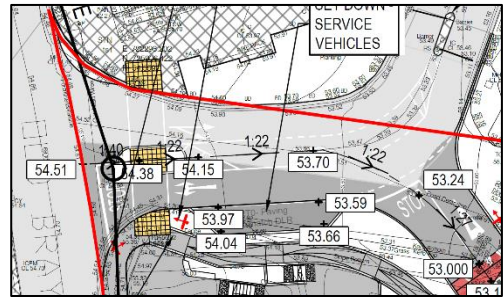
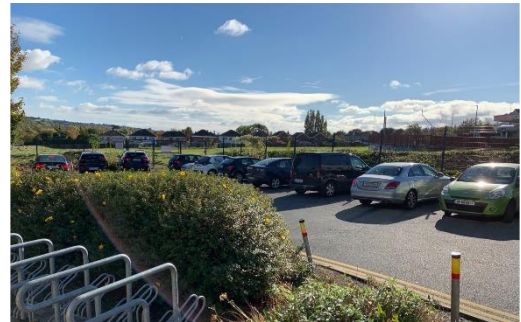
The auditors note that there are no parking restrictions proposed at the AIB access. During the site visit it was observed that cars were parked haphazardly on the southern side of the access. The auditors are concerned that vehicles parked kerbside within the vicinity of the site access junctions may adversely impact the availability of unobstructed visibility splays for vehicles exiting the junctions. This could potentially contribute to the generation of side-impact collisions between vehicles exiting the subject site and the AIB access.

It is recommended that parking restrictions are implemented in the vicinity of (i) the Old Bray Road/AIB access junction and the internal access route leading to/from both the existing AIB car park entrance/exit and the proposed site access junction with the objective of safeguarding the appropriate visibility splays and (ii) keeping the internal vehicle access route free from inappropriate car parking practices.

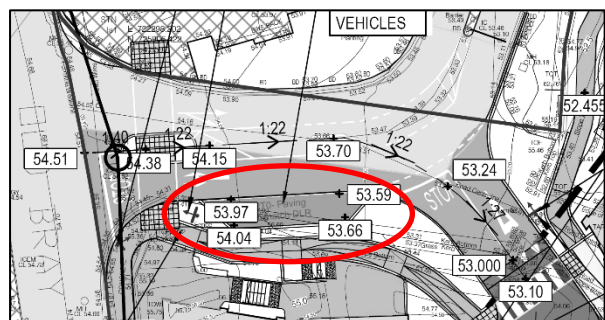
An indented kerbside layby facility is proposed on the southern side of the internal access between the Old Bray Rd junction and the access routes to/from the proposed residential development. The auditors

request clarification regarding how the adopted design vehicle can conveniently gain safe access into or from this kerbside facility without the need to undertake

a three point (or more depending upon vehicle type) u-turn manoeuvre on the internal road carriageway in the general area where the access roads diverts to the northwest (AIB car park) and southeast (development basement car park – podium access). Vehicle drivers undertaking turning manoeuvres in this general area could come into conflict with other vehicles or result in localised congestion leading to a queue of inbound vehicles extending back onto the Old Bray Road carriageway (where the potential for rear-end shunt incidents increases).

Clarification is required outlining how safe and convenient vehicle access can be achieved to the proposed kerbside layby facility in its present location. Should it prove difficult to achieve a safe and convenient access arrangement (e.g. one that does not require a u-turn manoeuvre on the main internal vehicle road carriageway) it is recommended that the kerbside bay is relocated to an appropriate location on Old Bray Road. Appropriate regulations may also need to be implemented to safeguard the availability of the kerbside bay (for its intended function) considering the existing demand at the neighbouring AIB facility.

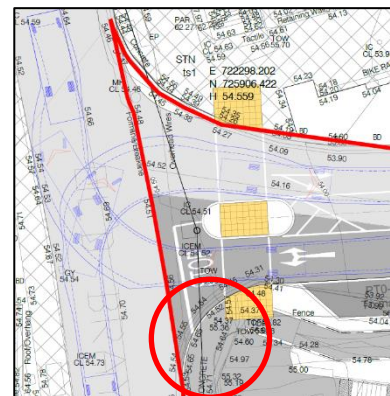
The auditors are concerned that the generous radii (approx. 5m) of the proposed site access junction layout could; (i) contribute to excessive vehicle speeds entering and exiting the site, and (ii) result in a longer (length) than necessary road crossing for pedestrians walking along the Bray Road footpath and who are required to walk across the proposed minor arm of this junction / access.

In the context of the modest number and size (predominately cars with no more than 1-3 LGV's per day and 2 HGV's per week) of vehicles that is predicted to travel through this site access junction, it is recommended that a tighter radius in the order of 3m is adopted at the site access junction to achieve a greater balance between pedestrian and vehicle access requirements.

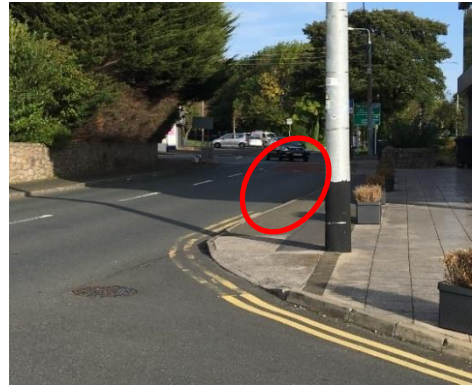
During the site visit it was observed that cars were parked haphazardly on the southern side of the access. The auditors are concerned that due to the new junction layout, vehicles will no longer be able to park on the southern side of the existing AIB access and may decide to park along the eastern side of Bray road in close

proximity to the junction. Haphazard parked cars along Bray Road at the AIB access junction may obstruct driver's visibility at the junctions. Failure to provide sufficient visibility for vehicle drivers at the junctions could result in overshoot incidents or side impact collisions with vehicles/cyclists travelling along the road.

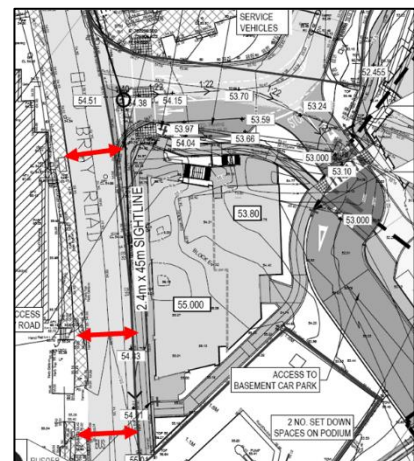
The audit team have concerns regarding the lack of pedestrian crossing facilities at the priority junction at Bray Road/AIB access road and along the Old Bray Road. Pedestrians may attempt to cross at the three locations illustrated, which are the immediate crossing desire lines to reach the shops, office blocks and bus stop on the western side of Bray Road along with the bus stop. As a result, mobility impaired pedestrians may experience difficulty in undertaking the crossings and accessing the footpath on the opposite side of the carriageway; or it could result in pedestrians entering into the Bray Road carriageway when it is unsafe to do so, resulting in conflict with vehicles (or cyclists) travelling along Bray Road.

Appropriate pedestrian crossing facilities should be provided to enable pedestrians to cross the Old Bray Road at key crossing desire lines.

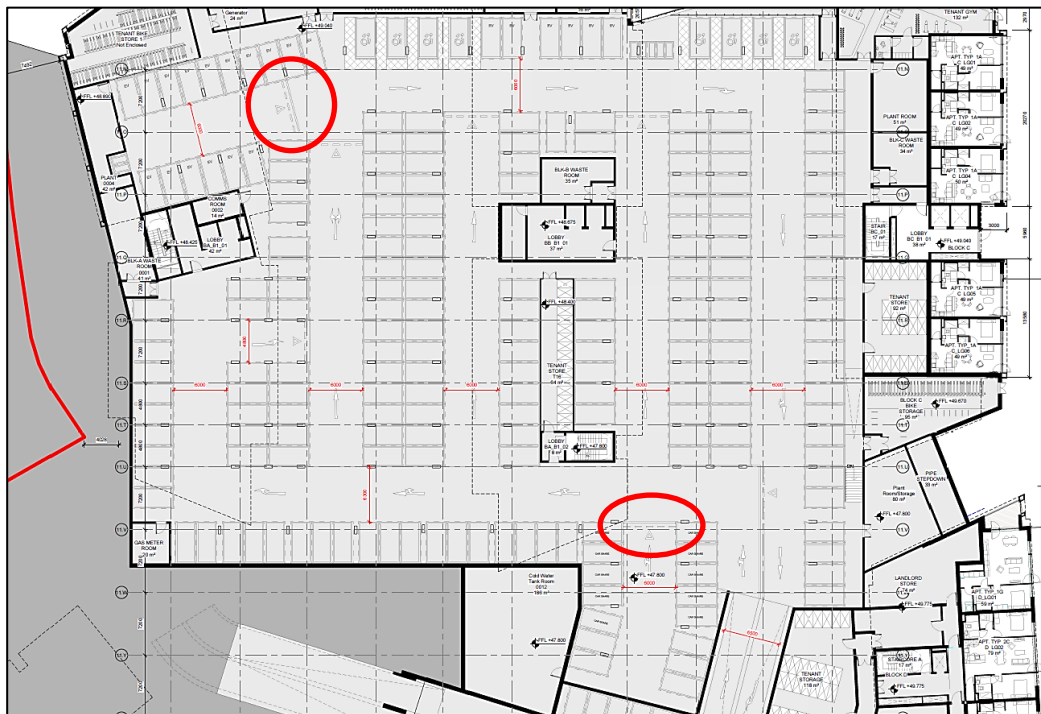
The basement proposal details the provision of 'No Entry' road markings at two locations where there is only one access/egress at each location (see below). This may cause confusion for drivers resulting in potential vehicular collisions.

In reference to the Traffic Signs Manual, the 'No Entry' road markings should be removed from these two locations and the appropriate 'Yield' and directional road markings are provided.

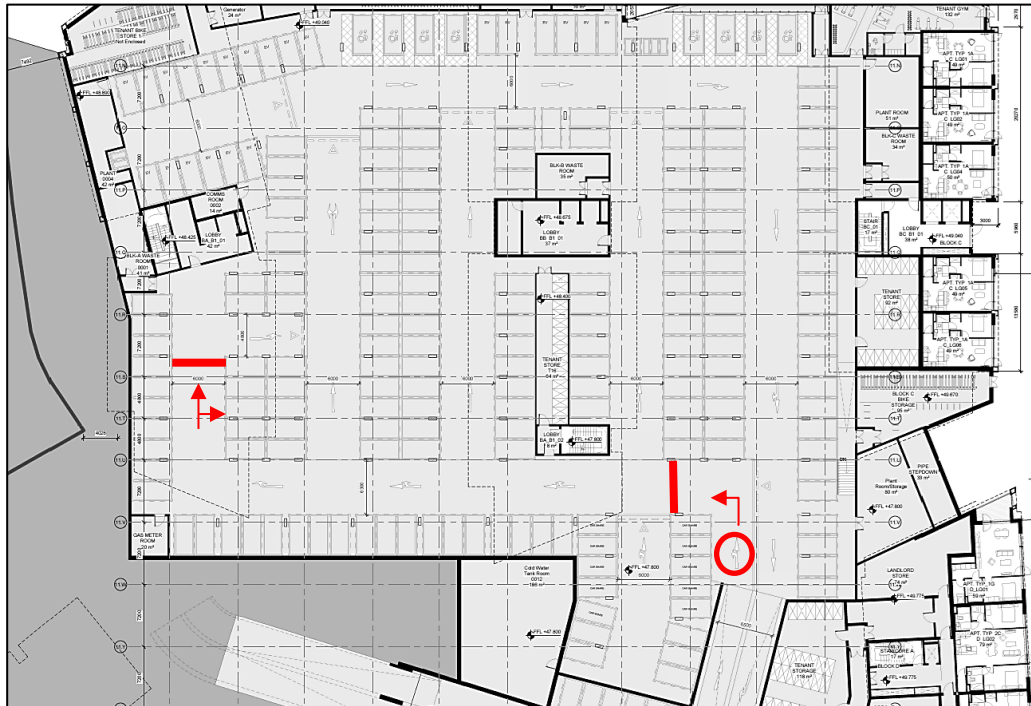
Due to omission of 'No Entry' road markings and directional arrows at particular junctions outlined in the schematic below, drivers may become confused and drive against traffic. This could result in head-on collisions between vehicles.

In reference to the Traffic Signs Manual, the 'No Entry' road markings and directional arrows in the basement should be reviewed and updated.

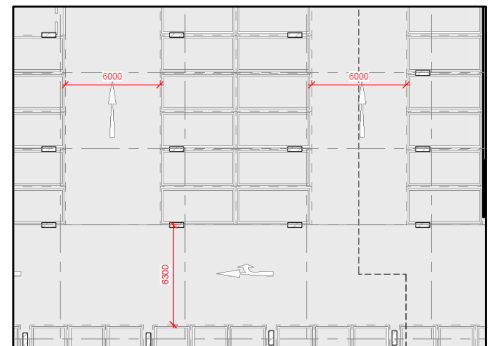
The basement has a number of wide 6.0-6.3m one-way vehicular routes, which may encourage excessive speeds, which could result in serious collisions if they strike pedestrians.

It is recommended that flush pedestrian / defensible walkways are provided either side of the carriageway to reduce the perceived width of the carriageway, while still providing the minimum width of 6m between perpendicular parking bays for manoeuvrability.

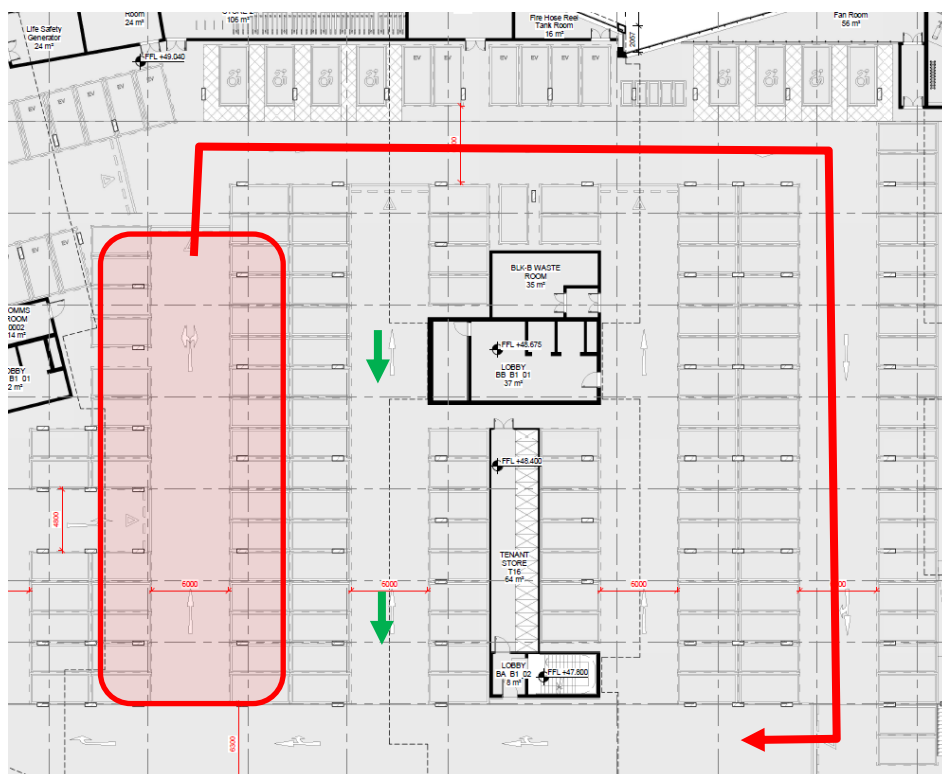
If there are no parking spaces available along the second 'western' section/row of car parking spaces, a driver will have to loop around the whole car park to access any of the 'eastern' sections/rows of car parking spaces due to the proposed one-way circulatory system. Due to the circuitous route, drivers may choose not to abide by the one-way circulatory system to access the 'eastern' sections/rows of parking and drive against traffic. This could result in head-on collisions between vehicles.

The designs should confirm if the on-site car parking is going to be assigned to specific users (e.g. individual bay) as part of a parking management regime or if parking is available on a first come basis. If the latter, it is recommended that the one-way circulatory system in the basement car park is review and updated. Potential to switch the direction of travel on the third 'western' section/row of car parking spaces (see green arrows).

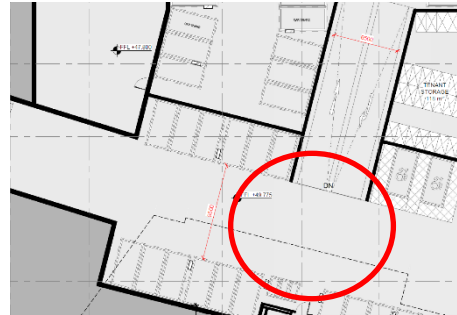
The access/egress route to/from the lower level of the basement car park is not very clear, particularly due to the very wide 9.6m two-way carriageway on approach to the lower level ramp. There is a risk of driver confusion and possible side-swipe collisions between vehicles.

There is also no regulatory road markings provided at this junction, such as a 'Stop' or 'Yield' road markings. This could lead to drivers being unaware of the priority and may result in collision with vehicles on main road.

It is recommended that appropriate wayfinding signage and road markings are provided to clearly outline the route to the lower level of the basement. Sufficient visibility splays should be safeguarded at all internal junctions within the basement car park facility.

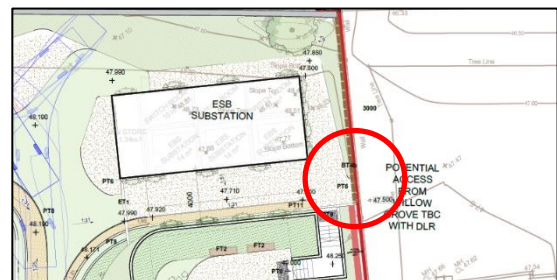
There is no tie-in between the proposed pedestrian/cycle route on the eastern side of the development and Willow Grove. There could be a risk of slips and falls in the green area during wet conditions.

It is recommended that a hard surface (of appropriate width and gradient) is provided through the green area to provide a link to Willow Grove.

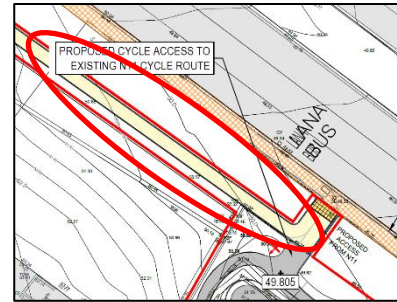
The shared two-way pedestrian/cycle route along the N11 appears to be of inadequate width. This pedestrian/cycle route could result in pedestrians/cyclists competing for space and increase the risk of pedestrian/cyclist collisions.

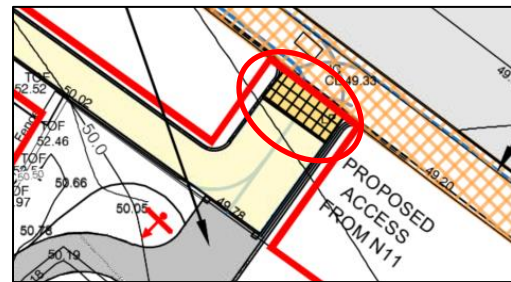
The audit team have noted the use of tactile paving at the start and end of the shared surface approaching the cycle lane along the N11. The use of blister tactile paving may be misleading to blind or partially sighted pedestrians who may feel that they are at a crossing point.

It is recommended that ladder type corduroy tactile paving is provided at the start and end of the shared use surface.

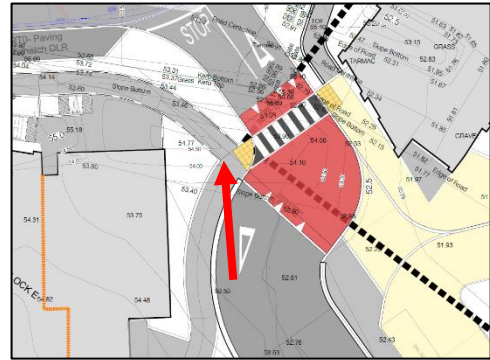
There is a pedestrian crossing route in close proximity to the entrance to the basement car park. It is unclear if there will be sufficient inter-visibility between pedestrians and drivers due to the presence of the wall/structure adversely impacting exiting vehicle drivers.

It is recommended that sufficient inter-visibility be provided on the approaches to the proposed zebra crossing. The pedestrian crossing could be shifted further north to provide sufficient visibility while also ensuring vehicles approach the crossing more perpendicular.

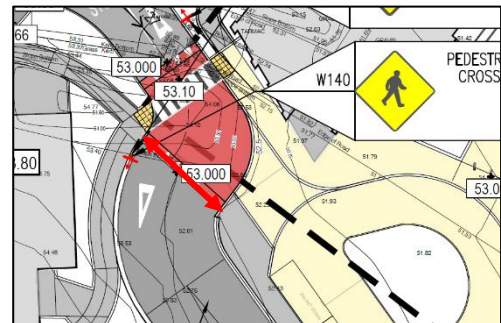
The Audit team have concerns that pedestrians may attempt to cross the basement access road along the immediate crossing desire lines to/from the footpath at the set down area (see in schematic). The steep crossfall of the ramp is along this pedestrian desire line, which may lead to pedestrian trips/falls.

It is recommended that the crossfall of the ramp is relocated outside of the pedestrian desire line and an appropriate pedestrian crossing is provided with tactile paving.

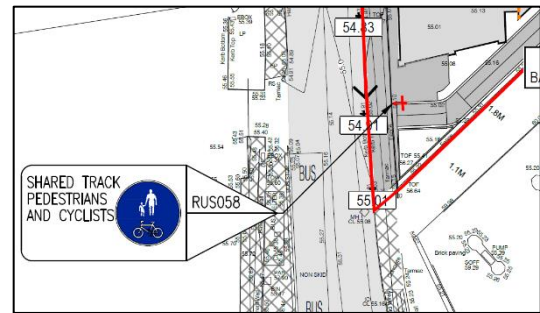
The auditors are unsure if the path approaching the zebra crossing is a pedestrian footpath, shared pedestrian/cycle routes or segregated footpath/cycle route (due to centreline)? If this is a shared

pedestrian/cycle routes or segregated footpath/cycle route, it would appear to be of inadequate width. This shared pedestrian/cycle routes could result in pedestrians/cyclists competing for space and increase the risk of pedestrian/cyclist collisions. Also, warning tactile paving has not been provided on approach to the existing footpath along the Old Bray Road.

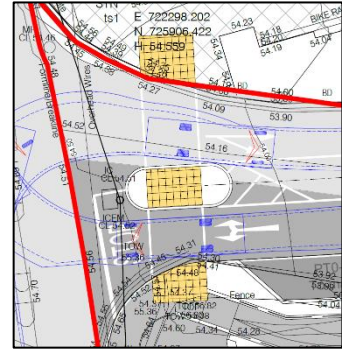
Pedestrians Lines (M131), are typically provided at controlled crossing, not uncontrolled crossings. DBFL have assumed that the Pedestrians Lines (M131) shown at the uncontrolled crossing is a drafting error.
