## LACKENROE SHD

# APPENDIX 11

**Cultural Heritage**

Historic Landscape Impact Assessment

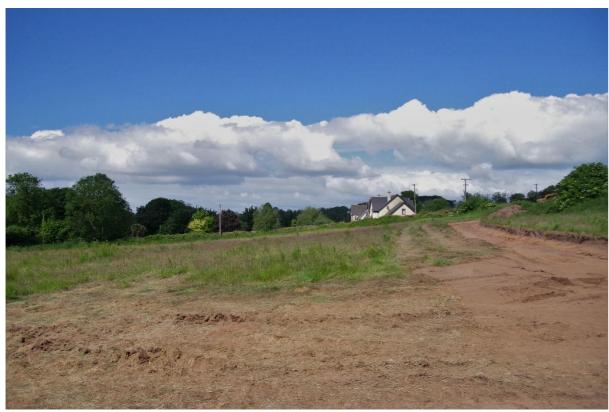
Plate 11.5 Field 3 north end showing recent ground works

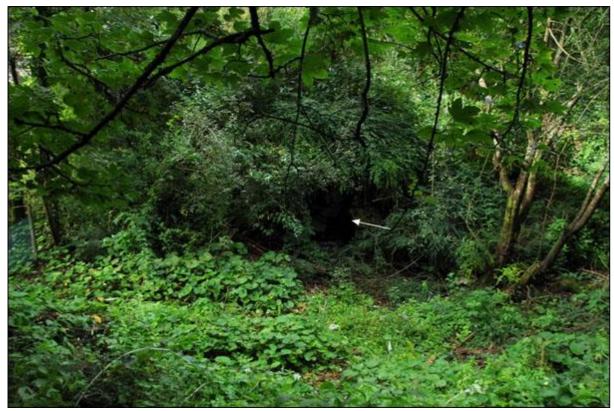
Plate 11.17 General view of grotto structure in quarry from east

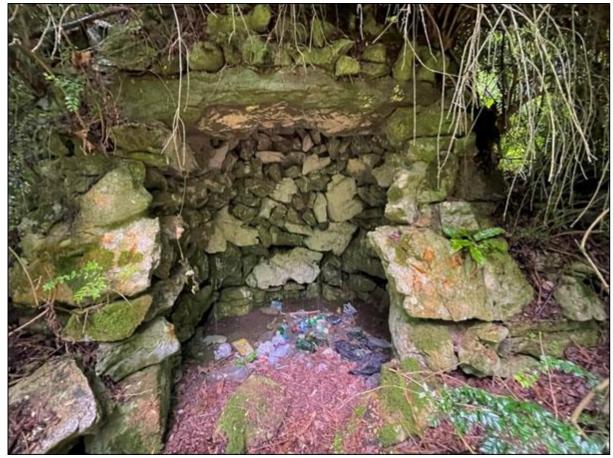
Plate 11.18 Close-up view of grotto structure

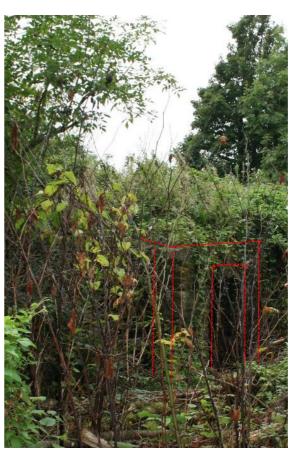
17. Evidence in former rock garden/quarry of additional potential rock mound

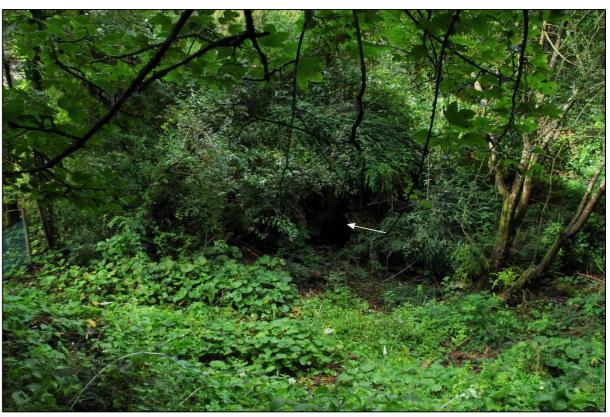
Figure 2: General view towards the overgrown structure from east (arrow indicates entrance)

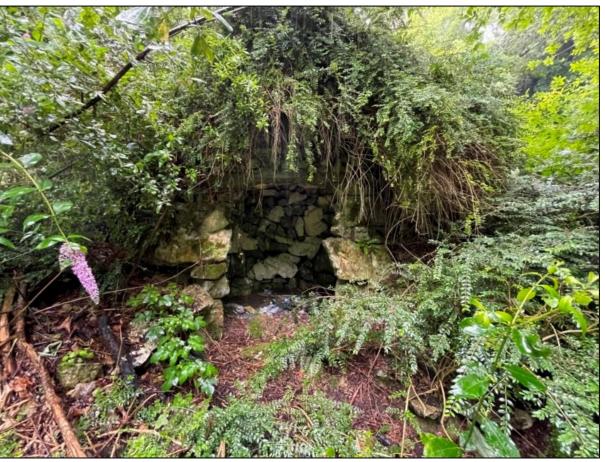
The structure is accessed from an opening on the east side which measures 1.56m in height with widths of 1.22m at top and 1.30m at base and is topped with a 1.60m long sandstone lintel. The internal area measures 160m in diameter by a maximum of 2.2m in height measured from the existing internal ground surface to the roof. Given the presence of thick overgrowth it was not possible to accurately assess the wall thickness but based on an inspection of the visible entrance area, the thickness in this area appears to be in the range of 0.5m to 0.7m.

Figure 3: Close up view of entrance on east side of structure

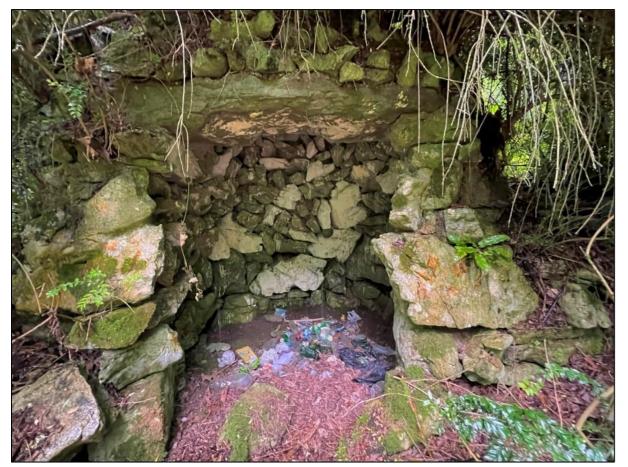
*Figure 4*: *View of interior of structure*

There were no visible traces of internal wall features present, e.g., seat ledges, storage niches, shelves, door features or a roof opening. The existing floor is formed by loose soil with no surface trace of a constructed surface feature and the only visible surface inclusions comprised modern debris, primarily discarded drink cans and various plastic wrappers and bottles. While the presence of thick overgrowth precluded a full inspection of the structure, it appears to be well-preserved, and no sections of collapsed stonework were noted within the internal space. A full appraisal of the structure, including a detailed drawn record, will not be feasible until careful vegetation removal from the exterior and its immediate surrounds has been undertaken.

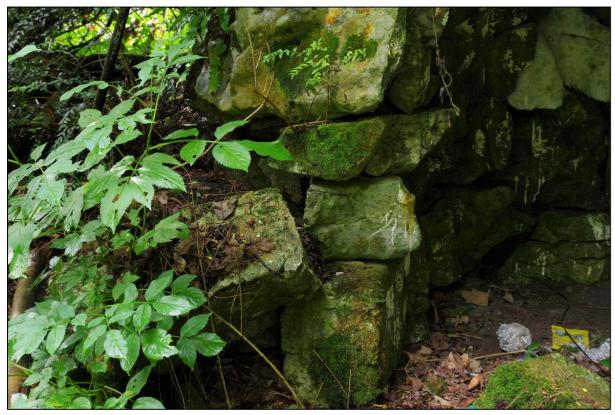
Figure 6: Detailed view of stonework on south side of entrance

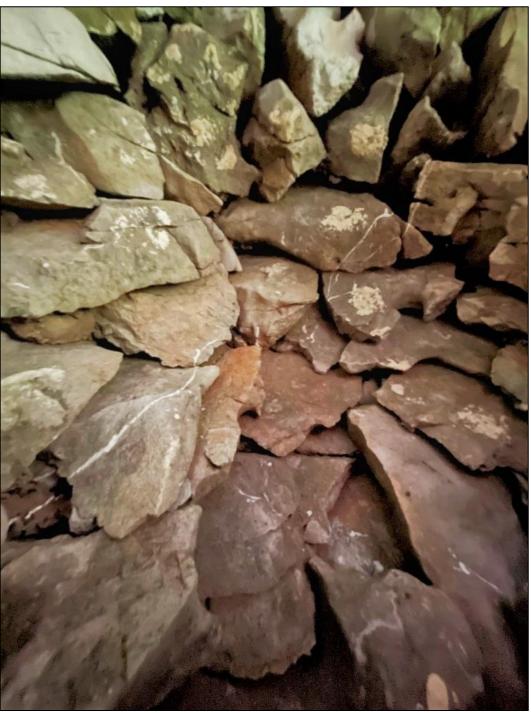
Figure 5: View of roof stonework
