Tree Management Services

Project: Title: Ashbourne House Residential Development,
Glounthaune Co. Cork

Report Title: Arboricultural Champion and Heritage Tree
Report

Client(s): BARLOW PROPERTIES LIMITED
Planning Ref: 21/05072

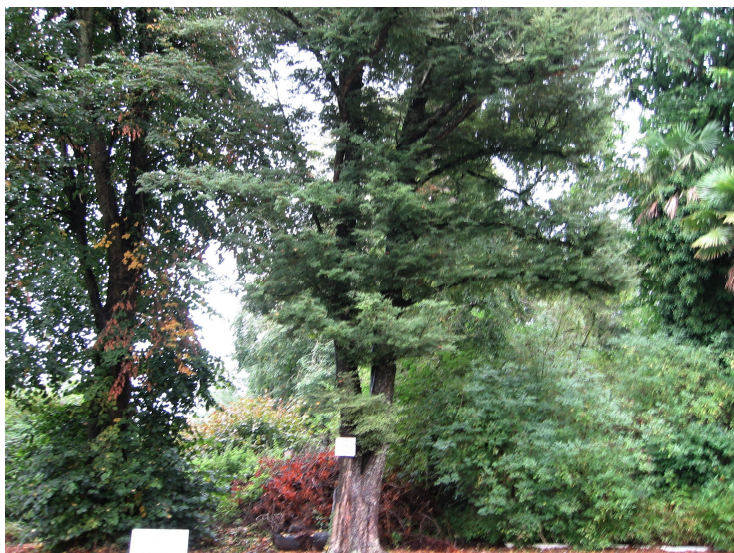
Photo 2: *Tree nos. 2 and 3.*

2	<i>Nothofagus solandri var. cliffortioides</i>	Mountain Beech	Fair	09/09/2021	14.5	76	2.6		✓	Tarmacadam over root zone. Some damage to root system. Decay at base on northern side; Forked at 1.5m. Crown topped in past; Good response to pruning.
161	<i>Parrotia persica</i>	Persian Ironwood	Good	15/09/2021	12	27,26	1.7	✓	✓	Wide-spreading;
213	<i>Parrotia persica</i>	Persian Ironwood	Good	15/09/2021	6.5	20 avg.	1.8	✓	✓	Multi-stemmed
953	<i>Picea omorika</i>	Serbian Spruce	Good	14/09/2021	21	75	2.5	✓	✓	Lighting fixture and cables attached
965	<i>Pinus armandii</i>	Armand's Pine	Fair	15/09/2021	10	36	1.12		✓	Could be <i>Pinus strobus</i>
995	<i>Pinus radiata</i>	Monterey Pine	Good	15/09/2021	23	230	6.8		✓	Forked from 1.5m. High pruned in past
1007	<i>Pittosporum eugenioides 'Variegatum'</i>	Pittosporum	Good	14/09/2021	12	30	1.2		✓	Attractive foliage. Crown slightly suppressed by overhanging limbs.
1100	<i>Pittosporum tenuifolium</i>	Pittosporum	Good	20/09/2021	14	42	1.3	✓	✓	Crooked stem see also tree no 1093 which has a smaller girth but ht measured at 18

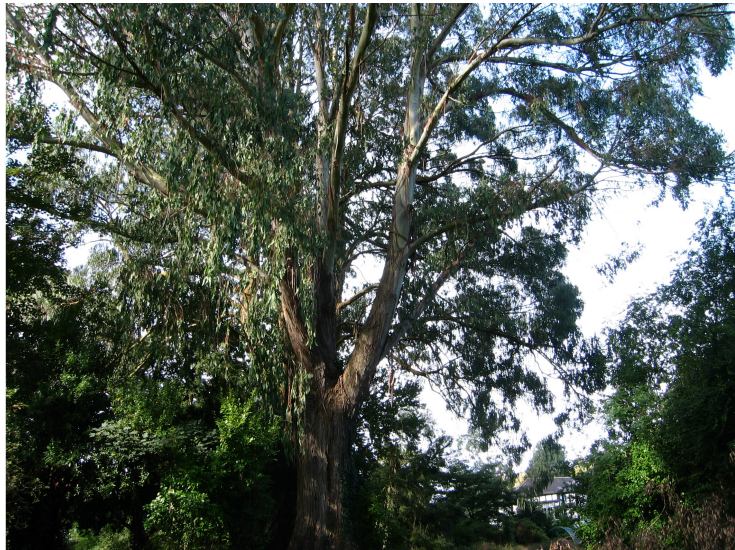
Photo 10: *Tree no. 61.*

61	<i>Eucalyptus pauciflora</i>	Snow Gum	Good	14/09/2021	32	170	5.6	✓	✓	Check cable bracing in crown
195	<i>Eucalyptus globulus</i>	Tasmanian Blue Gum	Good	15/09/2021	25	155E	4.5E		✓	Topped in past; Strong regrowth.
	<i>Ginkgo biloba</i>	Ginkgo/Maidenhair		05/10/1999	23.5		2.3			Probably Tree no 946
912	<i>Ginkgo biloba</i>	Ginkgo/Maidenhair	Good	14/09/2021	17	48	1.6		✓	
946	<i>Ginkgo biloba</i>	Ginkgo/Maidenhair	Good	14/09/2021	22	100	3.1		✓	Forked at 3m.
	<i>Ginkgo biloba</i>	Ginkgo/Maidenhair		05/10/1999	16.5		0.65			Probably Tree no 912
	<i>Ginkgo biloba</i>			18/06/2019	25		2.95			Probably Tree no 946
	<i>Gleditsia triacanthos</i>	Honey Locust		06/10/1999	22		1.45			Not on site
	<i>Gymnocladus dioica</i>	Kentucky Coffee Tree		05/10/1999	19		1.57			Not on site
34	<i>Gymnocladus dioica</i>	Kentucky Coffee Tree	Good	28/09/2021	10.5	11	0.55		✓	Leaning to south; Possibly a seedling or sucker from adjacent fallen tree

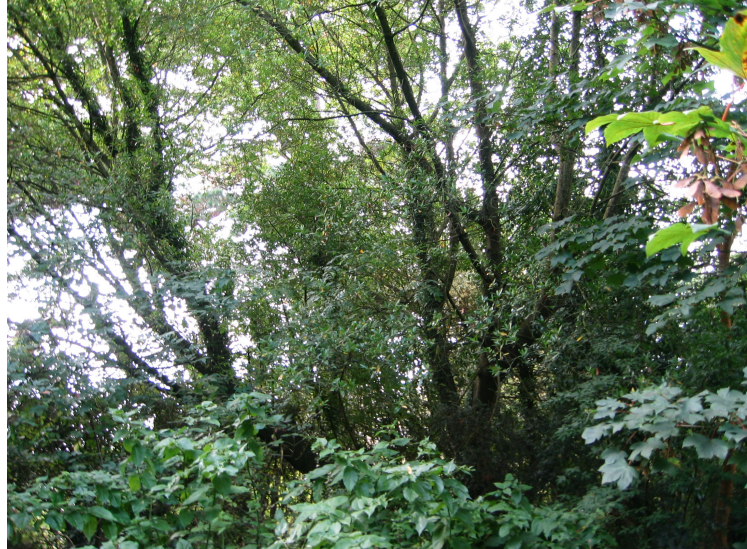
Photo 13: *Tree no. 1195.*

37	<i>Trachycarpus fortunei</i>	Chusan Palm	Good	23/09/2021	7	24	0.7		✓	
1195	<i>Umbellularia californica</i>	Californian Laurel or Headache Tree	Good	15/09/2021	21	55,64	2,1.9		✓	x 2 stems. Wide-spreading. Forked at 2m. Leaning stems to east.
	<u>Additional Important trees</u>									
984	<i>Pinus wallichiana</i>	Bhutan Pine	Fair	09/09/2021	22	110	3.6		✓	High pruned to 18m. Lightly topped in past. Leaning over avenue; Could be a Champion tree
941	<i>Magnolia x soulangiana</i>	Saucer Magnolia	Good	09/09/2021	9	63	2.2		✓	Forked at 1m. Cavity on north side of main stem
14	<i>Thuja plicata</i>	Western Red Cedar	Good	14/09/2021	28	117	3.2		✓	Broken minor co-dominant stem
910	<i>Thuja plicata</i>	Western Red Cedar	Good	14/09/2021	25	112	3.7		✓	Minor storm damage in crown
57	<i>Chamaecyparis obtusa</i>	Hinoki cypress	Good	14/09/2021	13	68	2.4		✓	Leaning to east; Remove heavy ivy growth.
184	<i>Pseudopanax arboreus</i>	Ivy tree	Fair	23/09/2021	13	25	0.9		✓	Leaning to north

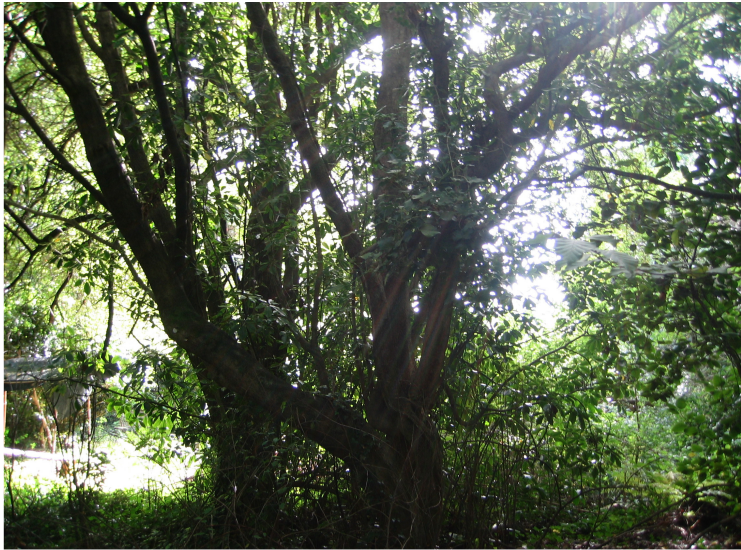
Photo 14: *Tree no. 180.*

<i>Prumnopitys andina</i>	Plum-Fruited Yew	Poor	17/05/2004	16.5		1.41			Not found
980	<i>Pseudopanax arboreus</i>	Ivy tree	Poor	22/09/2021	10	20	2		✓	Multi-stemmed from .5m. Suppressed by Griselinia. Sparse foliage
180	<i>Pseudopanax arboreus</i>	Ivy tree	Good	23/09/2021	16	28,14 ,22	1.1		✓	Forked from base
1091	<i>Quercus canariensis</i>	Mirbeck's Oak	Good	16/09/2021	28	97	3.1	✓	✓	Close to Ehretia no 1092
1060	<i>Quercus rubra</i>	Red Oak	Good	16/09/2021	30	95	3	✓	✓	Strong clear stem to 5m. Well-formed crown.
76	<i>Sciadopitys verticillata</i>	Japanese Umbrella Pine	Good	14/09/2021	12	46,44	1.61, .4	✓	✓	Forked from base. Well-formed crown
925	<i>Sequoiadendron giganteum</i>	Wellingtonia, Giant Sequoia	Good	13/09/2021	36	170	5.1		✓	Sparse foliage in upper crown
951	<i>Stewartia pseudocamellia</i>	Deciduous Camellia	Poor	14/09/2021	7	54	1.8	✓	✓	In advanced state of decline. Girth measured at .7m.

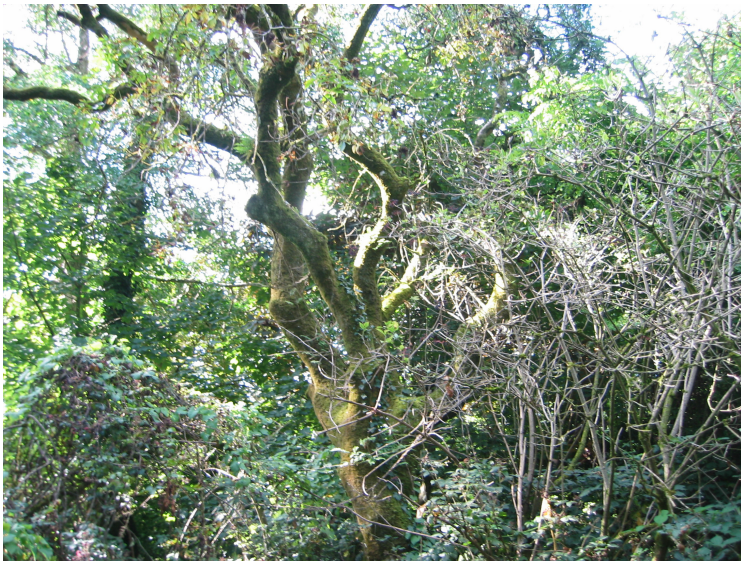
Photo 16: *Tree no. 948.*

Tag No	Latin Name	Common Name	Condition	Survey Date	Height	DBH	Girth_(m)	Champion Tree	Heritage Tree	Comments
1010	<i>Abies nordmanniana</i>	Caucasian Fir	Good	17/09/2021	28	88	2.9		✓	Possibly broken apical stem.
948	<i>Aesculus californica</i>	Indian Horse Chestnut	Poor	14/09/2021	12	51	1.6		✓	Lacks vigour; Signs of early decline
	<i>Azara microphylla</i>	Small-leaved azara		17/05/2004	8		0.81			Not Found
	<i>Catalpa speciosa</i>	Northern Catalpa		17/05/2004	9.5		1.33			Not recorded in recent Surveys
1088	<i>Cedrus atlantica</i>	Blue Atlas Cedar	Dead	16/09/2021						Dead standing tree
916	<i>Cedrus deodara</i>	Deodar	Good	14/09/2021	31	154	5		✓	Signs of decay at base. Peeling bark along main trunk. Check species if Cedar of Lebanon
921	<i>Cercidiphyllum japonicum</i>	Katsura Tree	Fair	14/09/2021	22	170	5.5	✓	✓	Girth measured at 1m. Infected with <i>Ganoderma spp.</i>
919	<i>Cercidiphyllum japonicum</i>	Katsura Tree	Fair		20	130	4.1		✓	Infected with <i>Ganoderma spp.</i>

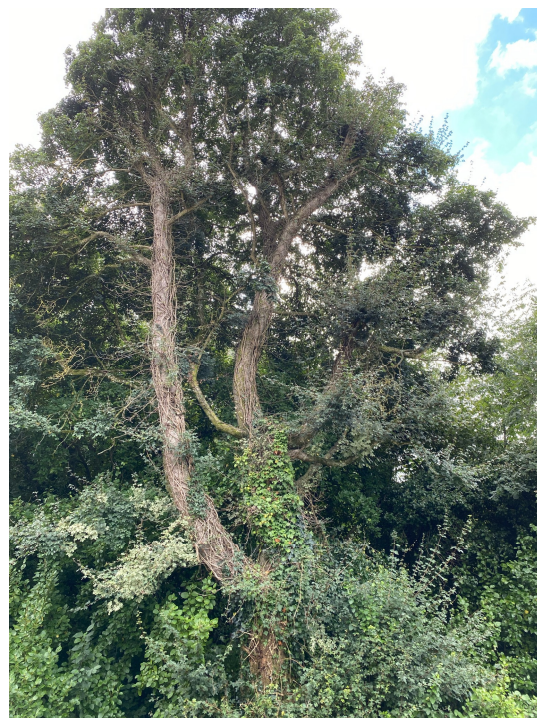
Photo 19: *Tree no. 988.*

988	<i>Acer campestre</i>	Field Maple	Good	24/09/2021	22	80	2.5		✓	Adjacent to car park; Could be a Champion tree
1204	<i>Araucaria araucana</i>	Monkey Puzzle	Good	25/09/2021	17.5	57	2		✓	Light ivy growth attached to main trunk
347	<i>Pseudopanax arboreus</i>	Ivy tree	Good	28/09/2021	12	8,7,5	0.4		✓	Forked from base
