Arboricultural Impact Assessment

**Ballymany
Newbridge
Co. Kildare**

Briargate Developments Newbridge LTD

Authored by qualified Arborist Kevin Lawlor in February 2022

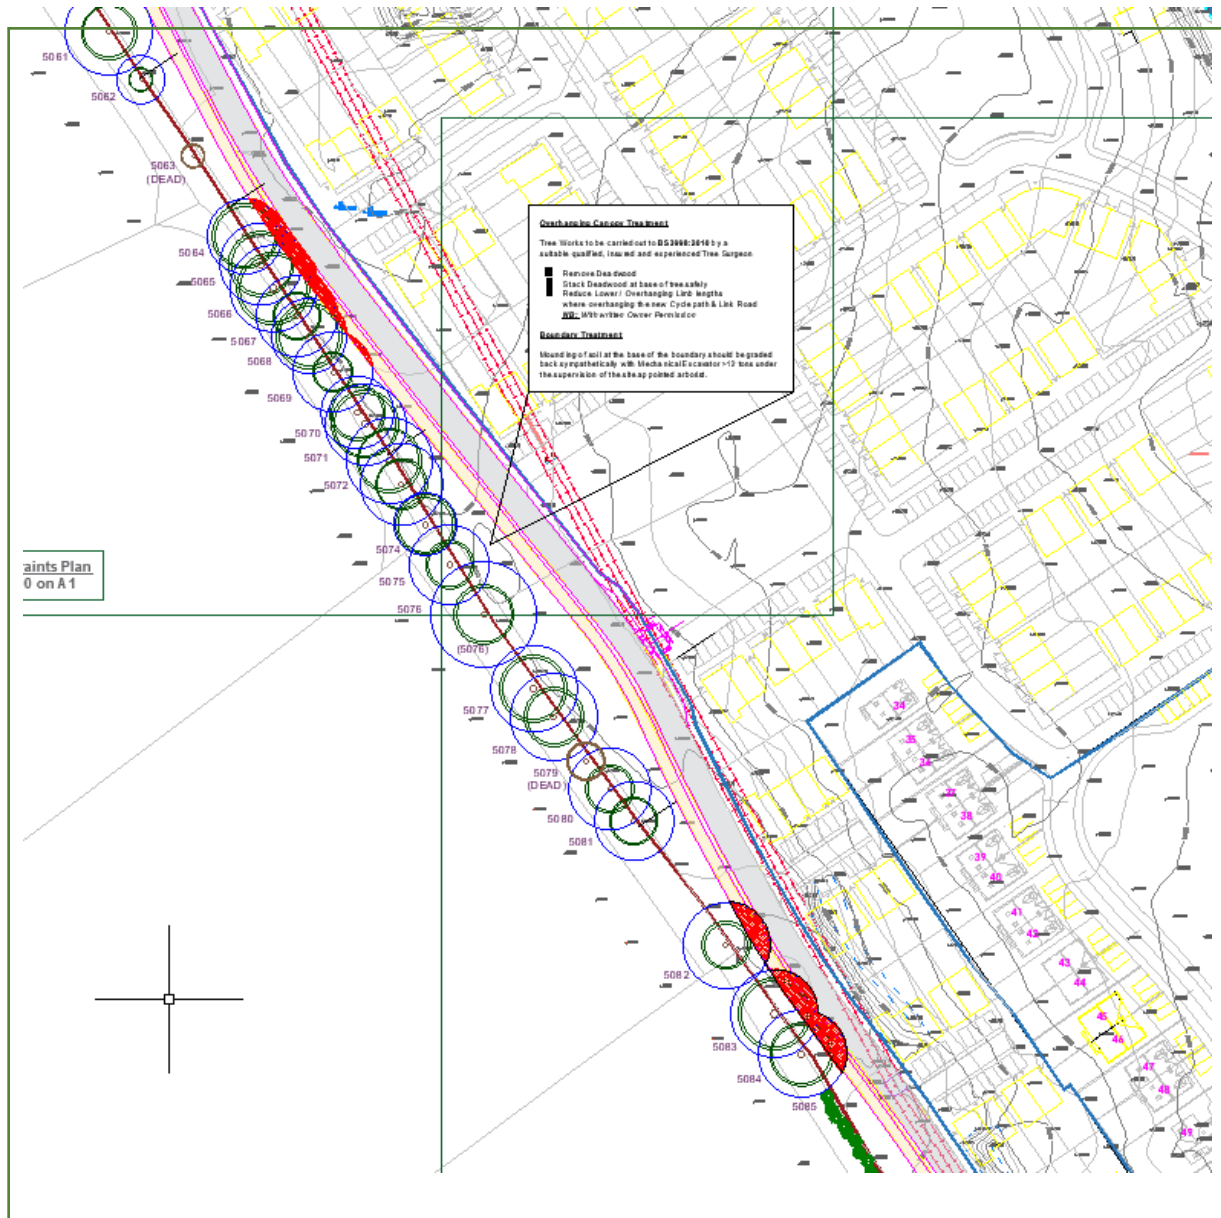
Figure 2 Main interaction of the Development with Existing Trees along the Western Boundary

Tree Protection has been proposed for these trees during general construction works. The cycle path to the west of the link road comes within the CEZ in some areas and a No Dig construction method should be proposed by the Site Engineer to ensure that the Root Protection Area is not disturbed or does not suffer long term effects from works.

Where the Link Road infringes on the RPA of 3 trees to the south a suitable solution will be proposed by the site engineer to minimise the impact of the road on the Roots of the trees 5082, 5083 and 5084.
