Arboricultural Survey and Tree Location Drawing

Project: Title: Development Site, Creamfields, Tramore Road,
Cork

Report Title: Arboricultural Tree Survey Report

Client(s): WATFORE LIMITED

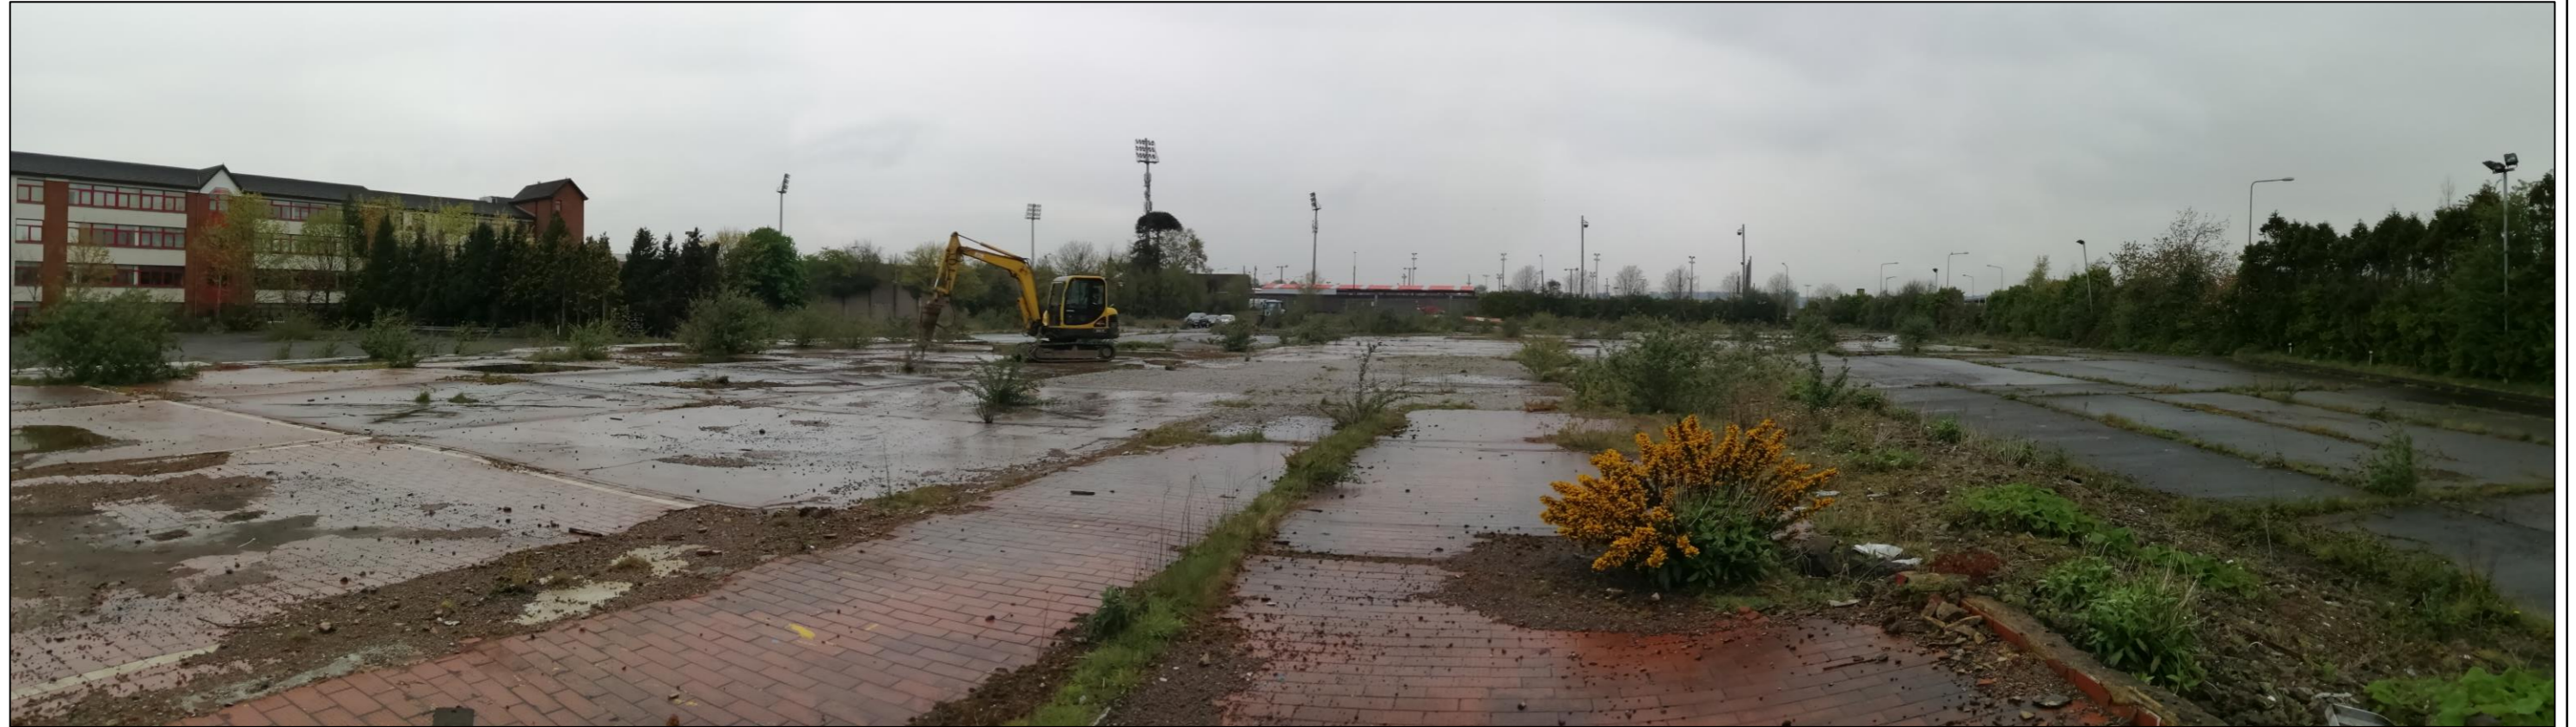
Appendix Figure 13.1.1

The northern and central sections of the site were predominately overlain with hardstanding (concrete slabs or asphalt) and the floors of the old factory or associated buildings

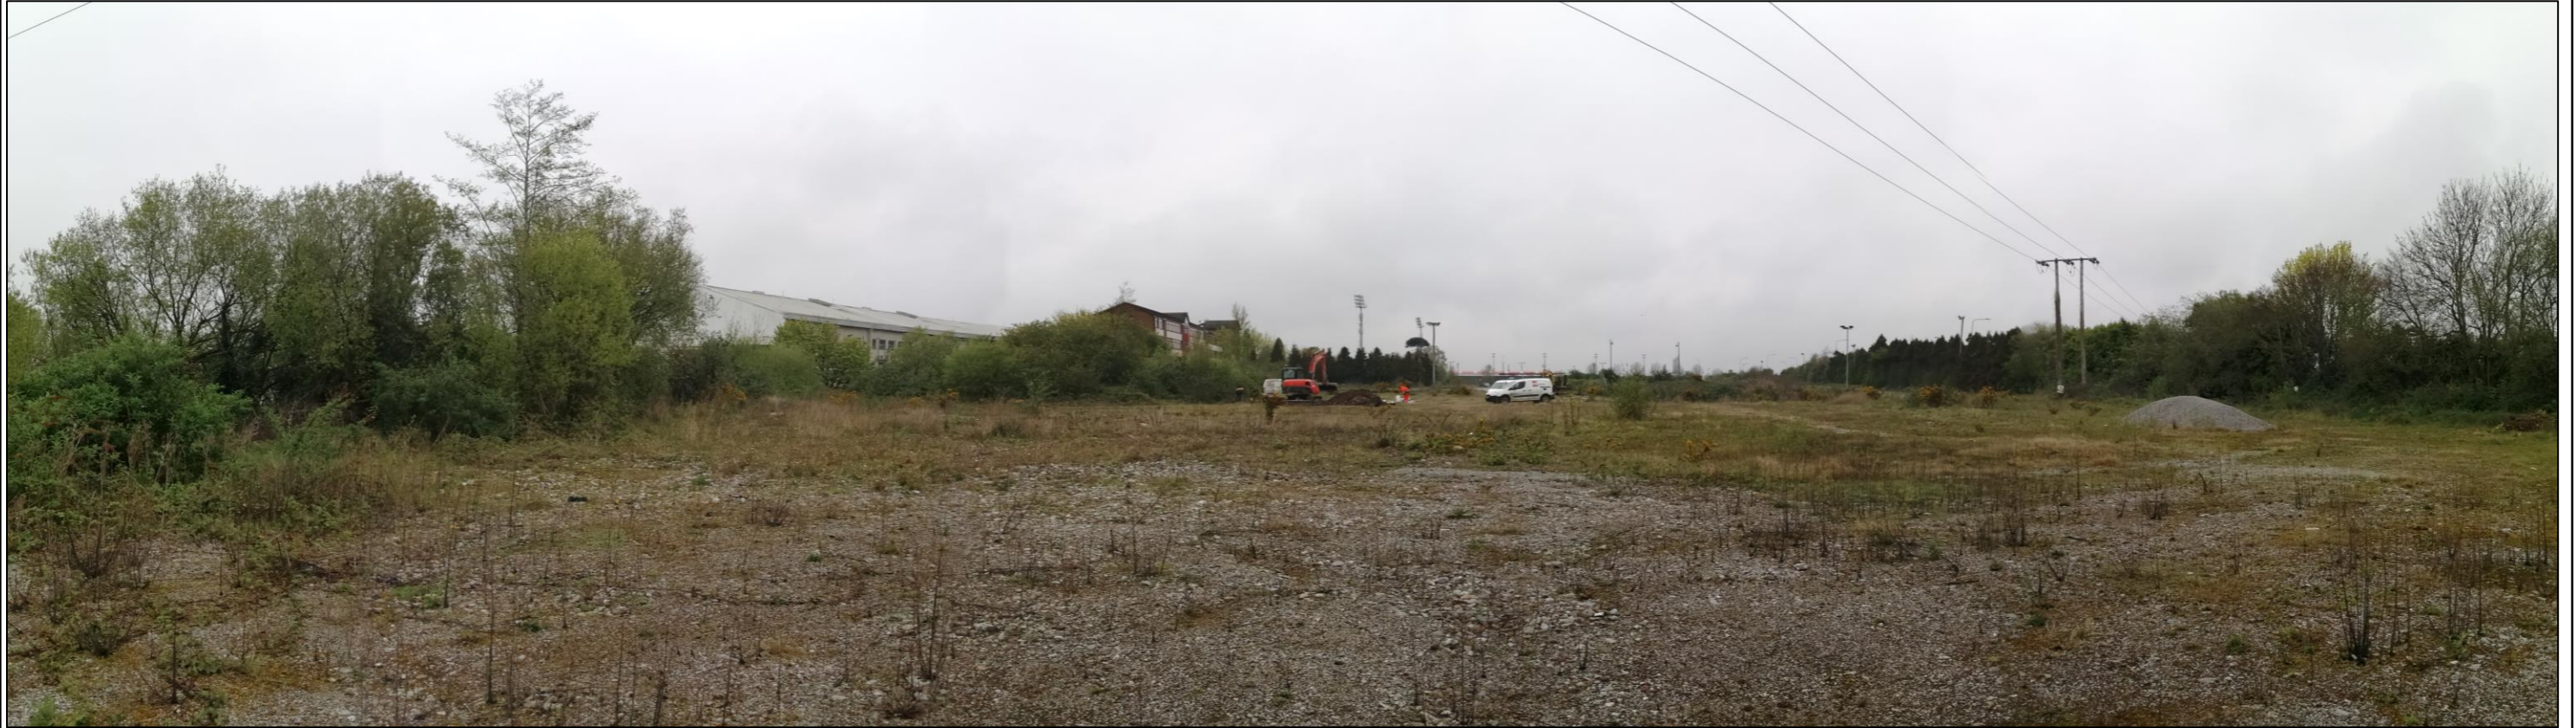
Appendix Figure 13.1.2
 The south of the site comprises uneven ground consisting of crushed construction and demolition materials

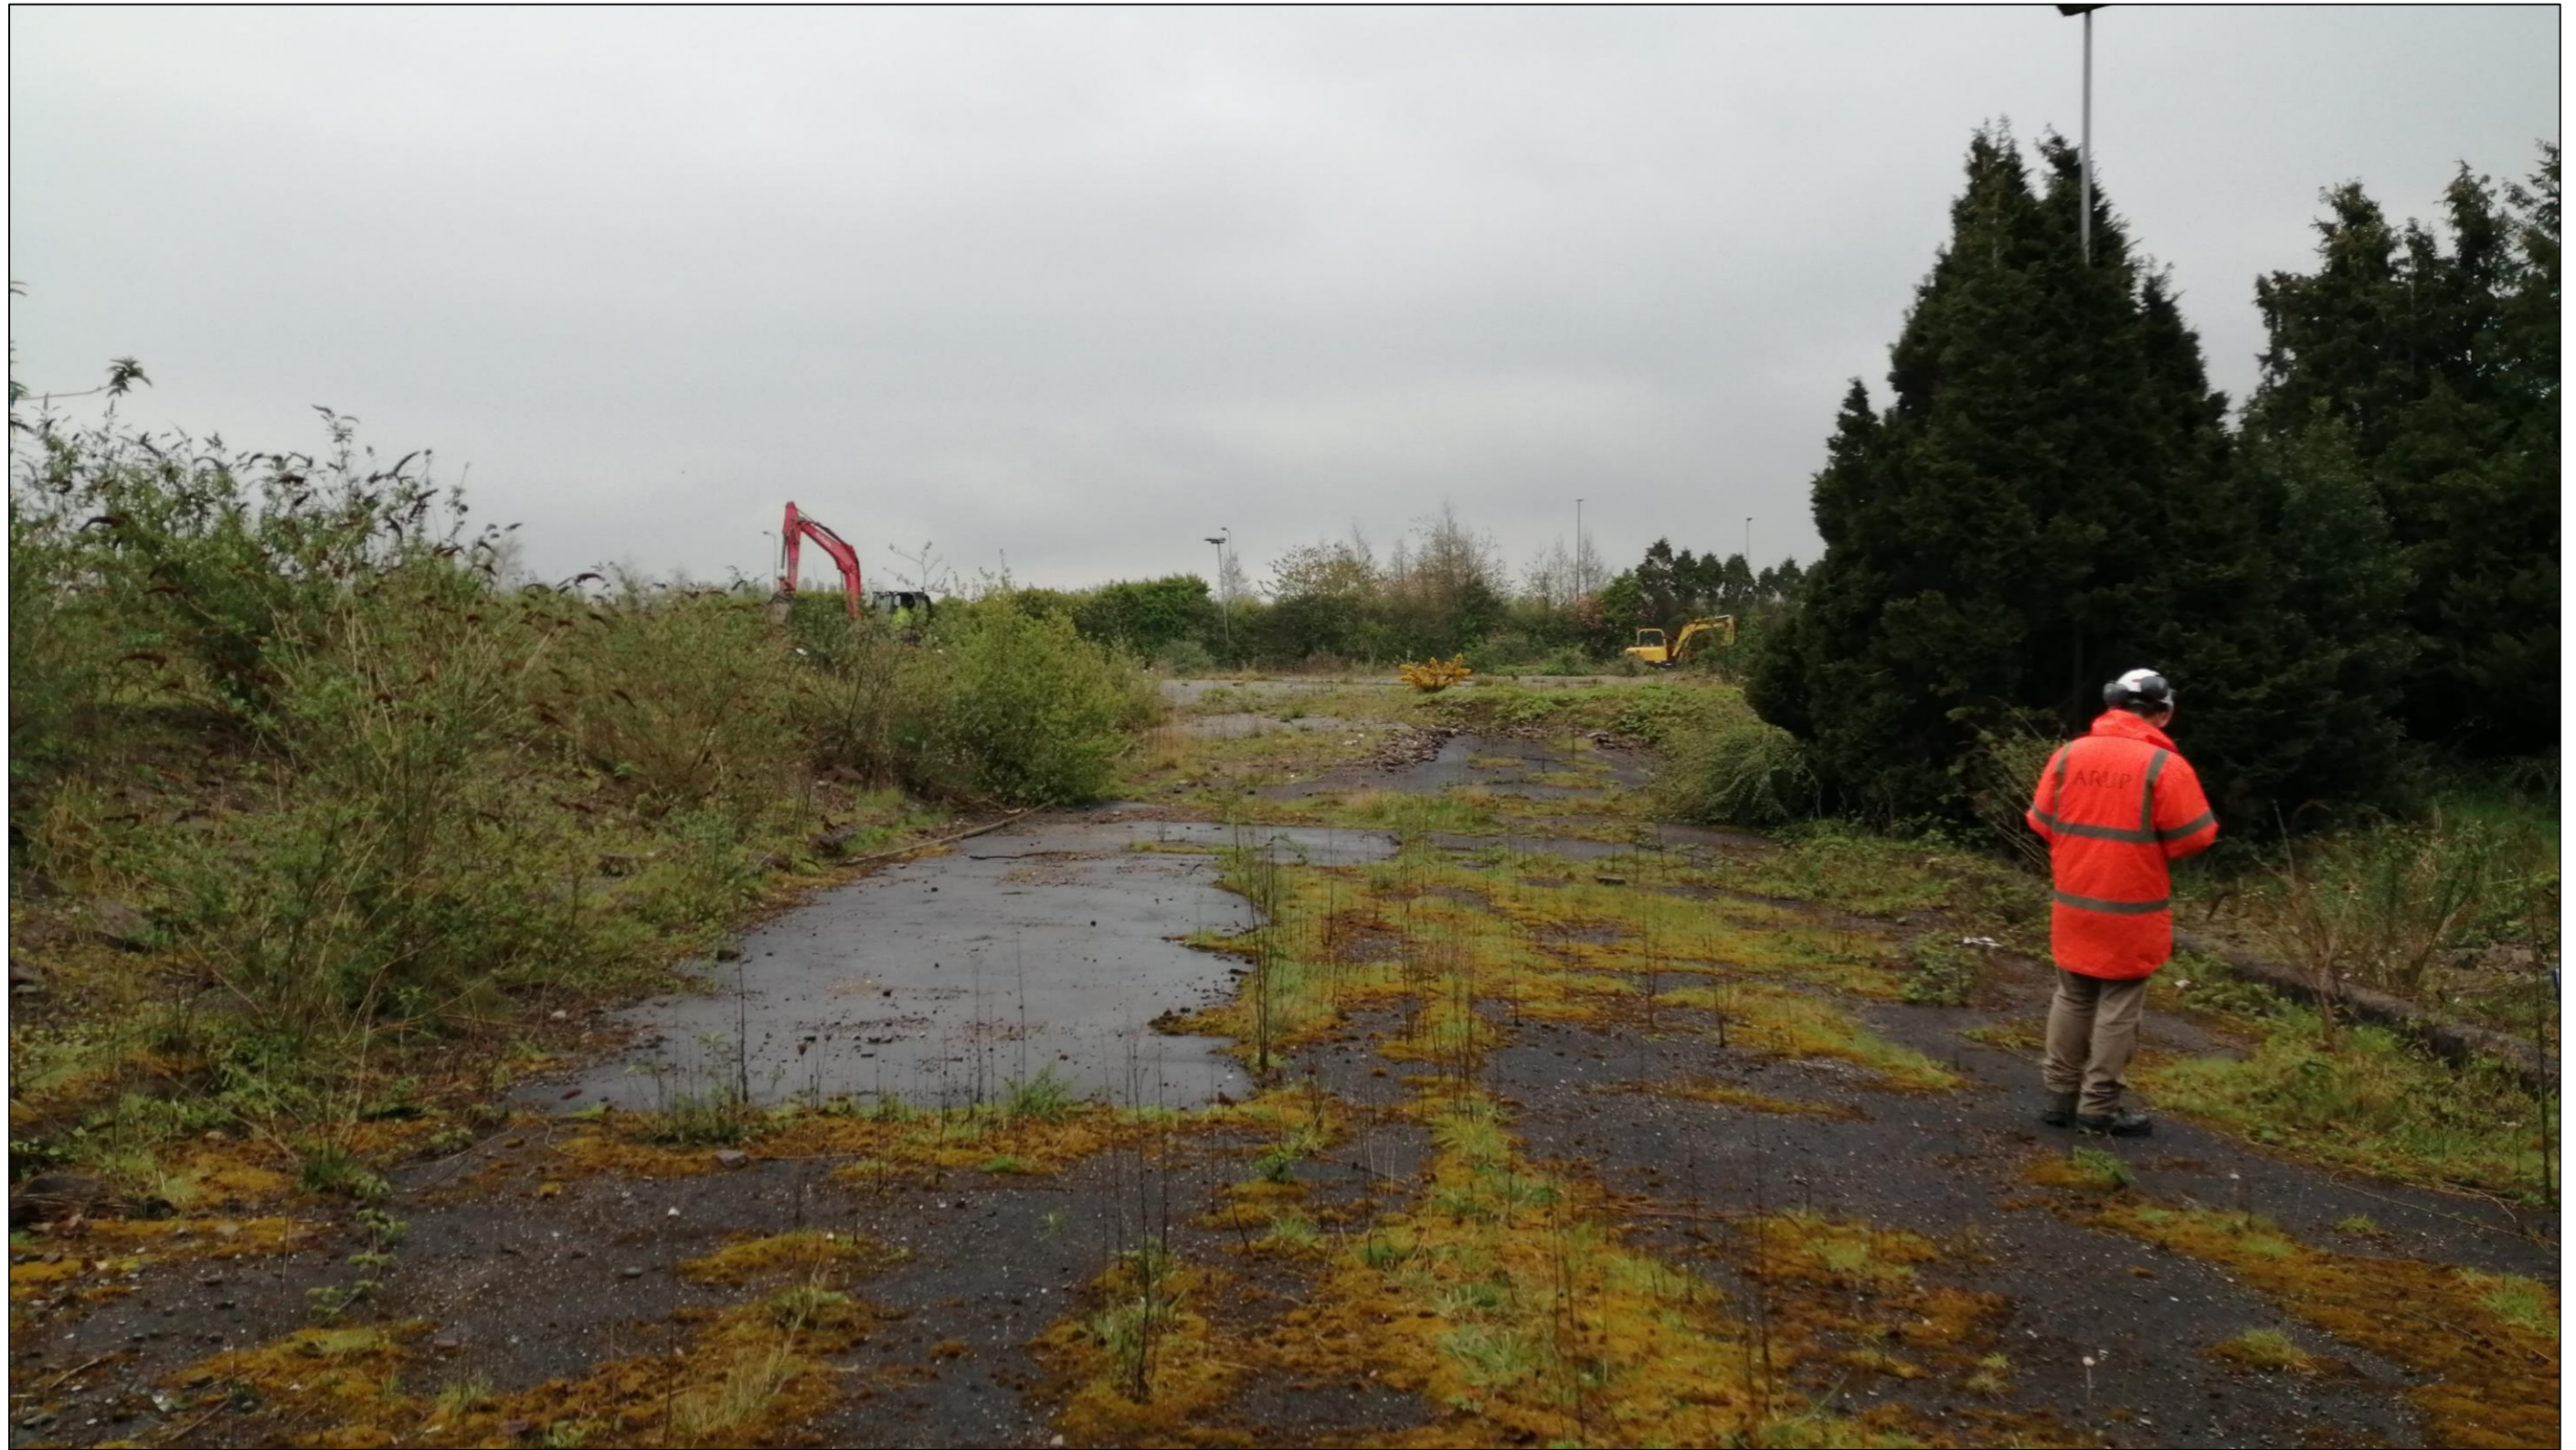
Appendix Figure 13.1.3
Northwest of the site where there was an area of lowered ground

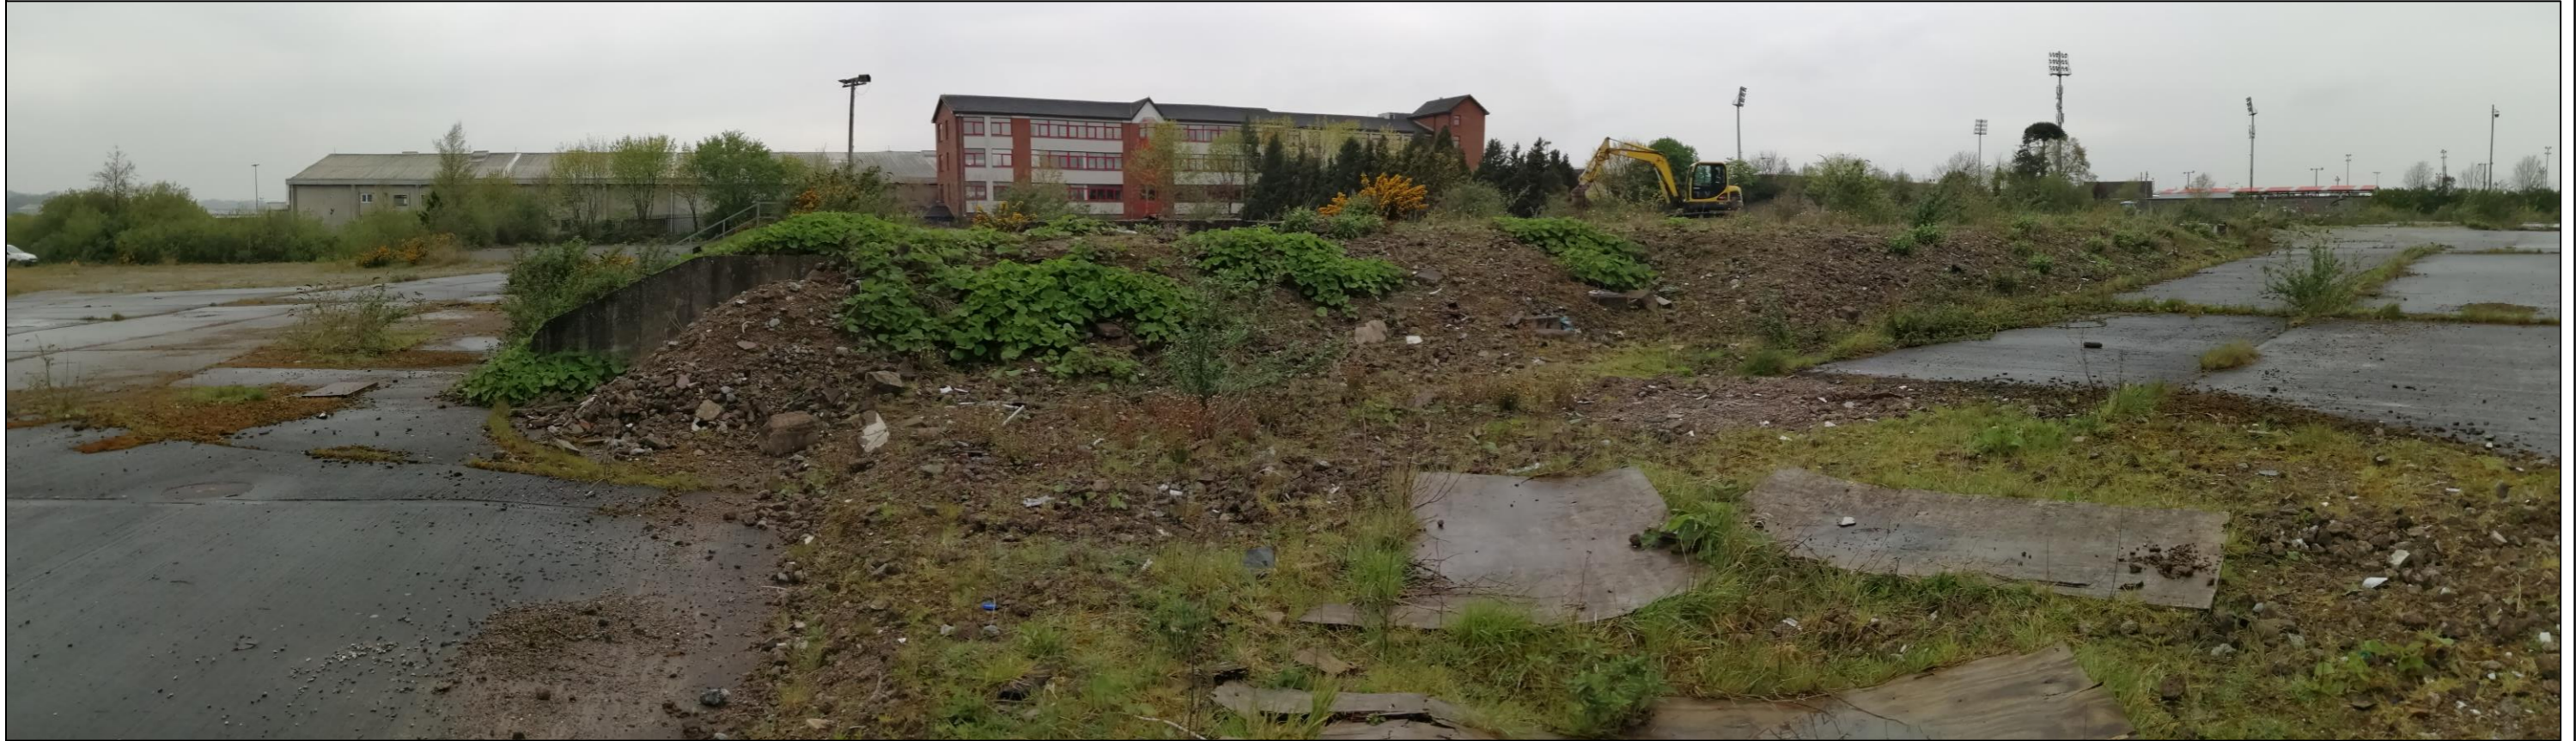
Appendix Figure 13.1.4
The centre of the site where the former factory was raised above the surrounding ground level

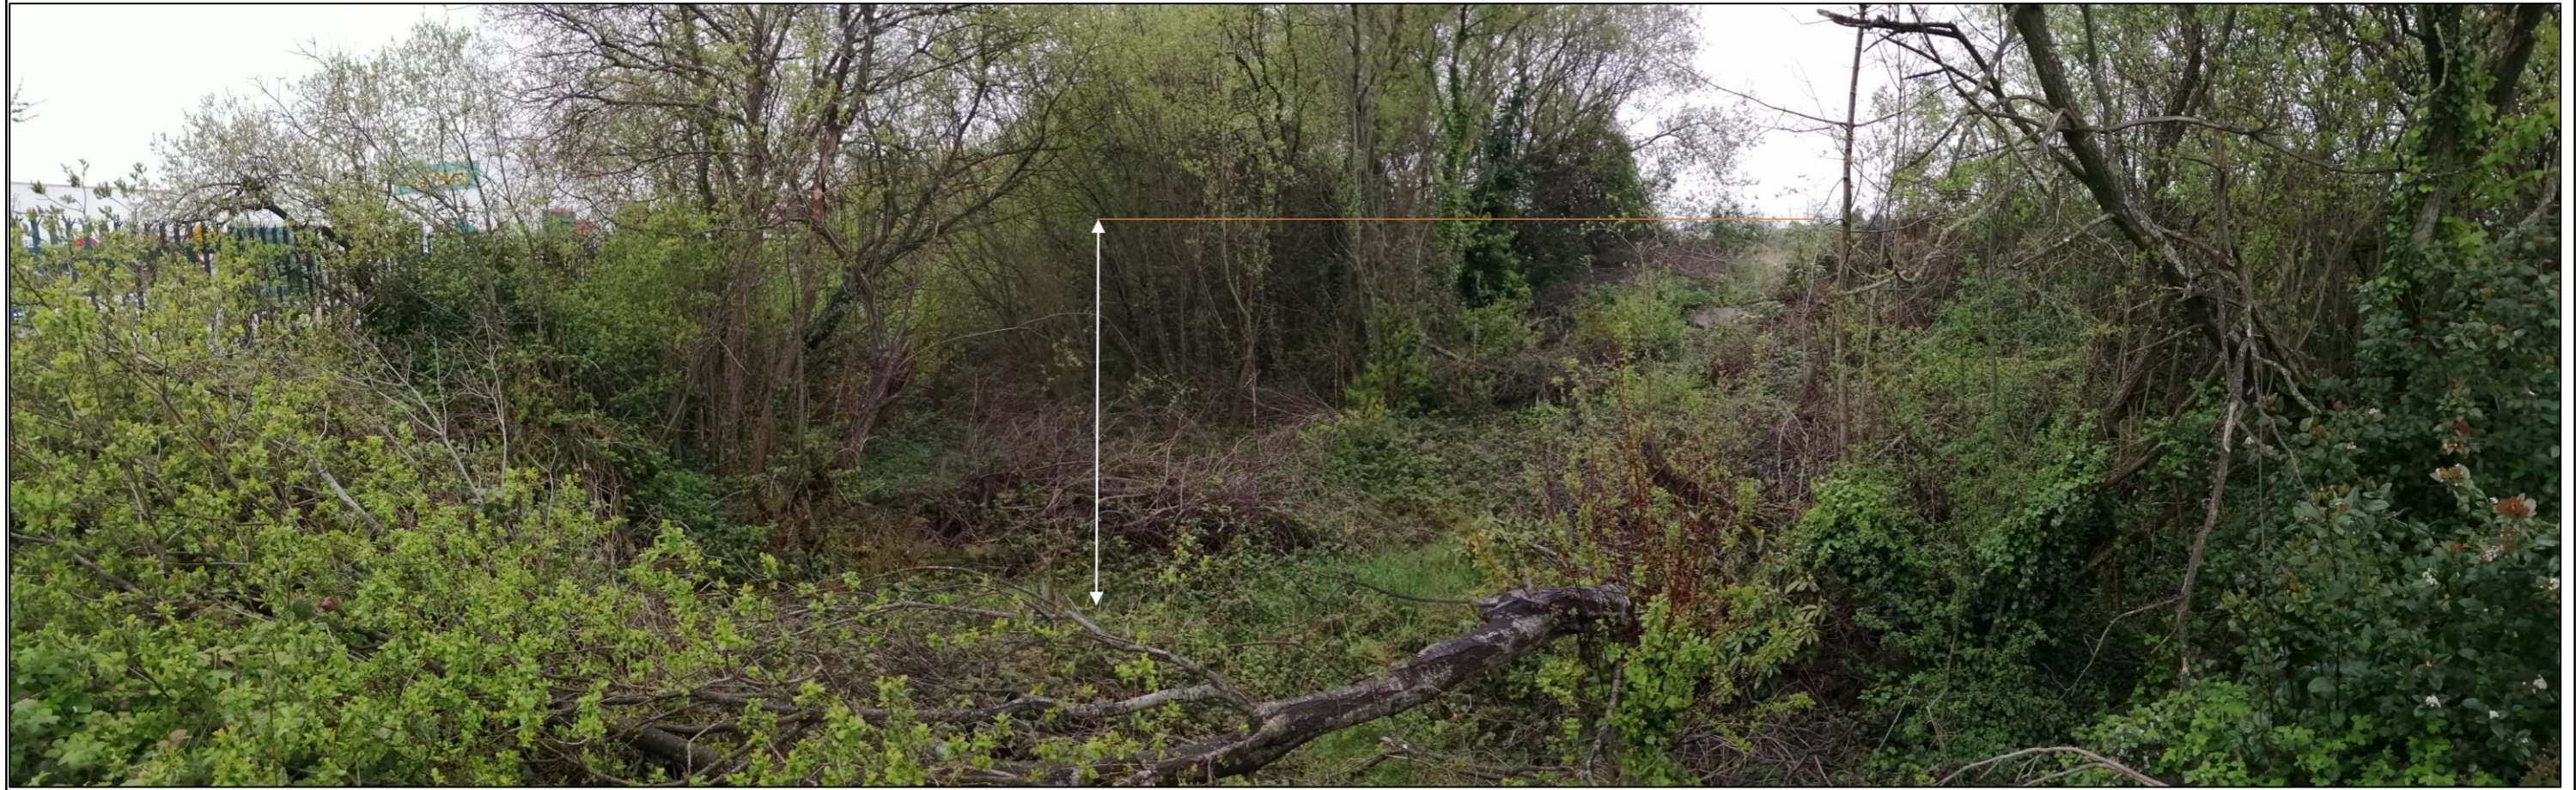
Appendix Figure 13.1.5
 Along the southern boundary of the site, in the area of dense vegetation there was a sharp drop off in ground level by approximately 1m to 2m

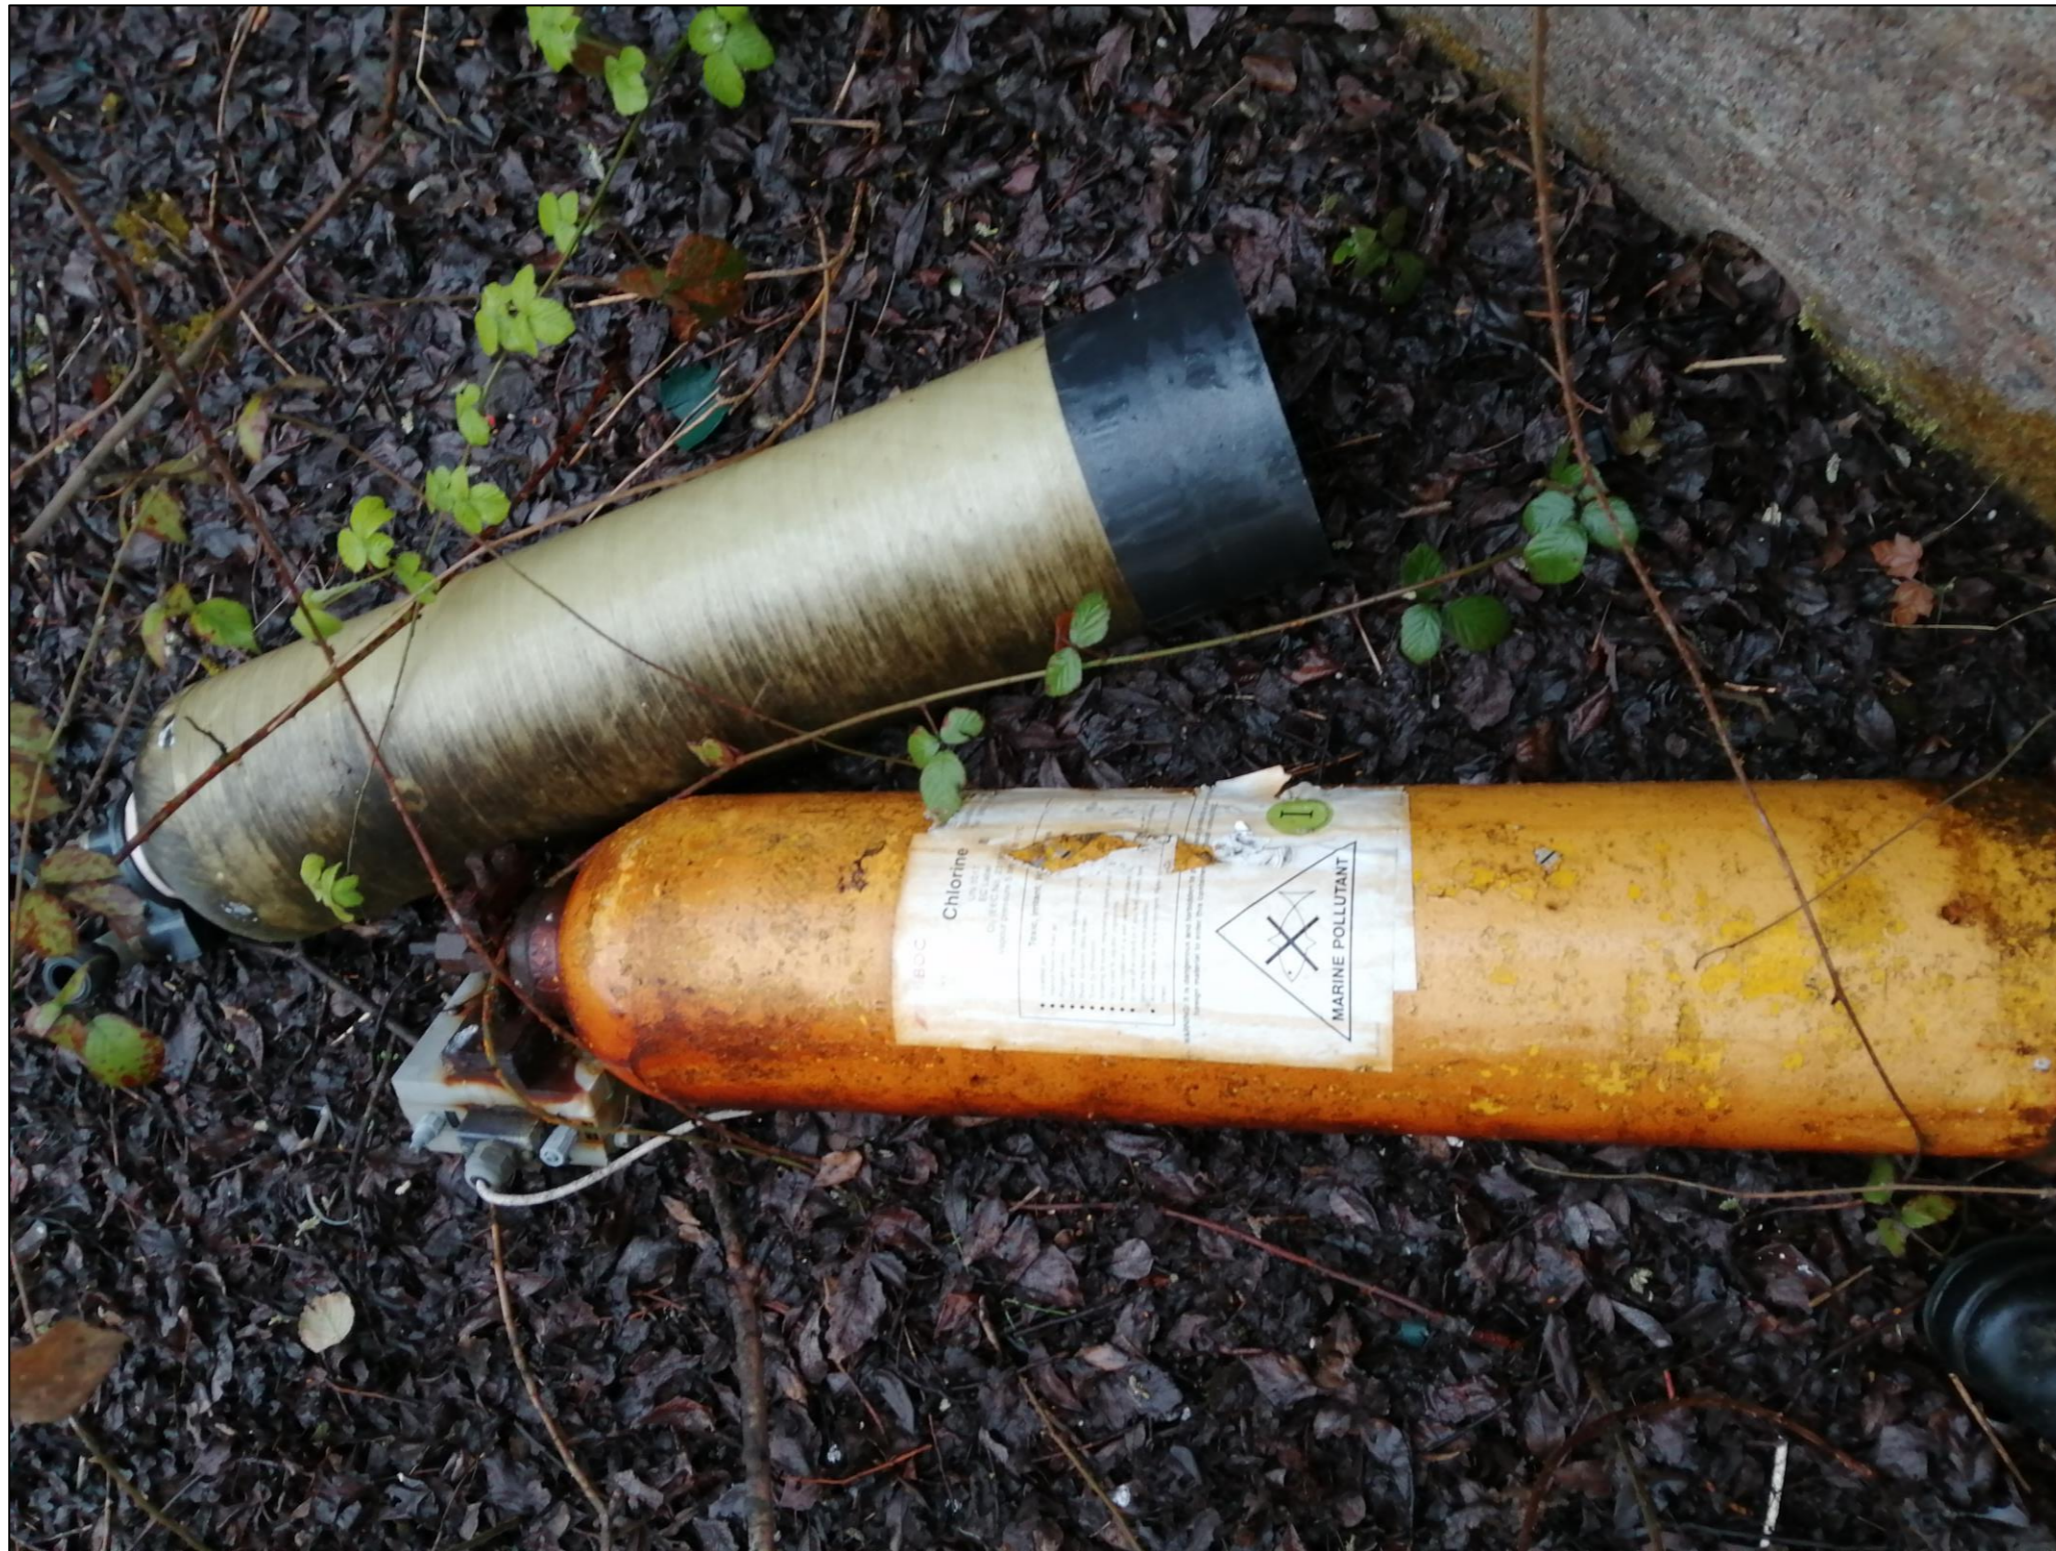
Appendix Figure 13.1.6

In the southwest of the site, close to the location where the well was indicated to be present in a depression, was a potential underground tank and chlorine canisters were noted nearby

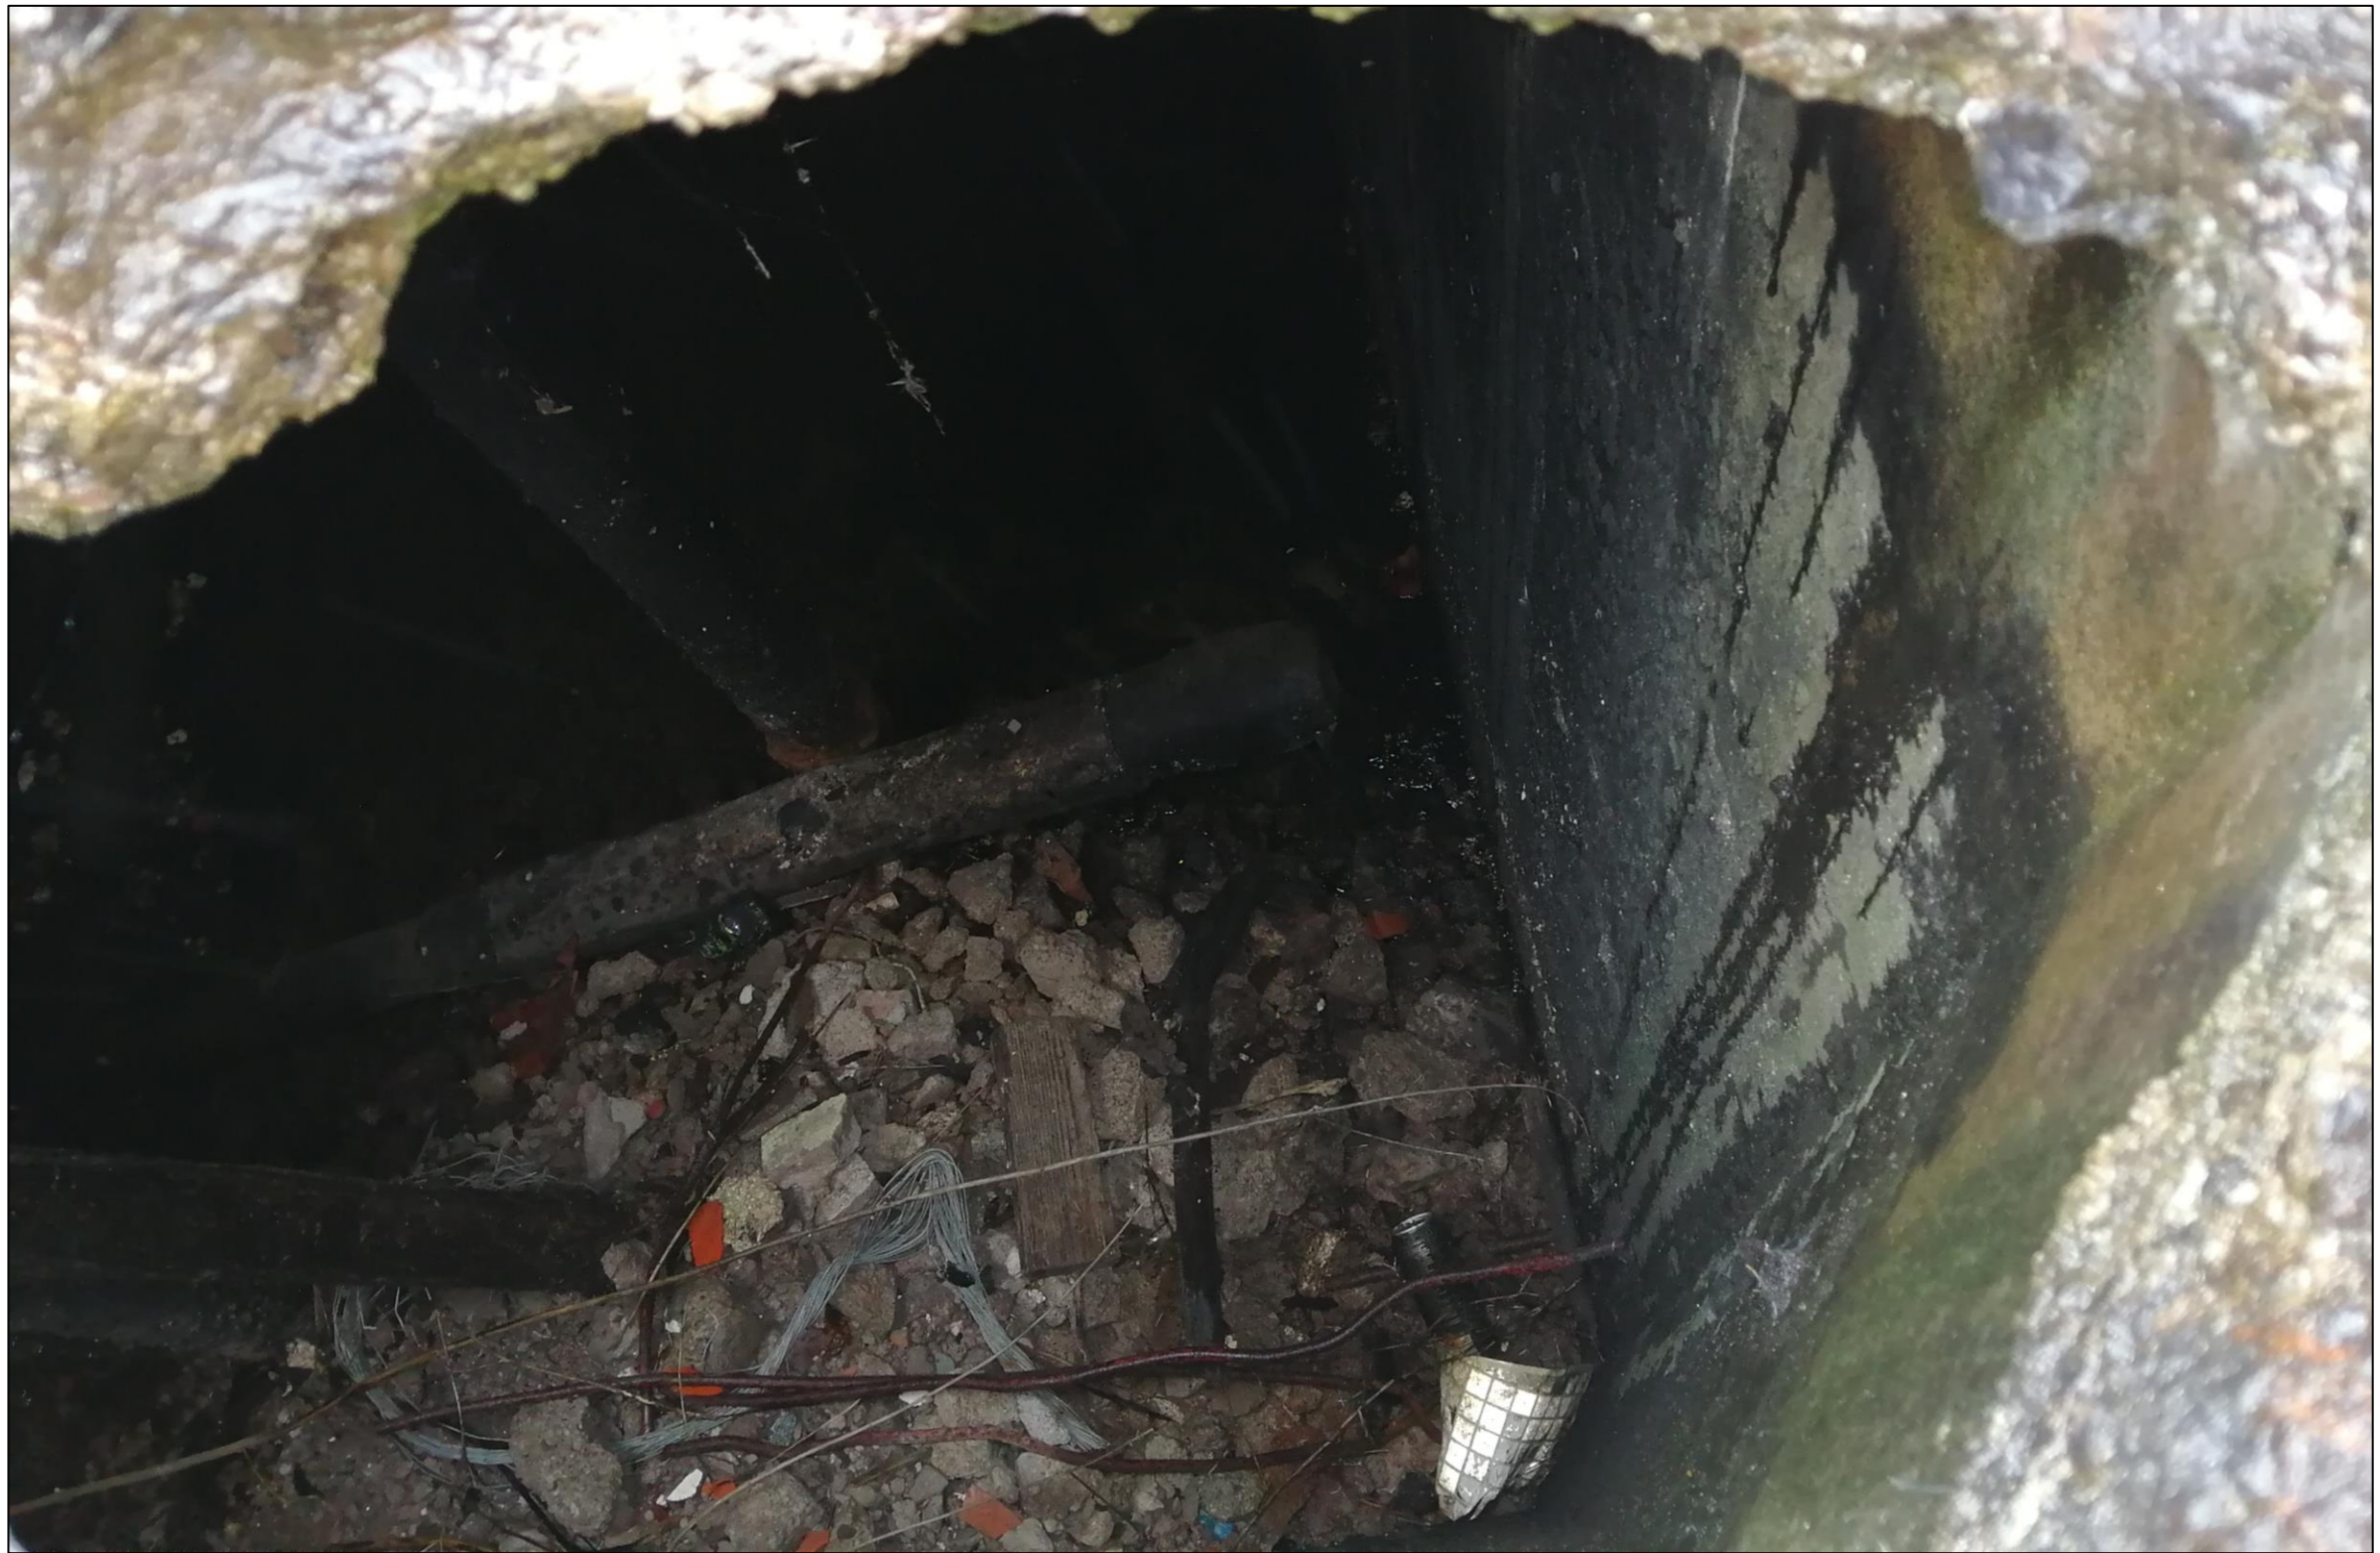
Appendix Figure 13.1.7
 In the northwest of the site there was an approximately 2m deep below ground level concrete tank or basement

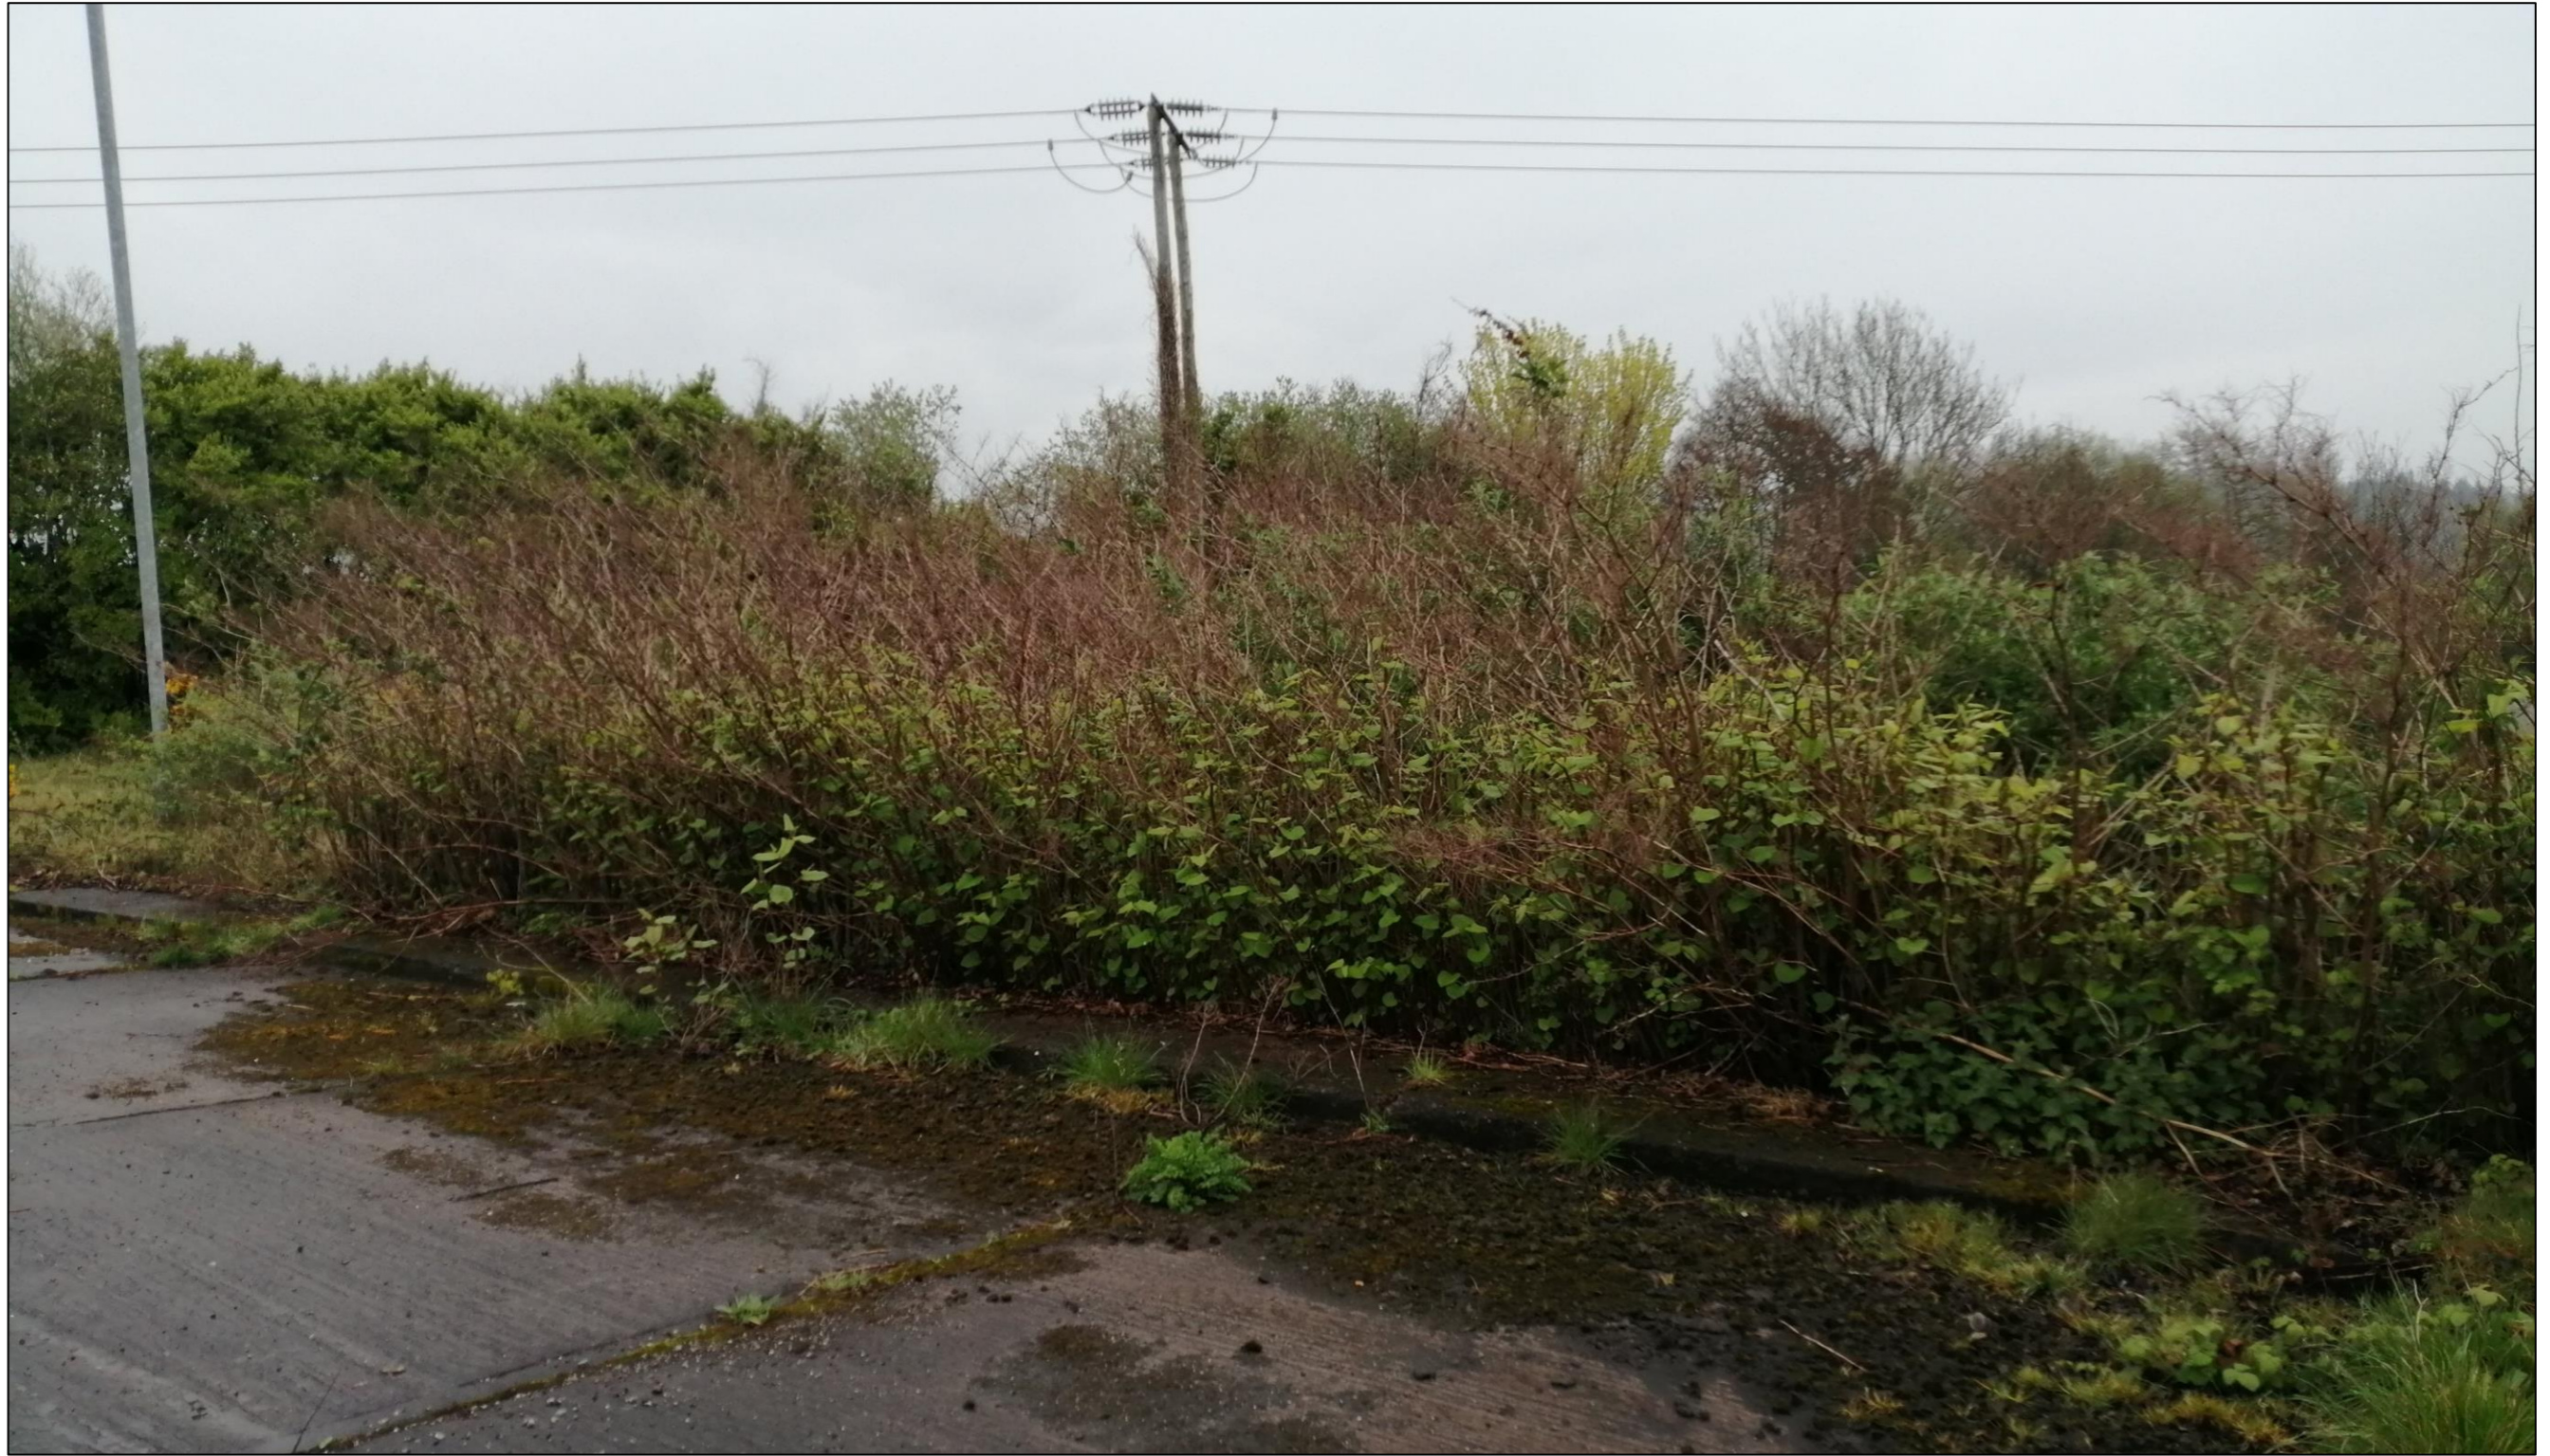
Appendix Figure 13.1.8
 Japanese Knotweed noted in several areas of the southern end of the site
