Arboricultural Survey and Tree Location Drawing

Project: Title: Development Site, Creamfields, Tramore Road,
Cork

Report Title: Arboricultural Tree Survey Report

Client(s): WATFORE LIMITED

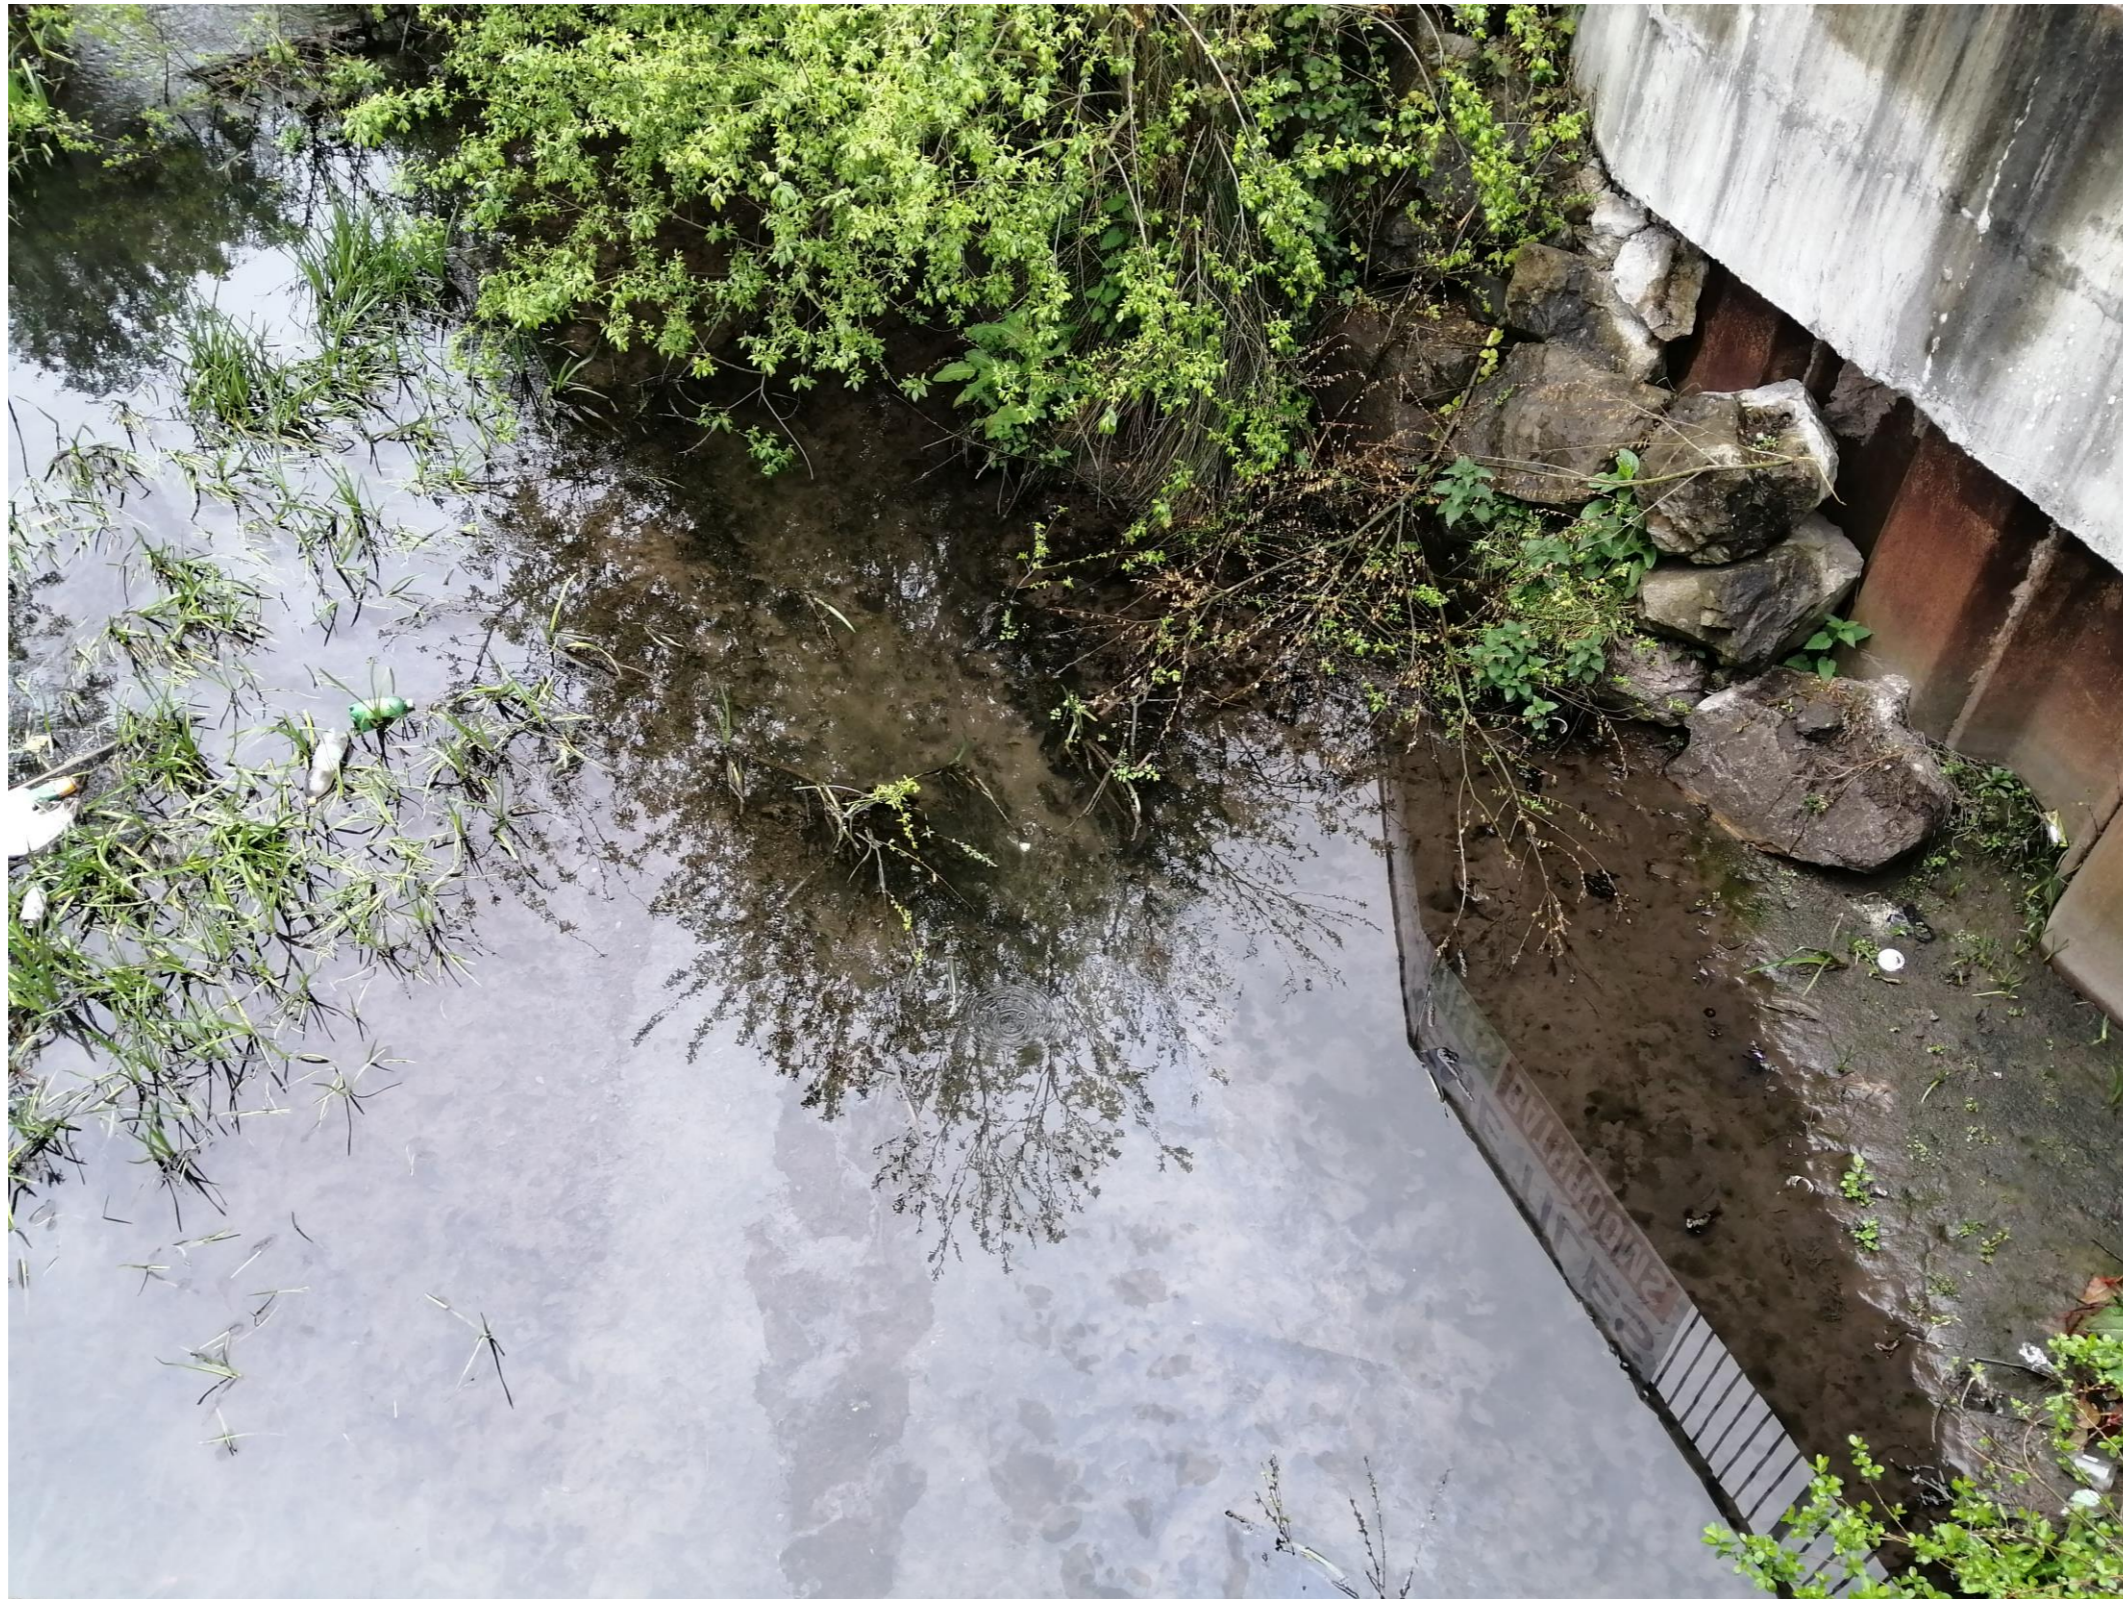
Appendix Figure 13.1.9

It was noted that on the day of site visit the Tramore River, 0.08km to the south of the site, had a potential hydrocarbon film
