Arboricultural Report

Tree Survey,
Arboricultural Impact Assessment &
Arboricultural Method Statement

Bridgegate
Rathgory & Mulladrillen
Ardee
Co. Louth

200214-PD-11-D

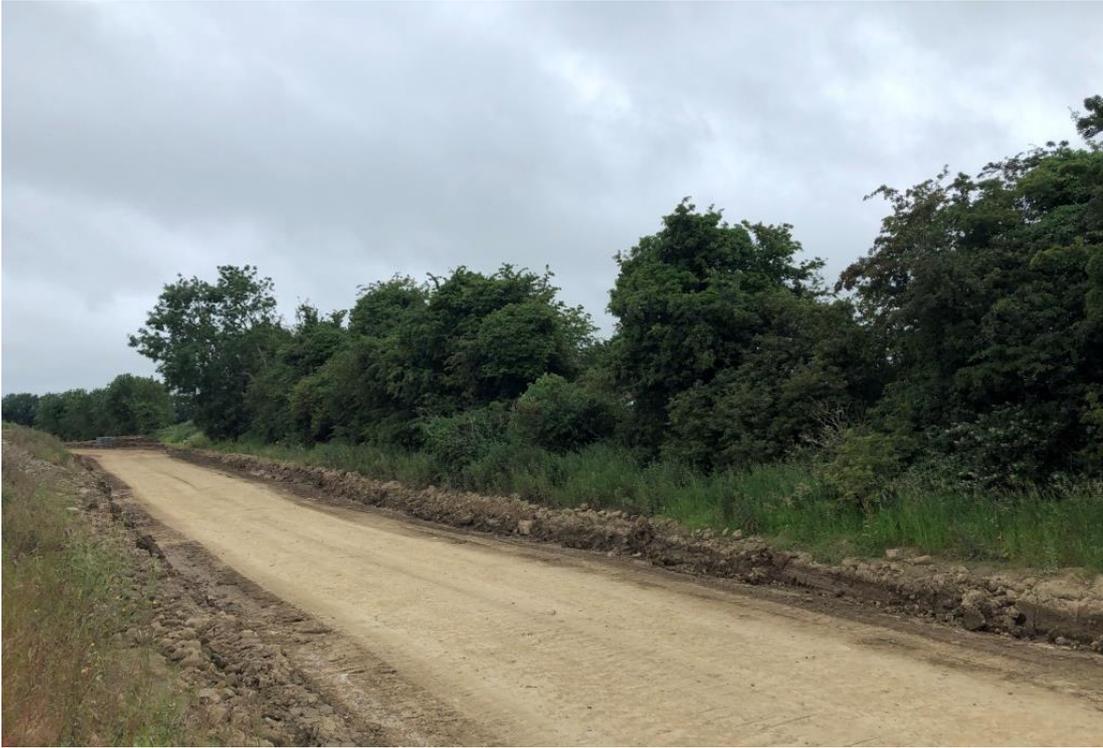
Photo 1: View of the south-western boundary native hedgerow H592.

- 6.5 **Pruning works** – It is recommended that the lateral growth of boundary hedgerows H575; H592; H593; H601; H609; and H610, are reduced, where necessary, to provide space adjacent to proposed dwellings, streetlights, roads, and gardens.

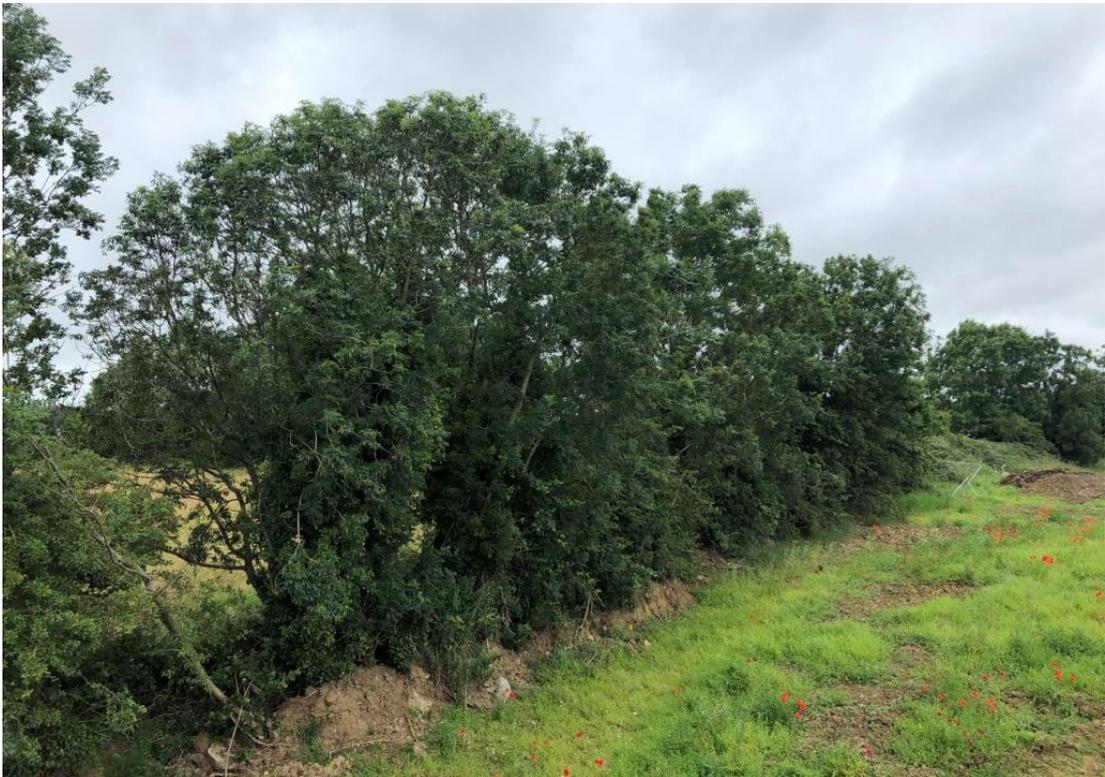
Photo 2: View of south-western hedgerow and tree line H575. Regrown ash coppice trees located within the hedgerow.

Tree ID	No. Species	Height (m)	Stem diameter (cm)	No. of Stems	CROWN SPREAD (m)								Crown clearance (m)	L.B. (m)	Life stage	Condition Notes	Survey date	RPA (m ²)	RPR (m)	Life expectancy (yrs)	BS Category		
					N	NE	E	SE	S	SW	W	NW											
Hedge H575	1 Rubus fruticosus s. (Blackberry/Bramble)	9.0	30 AVE	1										0.0		Early Mature	Structural condition Fair. Physiological condition Fair. Altered ground level - Recent. Coppice stool - Regrown. Deadwood - Minor. Excavation within root zone - Recent. Hedgerow - Neglected / overgrown. Ivy or climbing plant. Root damage - Suspected. Height and stem diameter are average for group. Native boundary hedgerow consisting of overstorey ash trees. Several ash trees showing signs of tip dieback - symptoms typical of ash dieback. Ash trees are regrown coppice stools that have been neglected. Quantities not recorded - only species mix. Rejuvenate hedgerow by coppicing ash and pruning hedgerow.	17/07/2020	40.7	3.6	20-40	C2

- 6.11 **Construction of main built element of the development** – The construction of the main built element of the development will require some excavation works that are marginally within the RPA of the retained hedgerow H575. The areas affected constitute a very small proportion of the rooting area of this hedgerow and is at the periphery of its RPA. It is not considered at all likely that this very minor incursion will cause harm to the health or structure of the hedgerow concerned and special methods of work are therefore not considered necessary.

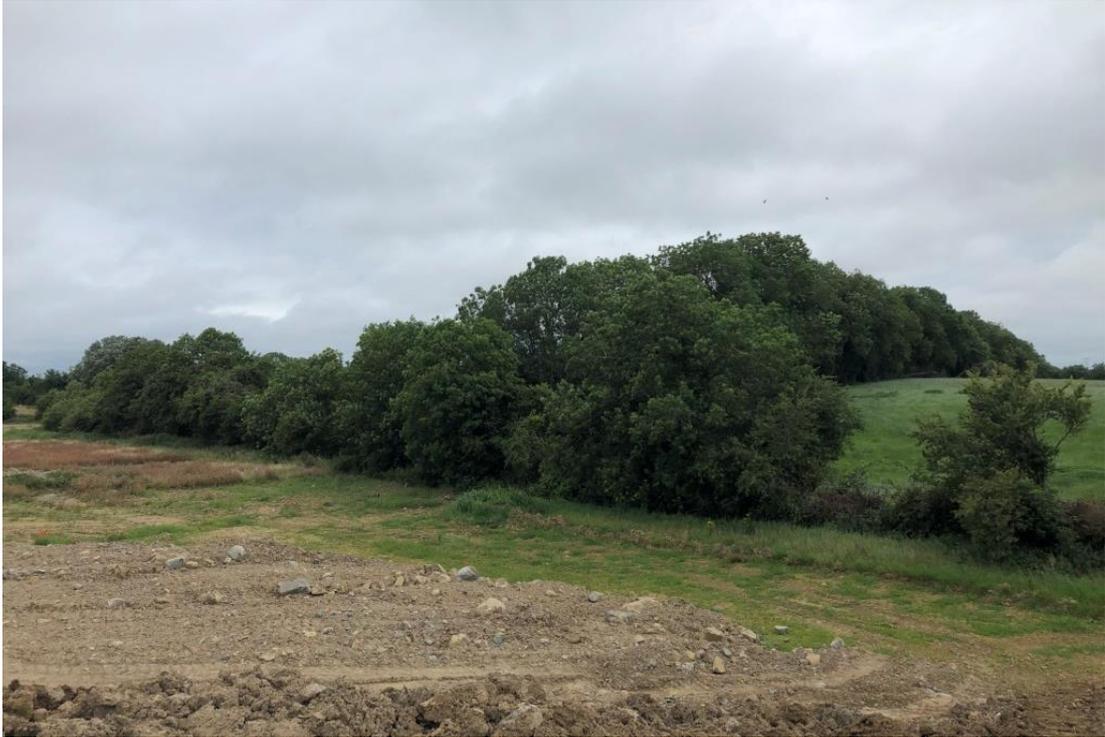
Photo 3: View of the eastern boundary native hedgerow and tree line (T576 to T579; T594 to T598; H601 & H609)

1 Hedera helix (Common Ivy)																						
	1 Fraxinus excelsior (Ash)																						
	1 Crataegus monogyna (Common Hawthorn/Quick/May)																						
Tree T576	1 Fraxinus excelsior (Ash)	10.0	50	1	5.5	6.0	5.5	5.0					1.0		Mature	Structural condition Fair. Physiological condition Fair. Access to inspect base - Restricted / obscured. Die-back - Upper crown. Deadwood - Minor. Ivy or climbing plant. Unable to inspect tree closely due to ivy cover. Tip dieback in upper crown - symptoms typical of ash dieback.	17/07/2020	113.1	6.0	10-20	C2		
Tree T577	1 Fraxinus excelsior (Ash)	12.5	55 COM	3	6.5	6.0	7.0	4.5					1.0		Mature	Structural condition Fair. Physiological condition Fair. Access to inspect base - Restricted / obscured. Competition - Adjacent trees. Deadwood - Minor. Ivy or climbing plant. Unable to inspect tree closely due to restricted access and ivy cover. Tree located on eastern side of ditch - ownership unknown.	17/07/2020	141.4	6.7	20-40	C2

Tree T578	1 Fraxinus excelsior (Ash)	10.0	30	1	4.5	3.0	4.0	4.0					0.0		Early Mature	Structural condition Fair. Physiological condition Fair. Competition - Adjacent trees. Die-back - Upper crown. Deadwood - Minor. Ivy or climbing plant. Tip dieback in upper crown - symptoms typical of ash dieback.	17/07/2020	40.7	3.6	10-20	C2		
Tree T579	1 Fraxinus excelsior (Ash)	11.0	40 COM	4	5.0	3.5	4.5	5.5					0.0		Early Mature	Structural condition Fair. Physiological condition Fair. Access to inspect base - Restricted / obscured. Competition - Adjacent trees. Deadwood - Minor. Ivy or climbing plant.	17/07/2020	72.4	4.8	10-20	C2

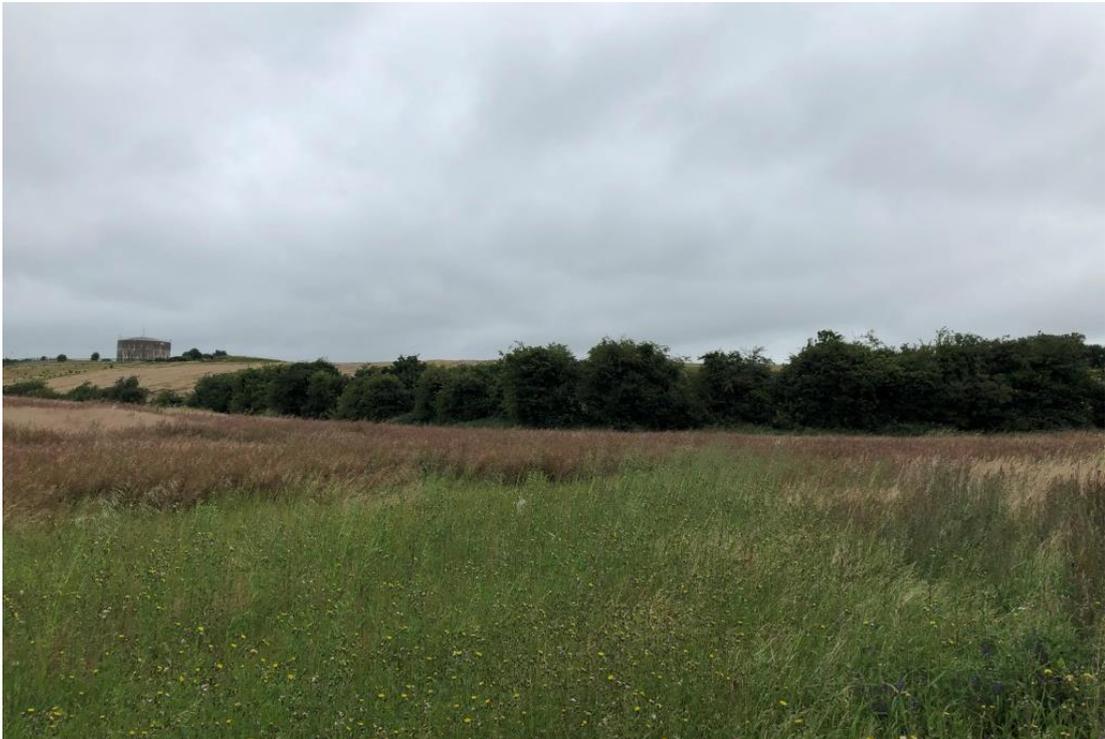
Photo 4: View of the internal native hedgerows (H602 to H604; H608) that separate the two fields that make up the site.

Hedge H602	1 Crataegus monogyna (Common Hawthorn/Quick/May)	5.0	20 AVE	1									0.0		Early Mature	Structural condition Fair. Physiological condition Fair. Hedgerow - Neglected / overgrown. Height and stem diameter are average for group. Quantities not recorded - only species mix. Hedgerow located on either side of the ditch. Borderline B Category.	17/07/2020	18.1	2.4	20-40	C2					
	1 Hedera helix (Common Ivy)																									
	1 Rubus fruticosus s. (Blackberry/Bramble)																									
	1 Salix caprea (Goat Willow/Great Sallow)																									
	1 Sambucus nigra (Elder)

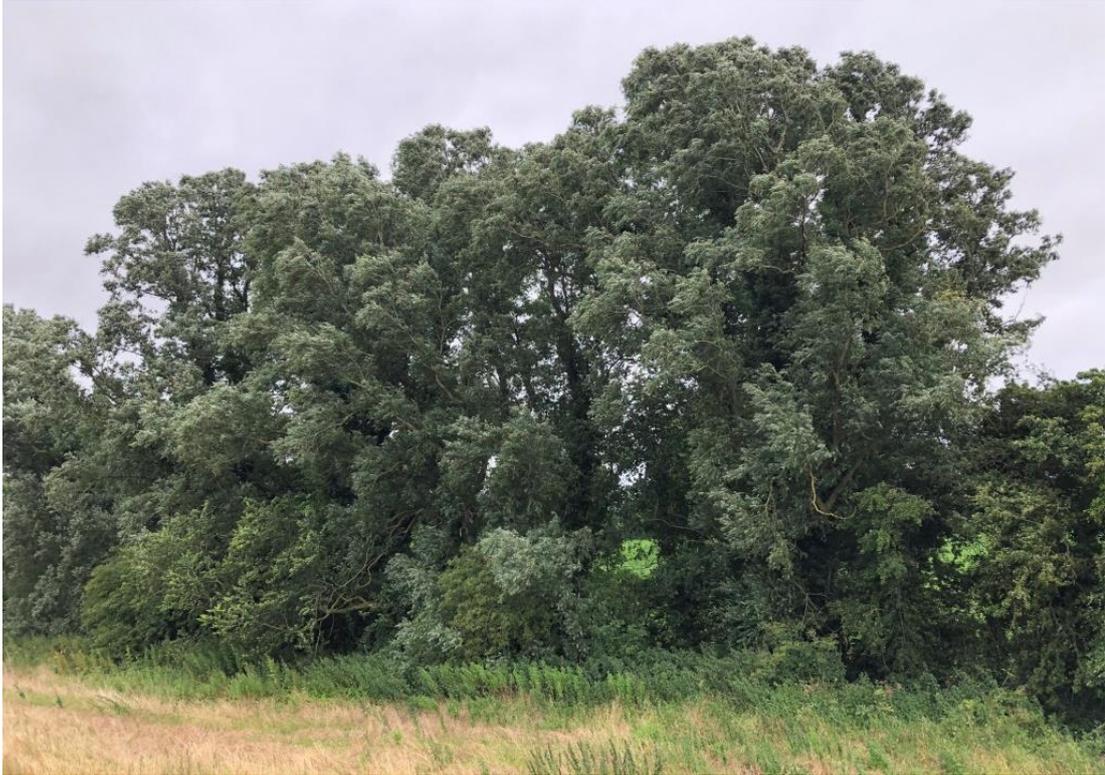
Photo 5: View of mature white willow trees (T581 to T595 & T606) located along the eastern boundary.

Tree T582	1 Salix alba (White Willow)	15.0	110	1	3.0		5.0		5.5		5.5		0.0		Mature	Structural condition Poor. Physiological condition Fair. Competition - Adjacent trees. Deadwood - Major. Stag-headed crown. Storm damage. Tree located on eastern side of ditch - ownership unknown. Unable to inspect tree closely due to ivy cover.	17/07/2020	547.4	13.2	0-10	U
Tree T583	1 Salix alba (White Willow)	20.0	91	1	3.0		7.0		4.0		8.0		3.0		Mature	Structural condition Poor. Physiological condition Fair. Competition - Adjacent trees. Deadwood - Minor. Decay / structural defect - Base. Exposed crown - Recent. Ivy or climbing plant. Tree located on eastern side of ditch - ownership unknown. Unable to inspect tree closely due to ivy cover.	17/07/2020	374.6	10.9	10-20	C2
Tree T584	1 Salix alba (White Willow)	20.0	126 COM	2	7.0		8.0		8.5		9.0		0.0		Mature	Structural condition Poor. Physiological condition Fair. Access to inspect base - Restricted / obscured. Decay / structural defect - Localised. Fork - Weak with included bark. Ivy or climbing plant. Shedding limb / limbs - Historic. Tree located on eastern side of ditch - ownership unknown. Unable to inspect tree closely due to ivy cover.	17/07/2020	706.9	15.0	10-20	C2

- 6.7 It has also been recommended that pruning works are carried out to six white willow trees T581 to T585 and T606 for arboricultural reasons. Four of these trees (T581; T582; T583; T585) are required to be pollarded due to their poor structural condition, while the other two trees (T584; T606) require crown reductions. By managing the trees in this manner, it is possible to retain them whilst reducing the level of risk they will pose to surrounding targets following the completion of the development. Any proposed pruning works to these trees will require written permission from the owner.

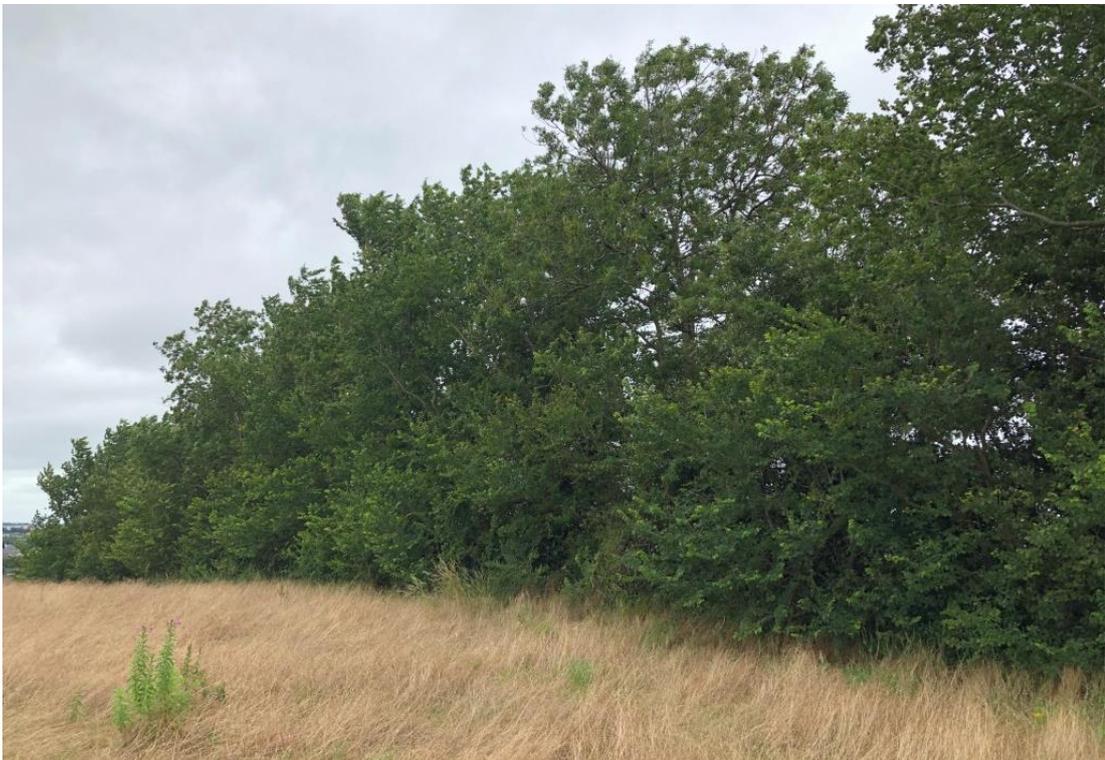
Photo 6: View of the north-eastern boundary tree group G611 which consists mainly of early-mature elm and ash trees.

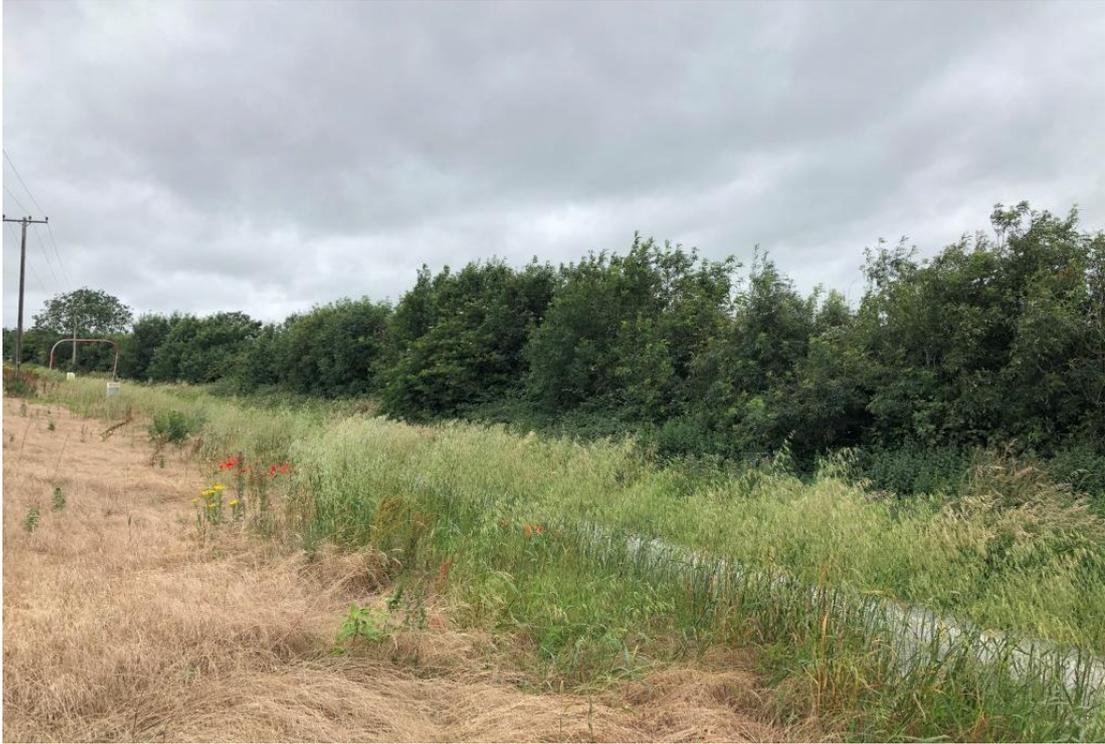
Photo 7: View of the northern boundary native hedgerow H614.

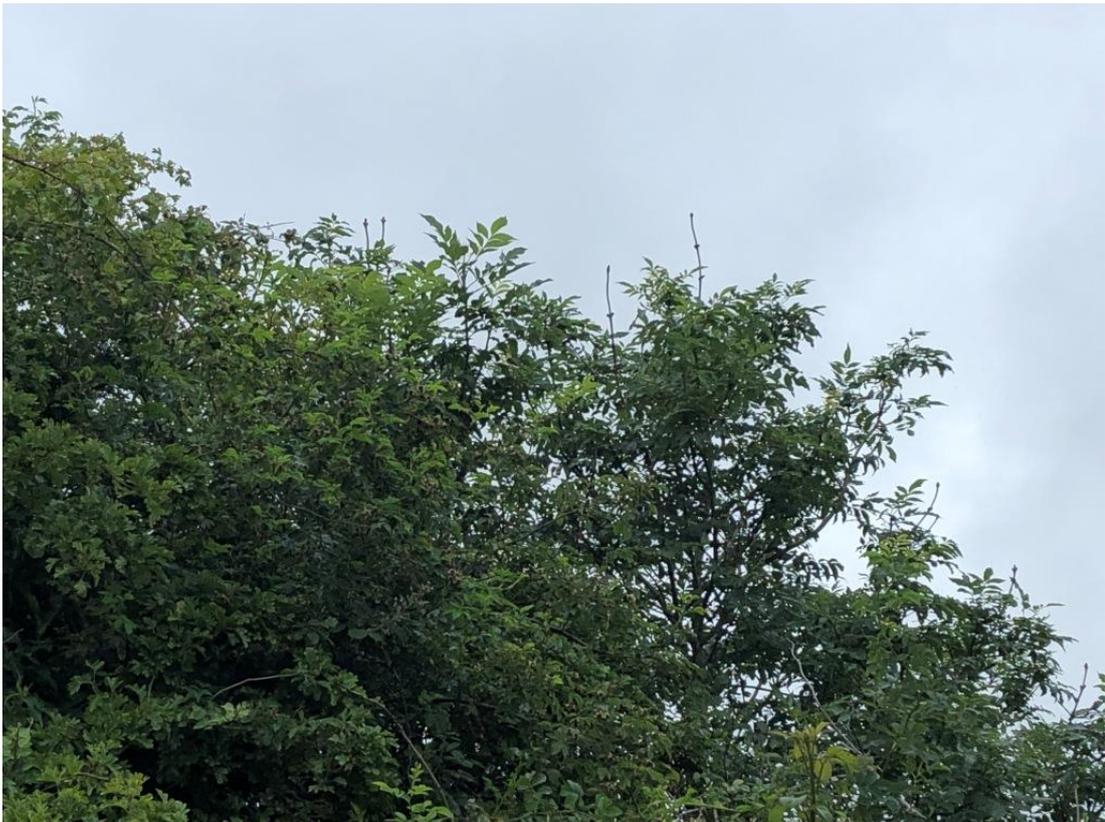
Photo 8: View of the crown dieback that was observed in the upper canopy of several ash trees on the site. These symptoms are typically associated with ash dieback (*Hymenoscyphus fraxineus*).
