# TREE SURVEY AND ARBORICULTURAL ASSESSMENT

Strategic Housing Development at Ballykeeffe,  
Raheen, Co. Limerick

SLR Ref: 000672.00003  
Version No: Rev2  
December / 2021

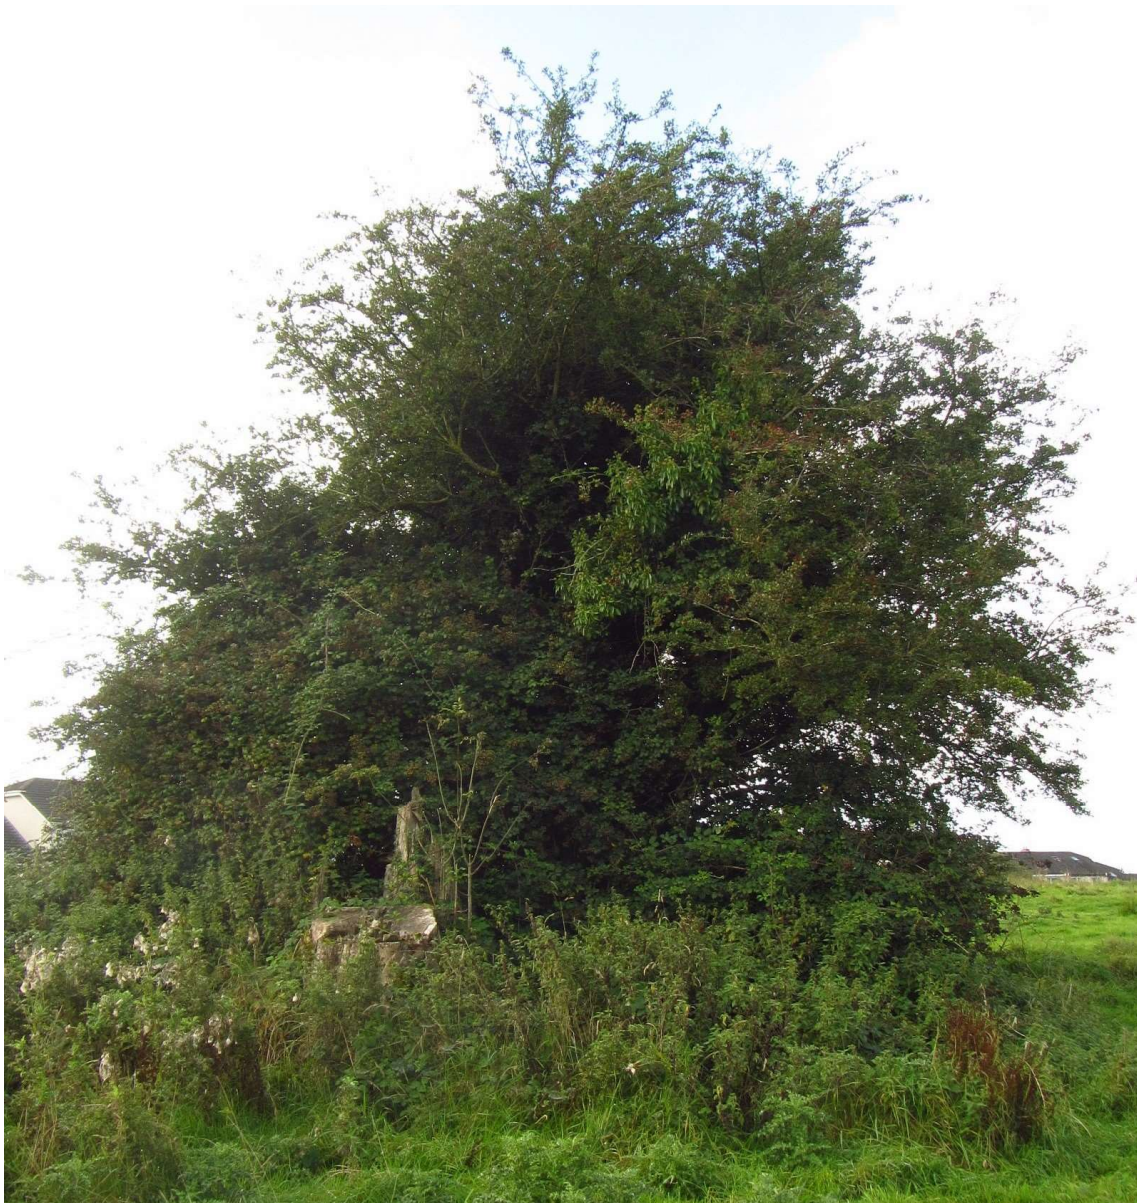
Figure 1: T5861

T5861 is a free-standing hawthorn (*Crataegus monogyna*) at the centre of the large field to the east of the site entrance. It is located on a local slope, where the levels within the field drop by approximately 1m over a short distance. The base of the tree is surrounded by dense nettles (*Urtica dioica*) and bramble (*Rubus fruticosus*), which makes it almost inaccessible. The tree has multiple stems, which are obscured by its dense branch system, as well as ivy. The tree is 8m in height and is classed as mature (i.e. within the final third of its life expectancy).

T5861 is placed into tree quality category B1, as per BS5837:2012, i.e. trees of medium arboricultural quality. While this is a good example of a free grown hawthorn, it does not have a particularly good form, possibly due to being restricted by dense ivy growth. It is therefore downgraded from the high quality category, as it lacks the special quality necessary to merit the category A designation.

Refer to Figure 1 for a photo of T5861, showing the dense growth of bramble and nettles around its base.

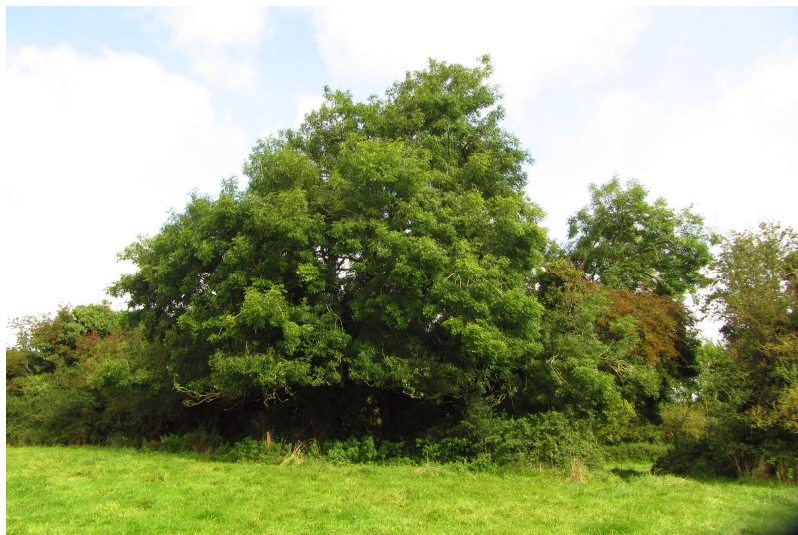
Figure 2: T5862

The trees range from 9m (lime) to 18m (T5862, ash) in height, with the three ash and the sycamore classed as mature (i.e. within the final third of its life expectancy) and the oak and the lime classed as over mature (i.e. tree in decline). Due to their location along hedgerows, part of their lower crowns have merged with neighbouring trees/shrubs. However, they are distinctly taller and/or wider than these neighbouring trees/shrubs and therefore stand out.

The three ash and the sycamore are placed into tree category A1, as per BS5837:2012, i.e. trees of high arboricultural quality. They are all very good examples of their species, which in the case of the ash is of note, considering the effects of ash dieback disease on the Irish ash population. No signs of the disease were identified, but unfortunately that does not preclude these trees from becoming infected in the future. The oak and the lime are of impaired condition and showing signs of decline. They are placed into category B3 as per BS5837:2012, i.e. trees of moderate arboricultural quality with material conservation value.

It should be noted that Hedge 4 and T5862 are fully located outside the development area and at a great enough distance, so that their Root Protection Areas (RPAs) will not be affected. It is however recommended that a protective barrier is established along the development boundary, to prevent accidental access close to this tree and hedgerow, as well as other tree/hedgerows outside the development area (see section 4.0 below).

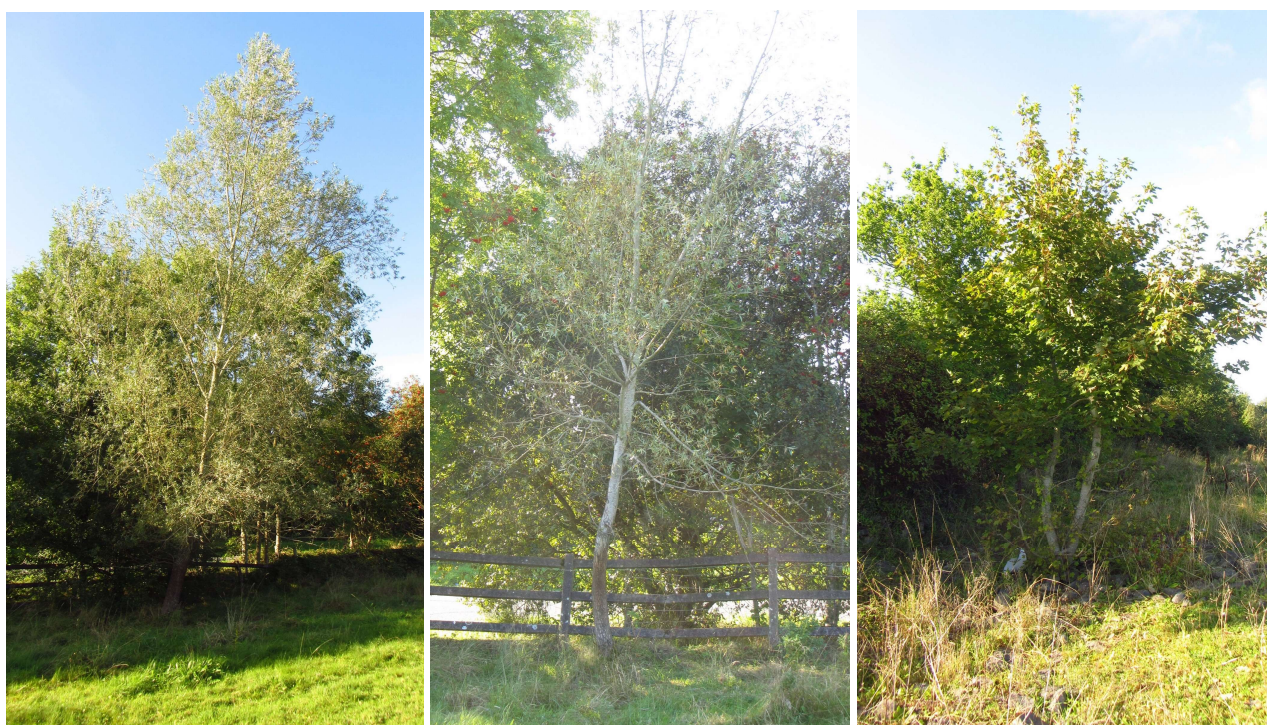
Figure 4: T5867-5870

T5868-T5870 are free-standing trees along the western boundary, two white willows (*Salix alba*) and one sycamore. The two willows are located inside the fence, which denotes the western development boundary. Both trees are leaning slightly into the site, probably due to their proximity to the trees outside the site boundary, along the R510, which block the light and restrict growth in that direction. The sycamore has potentially self-seeded in an area of disturbed ground near the site entrance, but has grown to a sufficient size to be recorded, as part of this tree survey.

The larger willow is placed into tree quality category B1, as per BS5837:2012, i.e. trees of medium arboricultural quality, as a good example of its species, but lacking the special quality necessary to merit the category A designation and also considering the short-lived nature of this species. The second willow and sycamore are placed into tree quality category C1, as per BS5837:2012, i.e. trees of low arboricultural quality, due to their small stem diameter.

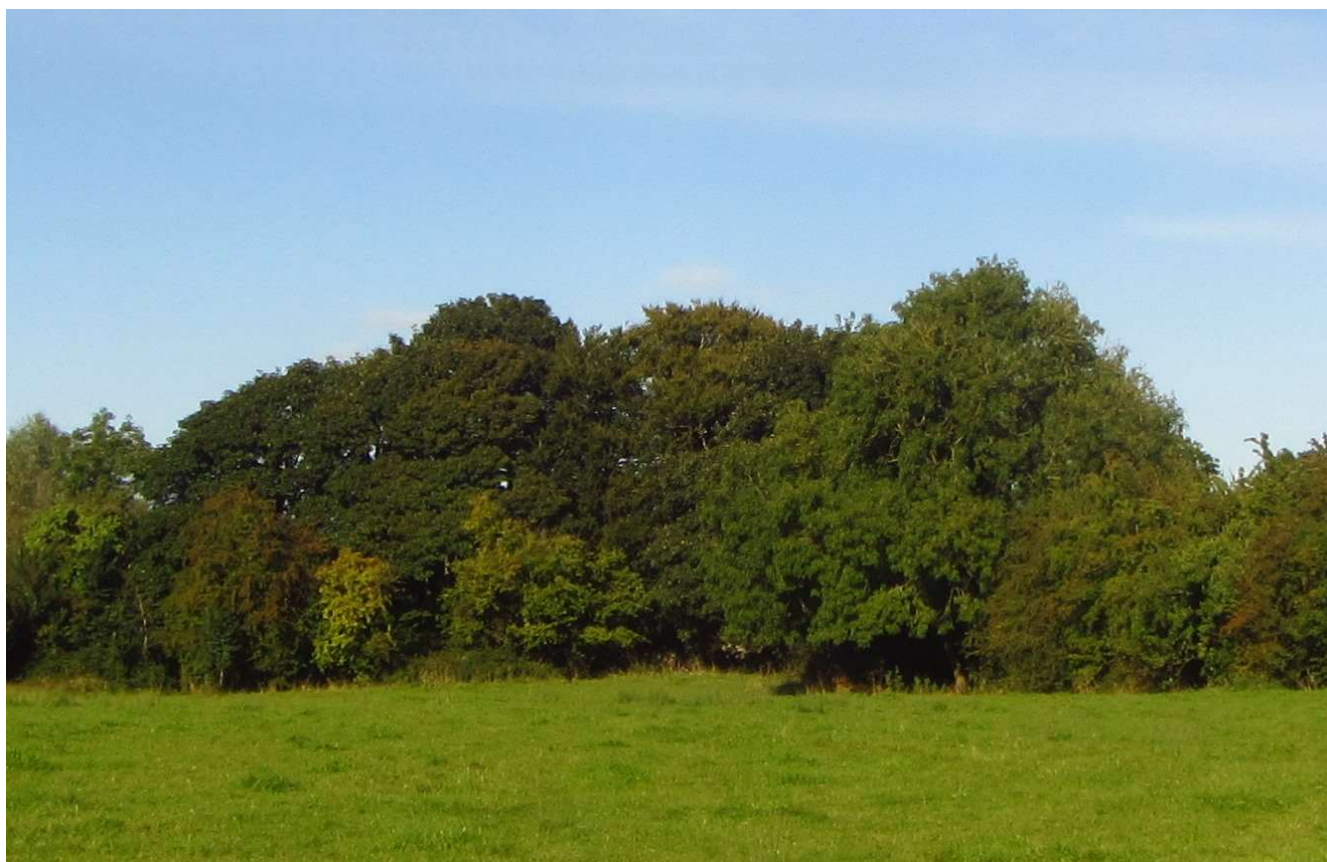
Figure 5: Group 1

This group comprises 14 large mature trees, 10 sycamore, 2 beech (*Fagus sylvatica*) and 2 ash, near the north-western corner of the site. As mentioned above they are likely to be over 100 years-old. The ground at the centre of the group is bare and uneven. There are some remnants of walls, which may have been associated with a spring and pump, which are shown in this area on the Historic 25'' map. There is an understorey of smaller trees, hazel (*Corylus colurna*) and hawthorn along the edge of the group. The mature trees are of a generally good condition, with healthy looking foliage. Some deadwood and small rot holes are present. The crowns of the trees are interlocked, restricting their growth in most directions. Therefore, the individual trees are not of great form/structure and would be prone to failure if they were retained, while some of the surrounding trees are removed.

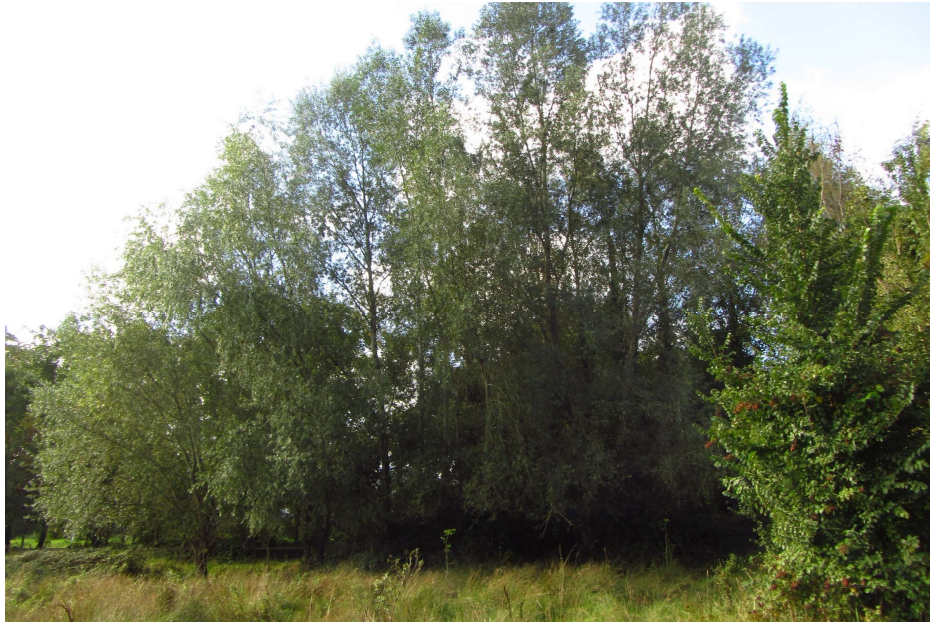
Figure 6: Group 2

This group comprises a line of approximately 10 white willow, just inside the western development boundary, near its northern end. Since they form a line, it is assumed that they were planted. They were planted at such short distances from each other that now, as mature trees, they form a dense mass, with individual trees hard to identify. The crowns of the trees are interlocked, restricting their growth in a northern and southern direction for each tree. Therefore, the individual trees are not of great form/structure and would be prone to failure if they were retained, while some of the adjoining trees are removed.

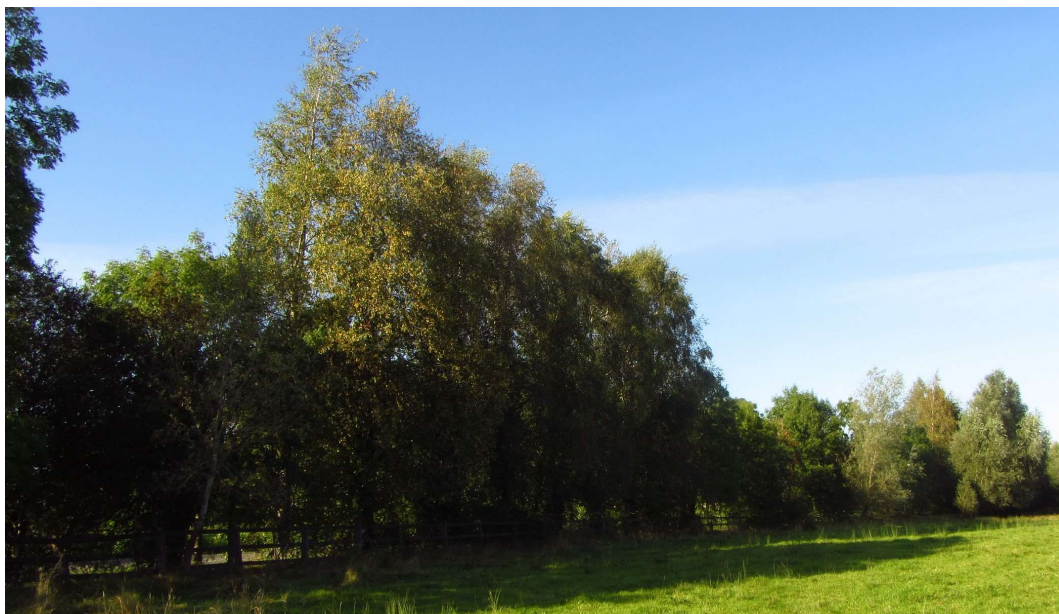
Figure 7: Group 3

This group comprises a line of 40+ mature trees, of several different species, including ash, birch (*Betula sp.*), larch (*Larix sp.*), rowan (*Sorbus aucuparia*), sycamore and willow (*Salix sp.*) along most of the western boundary of the development site. These trees are assumed to have been planted in conjunction with the construction of the R510 and are not in the ownership of the applicant.

In a number of locations short sections of single species were planted, resulting in distinct changes in height and character along the tree line (e.g. sections of tall ash and birch, beside much smaller rowan). This gives the treeline an uneven/irregular appearance.

The full extent of the RPA of Group 3 and Group 4, as well as the outlines of Hedge 13 and the section of Scrub 5 to be retained are to be enclosed by a protective barrier. The barrier must be installed prior to any other works being carried out on site and must be sturdy enough to prevent access into the RPA by people and machinery. Further to that, no material is to be stored within this area.

Prior to the removal of any trees within Group 3 to facilitate the temporary construction site access, a suitably qualified arborist should be consulted to identify an appropriate location, which would result in minimal tree loss, while the RPAs of the trees to be retained are protected. As mentioned before, we recommend that the ownership of the trees is confirmed, and the owner's consent sought, prior to the removal of any trees in this area.

Further to that, in agreement with the tree owner, a detailed assessment of the structural condition of all trees to be retained along the western boundary is recommended, including an assessment of the need for the removal of deadwood overhanging publicly accessible areas and appropriate formative pruning. This is to ensure the safety of road users, as well as the users of the cycle path and footpath to be constructed in the vicinity of these trees.

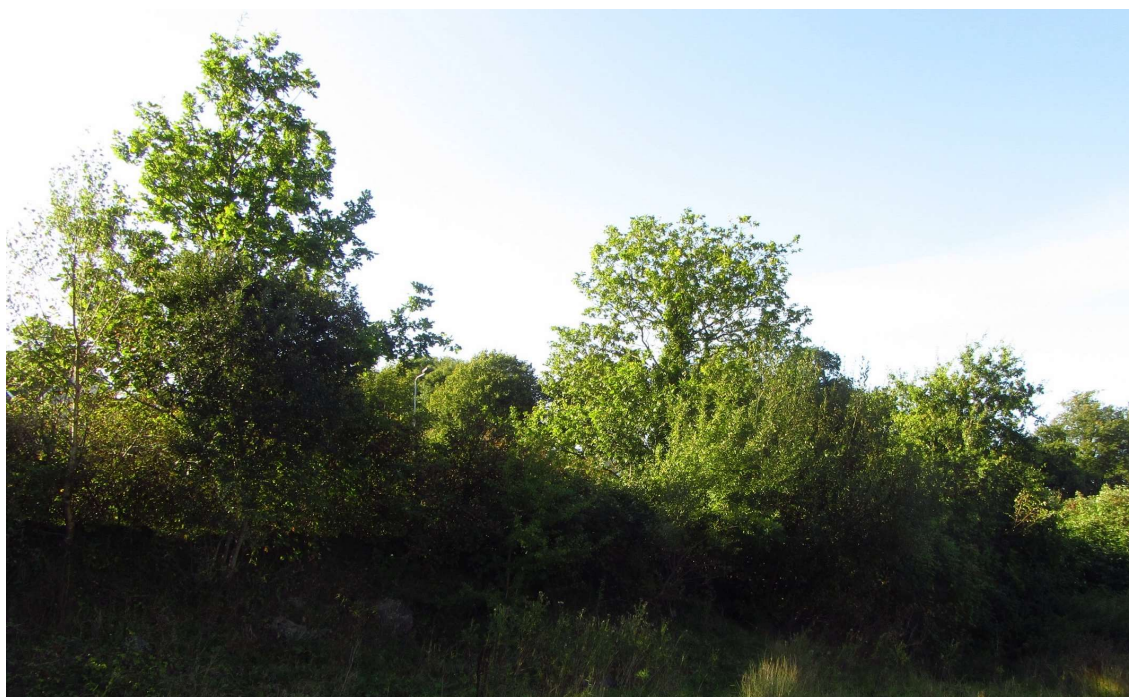
Figure 8: Group 4 & Hedge 13

Group 4 comprises nine oak (*Quercus* sp.), which were planted at regular distances on an earthen embankment along the western site boundary, just north of the site entrance. The trees have a dense understory of guelderrose (*Viburnum opulus*, refer to Hedge 13 below). Due to the embankment and understory, they are inaccessible. The trees have not yet reached maturity and therefore, do not yet present a distinctive landscape feature. It is possible that their location on an embankment restricts their vitality/growth, due to restricted rooting space and reduced access to water.

Hedge 13 is dominated by a mass of guelder-rose, which seems to have originated as underplanting to the row of oak (Group 4), north of the site entrance. Some incidental other species are present, including bramble, butterfly bush (*Buddleja* sp.), hawthorn, rowan and willow.

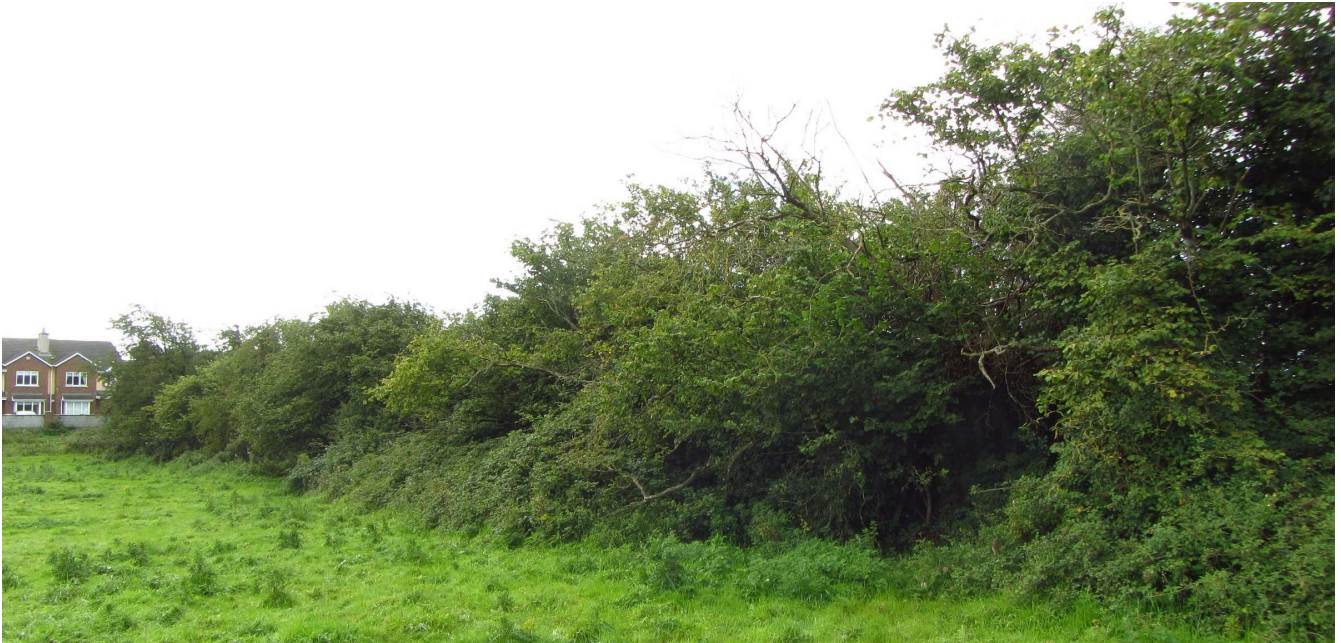
Figure 9: Hedge 2

Hedges 2-7 are very similar to each other. All originated as a double line, with one row planted on a stone ditch and the second ca. 2m to one side. These hedgerows have been unmaintained for years, so that the individual trees/shrubs have grown up to be tall, widely spreading and gappy. All hedgerows contain hawthorn and blackthorn, which are also typically the dominant species, with the exception of Hedge 2 where Hazel and Hedge

6 where Elm are the dominant species. Hedge 7 also contains some ash and sycamore. In most cases there is a dense understorey of bramble and ivy, with the bramble forming wide bands along the edge of some of the hedges, which results in them being unusually wide.

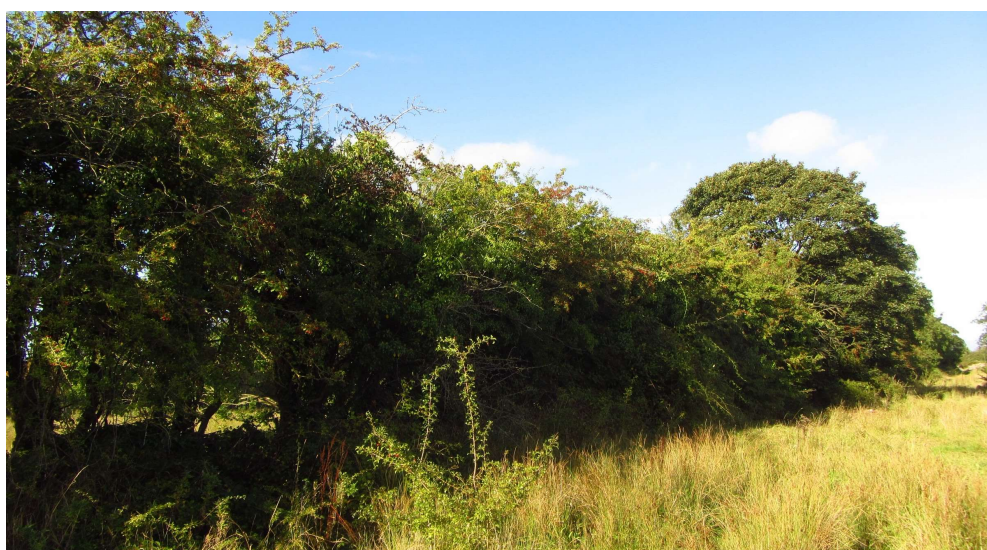
**Figure 12: Hedge 10**

Hedge 10 is a continuation of Hedge 8, but separated by a gap. It comprises a single line of hawthorn on a stone ditch, with some understorey of bramble and ivy. As with the other hedgerows these have been unmaintained for years, so that the individual trees/shrubs have grown up to be tall, widely spreading and gappy.

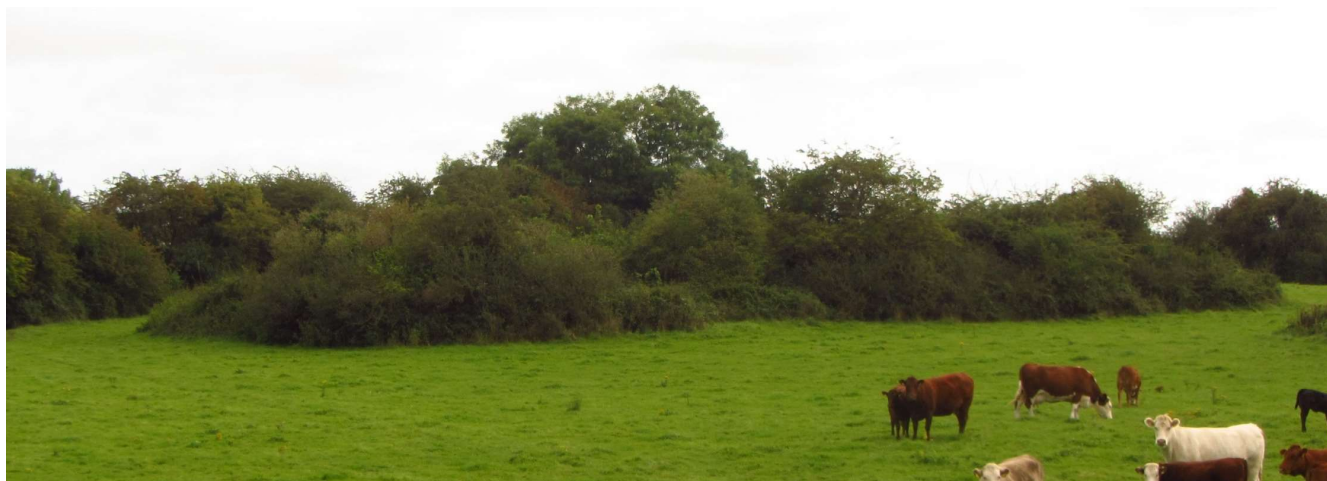
Figure 13: Scrub Area 1

These two scrub areas are located within the northernmost agricultural field within the development site. They appear to have been present for quite some time, as they are visible on the aerial photography dated 1995 on the GeoHive Map Viewer (<https://webapps.geohive.ie/mapviewer/index.html>). It is not clear how they originated.

They include woody species, some of which have grown up to 5m in height, but none form distinct individual trees. Woody species include blackthorn, bramble, elder, hawthorn, ivy, willow. Both have a dense understorey of bramble and nettle.

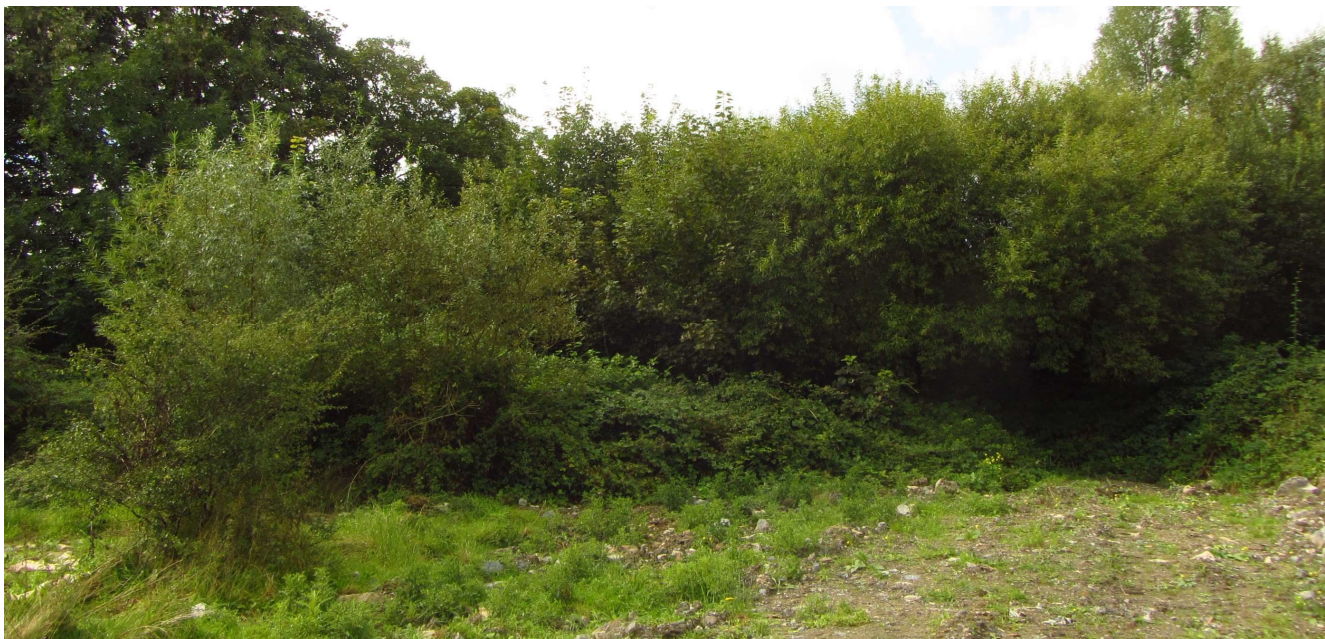
Figure 14: Scrub 3

Scrub areas 3-7 appear to have originated from areas of disturbed ground, within the last 15 years, as they are not yet visible on the aerial photography dated 2005 on the GeoHive Map Viewer. It is assumed that the scrub species present within these areas have self-seeded. They typically include blackthorn, bramble, buddleja, dog rose, elder, elm, guelder-rose, hawthorn, ivy, sycamore and willow. Scrub areas 3 and 5 contain a great variety of species and are quite large, while the other areas are smaller, less dense and contain fewer species. These scrub areas are still adjoined by areas of disturbed ground and/or rubble stockpiles.

Prior to any works being carried out, Scrub Area 3 is to be assessed on site, taking account of any rubble stockpiles within the area, which will be removed as part of the landscape works in this area. Any sections of Scrub 3, which are found suitable for retention are to be enclosed by a protective barrier. The barrier must be sturdy enough to prevent access into the scrub area by people and machinery. Further to that, no material is to be stored within this area.

A scrub management plan should be prepared and implemented, as part of the future maintenance of the green spaces within the site. Advice from a suitably qualified arborist should be sought.
