# WALKING AND CYCLING AUDIT

**Residential Development**  
**Bessboro**  
**Blackrock**  
**Cork**  
February 2022

<b>Client</b>	Estuary View Enterprises 2020 Ltd.
<b>Project Title</b>	Bessborough Residential Development
<b>Document Title</b>	Walking and Cycling Audit
<b>Document No.</b>	21107TT-WCA-D01
<b>Job No.</b>	21_107TT

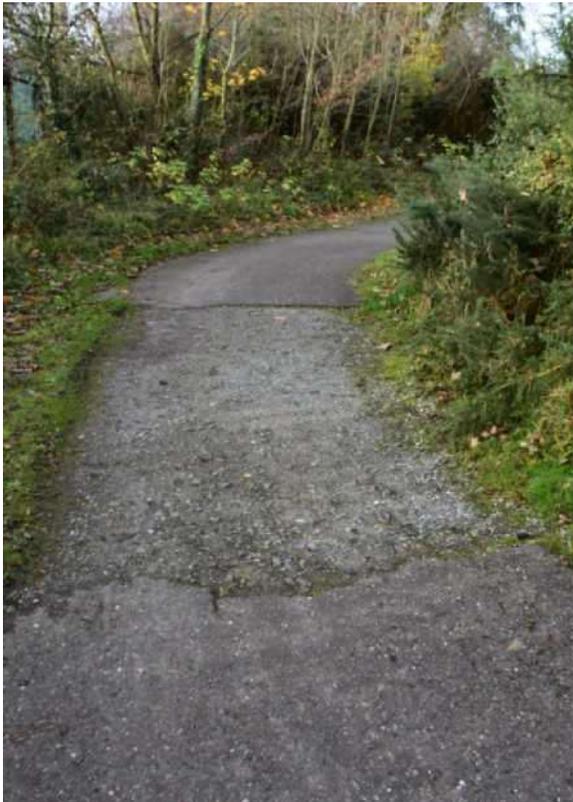
**Figure: Route 1 - Image 1**

4.2.2.1 Section of asphalt missing on link pathway connecting greenway to R852. (**Figure: Route 1 - Image 1**).

Route	Item	Mitigation	Reason/ Proposal
Route 1 (Image 1)	Pathway surface in poor condition	Yes	Repair section of asphalt pathway to ensure users have a continuity of pavement. This will minimise risk of falling over uneven surface.
Route 1 (Image 2)	Pathway in poor condition.	Yes	Repair dropped section of pathway. This will minimise risk of tripping for users.
Route 2 (Image 1)	Uneven section of pathway	Yes	Repair pathway section to minimise tripping risks to users.
Route 2 (Image 2)	Lack of public lighting in tunnel	Yes	Add public lighting to tunnel under Skehard Rd. to enhance personal security of users.
Route 3 (Image 1)	Uneven footpath	Yes	Repair section of footpath to remove tripping hazard for users.
Route 3 (Image 2)	Overgrowth over footpath	Yes	Trim back vegetation to maintain width of footpath.
Route 3 (Image 3)	Lack of tactile paving	Yes	Tactile paving should be provided at both sides of entrance junction.

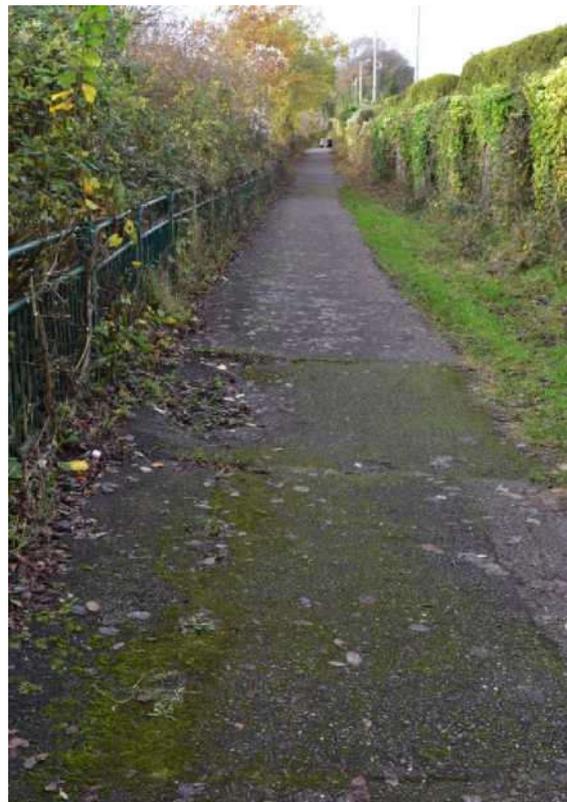
**Figure: Route 1 - Image 2**

4.2.2.2 Section of asphalt settled creating a hazard for cyclists and vulnerable road users. (**Figure: Route 1 - Image 2**).

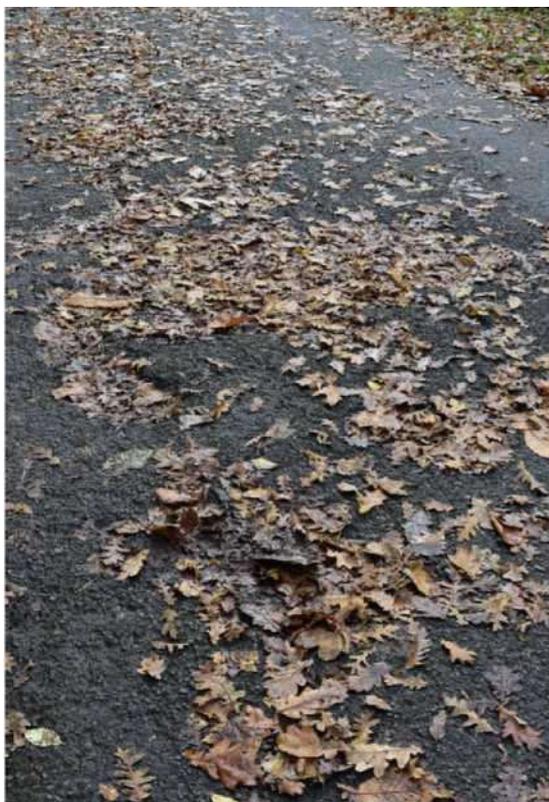
**Figure: Route 2 - Image 1**

4.2.2.1 Some uneven asphalt on greenway representing a tripping hazard for users. (**Figure: Route 2 - Image 1**).

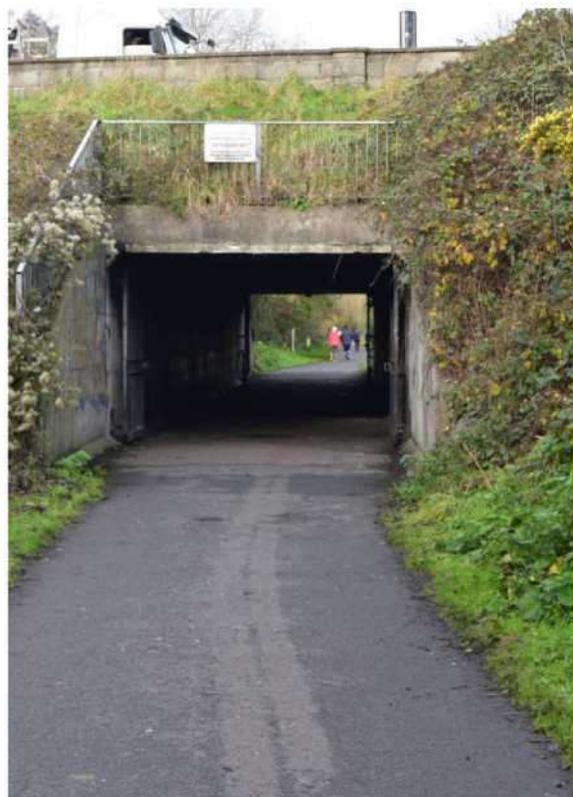
**Figure: Route 2 - Image 2**

4.2.2.2 Greenway tunnel under Skehard Rd. does not contain any public lighting. (**Figure: Route 2 - Image 2**).

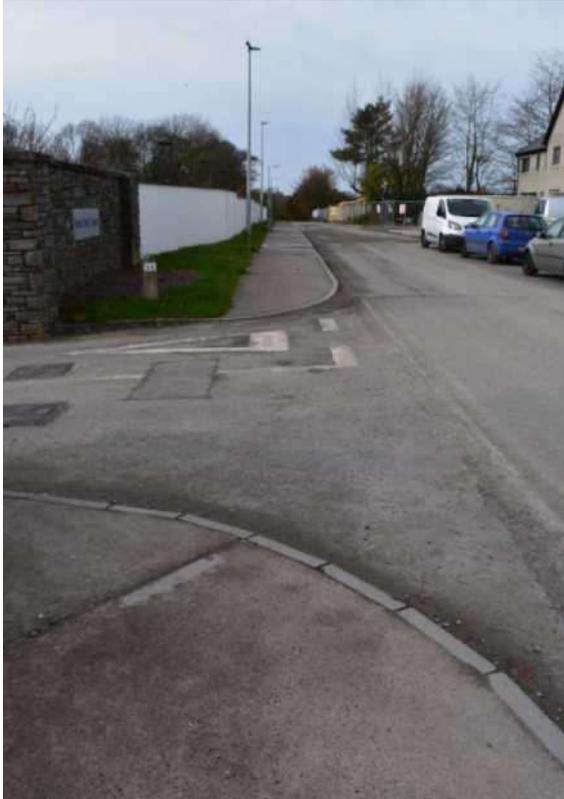
**Figure: Route 3 - Image 3**

- 4.3.2.3 No tactile paving at entrance to Sacred Heart Convent (**Figure: Route 3 - Image 3**).
- 4.3.2.4 Cracked footpath on section west of Sacred Heart Convent entrance (**Figure: Route 3 - Image 4**).

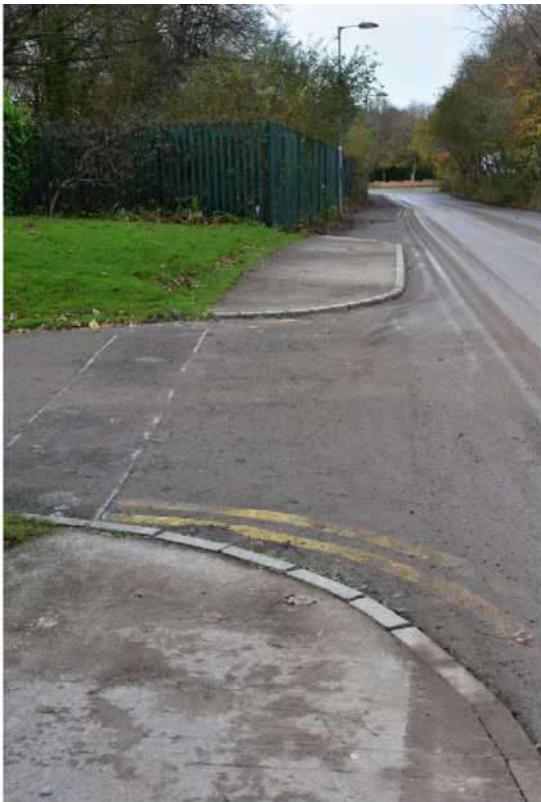
**Figure: Route 3 - Image 5**

- 4.3.2.5 No tactile paving or dropped kerbing at private entrance (**Figure: Route 3 - Image 5**).
- 4.3.2.6 No tactile paving or dropped kerbing alongside palisade fencing (**Figure: Route 3 - Image 6**).

Route 3 (Image 4)	Footpath in poor condition	Yes	Repair damaged section of footpath to minimise risk of tripping for users.
Route 3 (Image 5)	Lack of tactile paving and dropped kerbing	Yes	Tactile paving and dropped kerbing should be provided at both sides of the junction.
Route 3 (Image 6)	Lack of tactile paving and dropped kerbing	Yes	Tactile paving and dropped kerbing should be provided on both sides of the junction
Route 3 (Image 7)	Uneven footpath around tactile paving.	Yes	Repair section of footpath around tactile paving to increase road safety of vulnerable users.
Route 3 (Image 8)	Narrowing of footpath	Yes	Widen section of footpath to maintain width.
Route 3 (Image 9)	Lighting column installed in footpath	Yes	Relocate lighting column to ensure pedestrians have a clear and unobstructed path.
Route 3 (Image 10)	No pedestrian crossing at mini roundabout	Yes	Construct designated pedestrian crossing to cross Bessboro Rd. close

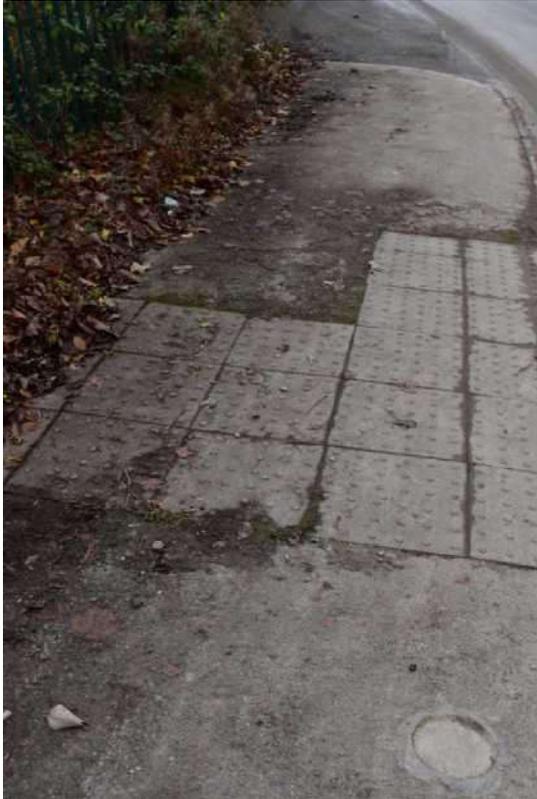
Figure: Route 3 - Image 7

- 4.3.2.7 Uneven footpath around tactile paving for development access road crossing (**Figure: Route 3 - Image 7**).
- 4.3.2.8 Narrowing of footpath on northern side of pedestrian crossing (**Figure: Route 3 - Image 8**).

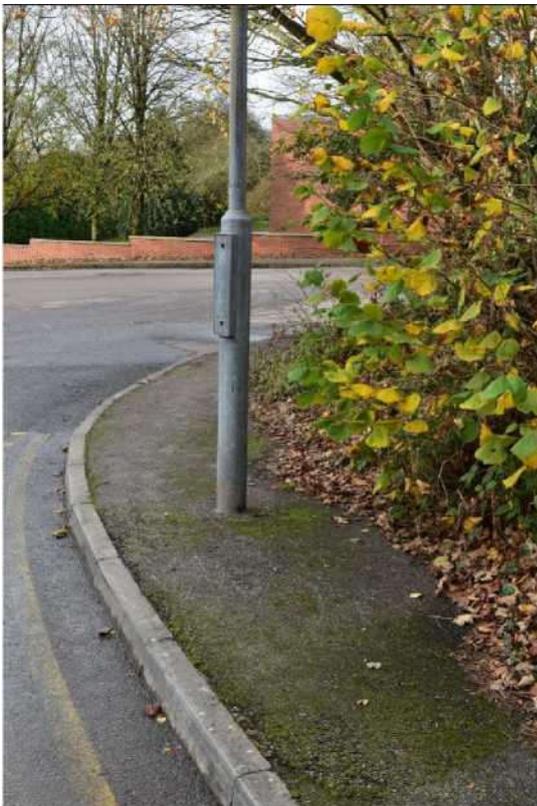
Figure: Route 3 - Image 9

- 4.3.2.9 Light post installed centre of footpath (**Figure: Route 3 – Image 9**).
- 4.3.2.10 No designated pedestrian crossing at mini roundabout to cross Bessboro Rd. and proceed west (**Figure: Route 3 – Image 10**).

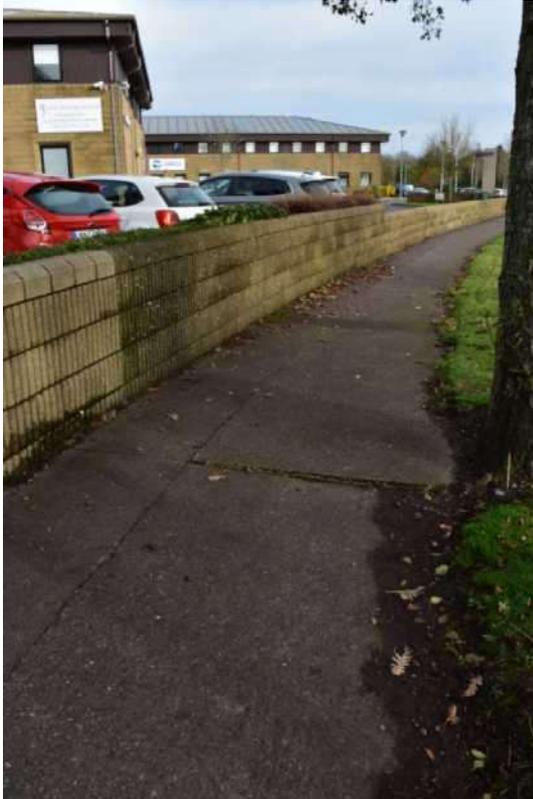
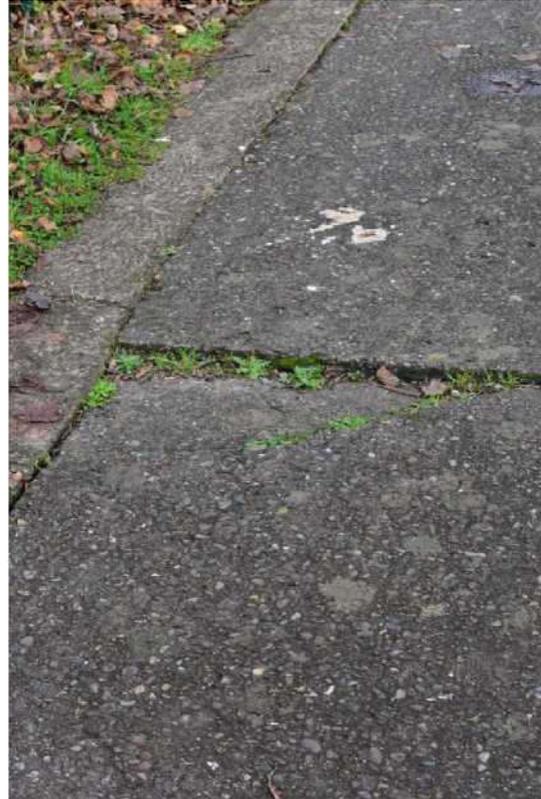
- 4.3.2.11 Several instances of uneven footpath along Bessboro Rd. (**Figure: Route 3 – Image 11 & 12**).
- 4.3.2.12 Tactile paving and dropped kerbing missing at entrance alongside palisade fencing. (**Figure: Route 3 – Image 13**).

to mini roundabout to improve road safety of users.
Route 3 (Image 11 & 12)	Uneven footpath along Bessboro Rd.	Yes	Repair footpath to minimise risk of tripping to users.
Route 3 (Image 13)	Lack of tactile paving and dropped kerbing	Yes	Tactile paving and dropped kerbing should be provided on both sides of the junction
Route 3 (Image 14)	Lack of tactile paving and dropped kerbing	Yes	Tactile paving and dropped kerbing should be provided on both sides of the junction
Route 3 (Image 15)	Lack of tactile paving and dropped kerbing	Yes	Tactile paving and dropped kerbing should be provided on both sides of the junction
Route 3 (Image 16)	Lack of tactile paving	Yes	Tactile paving should be provided on both sides of the junction
Route 3 (Image 17)	Lack of tactile paving and dropped kerbing	Yes	Tactile paving and dropped kerbing should be provided on both sides of the junction
Route 3 (Image 18)	Lack of tactile paving and dropped kerbing	Yes	Tactile paving and dropped kerbing should be provided on both sides of the junction

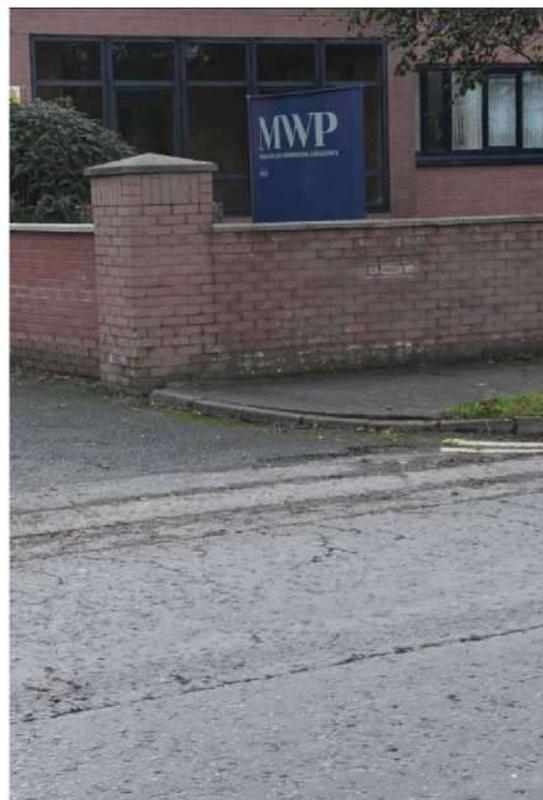
Figure: Route 3 - Image 14

- 4.3.2.13 Tactile paving and dropped kerbing missing at entrance to commercial enterprise (**Figure: Route 3 – Image 14**).
- 4.3.2.14 Tactile paving and dropped kerbing missing at entrance to industrial enterprise (**Figure: Route 3 – Image 15**).

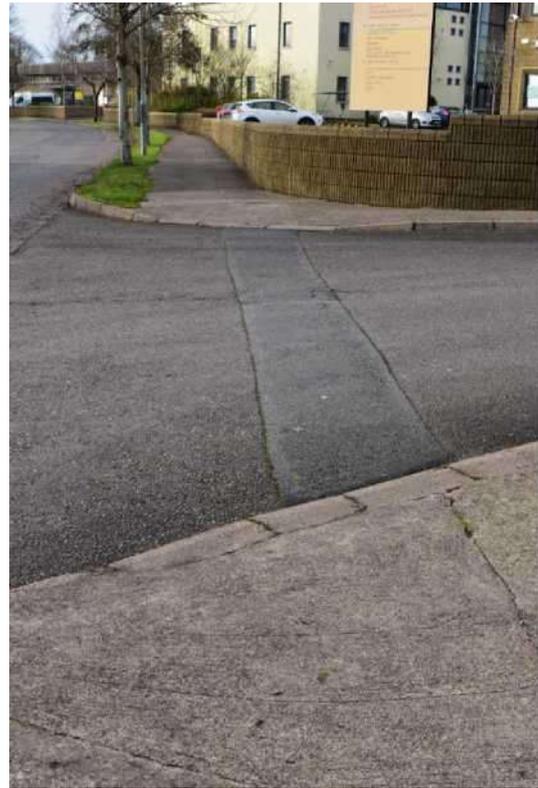
Figure: Route 3 - Image 16

- 4.3.2.15 Tactile paving missing at entrance to Riverview Business Park (**Figure: Route 3 – Image 16**).
- 4.3.2.16 Tactile paving and dropped kerbing missing at entrance to industrial enterprise (**Figure: Route 3 – Image 17**).

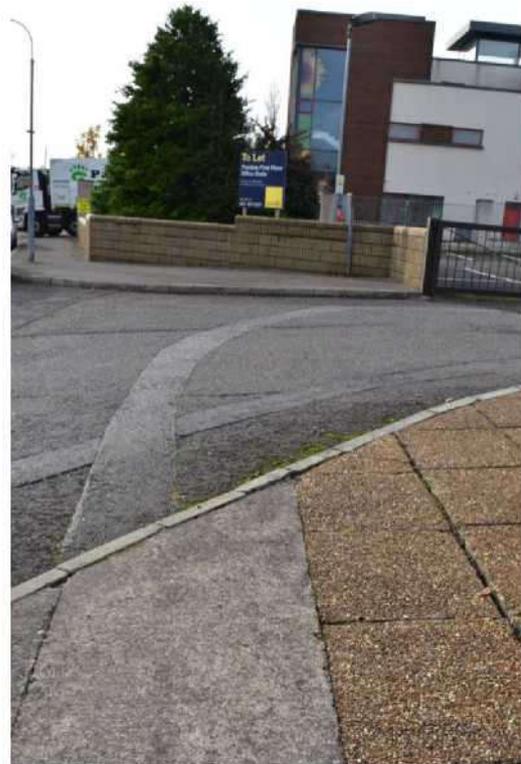
Figure: Route 3 - Image 18

- 4.3.2.17 Tactile paving and dropped kerbing missing at entrance to Oak House (**Figure: Route 3 – Image 18**).
- 4.3.2.18 Tactile paving missing at entrance and exit to childcare facility (**Figure: Route 3 – Image 19 & 20**).

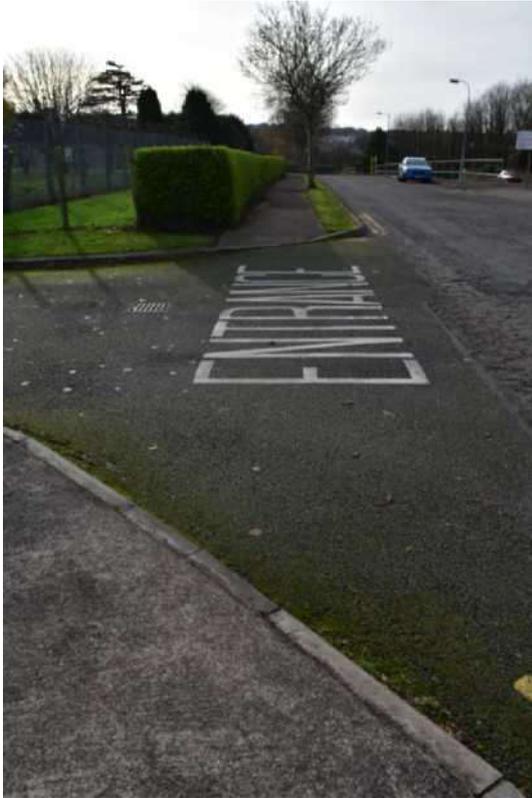
Figure: Route 3 - Image 21

- 4.3.2.19 Tactile paving and dropped kerbing missing at entrance to industrial enterprise (**Figure: Route 3 – Image 21**).

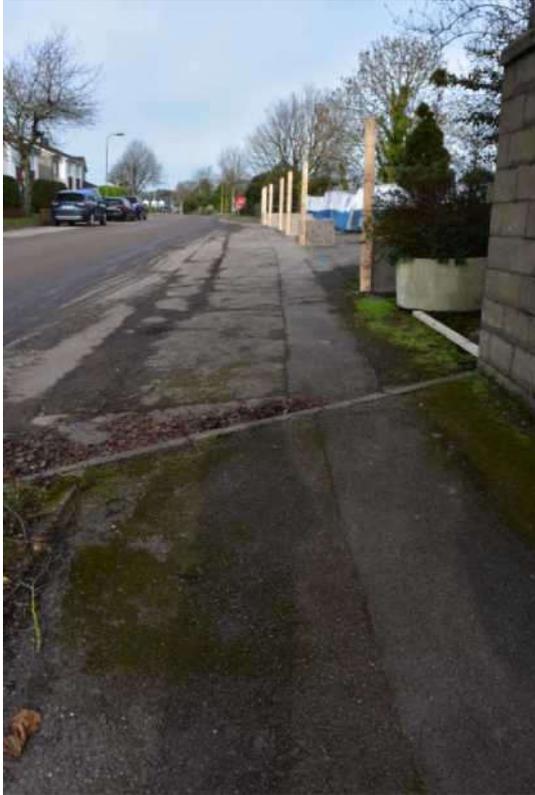
Figure: Route 4 - Image 3

- 4.4.2.3 No tactile paving or dropped kerbing at entrance to former Railway Tile site (**Figure: Route 4 - Image 3**).
- 4.4.2.4 No tactile paving or dropped kerbing at entrance to RCI (**Figure: Route 4 - Image 4**).

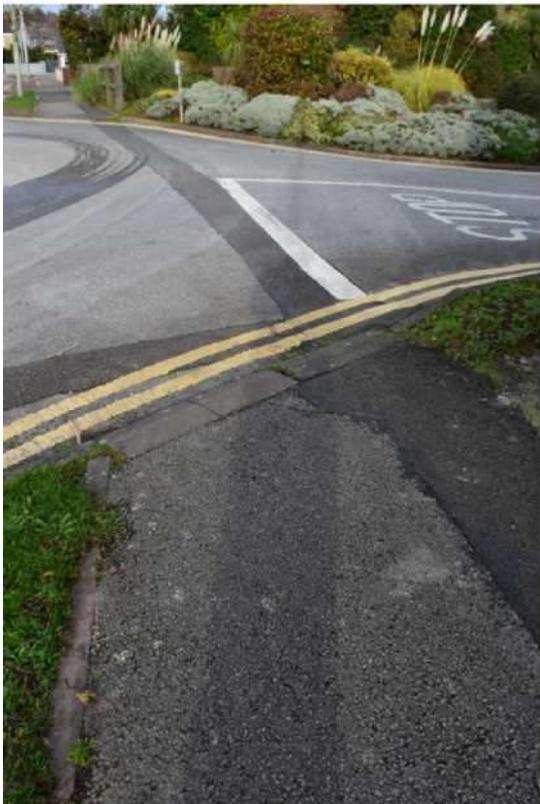
Figure: Route 4 - Image 5

- 4.4.2.5 No tactile paving at entrance to Abtran (**Figure: Route 4 - Image 5**).
- 4.4.2.6 No tactile paving at entrance to St. Michaels Credit Union (**Figure: Route 4 - Image 6**).

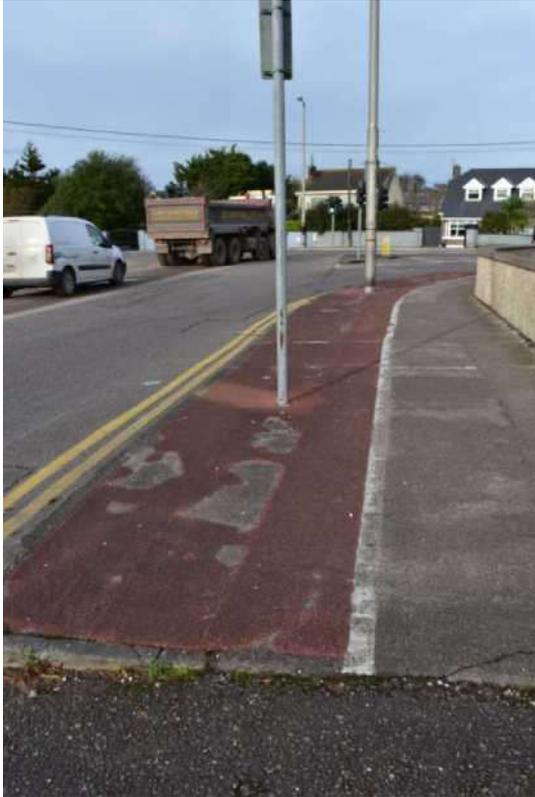
Figure: Route 4 - Image 7

- 4.4.2.7 Cycling lane provided to the south of Bessboro Rd./ Skehard Rd. junction stops suddenly with no given notice (**Figure: Route 4 - Image 7**).

- 4.4.2.8 Several posts present in cycling lane restricting movement (**Figure: Route 4 - Image 7 & 8**).
- 4.4.2.9 Cycling lane surface in poor condition (**Figure: Route 4 - Image 9**).

Route 4 (Image 7)	Sudden stop of cycle lane with no notice to users	Yes	Road signage to be provided to cyclists ensuring safe transfer to shared surface
Route 4 (Image 7 & 8)	Various poles present in cycle lane	Yes	Relocate poles to ensure cyclists have a clear and unobstructed path.
Route 4 (Image 9)	Cycle lane surface in poor condition	Yes	Repair cycle lane surface to minimise risk of sliding or falling.
Route 4 (Image 10)	Lack of tactile paving	Yes	Tactile paving should be provided on both sides of the junction

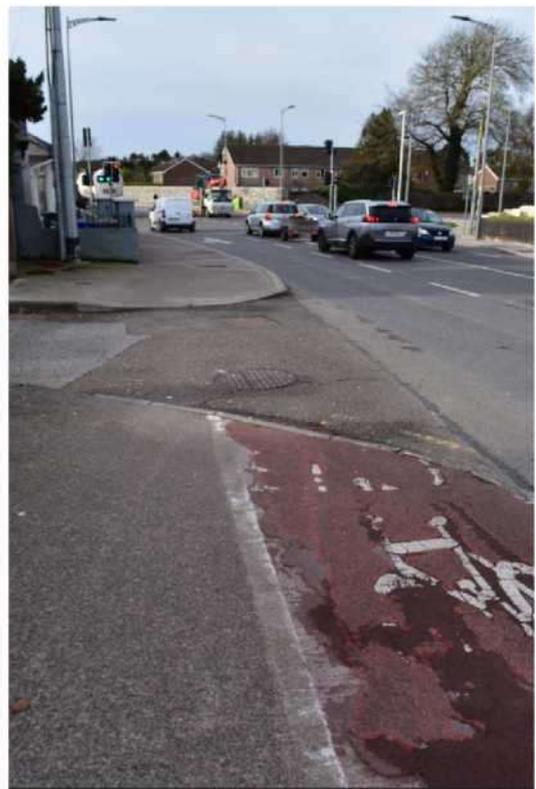
Figure: Route 4 - Image 10

- 4.4.2.10 No tactile paving provided at private entrance located on Skehard Rd. approximately 40m east of Scally's Supervalu car park (**Figure: Route 4 - Image 10**).
