Arboricultural Report

Tree Survey,
Arboricultural Impact Assessment &
Arboricultural Method Statement

Lands at Fosterstown North

200902-PD-11

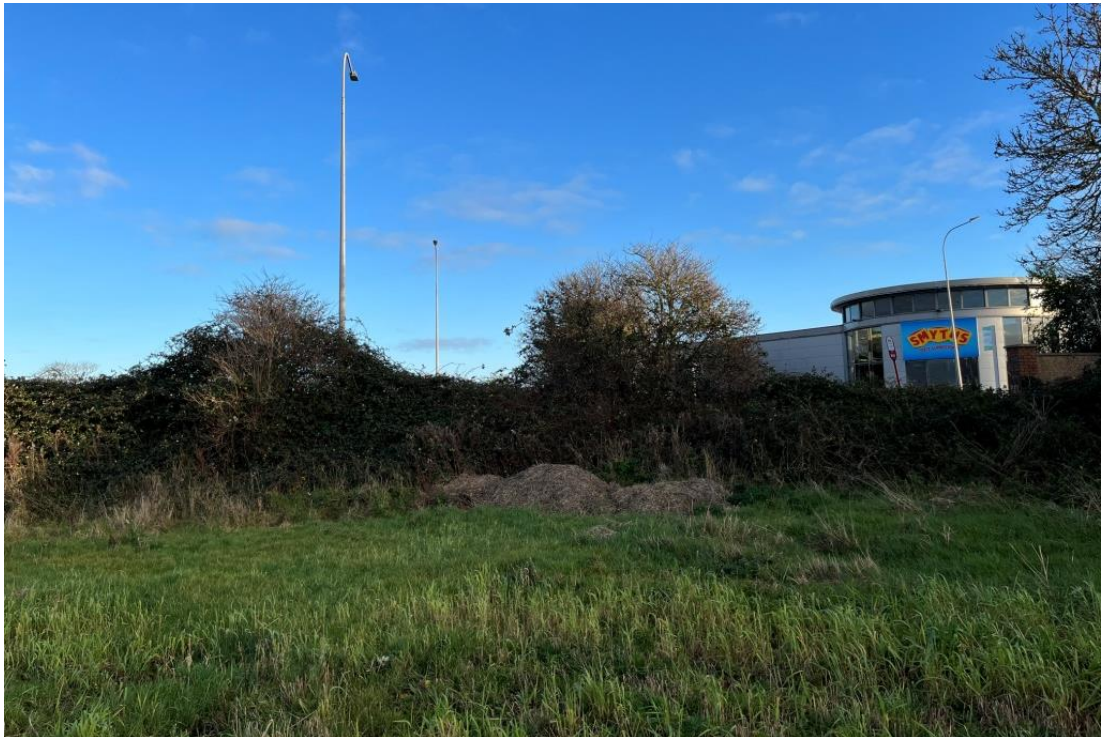
Photo 1: View of hedge H1 consisting of brambles and elder located on the eastern boundary.

ID	No. / Species	BS5837 Category	Purpose of works Recommended works	Status
H1	1 <i>Rubus fruticosus s.</i> Blackberry/Bramble	C2	To facilitate development Fell - Ground level.	Proposed
	1 <i>Sambucus nigra</i> Elder			
T2	1 <i>Fraxinus excelsior</i> Ash	C2	Good arboricultural practice Remove faulted stem / stems. Remove eastern leaning stem.	Proposed
			Good arboricultural practice Climbing plant - Sever.	Proposed
H3	1 <i>Crataegus monogyna</i> Common Hawthorn/Quick/May	B2	Landscape improvement Reduce crown by - Specified extent. Reduce lateral growth of hedgerow as highlighted on the Tree Works Plan to facilitate the development.	Proposed
	1 <i>Fraxinus excelsior</i> Ash			
	1 <i>Rosa canina</i> Dog-rose			
	1 <i>Rubus fruticosus s.</i> Blackberry/Bramble			
	1 <i>Salix caprea</i> Goat Willow/Great Sallow			
	1 <i>Sambucus nigra</i> Elder			
T4	1 <i>Fraxinus excelsior</i> Ash	C2	Good arboricultural practice Climbing plant - Sever.	Proposed

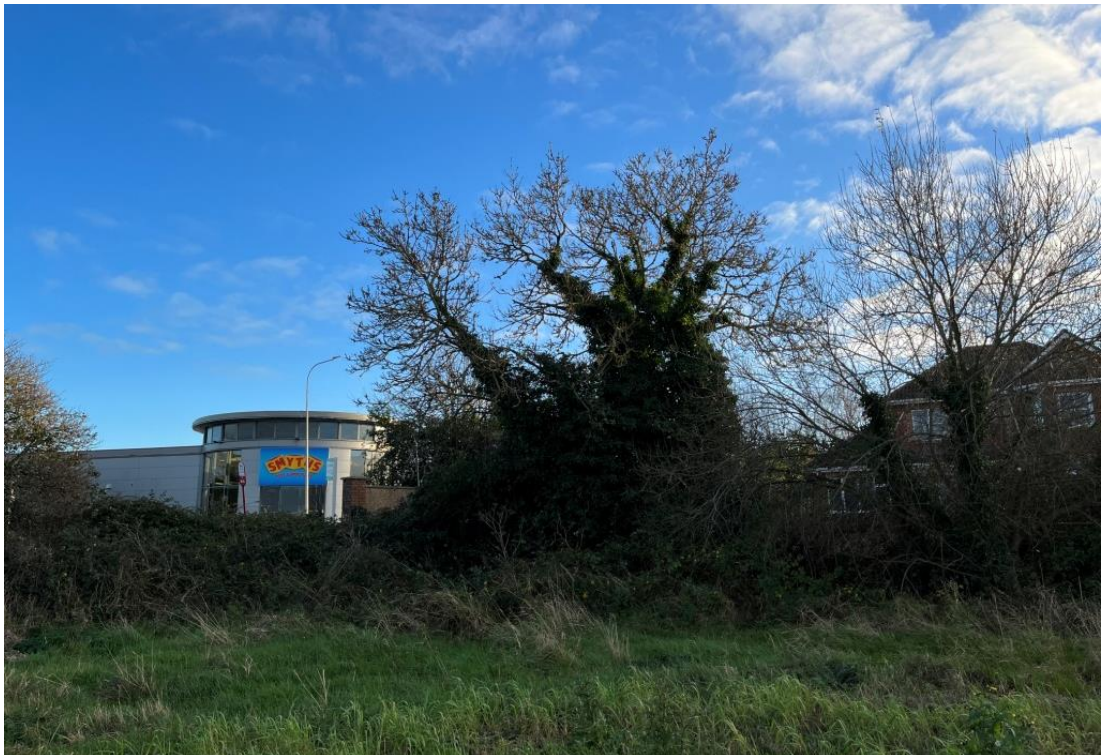
Photo 2: View of the early-mature ash tree T2.

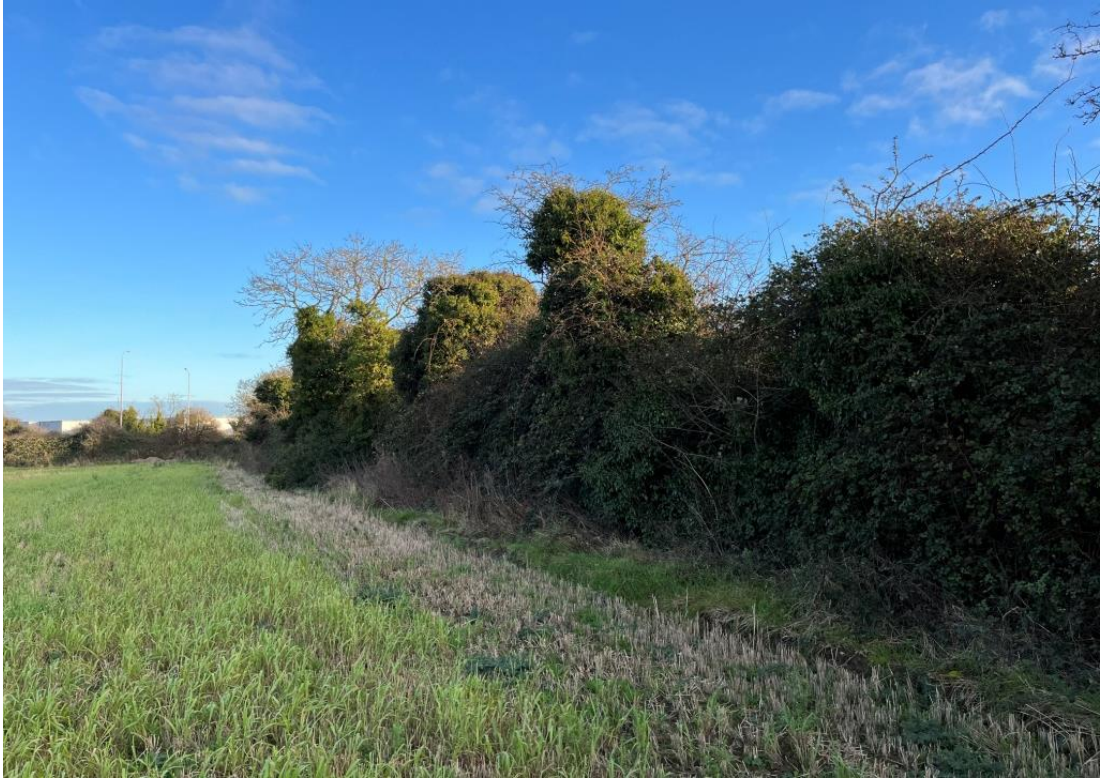
Photo 3: View of the mixed native hedgerow H3 located along the southern boundary.

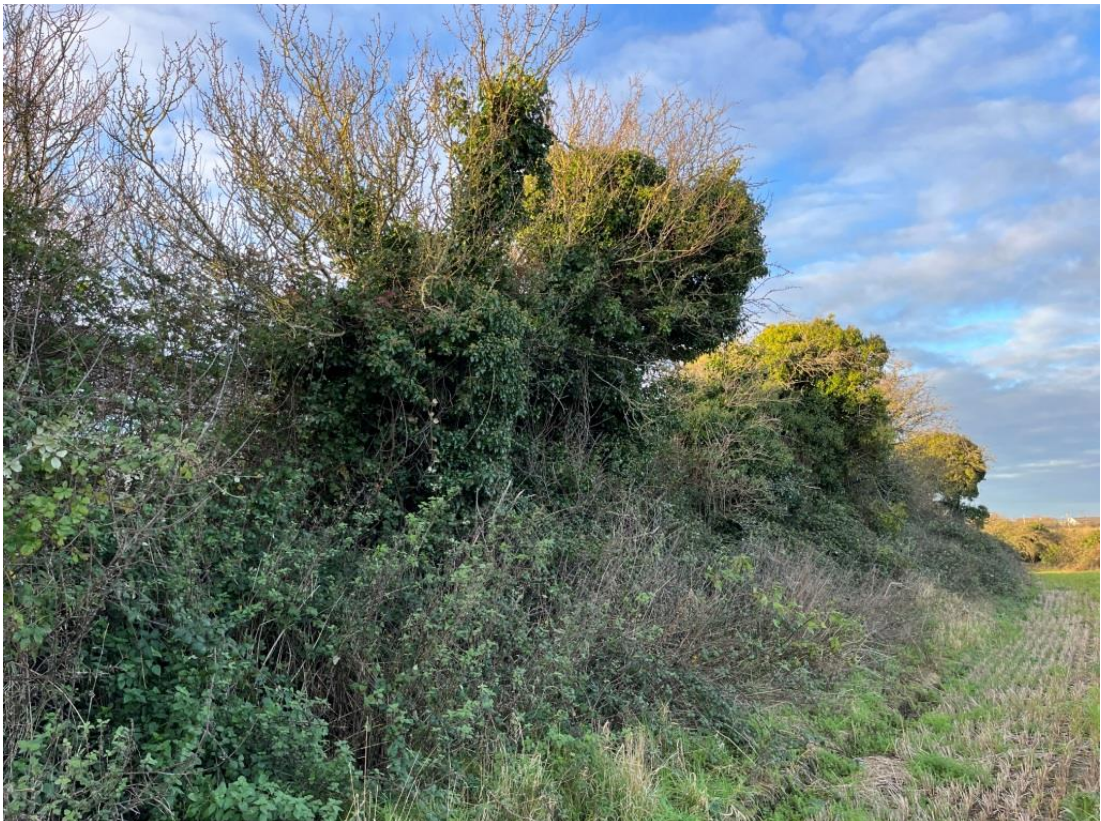
Photo 4: View of the mixed native hedgerow H7 located along the southern side of the western boundary.

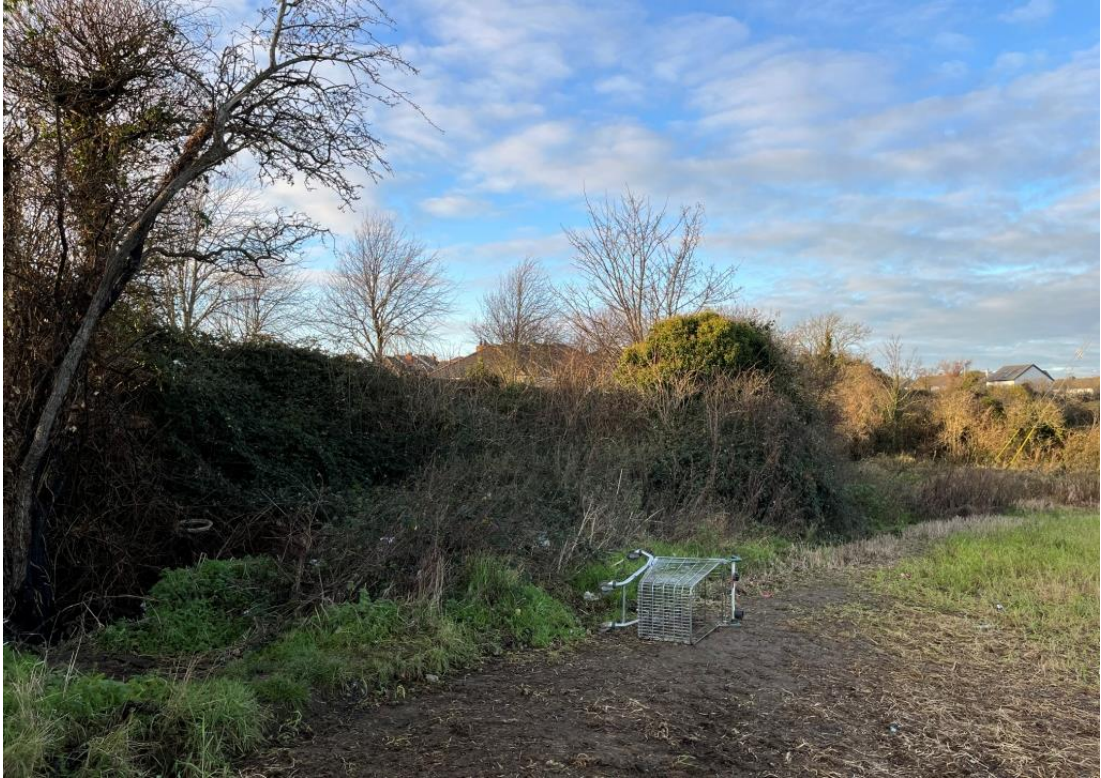
Photo 5: View of the mixed native hedgerow H8 located along the northern side of the western boundary.

ID	No. / Species	BS5837 Category	Purpose of works Recommended works	Status
H8	1 <i>Crataegus monogyna</i> Common Hawthorn/Quick/May	C2	To facilitate development Fell - Ground level. Part removal of group as shown on Tree Works Plan.	Proposed
	1 <i>Prunus spinosa</i> Blackthorn/Sloe			
	1 <i>Rosa canina</i> Dog-rose			
	1 <i>Rubus fruticosus s.</i> Blackberry/Bramble			
	1 <i>Sambucus nigra</i> Elder			
H24	1 <i>Crataegus monogyna</i> Common Hawthorn/Quick/May	C2	To facilitate development Fell - Ground level.	Proposed
	1 <i>Prunus spinosa</i> Blackthorn/Sloe			
	1 <i>Rosa canina</i> Dog-rose			
	1 <i>Rubus fruticosus s.</i> Blackberry/Bramble			
	1 <i>Sambucus nigra</i> Elder

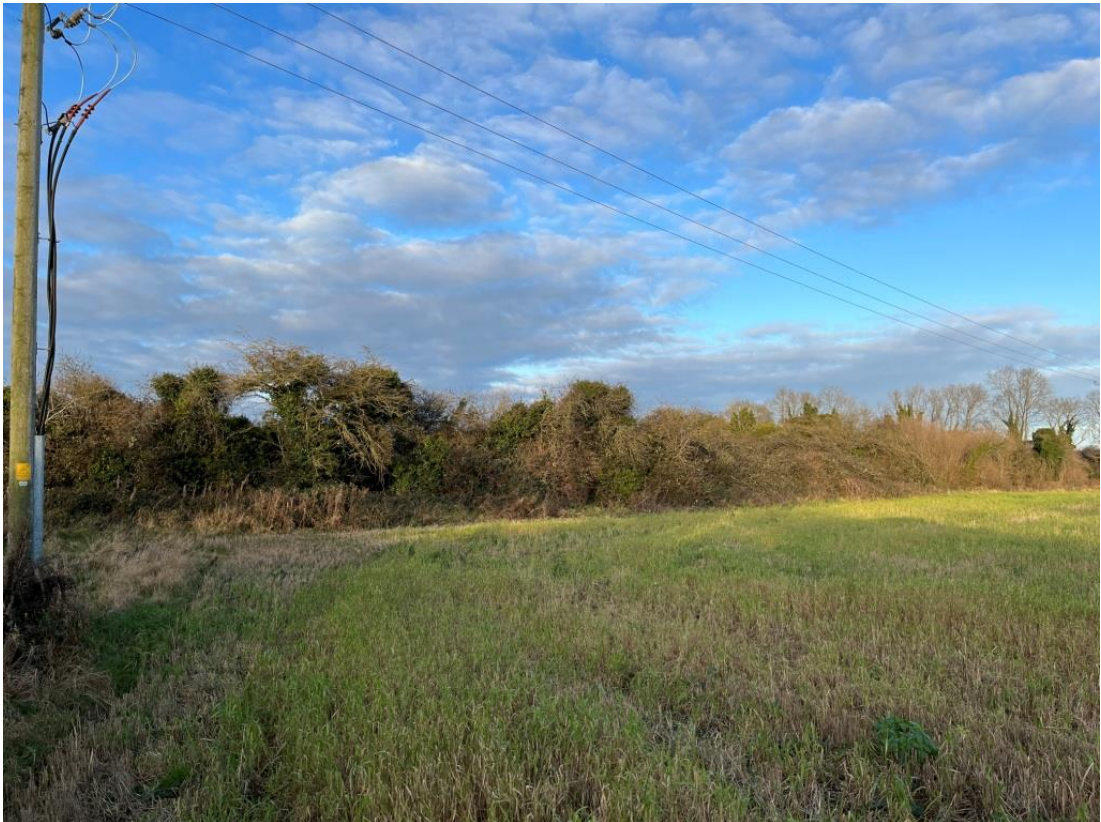
Photo 6: View of the mixed native hedgerow H9 located along the western side of the northern boundary.

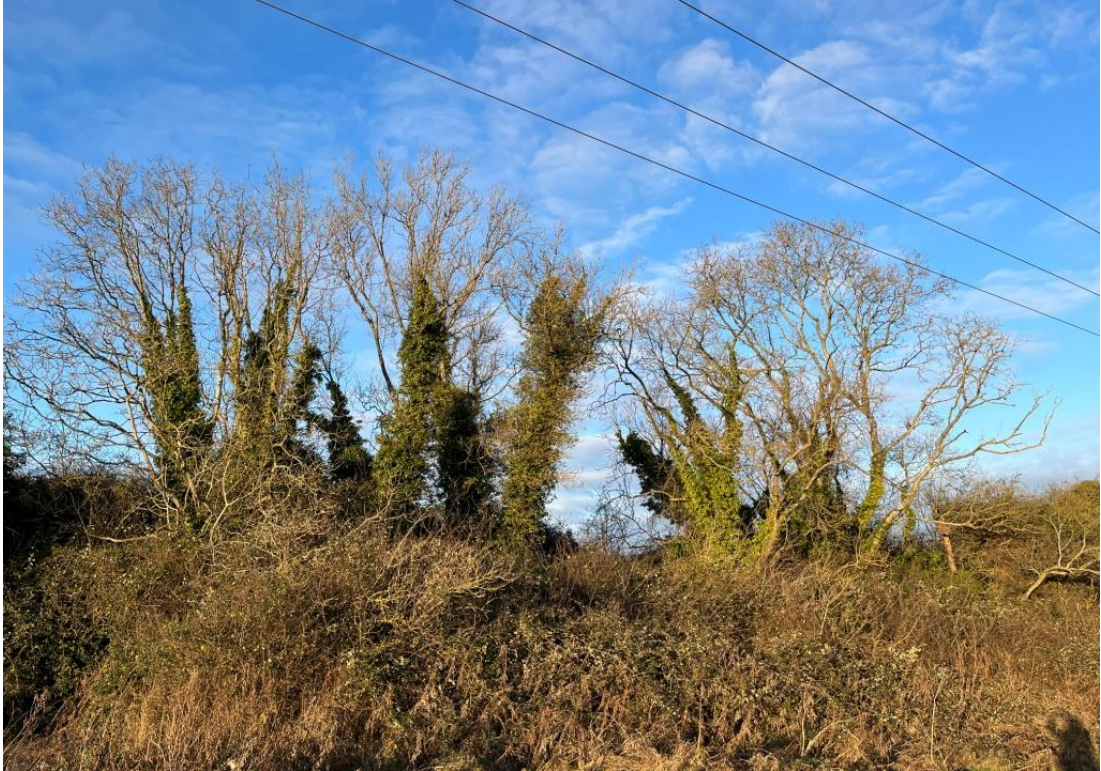
Photo 7: View of the early-mature and mature ash trees located adjacent to the northeastern corner of the boundary.

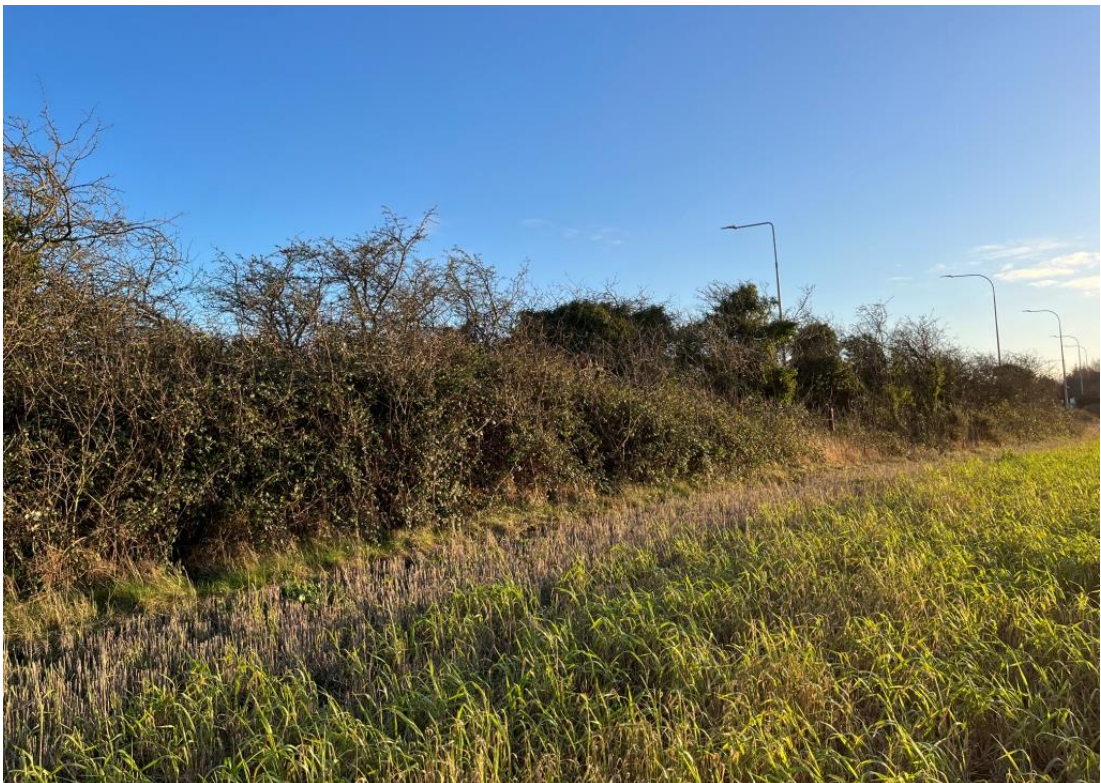
Photo 8: View of the mixed native hedgerow H24 located along the eastern boundary.

Hedge H24	1 Crataegus monogyna (Common Hawthorn/Quick/May) 1 Prunus spinosa (Blackthorn/Sloe) 1 Rosa canina (Dog-rose) 1 Rubus fruticosus s. (Blackberry/Bramble) 1 Sambucus nigra (Elder)	5.0	15 AVE	1									0.0		Early Mature	Structural condition Fair. Physiological condition Fair. Hedgerow - Neglected / overgrown. Height and stem diameter are average for group. Quantities not recorded - only species mix. Native boundary hedgerow consisting mainly of self-seeded blackthorn and early-mature hawthorn. Hedgerow is a borderline C/B Category.	05/01/2022	10.2	1.8	20-40	C2
