S.I. Ltd Contract No: 5588

Client: Cairn Homes
Engineer: Waterman Moylan
Contractor: Site Investigations Ltd

Hollybank,
Swords, Co. Dublin
Additional Site Investigation Report

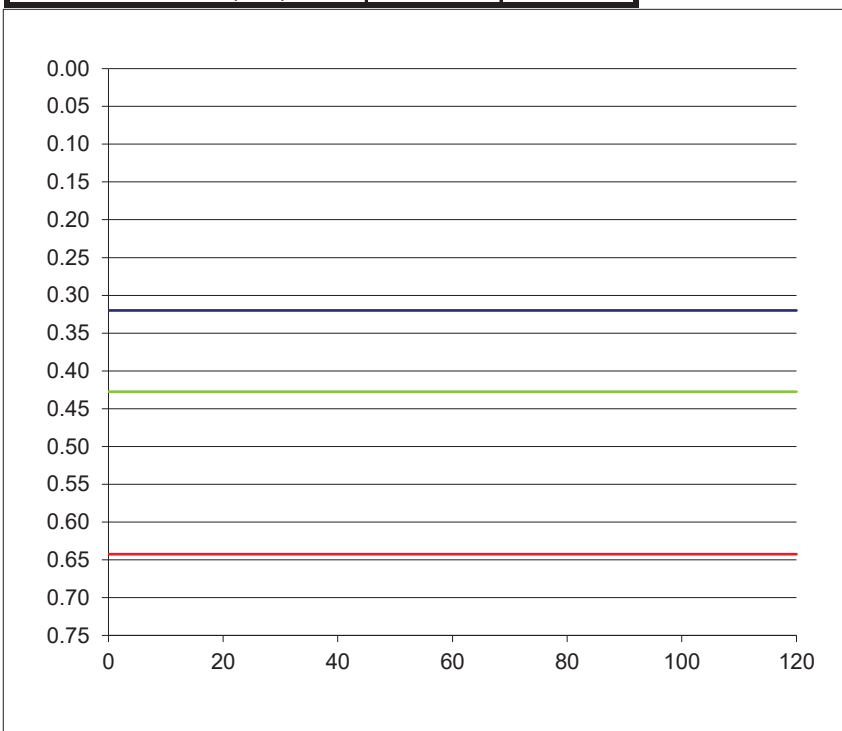
| Test No: | SA07 |

f = Fail m/min or Fail m/s

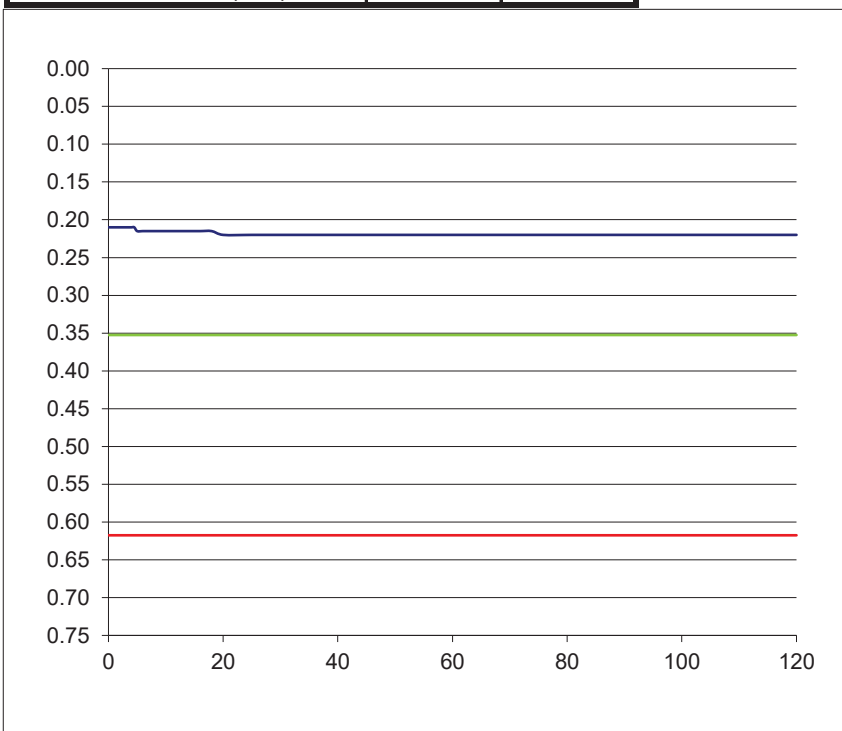
| Test No: | SA08 |

f = **Fail** or **Fail**
m/min m/s

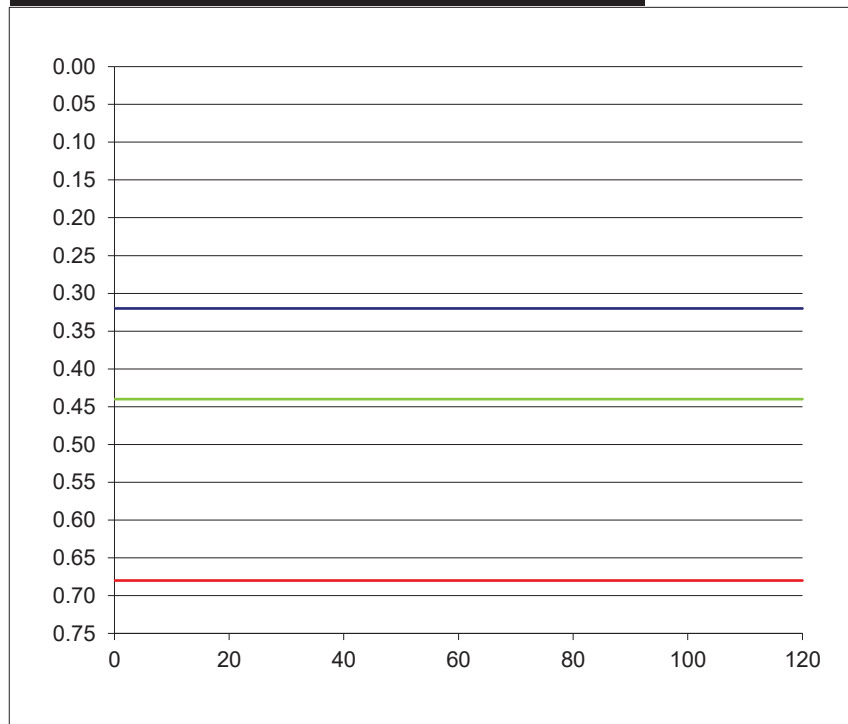
| Test No: | SA09 |

f = **Fail** m/min or **Fail** m/s

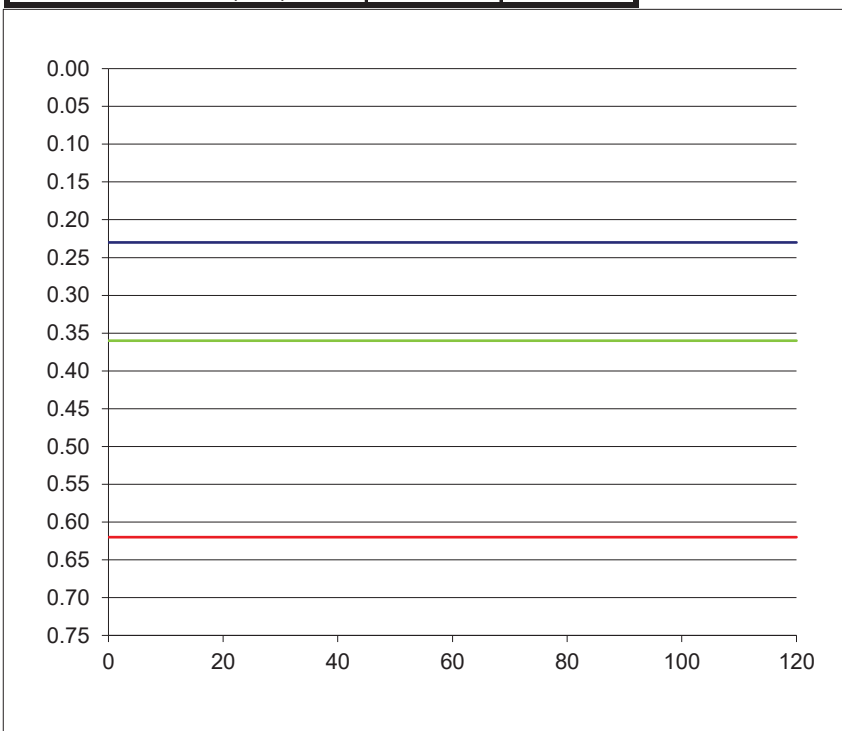
| Test No: | SA10 |

f = **Fail** m/min or **Fail** m/s

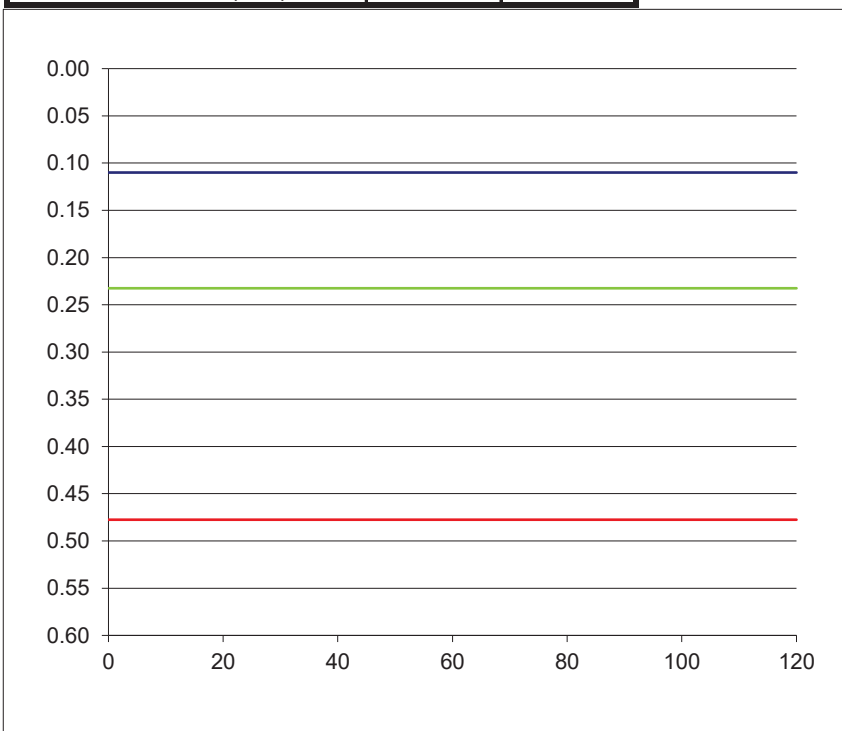
| Test No: | SA11 |

f = **Fail** m/min or **Fail** m/s
