Arboricultural Report

Tree Survey,
Arboricultural Impact Assessment &
Arboricultural Method Statement

**Back Road
Malahide
Co. Dublin**

March 2022

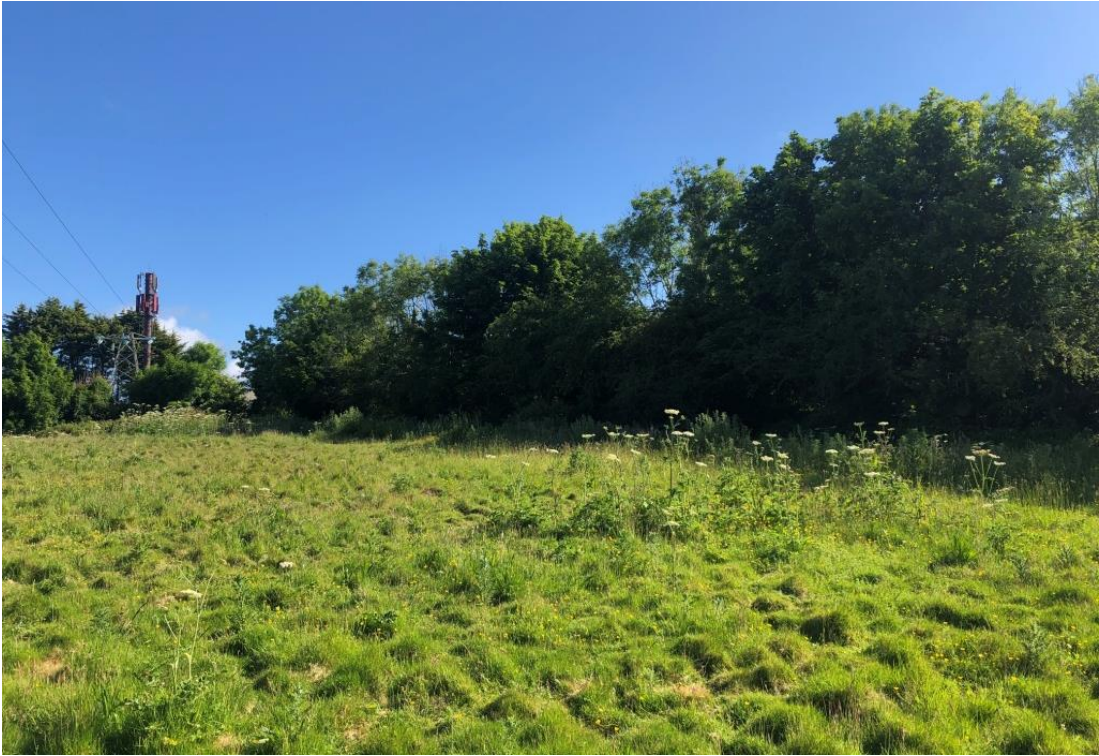
Photo 1: View of the eastern boundary tree groups (G206 & G207) located within the northernmost field.

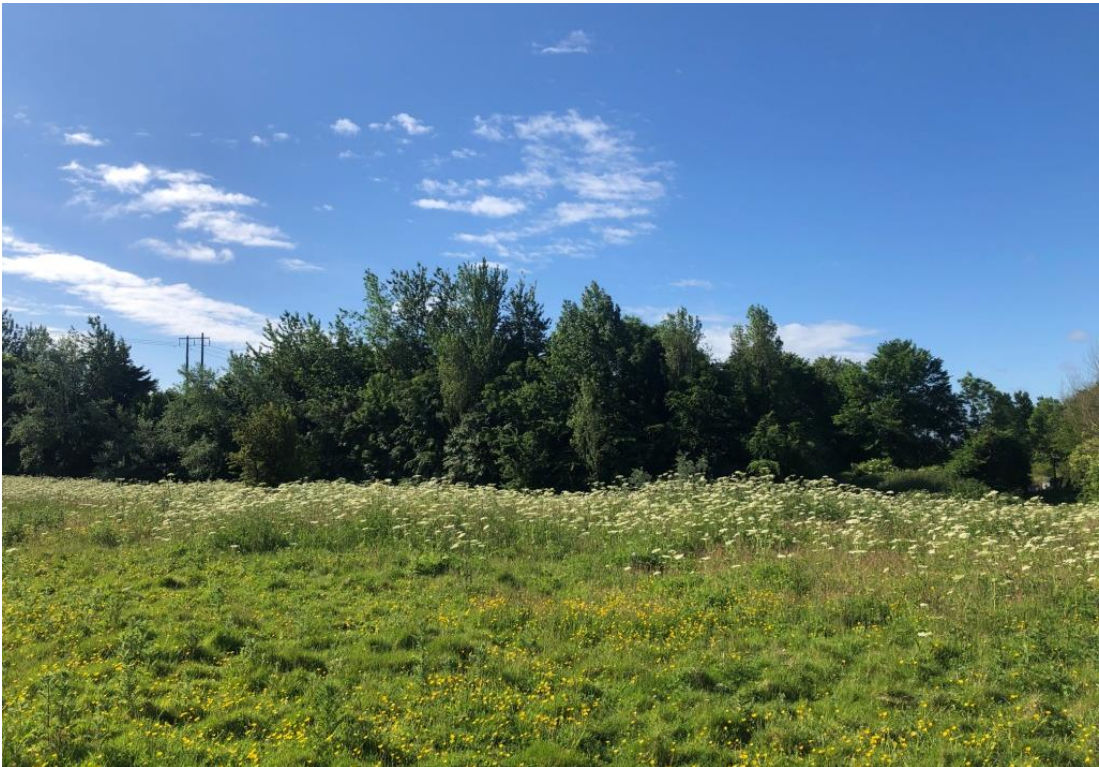
Photo 2: View of the large mixed group of trees G202 located between the clubhouse and the northern grass field.

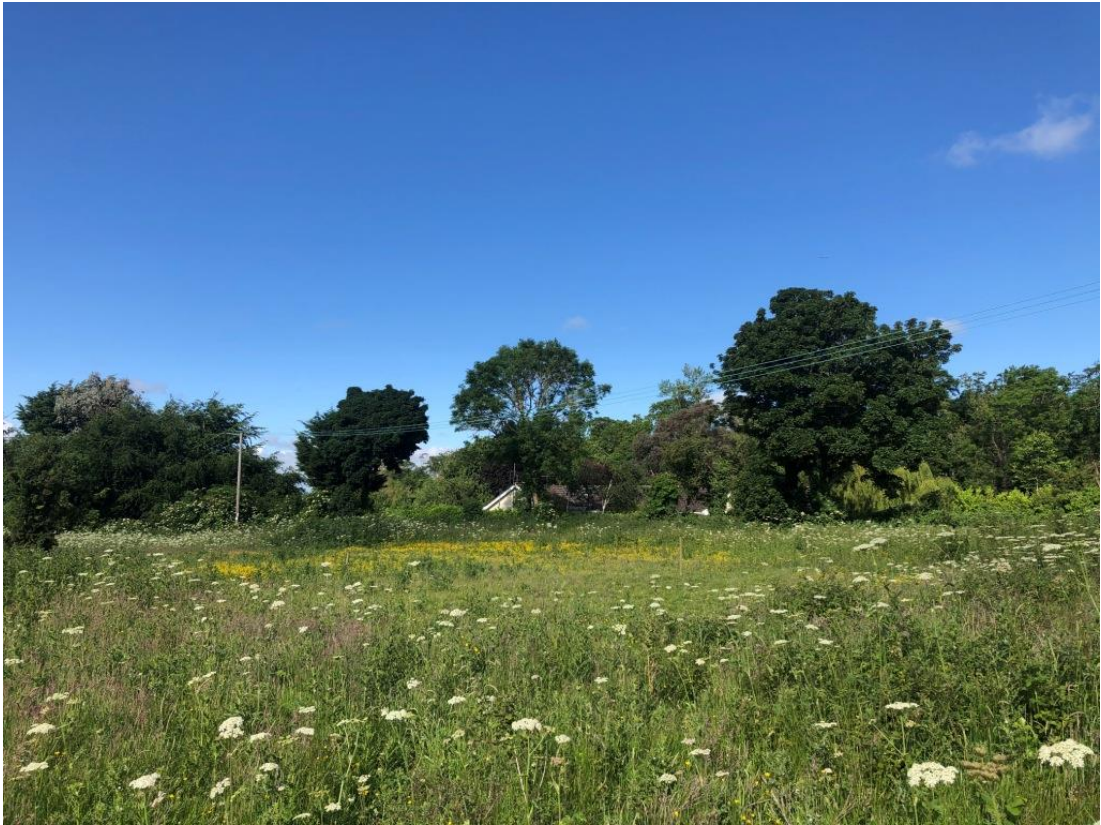
Photo 3: View of the western boundary of the northern grass field.

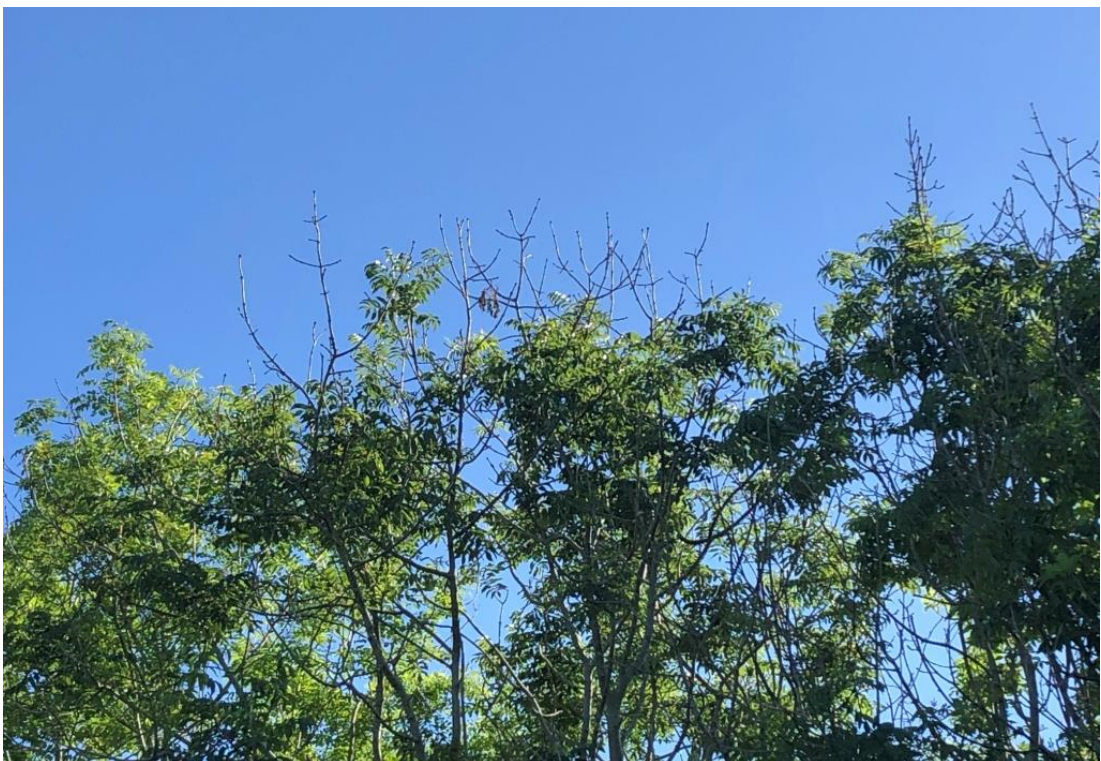
Photo 4: View of the crown dieback that was observed on several ash trees across the site. This is a symptom of the fungal pathogen ash dieback.

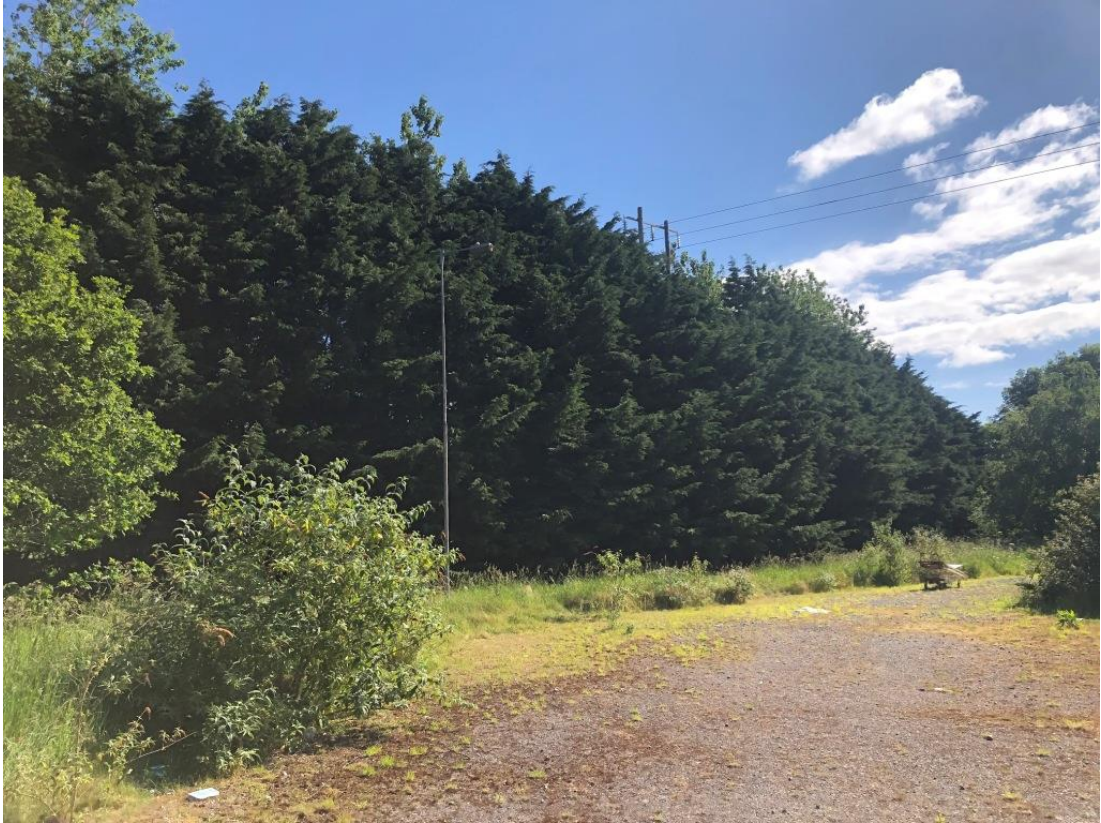
Photo 5: View of the mature Leyland cypress group G198 located between the clubhouse and the northern grass field.

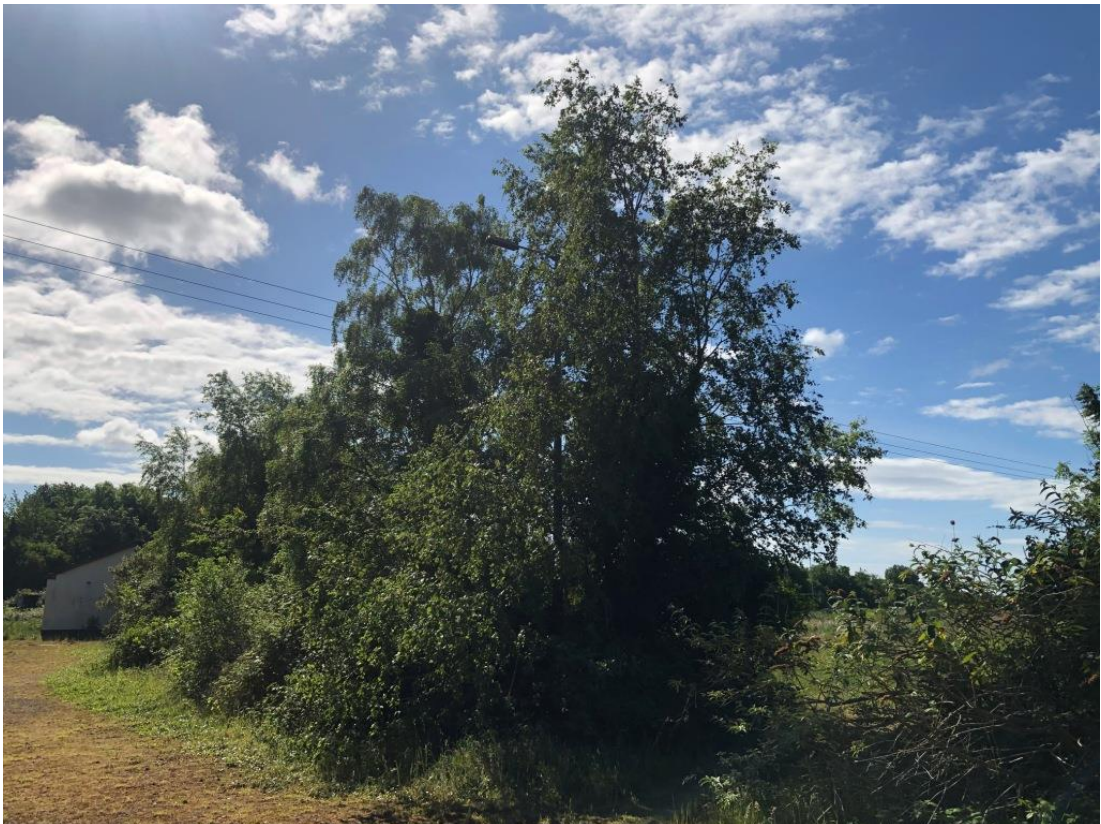
Photo 6: View of the birch (T181 to T185) located adjacent to the clubhouse.

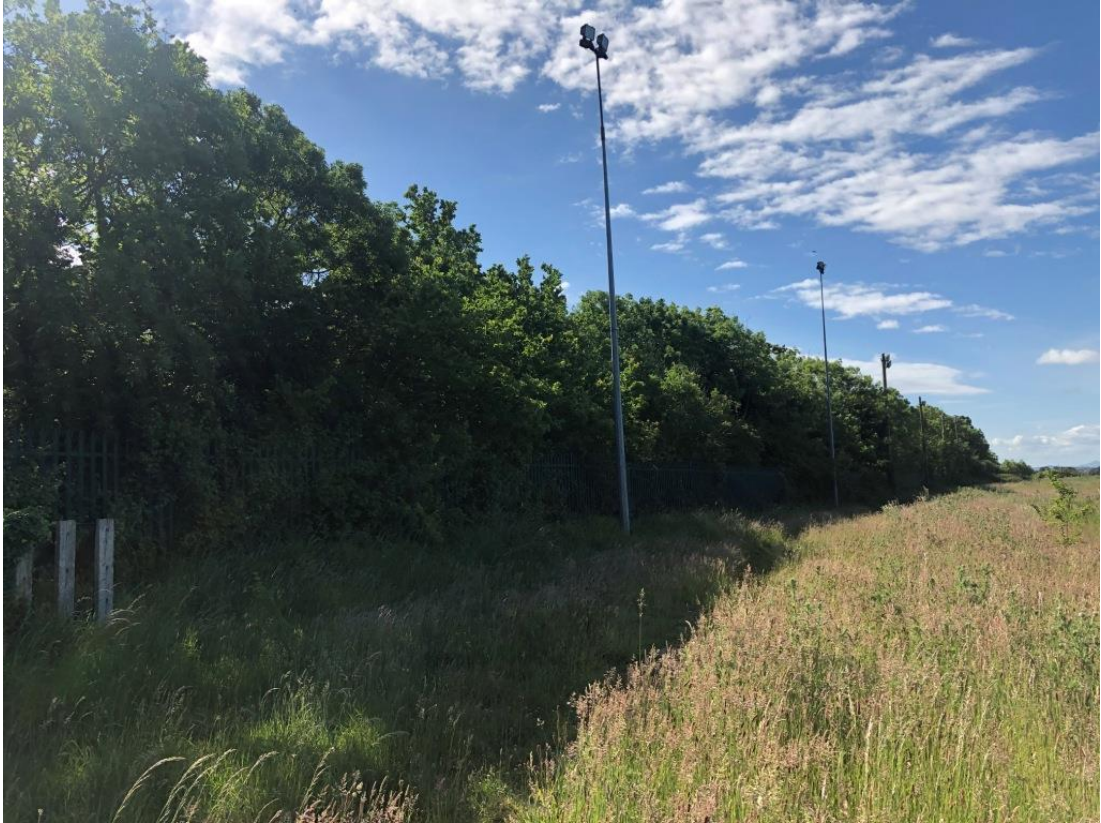
Photo 7: View of the mixed native tree group G227 which is located off-site adjacent to the railway line along the eastern boundary. This vegetation cover provides important visual and acoustic screening to the site.

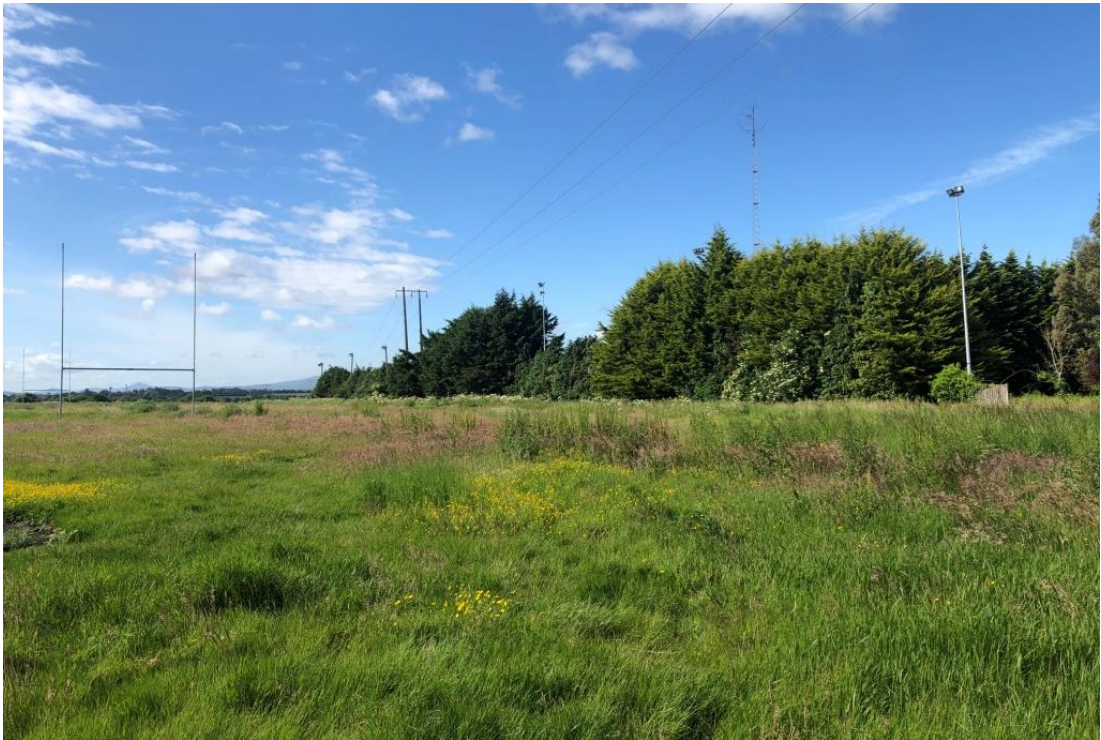
Photo 8: View of Leyland and Lawson cypress tree groups (G171 & G222 to G224) which are located on the western side of the old sports fields.

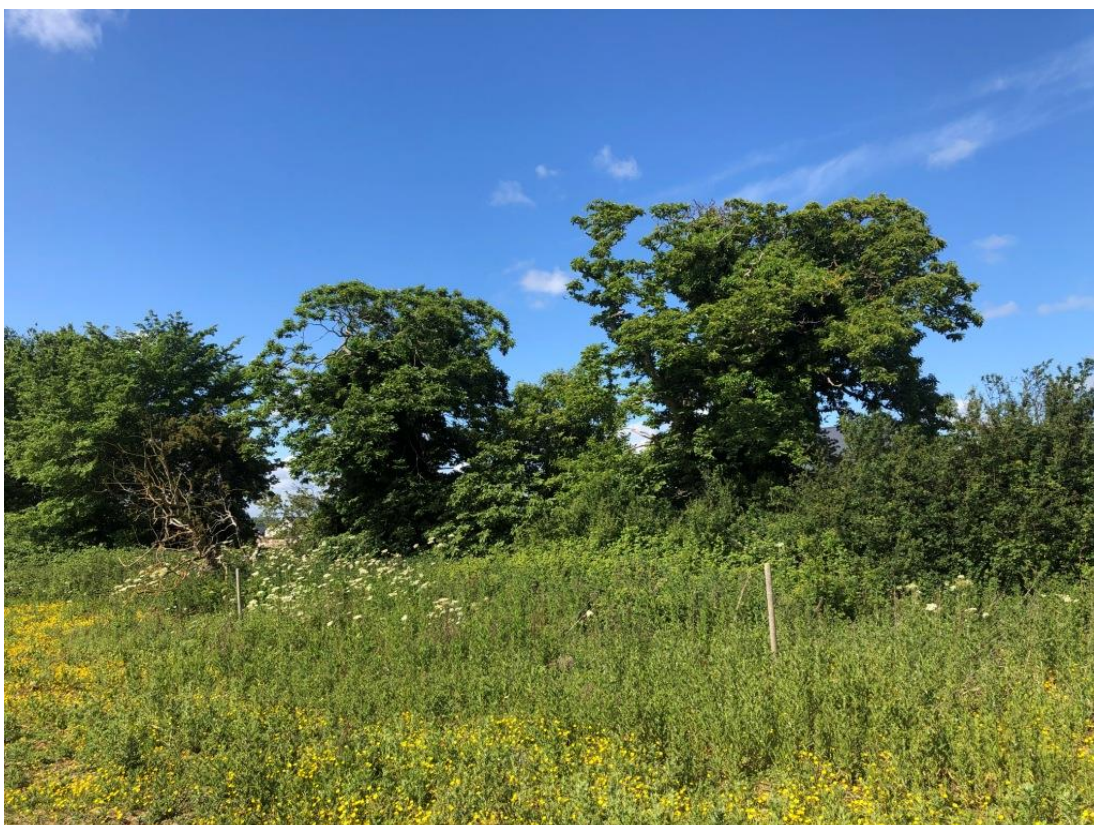
Photo 9: View of the western boundary native tree and hedge groups (G243 & G245) and late-mature sweet chestnuts (T155 & T156).

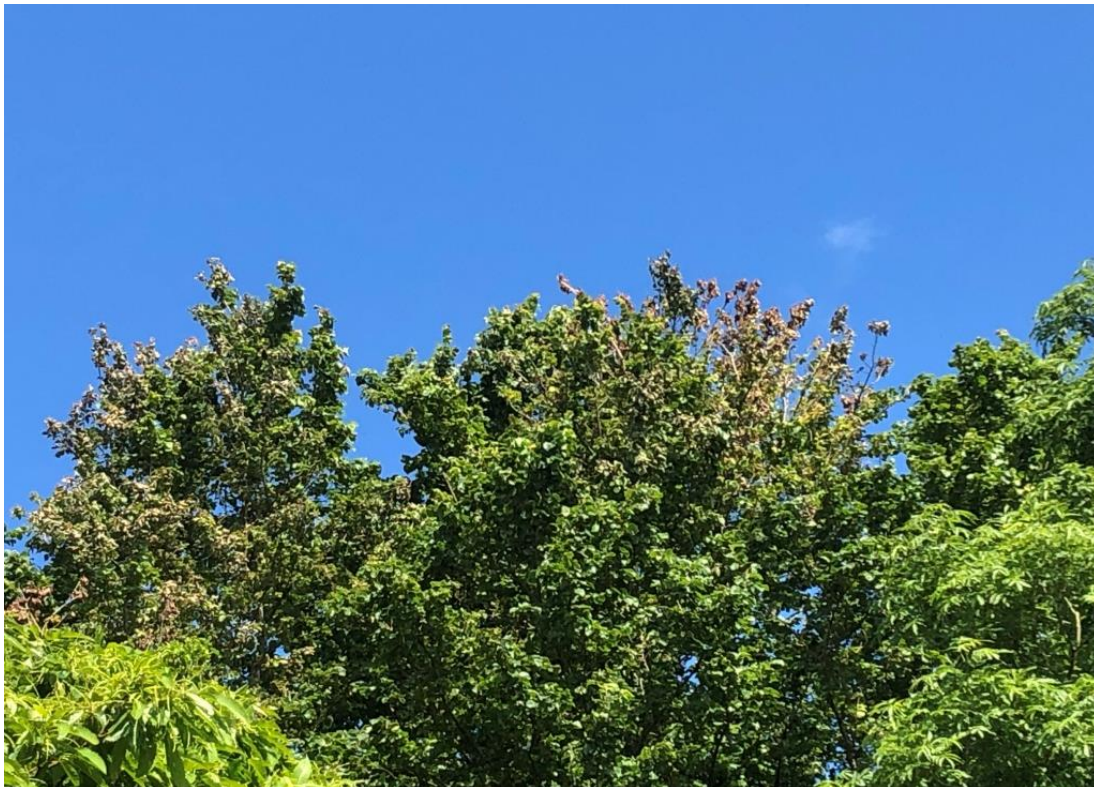
Photo 10: View of the crown dieback observed during the assessment on several elm trees that are infected and declining as a result of the fungal pathogen Dutch elm disease.
