4.0 Geotechnical investigations

6.0 Underwater inspection

6.0 Intertidal inspection

Hydrodynamic and Sediment Regime Assessment **Howth FHC Dredging EIAR**

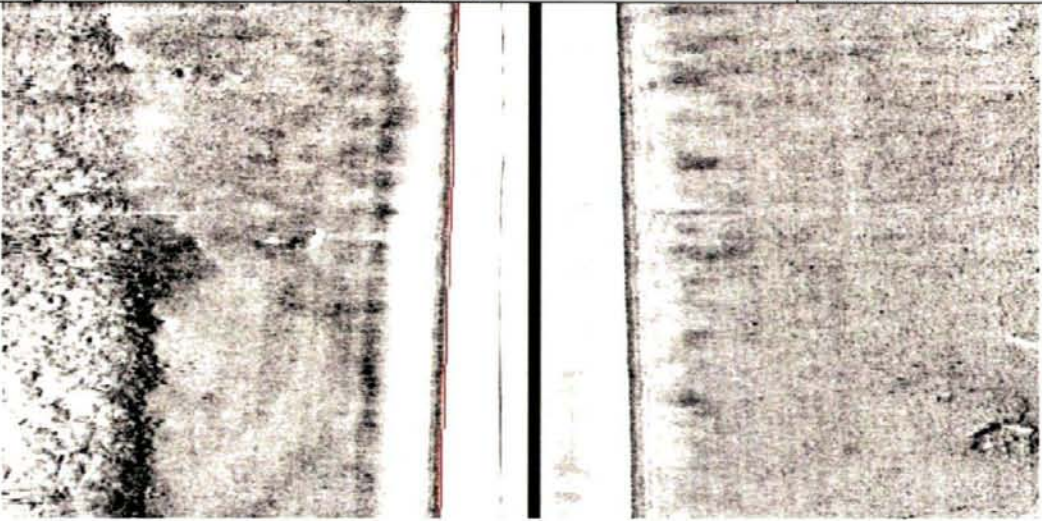
Reference	Geophysical survey interpretation	Dive description
DT_01, next to W pier base	Target off foot of rock armour	Collapse from rock armour
ITM	728388e	739811n
Lat/Long Deg Min Sec	53° 23' 34.184543"	-6° 04' 10.788311"
Decimal Degrees	53.392829	-6.069663
Degrees Minutes	53 23. 569742	-6 04. 179805

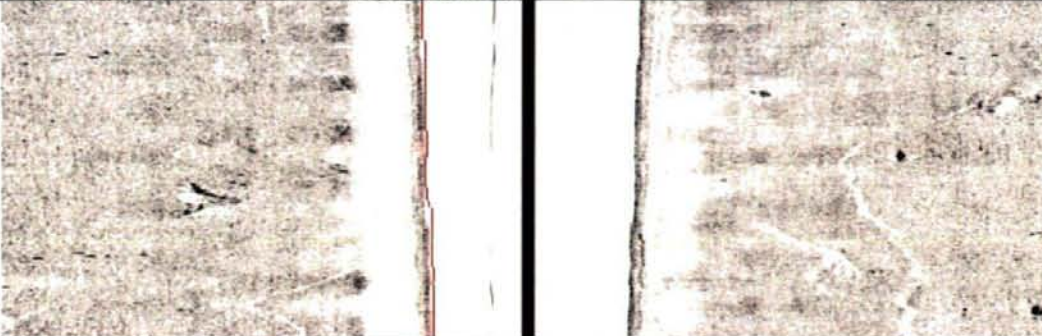
Reference	Geophysical survey interpretation	Dive description
DT_02	Single target	Boulder
ITM	728351e	739864n
Lat/Long Deg Min Sec	53° 23' 35.930626"	-6° 04' 12.712206"
Decimal Degrees	53.393314	-6.070198
Degrees Minutes	53 23. 598844	-6 04. 211870

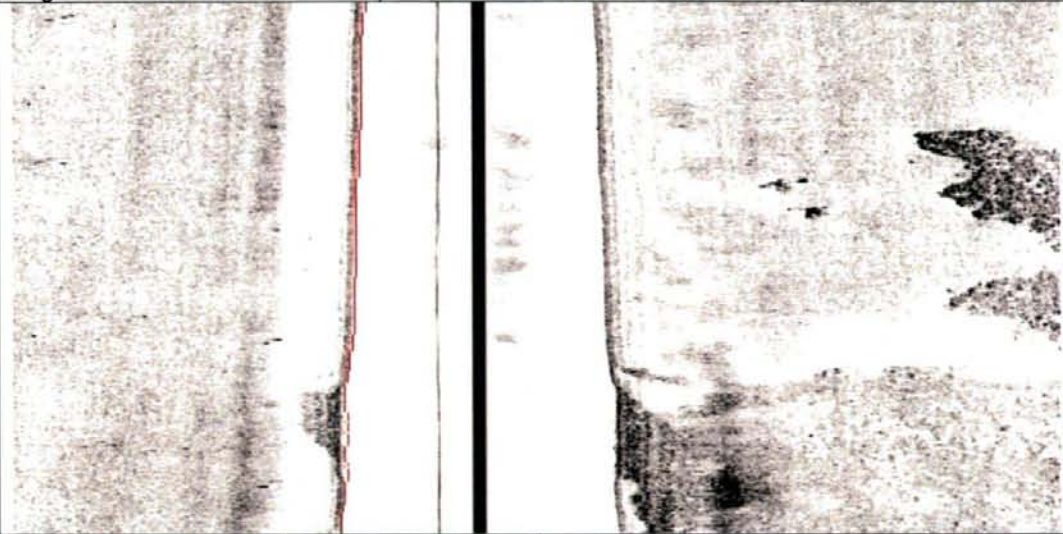
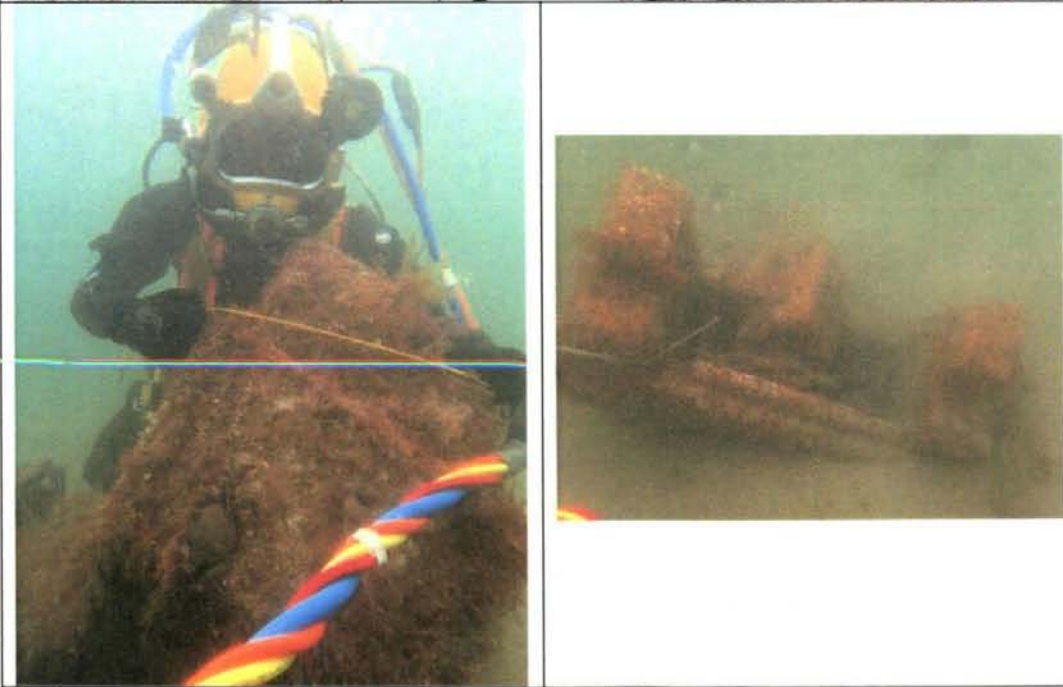
No features of archaeological interest were observed on the seabed, and one of the targets, DT_03, was confirmed to be a large upstanding metal object that is modern in origin.

A more accurate position was taken of DT_03 and it is recorded as Target 01. It is a composite steel piece that appears to be counter-weights of a steel crane, perhaps placed there as a temporary mooring. It is outside the proposed footprint for the reclamation area and will remain exposed on the seabed. It should be considered a navigation hazard and be removed.

Reference	Geophysical survey interpretation	Dive description
DT_03 with Mag target	Two targets close together	Counterweights, navigation hazard
ITM	728353e	739918n
Lat/Long Deg Min Sec	53° 23' 37.674929"	-6° 04' 12.525008"
Decimal Degrees	53. 393799	-6.070146
Degrees Minutes	53 23. 627915	-6 04. 208750

Underwater photographs of the modern metal object at DT_03/Target 1.

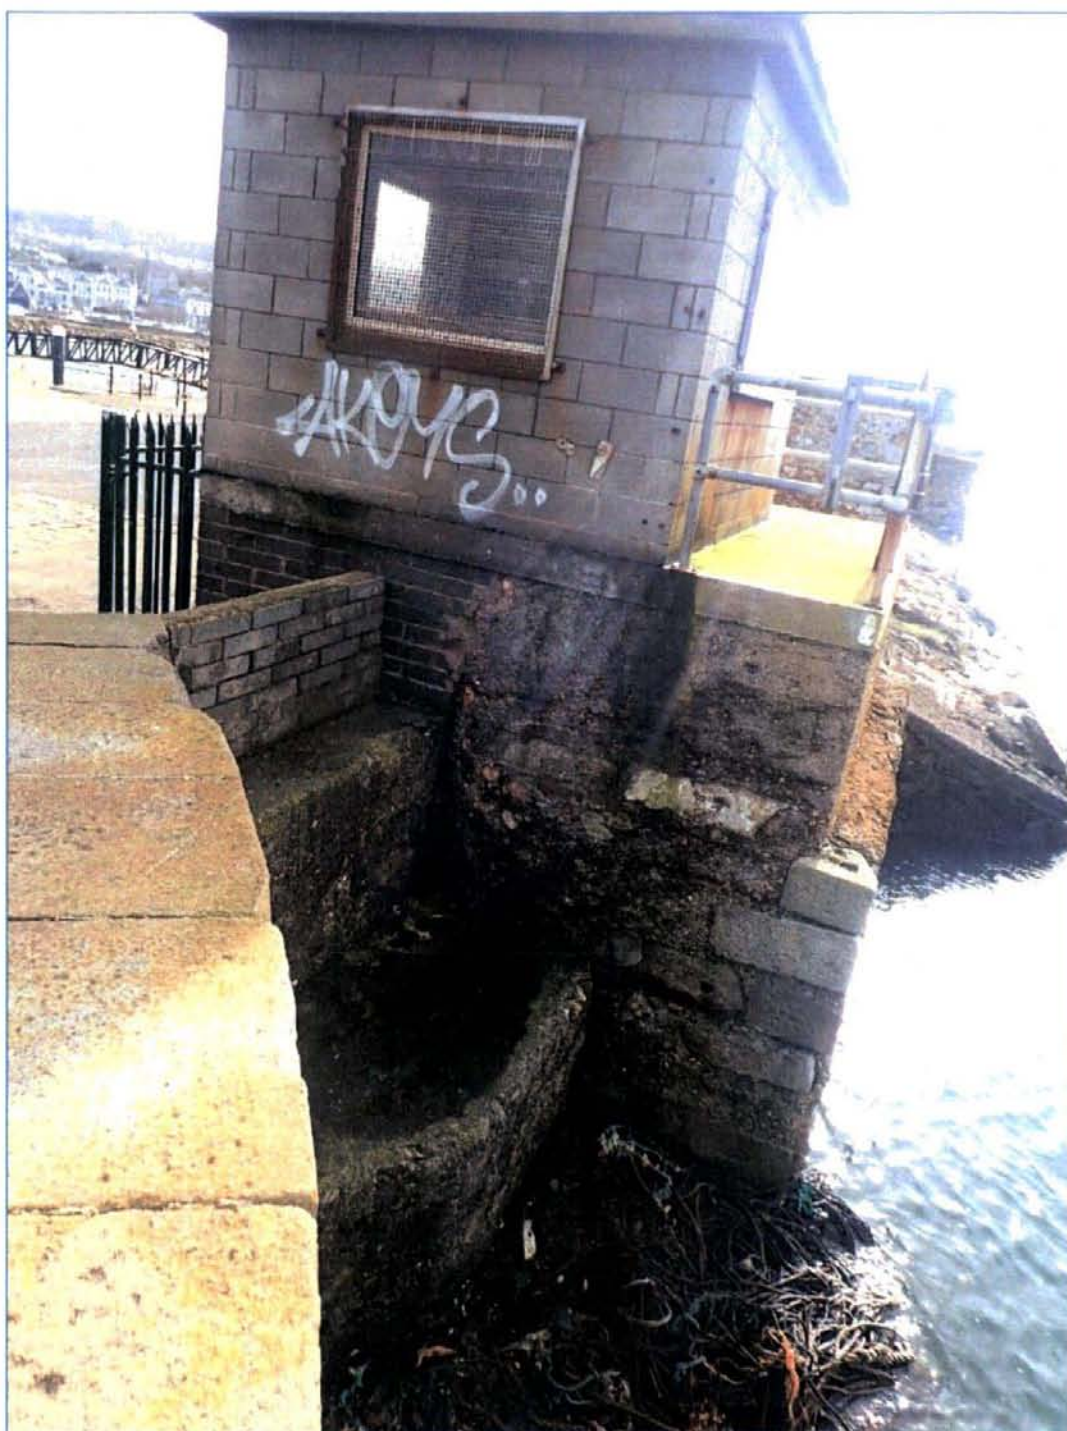
Plate 24: View looking South from roundel showing the non-uniform nature of the integration with the West Pier. The picture also shows the later observation building and its construction of earlier foundations.

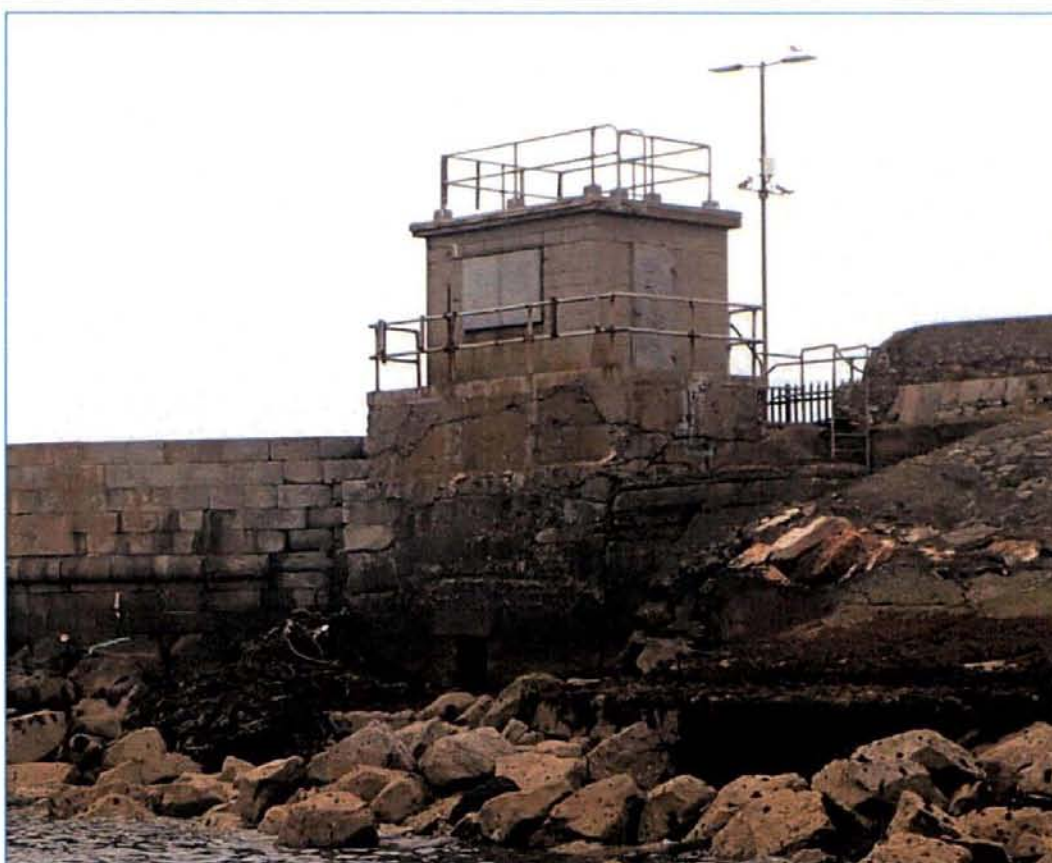
Plate 28: View from the sea highlighting the observation building and its squared concrete foundations standing on top of and earlier stone-and-concrete foundation.

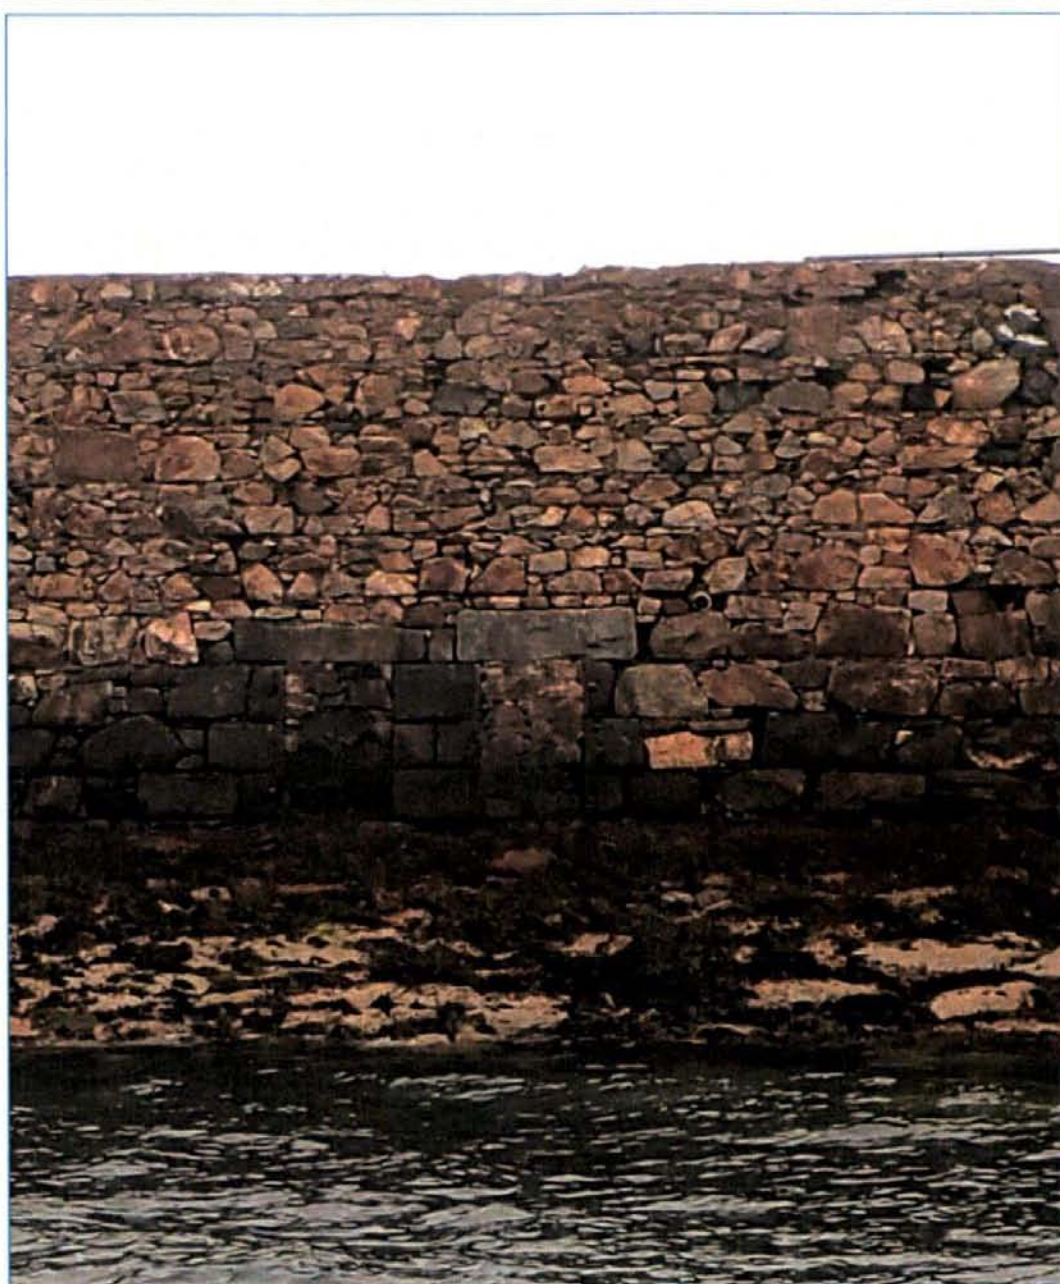
The next length of walling is different (Plates 34–35). The walling is stepped out onto the glacis slightly further. It is constructed using better stonework, and while both its corners are also built using ashlar granite, there is a series of six lintelled culverts grouped into three clusters of two culverts each that are located more or less equidistant along its base. The culverts are blocked-up using stone. There are also two significant expanses of breaches in the wall that have been repaired, along with several smaller repairs. The wall length corresponds with the rear of properties recorded on the 1840 and the 1911 OS maps, which indicate a terrace of six buildings. The historic photograph included as Figure 7B shows the terrace as a row of two-storeyed houses (Figure 7B). The number of culverts corresponds to that of the houses and are clearly associated with them. The culverts presumably served as the foul-water egress from each house.

Plate 35: Detail of Plate 34 highlighting a pair of the lintelled culverts that have been blocked up.

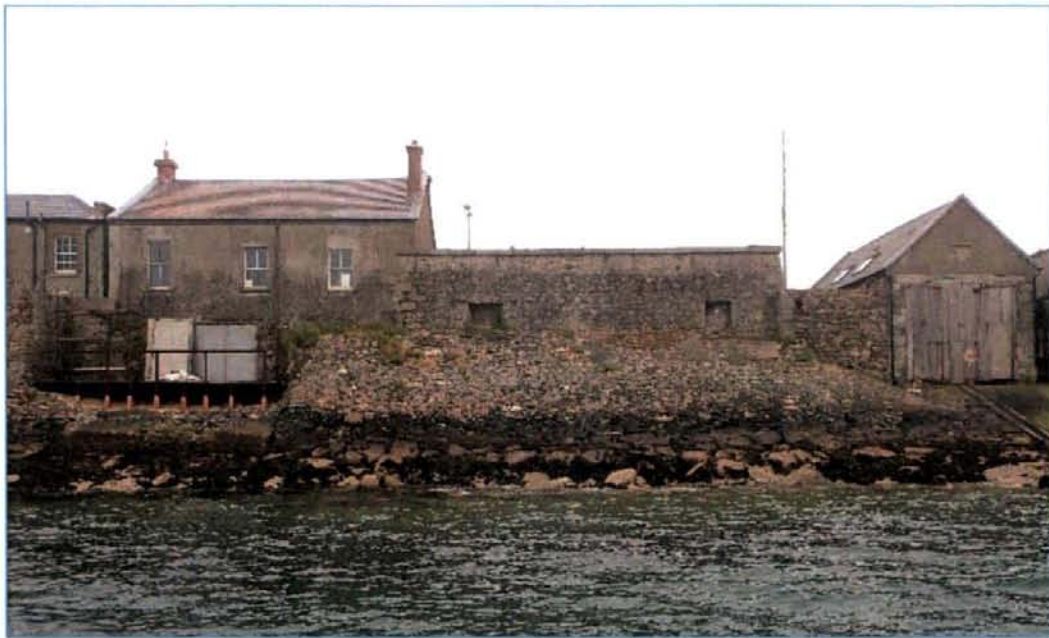
Plate 43: View from the sea, showing the rear of boathouse NIAH 1359044, and the elevated nature of the glacis constructed across it, effectively blocking any access to a boathouse entrance.

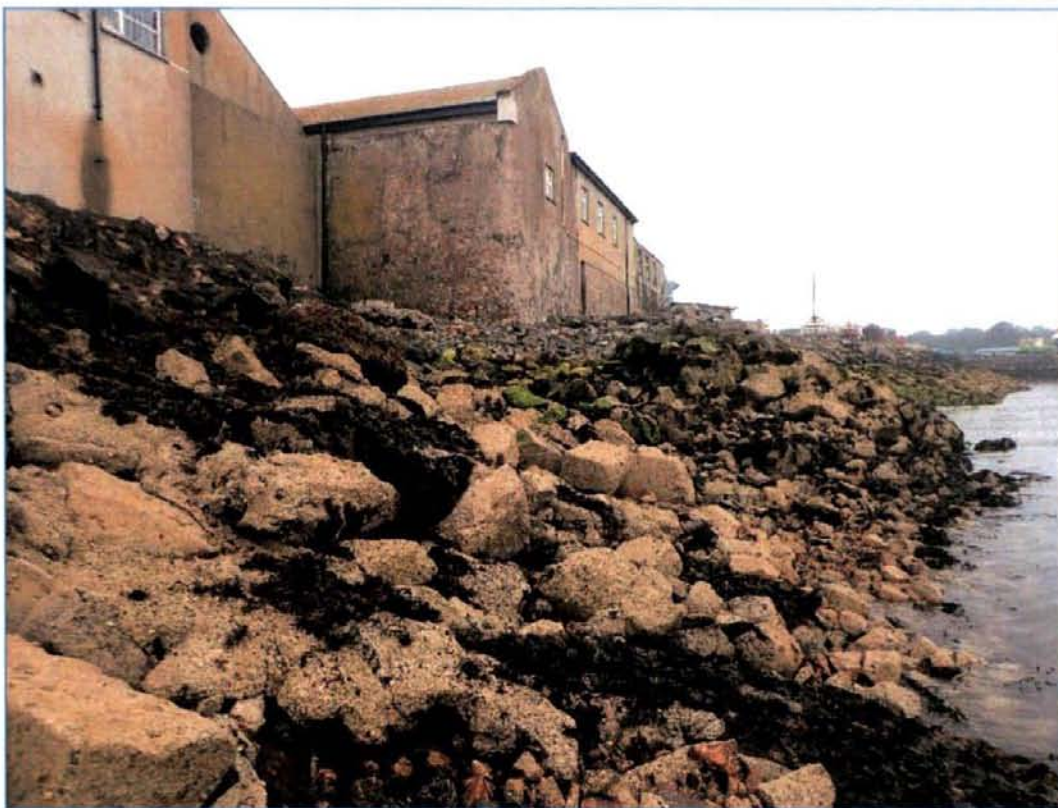
Plate 47: View looking South from the slipway at the coastguard slipway along rock armour that has been added, effectively burying the glacis.
