**Gortyrahilly WF (GWF), Co. Cork**

**Photographs**

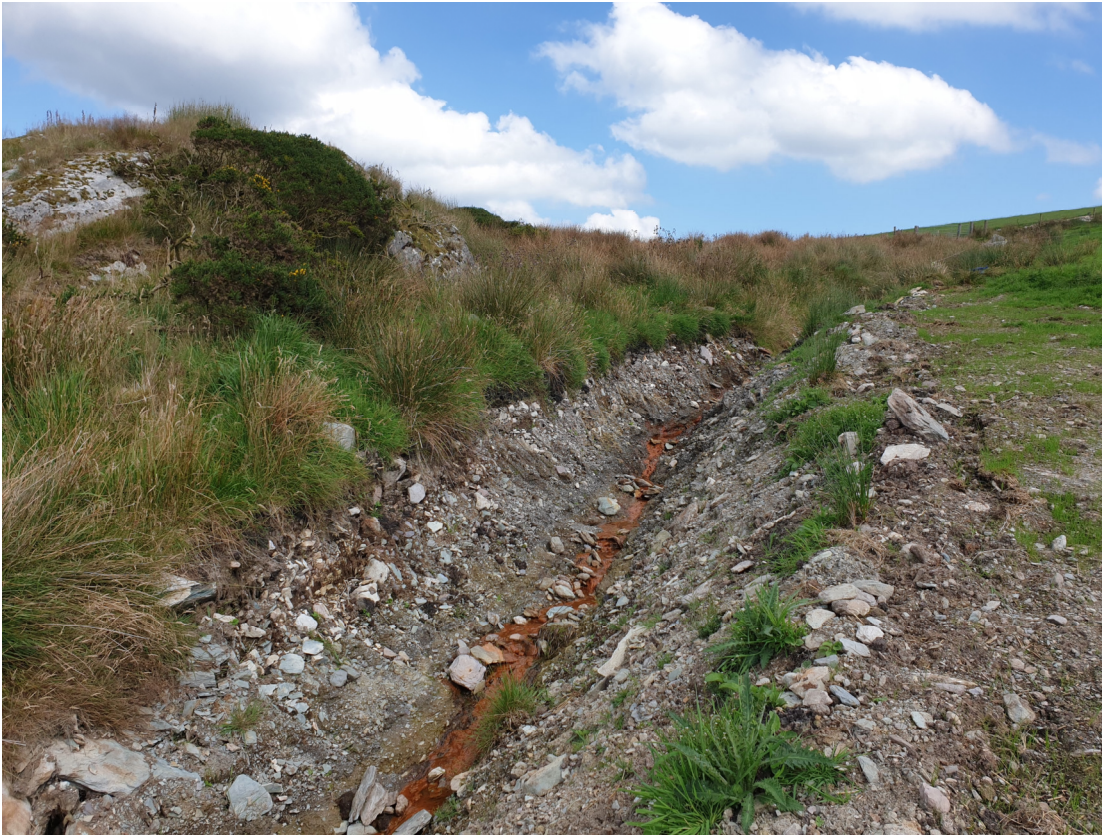
Recently excavated drainage observed during Surface Water Sampling R1 12/08/2020, near WC2.

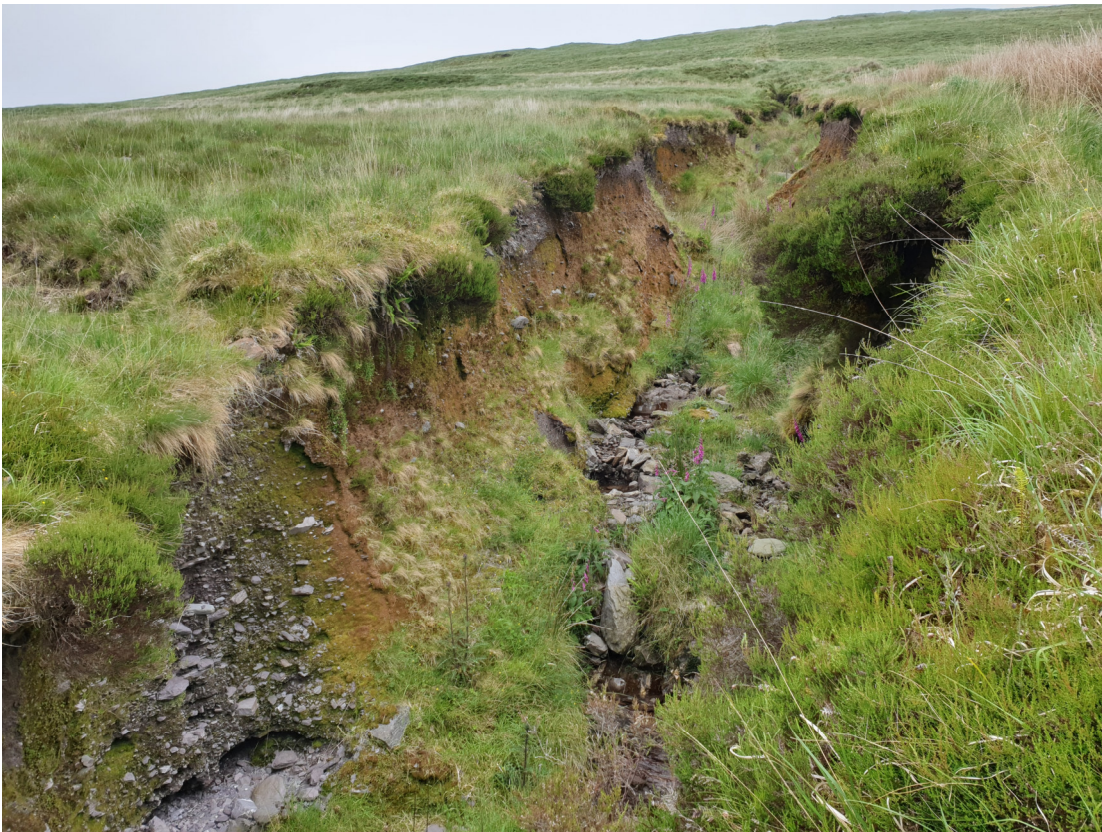
Natural drainage, deeply eroded channel in till observed during Site surveys 16/06/2020, near WC2.

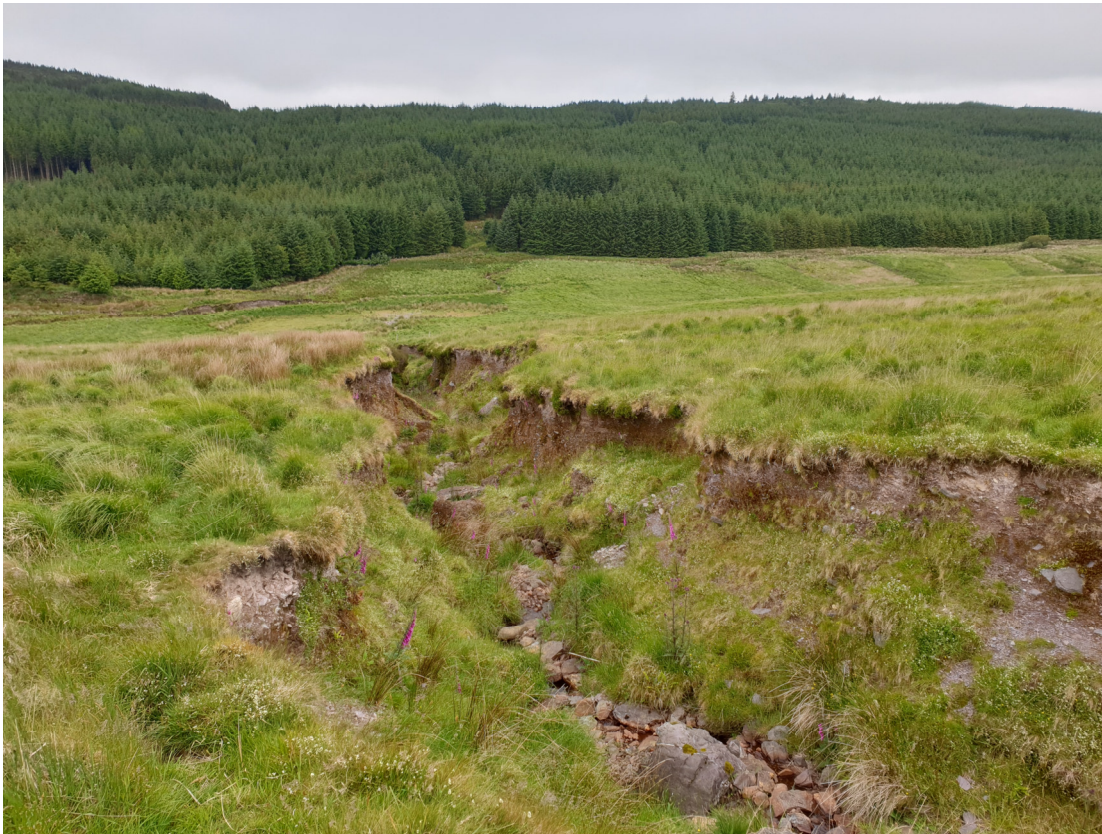
Natural drainage, deeply eroded channel in till observed during site surveys 16/06/2020, near WC2.

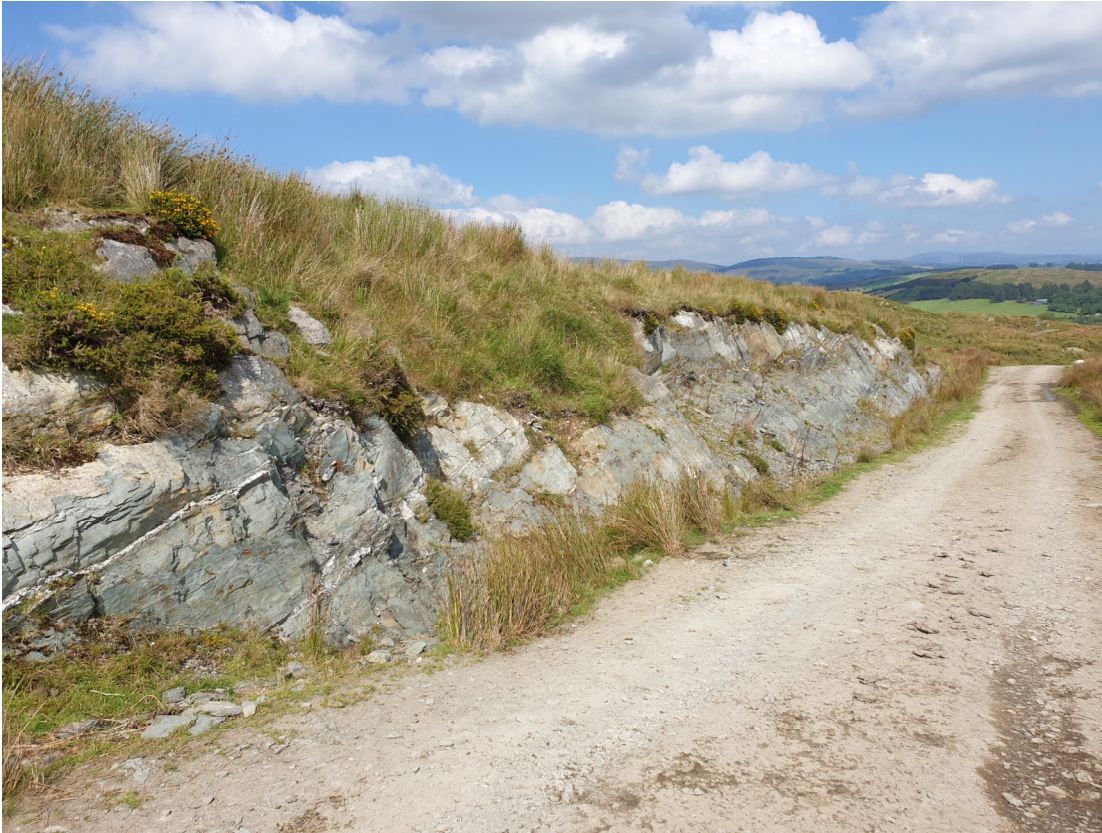
Exposed bedrock along existing access track observed during Surface Water Sampling R1 12/08/2020, near WC2 and WC4.

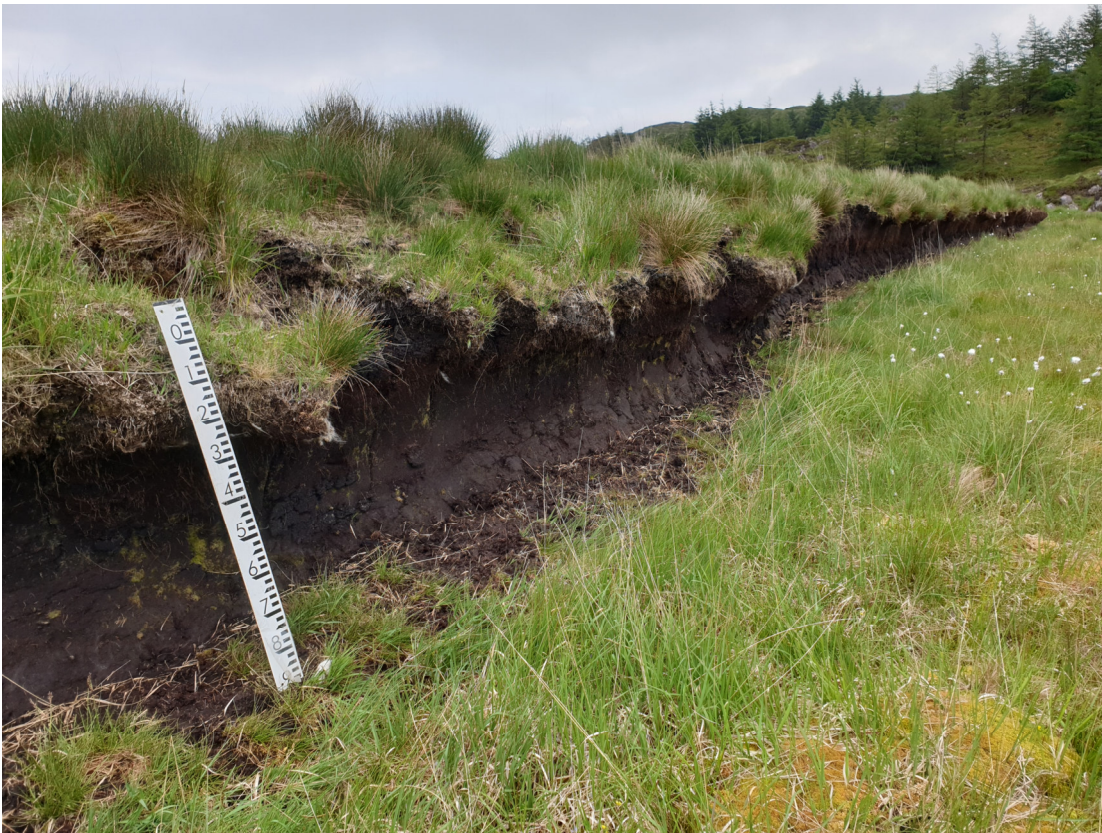
Evidence of peat cutting observed during site surveys 16/06/2020.

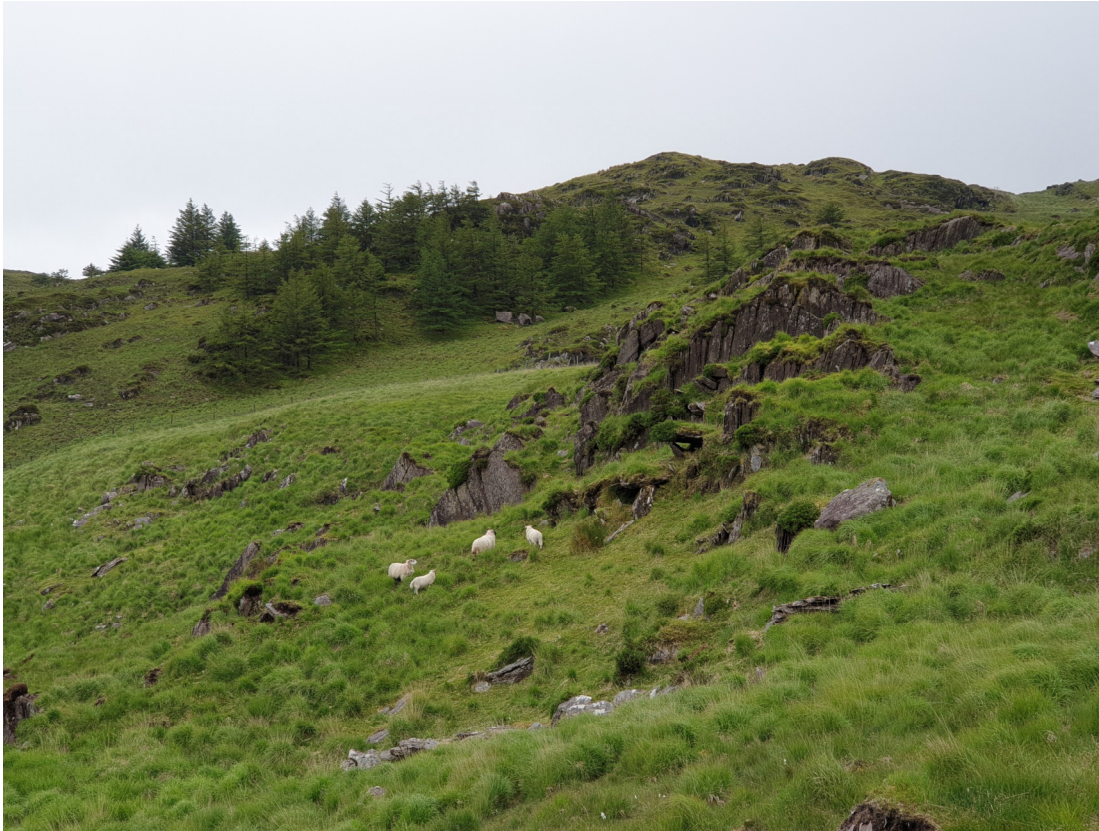
Steep and complex topography and exposed bedrock observed during site survey 16/06/2021.

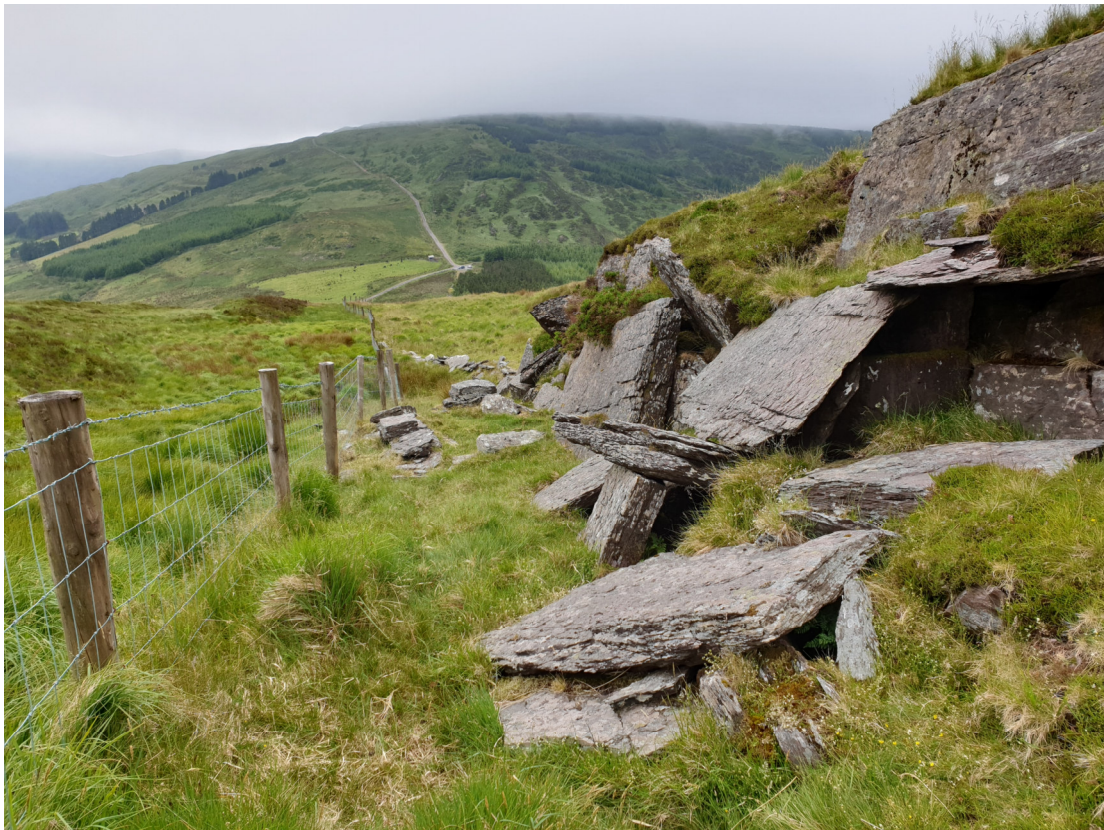
Exposed and weathered bedrock outcrop observed during site survey 16/06/2021.

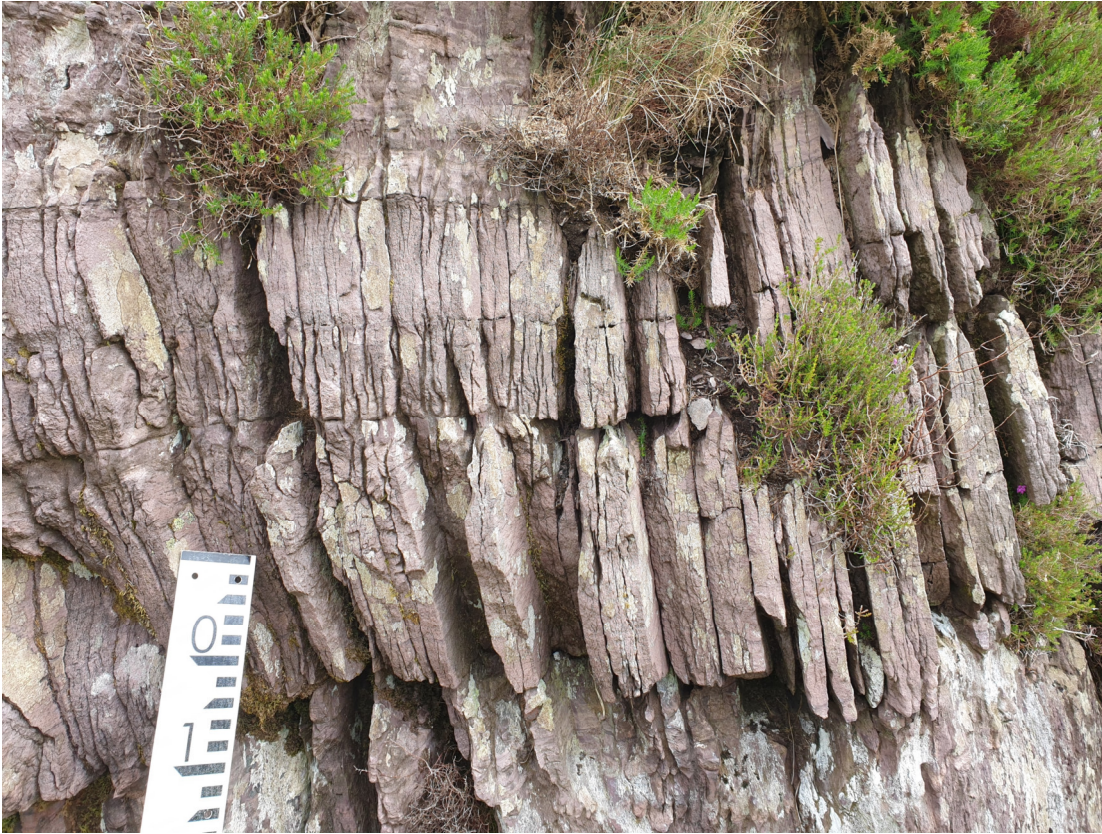
Exposed and weathered bedrock outcrop observed during site survey 18/06/2020.

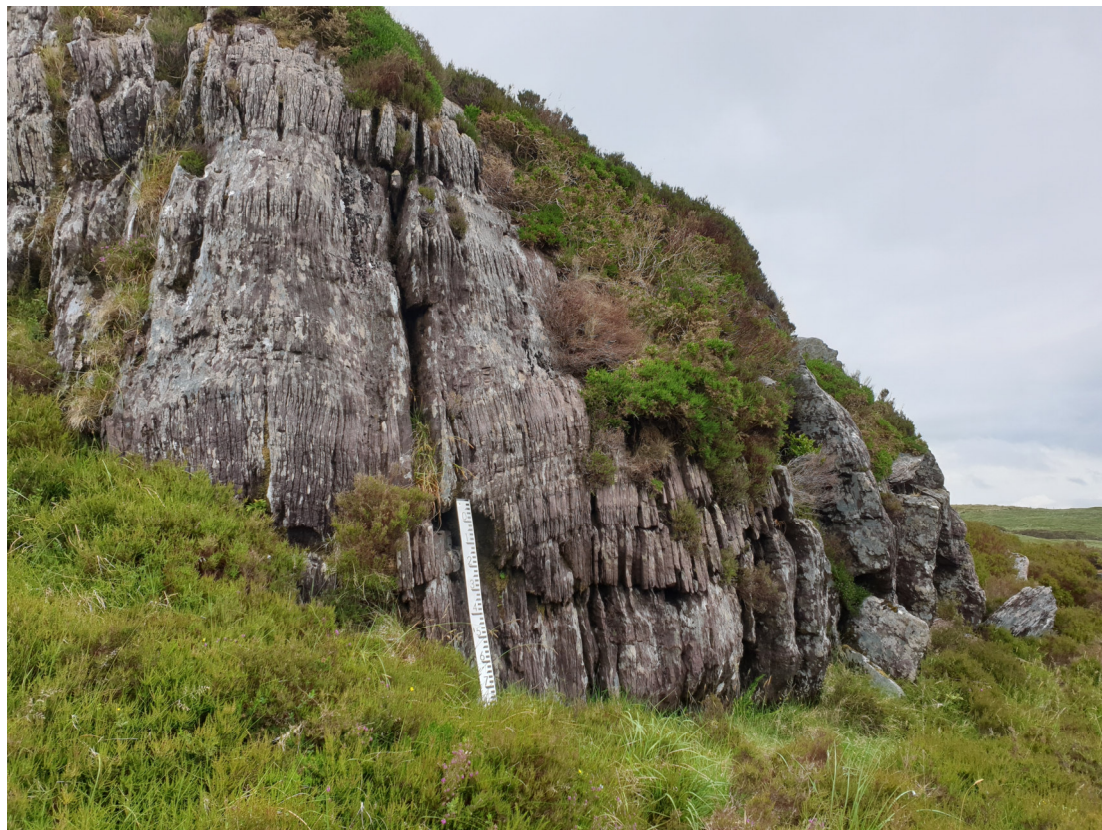
Exposed and weathered bedrock outcrop observed during site survey 18/06/2020.

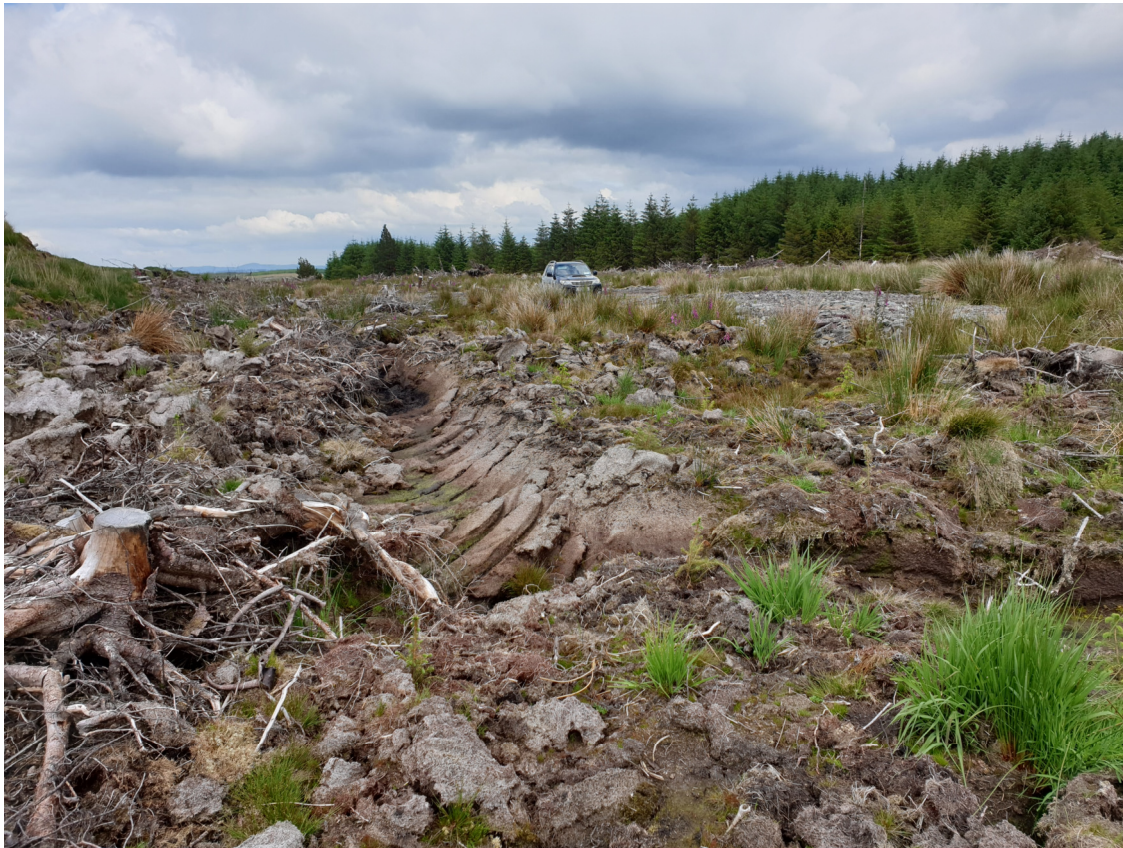
Recent forestry activity observed during site survey 18/06/2020.

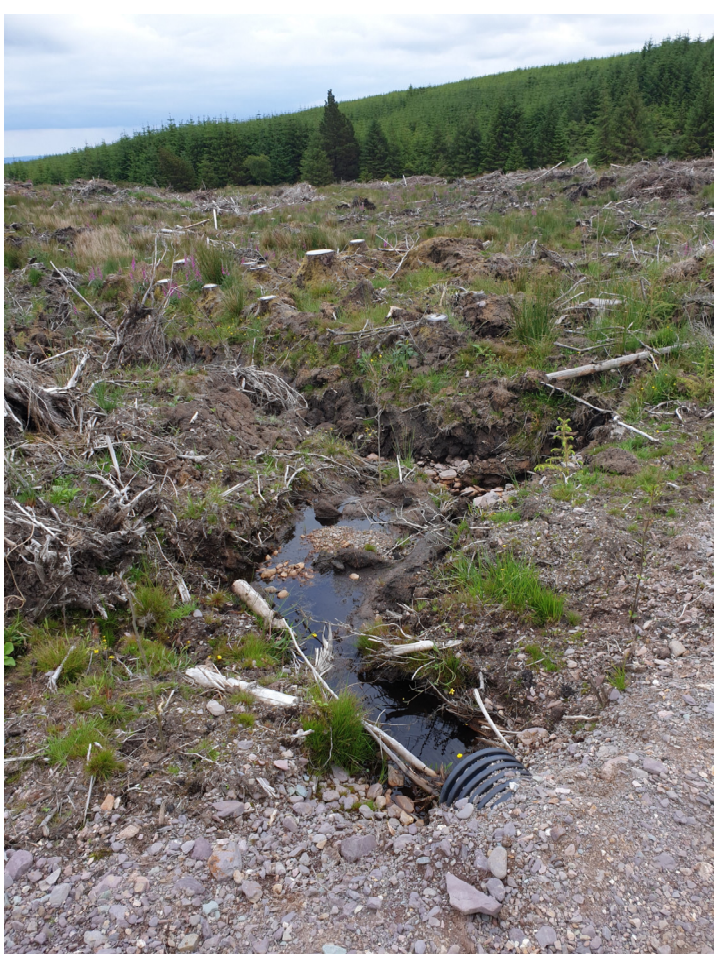
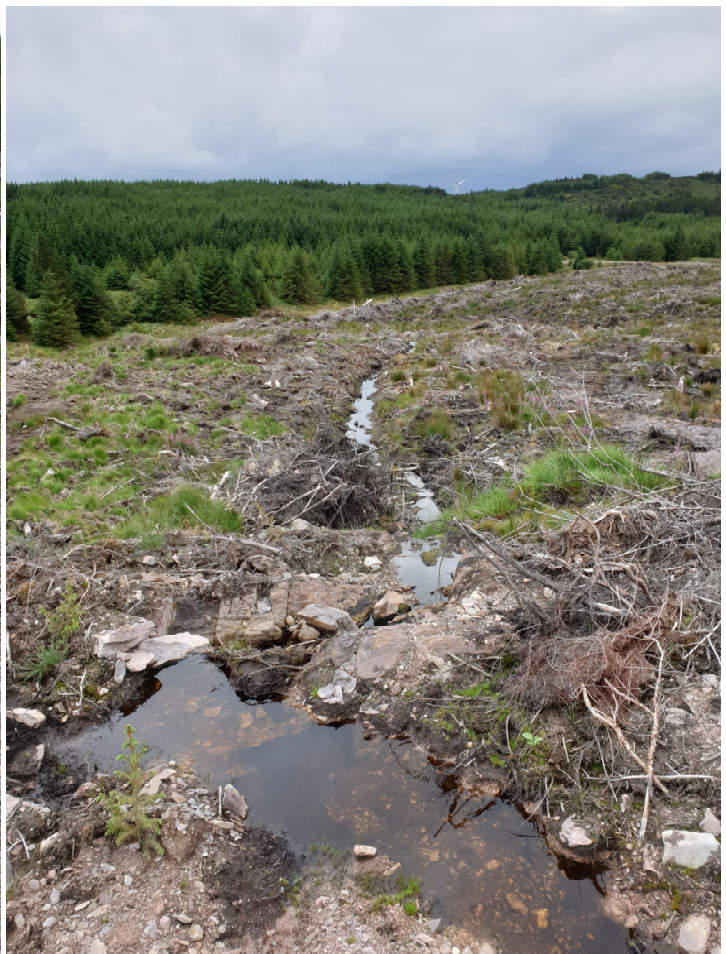
Recent forestry activity observed during site survey 18/06/2020.
