Appendix A17.1

Arboricultural Impact Assessment

Scheme 03:
Ballymun To
City Centre

Project No.	TBAL001	Date	24/08/22
Project Name	BUSCONNECTS Core Bus Corridors. Emerging Preferred Routes / Public Consultation	Revision	-

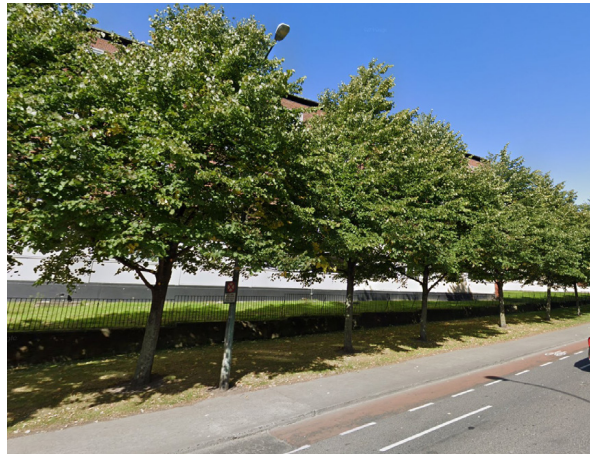
From Aran Quay to the Phibsborough Road bridge, there is a low density of urban tree stock, of which Norway maple *Acer platanoides* and London plane *Platanus × acerifolia* are the most common species located here. These trees are of a healthy mix of age profiles, with the majority being early mature. The largest single group of trees in this area, are within an wide open grass area on Constitution Hill. These benefit form these favourable soil conditions and are well developed as a result (image 2).

Image 2. Lime trees on Constitution Hill.

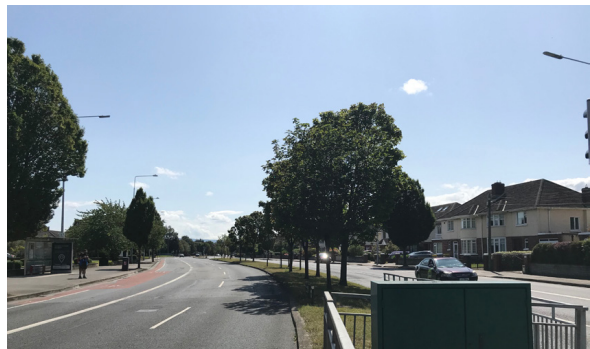
Conversely, the largest concentration of less vigorous trees are found in the median areas between Our Lady of Victories Catholic Church and Griffith Avenue (images 4&5). With many trees in this area being of a younger age profile and suffering poor drainage.

Image 4. Sycamore and Norway maple adjacent to Our Lady of Victories church.

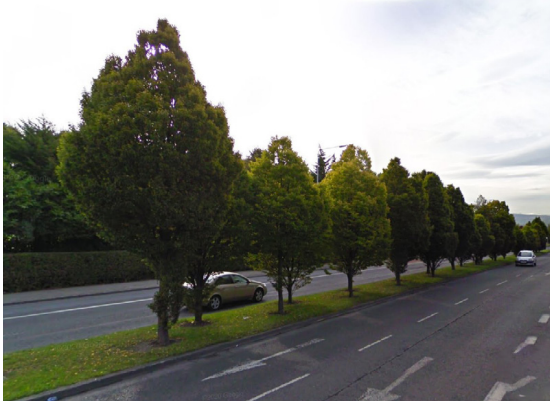
Image 6 Hornbeams adjacent to Albert College Park in 2010.

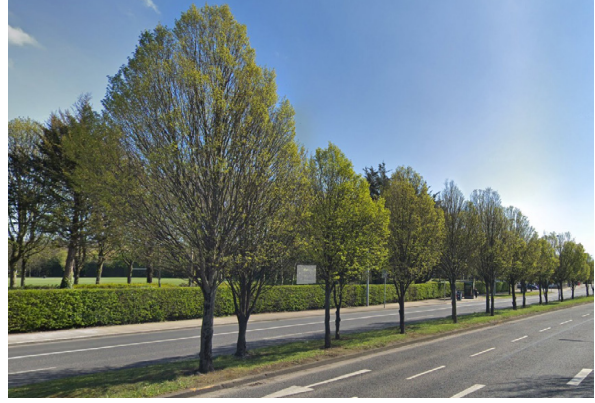
Image 7. Hornbeams adjacent to Albert College Park in 2020 (same trees as image 6).

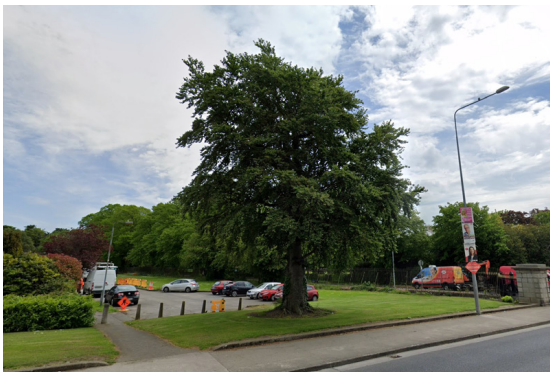
Image 8. A large beech (03-T228) dominates the entrance to DCU.

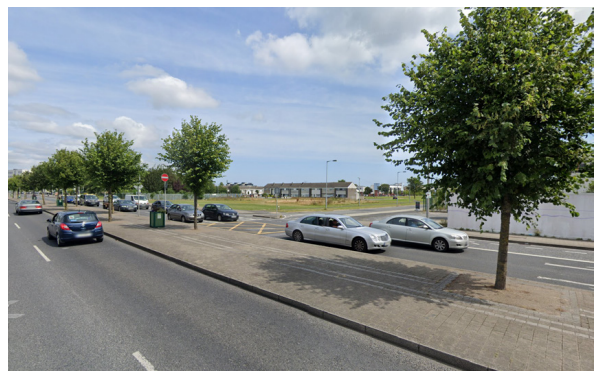
Image 9. Lime trees within central median in Ballymun.

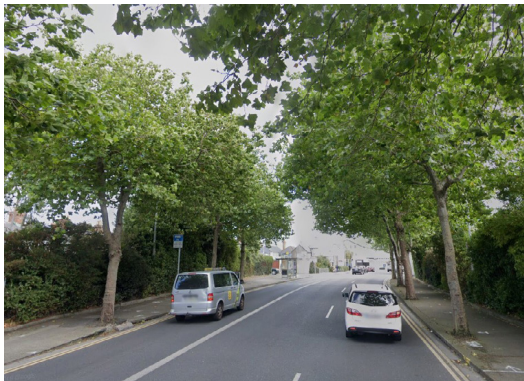
This description of surveyed trees begins in the southern section of the route, on the R108 adjacent to the intersection with Prospect Avenue are located more established street trees; London plane (*Platanus × acerifolia*). These are in contrast with the majority of younger specimens of street trees located throughout the route (image 2).

Image 2. Early mature London plane on the R108 adjacent to the intersection with Prospect Avenue.

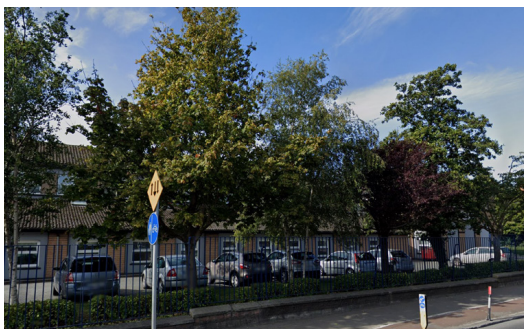
North, adjacent to younger London plane street plantings are a line of private trees within the grounds of St. Vincent’s Secondary School (image 3). Less than 1m from the public foot path, these include some well formed early mature rowan (*Sorbus aucuparia*), Birch (*Betula pendula*), Purple leaf plum (*Prunus cerasifera Nigra*) and mature Black alder (*Alnus glutinosa*),

Image 3. Early mature cherry, sycamore, birch and rowan withing the grounds of St.Vincent’s Secondary School.

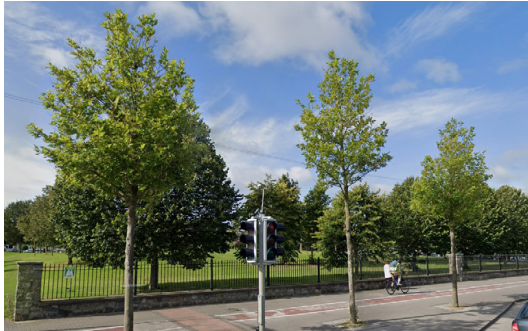
Within Claremont Lawns Park, 200m north and 4.5m from the boundary wall, are a line of common lime (*Tilia x europaea*). This group of 17 trees are

Image 4. Lime trees within Claremont Lawns Park and silver maple street trees.

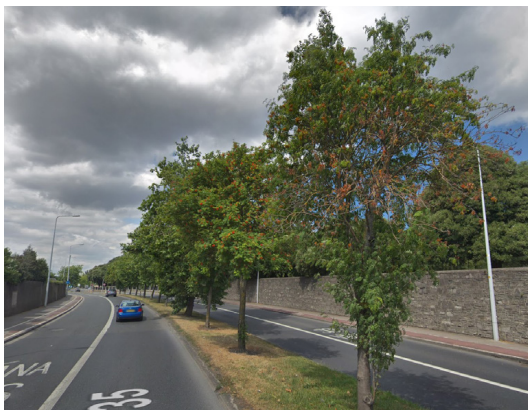
vigorous and well developed (image 4). 300m north of Claremont Lawns Park is the first central median on the surveyed route (image 5). This contains Rowan (*Sorbus aucuparia*) and London plane (*Platanus x acerifolia*) within a gently sloping grass verge median. Many of

Image 5. Rowan and London plane on the central median between Claremont court and the Willows.

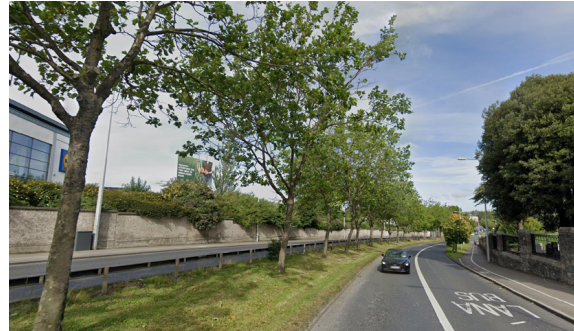
Adjacent to the Glasnevin cemetery a longer, 400m, median contains a group of 28 London plane (*Platanus x acerifolia*) of mixed age profiles, with the majority being younger early mature. These trees are likely to be suited to this environment due to their drought tolerance (image 6).

Image 6. Early mature London plane trees in the central median adjacent to Glasnevin Cemetery.

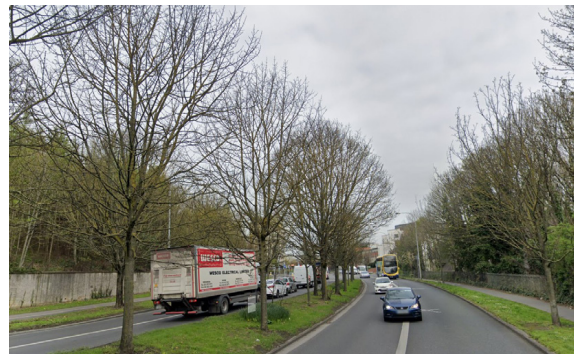
North of the Old Finglas Road and Tolka Valley apartments Fastigate hornbeam (*Carpinus betulus 'Fastigiata'*) and Sycamore (*Acer pseudoplatanus*) populate the central median (image 7). These trees contain some poorer specimens due to poor soil conditions. More mature sycamores are located in grass verges along the western side of the roadway. These trees are better developed and have benefited from larger planting areas.

Image 7. Sycamore in the central median north of the Old Finglas Road.

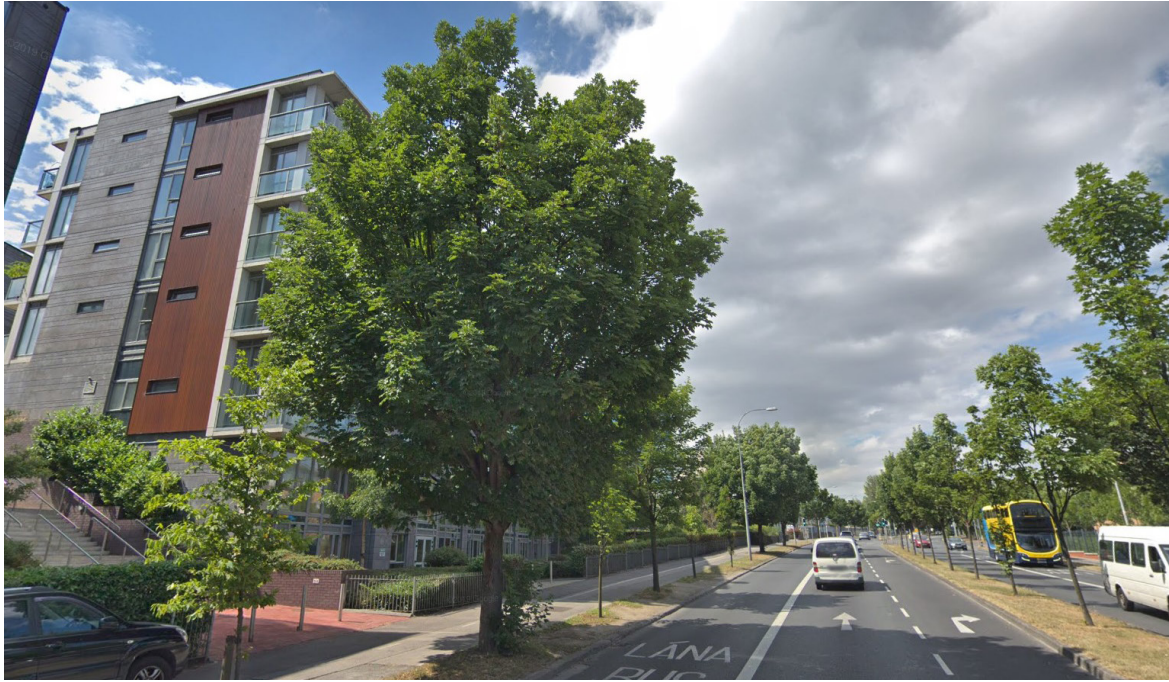
Image 8. A larger early mature sycamore street tree adjacent to the Tolka and Eden Apartments.

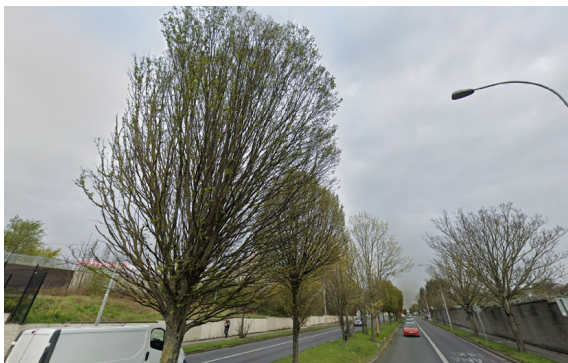
Image 9. Sycamore and hornbeam in the central median south of Glenhill Road. the city. Planted in an open area these have become well established.

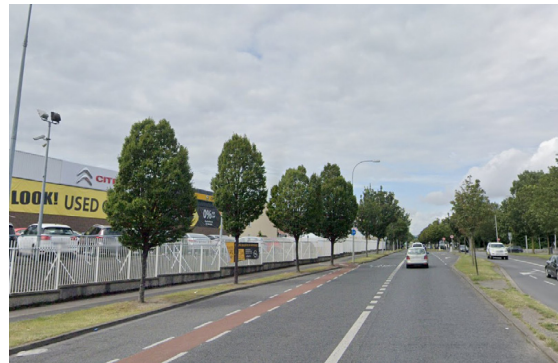
North of the Clearwater shopping centre a street plantings of early mature Fastigate hornbeam (*Carpinus betulus 'Fastigiata'*) are located along the foot paths in grass verges. Younger specimens populate the central median (image 11).

Image 11. Street planting of early mature fastigate hornbeam north of the Clearwater shopping centre.

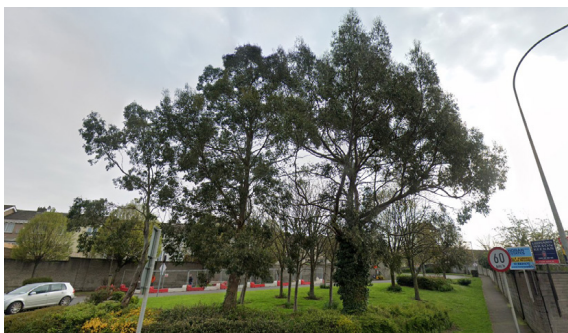
At the entrance to Glenhill Road are two mature gum trees (*Eucalyptus spp*) (image 10). These are unusual to find in north Dublin, the majority being found south of

Image 10. Two mature eucalyptus at the entrance to Glenhill Road.

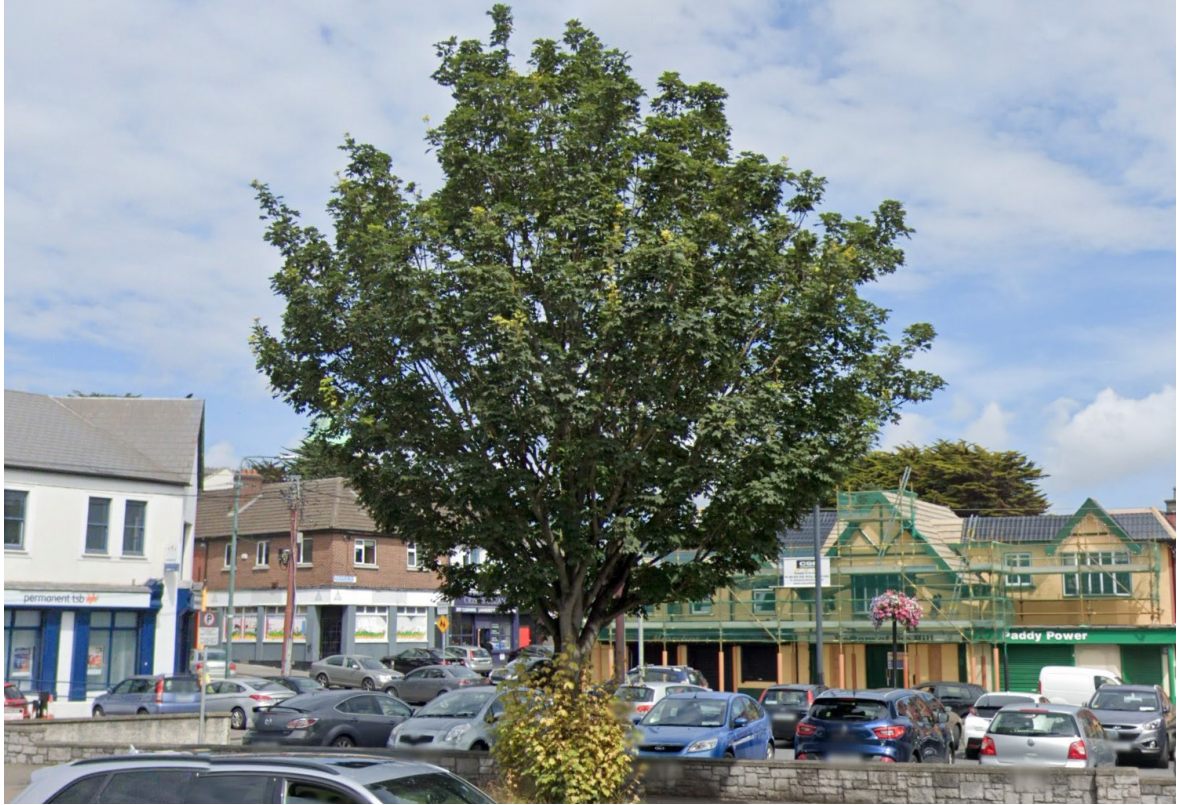
Image 12. An early mature sycamore in Finglas village.

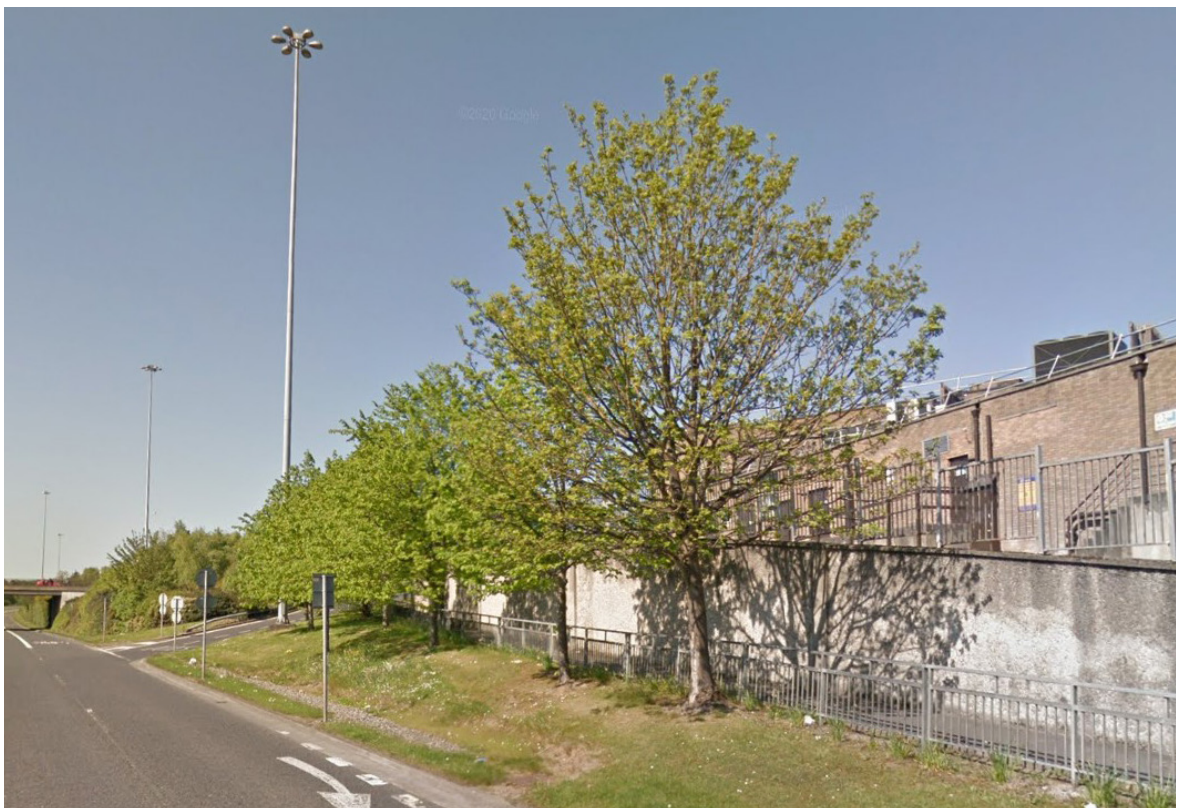
Within the north-most section of the surveyed route, a group of small-leaf lime (*Tilia cordata*) are located on a sloping grass verge before the turn-off to Seamus Ennis Road in Finglas village. These have developed well due to good soil conditions (image 13).

Image 13. Young small leaf lime and sycamore before the turn-off to Seamus Ennis Road in Finglas village.
