Appendix D2
Arboricultural Impact
Assessment Report -
Finglas to
Phibsborough

Arboricultural Assessment, Report

Scheme 04: Finglas To City Centre

Project No.	TFIN001	Date	24/08/22
Project Name	BUSCONNECTS Core Bus Corridors. Emerging Preferred Routes / Public Consultation	Revision	-

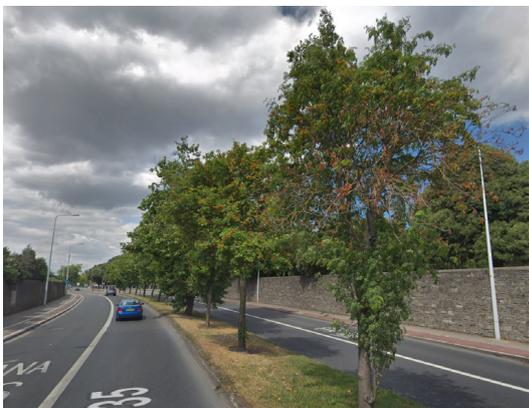
Image 5. Rowan and London plane on the central median between Claremont court and the Willows.

these specimens are suffering from soil buildup near root flares.

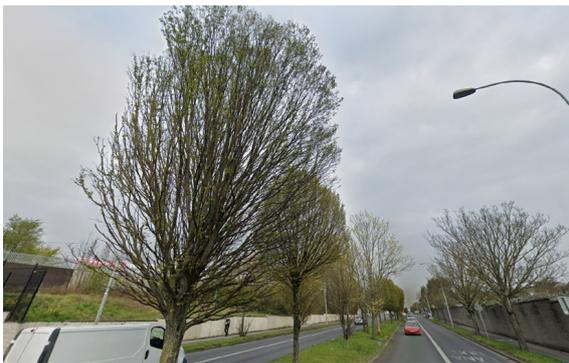
South of Glenhill road within the central median here, are Fastigiata hornbeam (*Carpinus betulus 'Fastigiata'*) and Sycamore (*Acer pseudoplatanus*). These have not reached their full potential due to over crowding from tight proximity planting (image 9).

Image 9. Sycamore and hornbeam in the central median south of Glenhill Road. the city. Planted in an open area these have become well established.

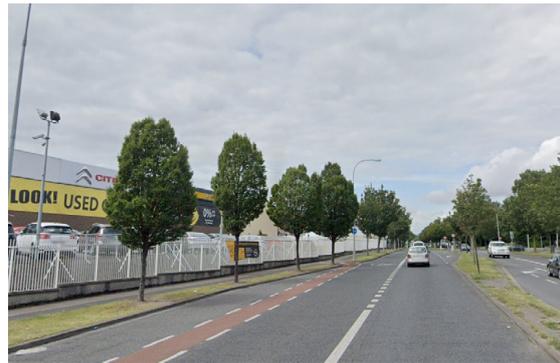
Image 11. Street planting of early mature fastigate hornbeam north of the Clearwater shopping centre.

These are some of the poorer quality trees, located in this section, due to sub-optimal soil conditions and close proximity planting. Adjacent to Finglas Village are located early mature Sycamore (*Acer pseudoplatanus*) (image 12). Some of these trees exhibit basal growth near footpaths, that would be best removed for aesthetic and safety concerns.
