METROLINK

A27.3

**Arboricultural
Impact
Assessment**

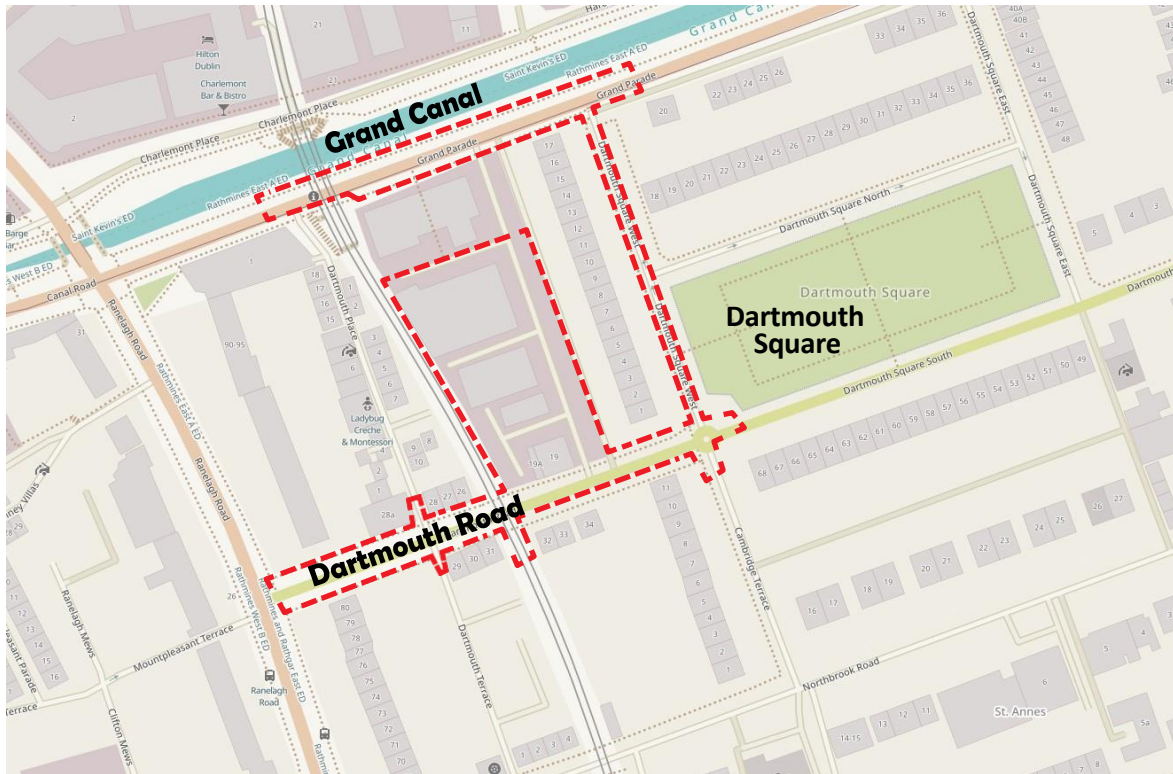
Map 1: Charlemont Station assessment boundary

A total of 16 trees were surveyed. The trees within this assessment boundary are all street trees and composed of mature common lime (*Tilia x europaea*) and London plane (*Platanus x hispanica*). Their condition is generally good, notwithstanding normal age-related decay.

Younger limes within the footprint of the proposed station will be impacted. These have been noted to have poor crown formation due to repeated canopy pruning likely due to accommodate previous works in the area.

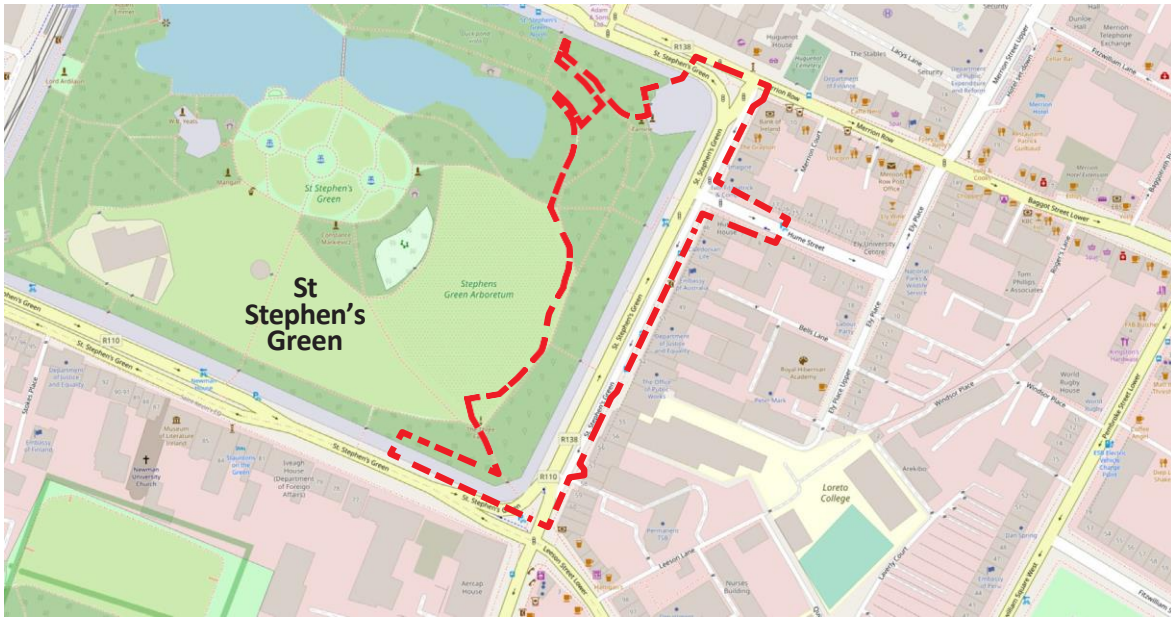
Map 2: St Stephen's Green assessment boundary

The boundaries appear to have been planted with holly (*Ilex auditorium*) and privet (*Ligustrum ovalifolium*) to form an understory and provide screening. Many of these trees/shrubs are now mature and in mixed condition. Horse chestnut (*Aesculus hippocastanum*) appear to have been also planted on the boundaries. This would be consistent with similar parks and demesne landscapes where these trees were planted for their ornamental value, in particular when flowering and displaying autumn colour. Disease and age-related decay appear to have reduced the numbers of

Large, impressive holm oak (*Quercus ilex*) are also present within this section of the park with many exhibiting areas of decay which are consistent with age rather than overall decline.

A total of 225 trees were recorded within St Stephen's Green in the proximity of the north-eastern, eastern and south-eastern boundaries of the park. Street trees within paving on Hume Street were also included. A total of 64 trees will need to be removed to facilitate the proposed works (refer to table 2). The age profile of the impacted trees contains a high number of older specimens, with 69% in the mature category. A further 15 trees (category U) are found to be in a state of decline and are recommended to be removed.

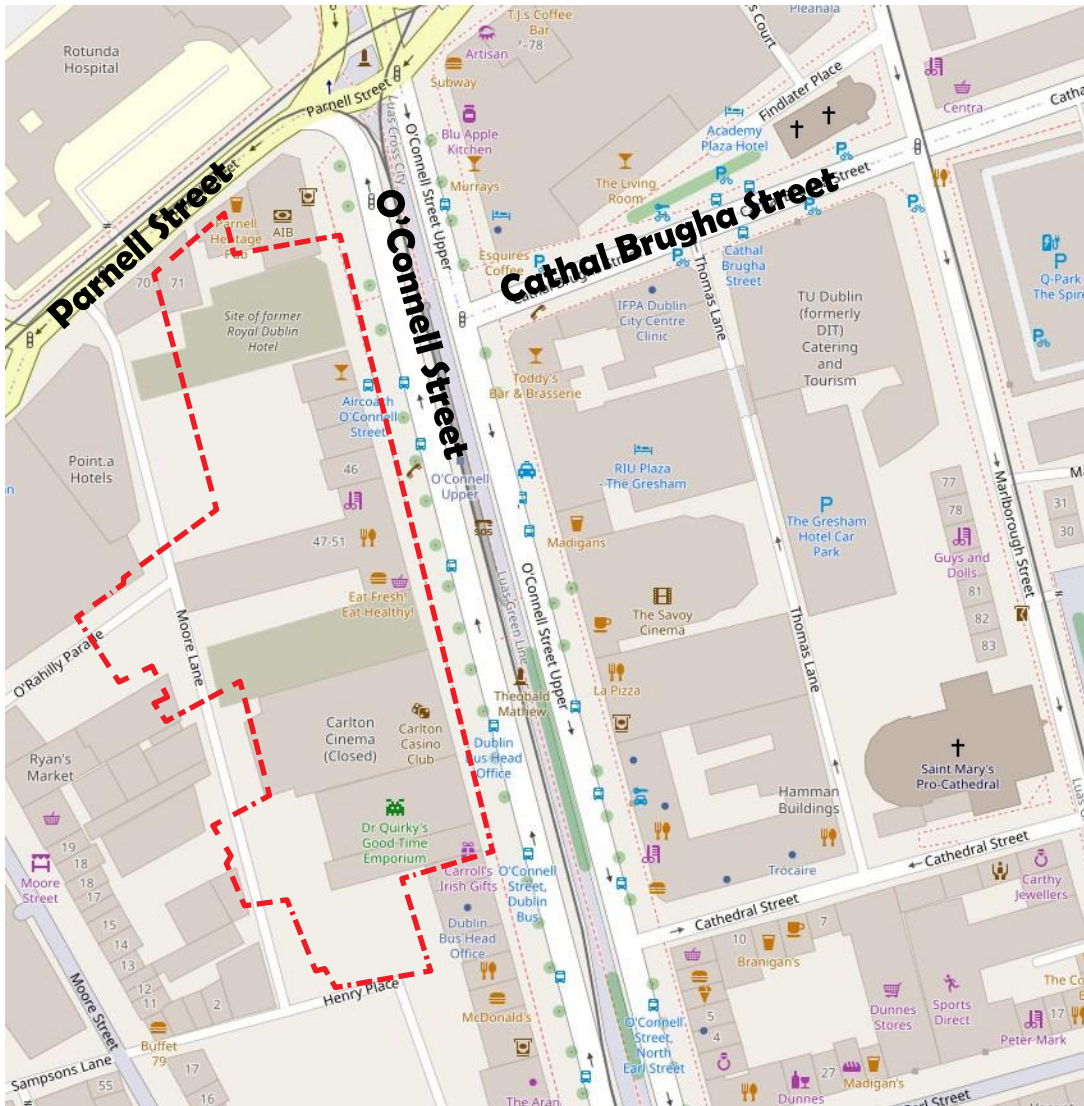
Map 3: O'Connell Street Station assessment boundary

The trees within this area are located within the pavement on a section of O'Connell Street Upper. The trees are London plane (*Platanus x hispanica*) planted within paving on both sides of the road and small leaved lime cultivars (*Tilia cordata cv*) within the central median and the area adjacent to the LUAS stop. The trees are generally in good condition however there has been a degree of storm damage to a number of specimens particularly the London plane. The trees in the vicinity of the LUAS stop have been pruned heavily to restrict crowns extending toward the LUAS infrastructure. The pruning of many of these trees has resulted in poor crown form.

Although no works are proposed directly on O'Connell Street, the proposed construction of façade retention support structures on the west side of the street may necessitate the removal of 13 London plane (*Platanus x hispanica*) trees planted within paving on the western side of the road. These trees are generally in good condition, notwithstanding a degree of storm damage to two specimens. Their removal will represent a significant but temporary loss of tree cover on this

street. A new generation of similar sized replacement trees can be sourced to match those lost (refer to table 3 for a breakdown of Tree Removal Categories).

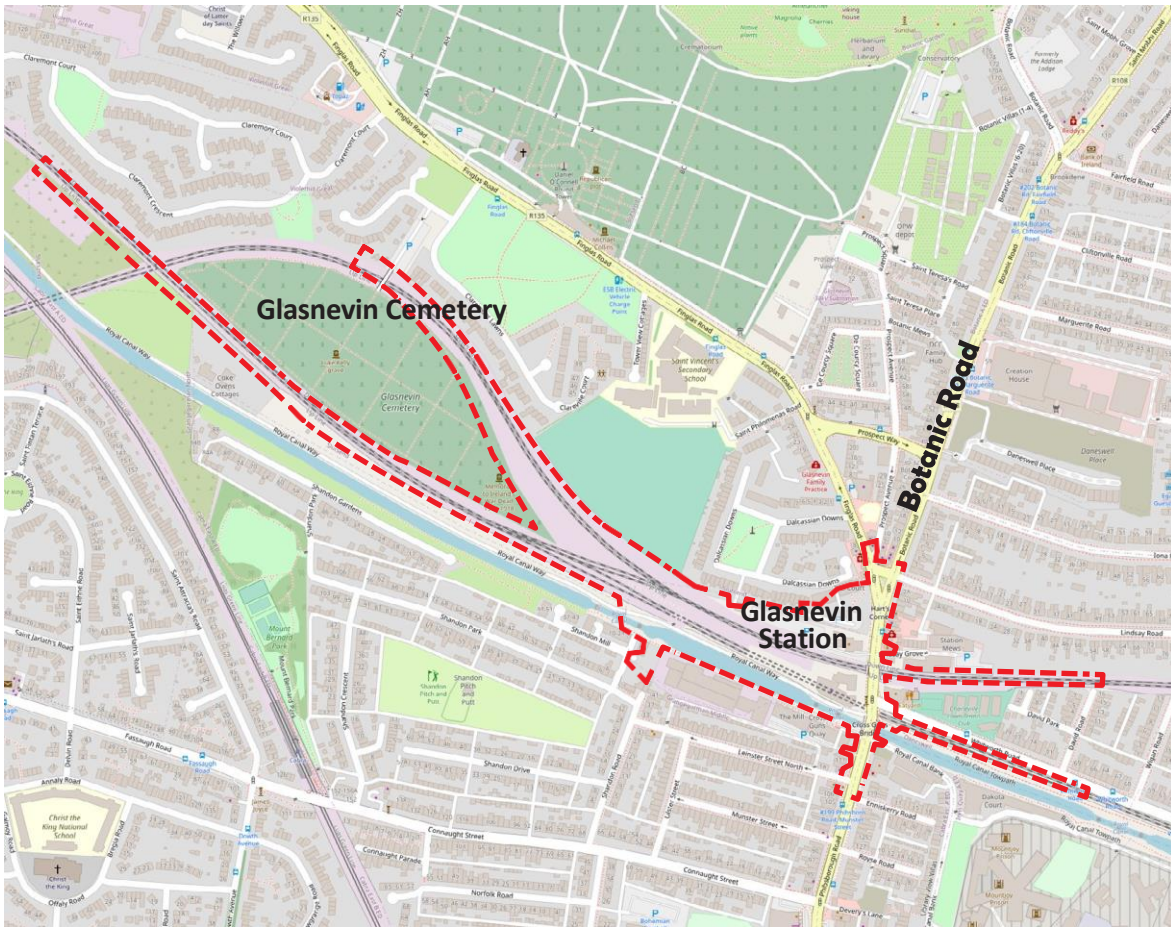
Map 5: Glasnevin Station assessment boundary

The trees along on the railway embankment are mainly sycamore (*Acer pseudoplatanus*) which have self-seeded in these areas. The trees along the canal are early-mature Norway maple cultivars (*Acer platanoides cv*) planted in a single line. The trees within Dalcassian Downs are a combination of mature specimens which were present prior to the construction of the current housing stock and trees planted as part of the landscaping works associated with the development. There is diverse mix of species and age classes within the trees in this estate with the condition of the trees generally good. Species include Himalayan birch (*Betula albo-sinensis*), Monterey cypress (*Cupressus macrocarpa*) and Leyland cypress (*Cupressus leylandii*).

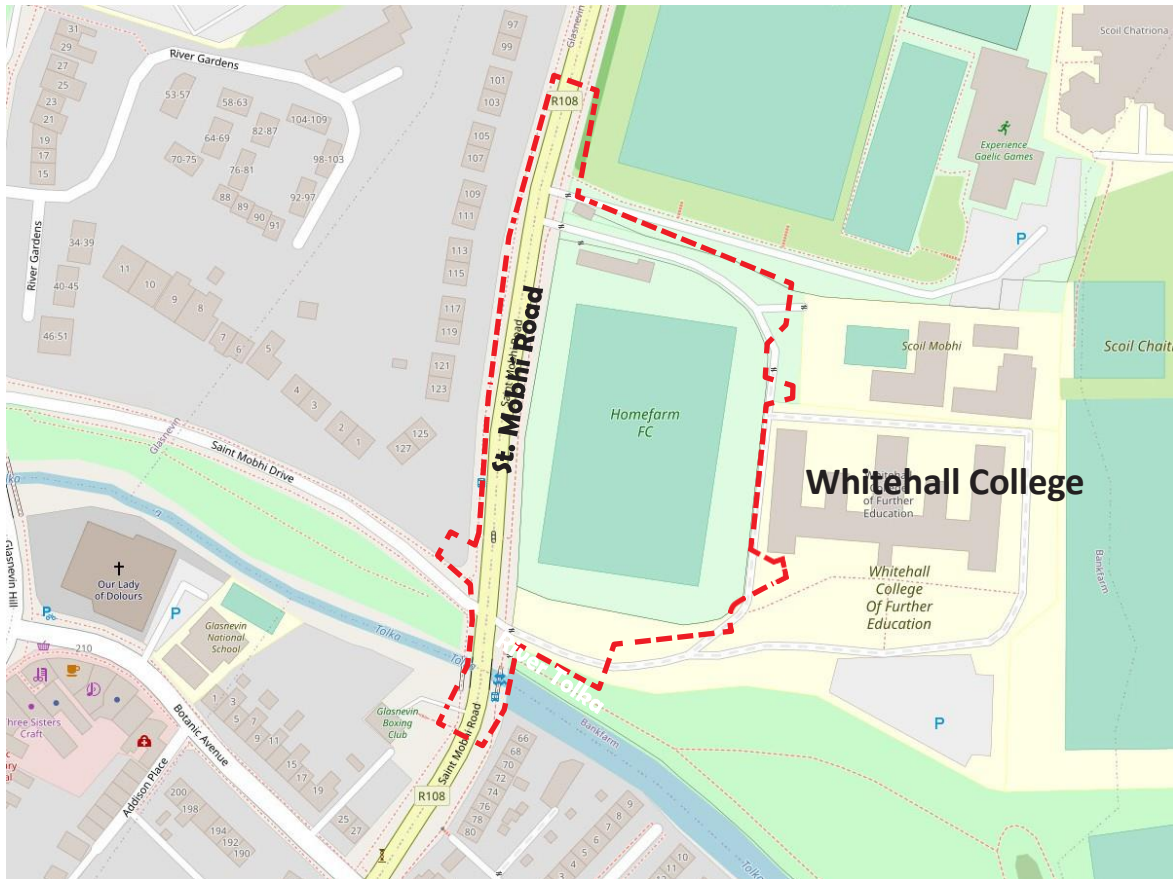
Map 6: Glasnevin Station assessment boundary

Large Monterey cypress (*Cupressus macrocarpa*) and Leyland cypress (*x Cuprocyparis leylandii*) are located on the boundary of the Home Farm training grounds with the R108. Their condition

The trees along Mobhi Road are mainly London plane (*Platanus x hispanica*) and sycamore (*Acer pseudoplatanus*). These are mature specimens of mixed quality though the majority of the trees are in good condition. A number are becoming suppressed by trees within the Home Farm training grounds.

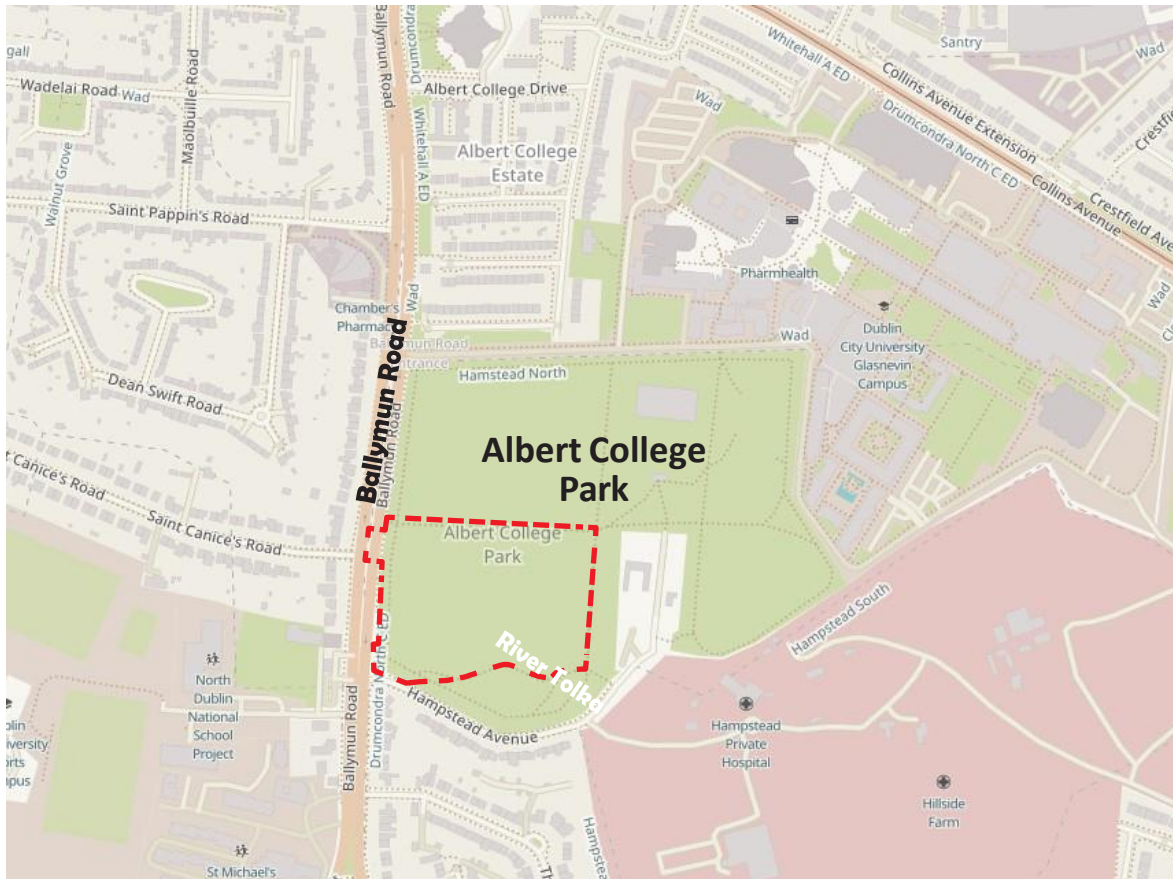
Map 7: Albert College Park Intervention Shaft assessment boundary

The general condition of these trees is good with issues confined to light suppressed deadwood and confined canopies from local competition.

The majority of these trees are within category 'B' (moderate value). A noted mitigating factor for the loss of these ash, is their susceptibility to ash dieback (*Hymenoscyphus fraxineus*), which is expected to kill up to 80% of the species in less isolated areas such as this location in the near future.

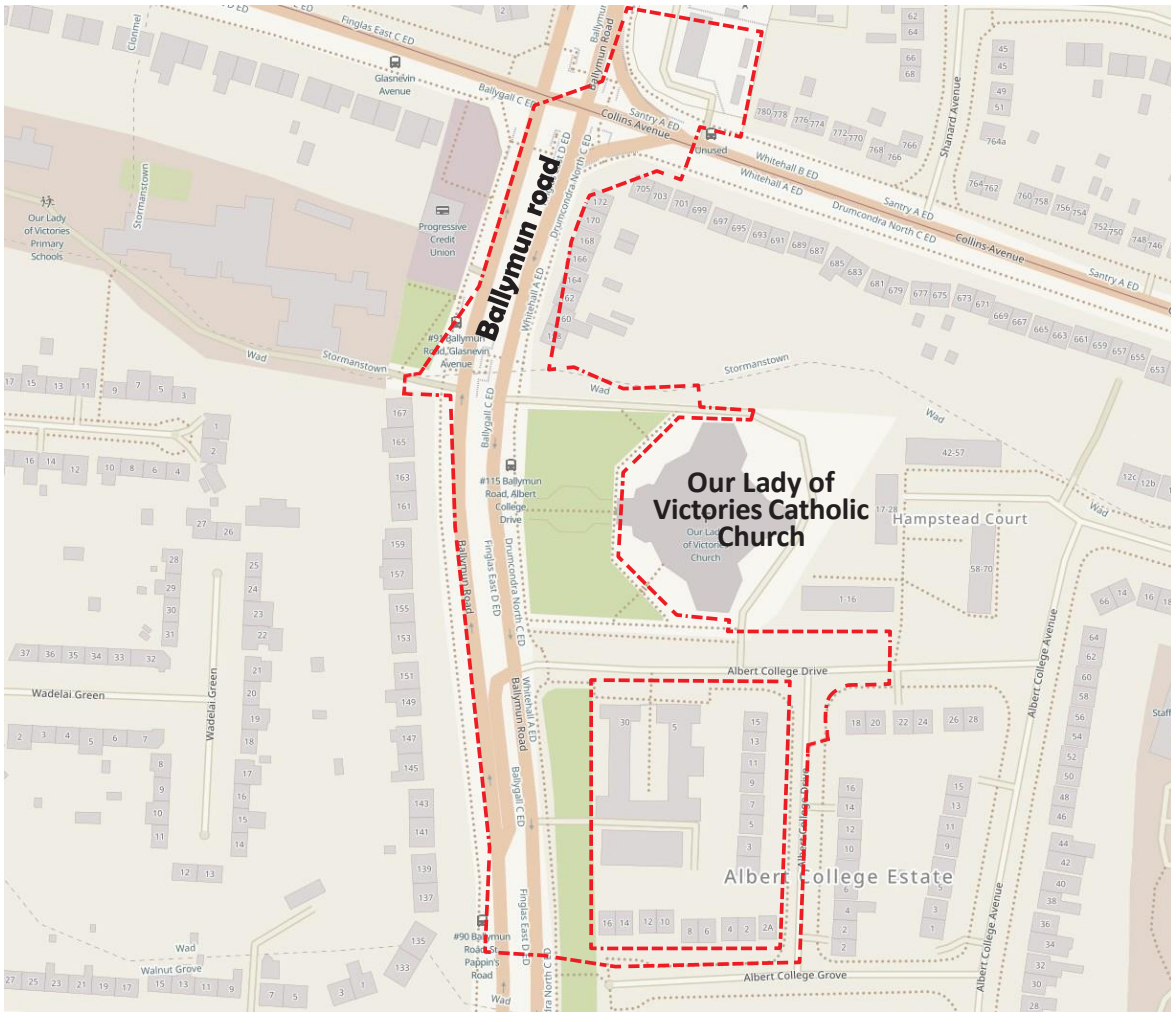
Map 8: Collins Avenue Station assessment boundary

A total of 112 trees were surveyed within this area. The trees within this section of the site are located within the central median of the R108 (Ballymun Road) and within the grounds of Our Lady of Victories Church. The trees within the central median streetscape are young to early-mature Norway maple cultivars (*Acer platanoides* cv). Their general condition is fair to poor with one dead specimen present. A relatively well developed fastigate hornbeam (*Carpinus betulus* ‘Fastigiata’) is located with paving on the eastern side of the road.

cultivars (*Berberis* cv). Most are relatively well developed. The trees in this area are a young oak (*Quercus robur*), a small-leaved lime cultivar (*Tilia cordata* cv) and a Norway maple cultivar (*Acer platanoides* cv). The condition of the trees is generally good.

During the design stage efforts were made to retain the majority of the hornbeam trees that screen the northern boundary of Our Lady of Victories church with the adjacent houses directly north (those on the southern side of Collins Avenue – east of the intersection of R108 and Collins Avenue). These have been mostly shown for retention, as they provide an important screen to adjacent residents, with the exception of three trees that are necessary for removal due to required services and a single tree overhanging the R108 roadside that had failed.

The loss of trees within the Our Lady of Victories church grounds represents a diverse mix of younger and early mature ornamental specimens. As noted in table X, the majority of affected trees are of moderate quality.

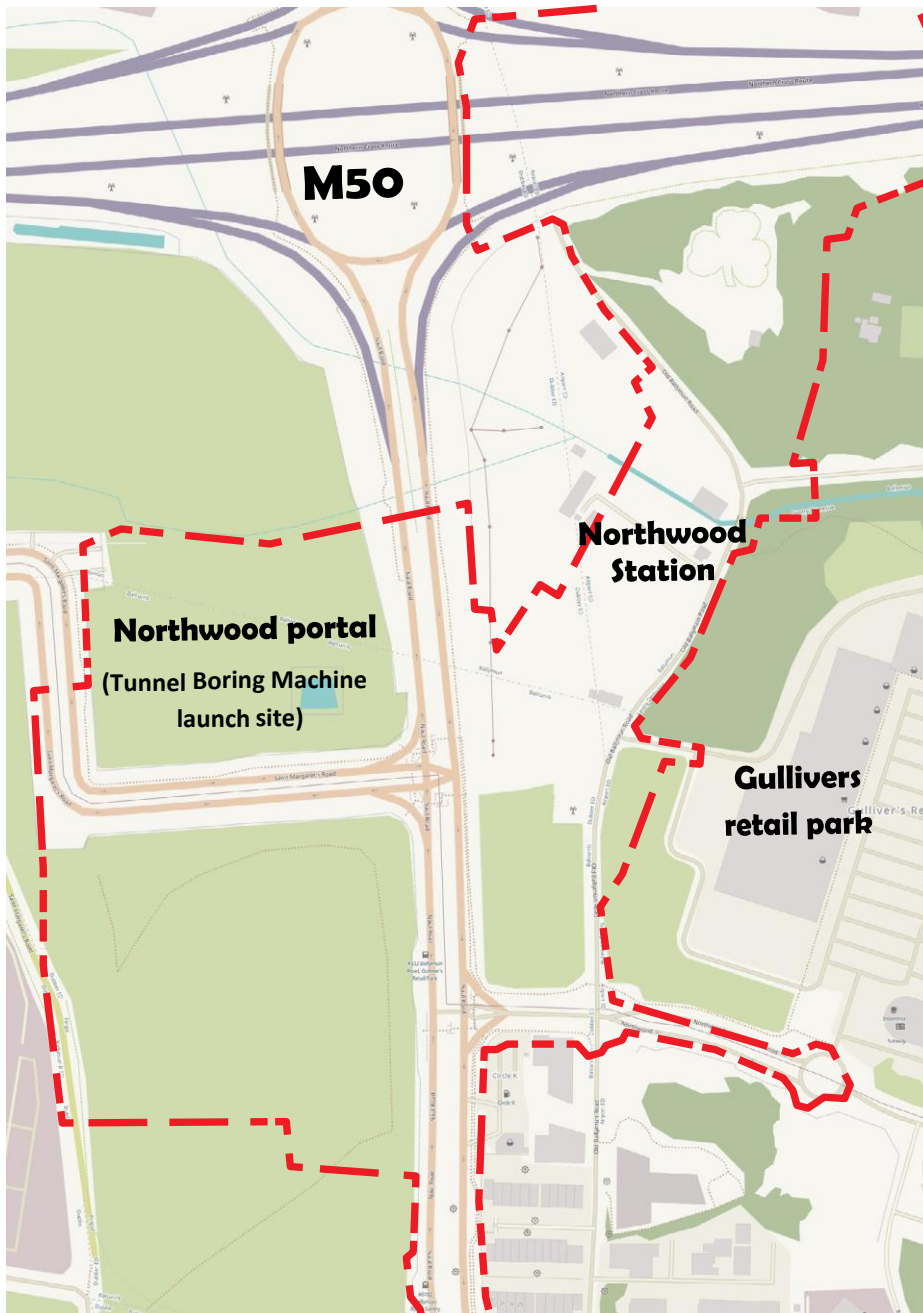
Map 10: Northwood Station and Portal assessment boundary

Mature horse chestnut (*Aesculus hippocastanum*) and sycamore are located to either side of the access road. The condition of the horse chestnut (*Aesculus hippocastanum*) is mixed with age related defects and infection from bleeding canker (*Pseudomonas syringae pathovar aesculi*). The sycamore are generally in good condition.

The trees within the proposed portal site once formed elements of agricultural hedgerows within agricultural lands. The predominant species are sycamore (*Acer pseudoplatanus*) and ash with more occasional blackthorn (*Prunus spinosa*) and goat willow (*Salix caprea*). The condition of the trees is mixed with occasional areas of fire damage and general decay within individual specimens.

A total of 894 trees were recorded and assessed within the Northwood Station site. Of these the most common species types were Leyland cypress (*xCupressus leylandii*) at 19.9%, Ash (*Fraxinus excelsior*) at 18.2% and Monterey pine (*Pinus radiata*) at 15.2%. Although few high value specimens were recorded, the general condition of trees was moderate to good. Due to relatively tight planting the majority of these trees were drawn up in form and they should therefore only be considered for retention as part of sheltered groups, as individual retained trees would be susceptible to wind throw.

The impact of the proposed Northwood Station and compound area will necessitate the removal of 686 trees. A further 53 should be removed due to poor condition and likelihood of failure (refer to table 10).

A total of 48 trees were recorded and assessed within the Northwood Portal site (refer to pg163 for tree schedule). Wych elm (*Ulmus glabra*) and ash made up the majority of these trees (89.5%). Among these featured a notable number had fire damage present near the base of trunks which is likely to reduce long-term potential and result in failure within the next 5-10 years.

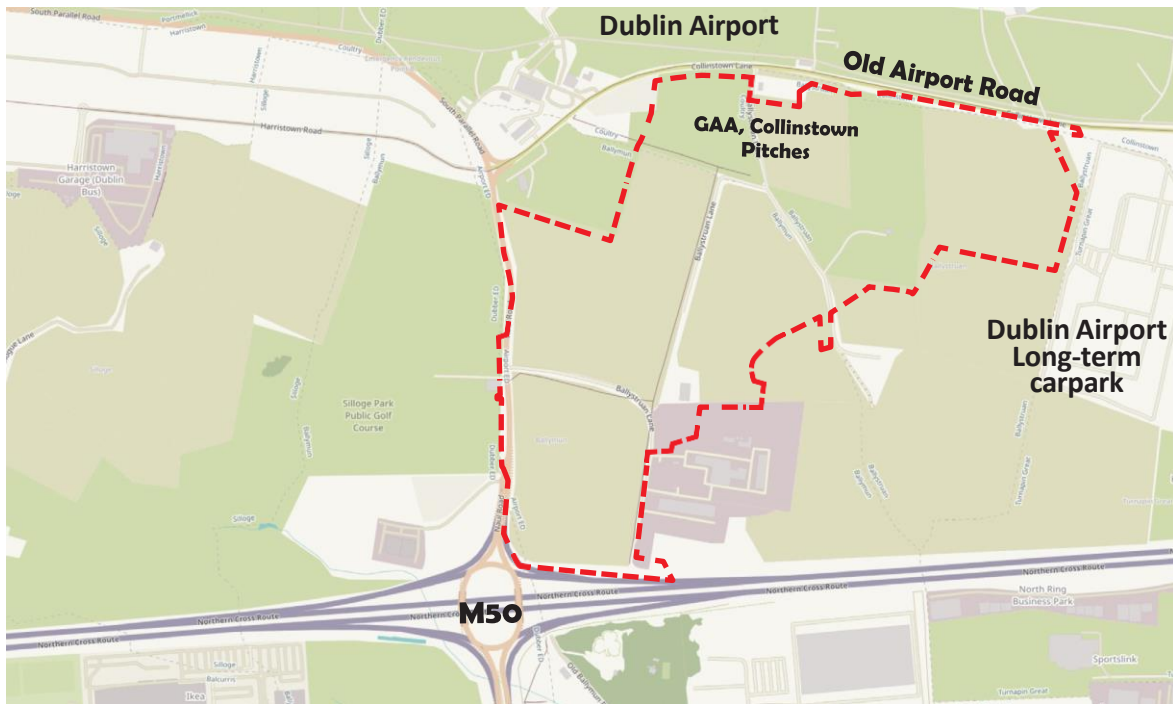
Map 11: Dardistown Station and Depot assessment boundary

The trees within this boundary are a mix of those typically found within agricultural field boundaries; hawthorn (*Crataegus monogyna*) and ash (*Fraxinus excelsior*).

The impacted hedgerows are primarily composed of ash (*Fraxinus excelsior*) and hawthorn (*Crataegus monogyna*). The condition of the hedgerows is variable with management mixed over the area.

Most of the ash (*Fraxinus excelsior*) contain heavy ivy growth which can lead to windsail and storm damage. Due to the prevalence of ash dieback (a serious disease of ash trees caused by the invasive fungal pathogen *Hymenoscyphus fraxineus*) these trees, despite their current fair condition, are likely to have reduced life spans as a result.

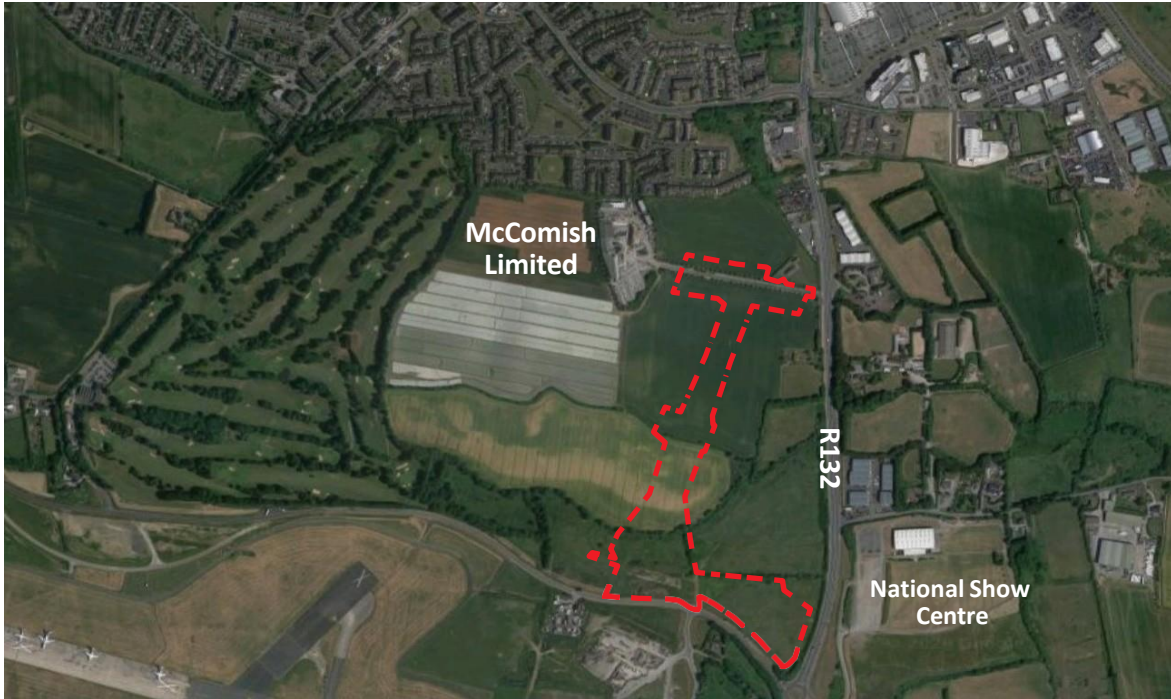
Map 12: Fosterstown Accommodation Bridge and ESNB substation assessment boundary

The southern boundary is made up of ash (*Fraxinus excelsior*) located on the side of hedgerow ditches. The trees cover a range of age-classes in a range of conditions from poor to good. Many have been coppiced in the past with resulting multiple basal regrowths.

Within these hedgerows are 7 ash (*Fraxinus excelsior*) trees. These ash trees cover a range of age-classes in a range of conditions from poor to good (refer to table 13). Many have been coppiced in the past with resulting multiple basal regrowths.

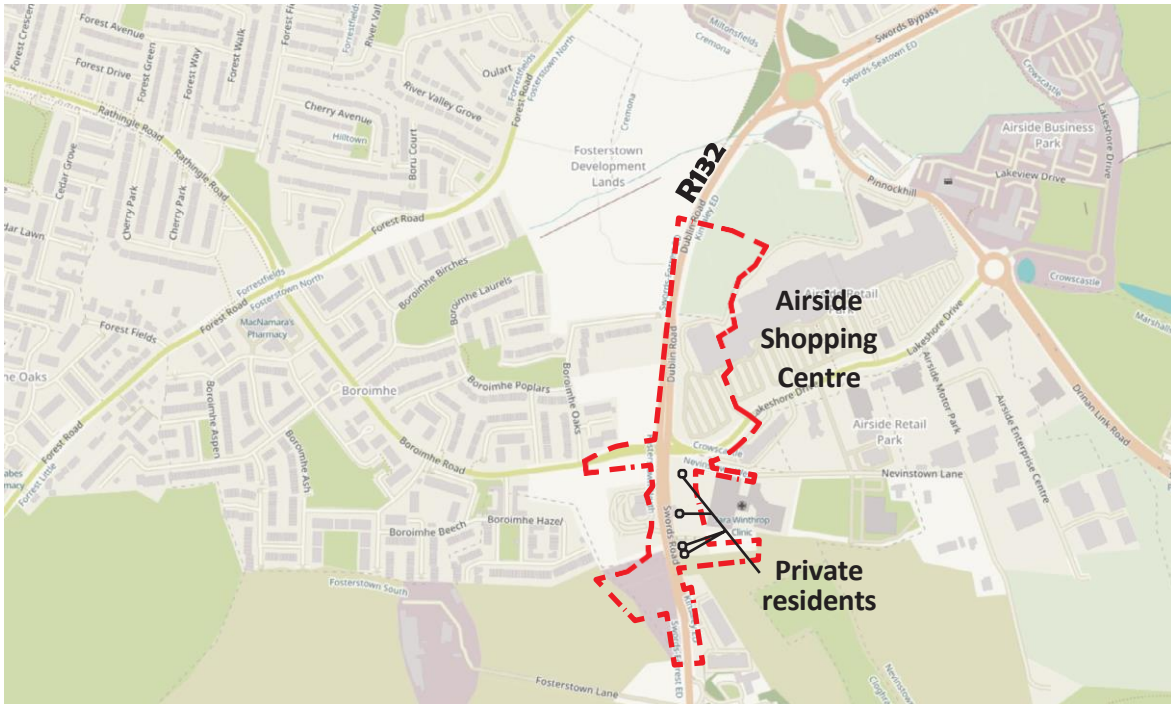
Map 13: Fosterstown Station assessment boundary

The trees within this boundary are a mix of those typically found within agricultural field boundaries; hawthorn (*Crataegus monogyna*) and ash (*Fraxinus excelsior*), cypress hedging within private residential gardens along with ornamental varieties such as maples (i.e. Norway maple (*Acer platanoides*)) and compact lime cultivars within the car park area south of the Airside Retail Park.

The proposed Fosterstown Station and track alignment will result in the loss of 21 trees (5 of which have failed) and 264 metres of agricultural hedgerow (refer to table 14).

The majority of these (79%) are young Norway maple (*Acer platanoides*). Other species include early mature fastigate oak (*Quercus robur* 'Fastigiata Koster') 7.1%, sycamore cultivar (*Acer pseudoplatanus* cv) 4.8%, lime cultivar (*Tilia* cv) 7.1%. A fastigate oak has failed and should be removed regardless of future construction plans.

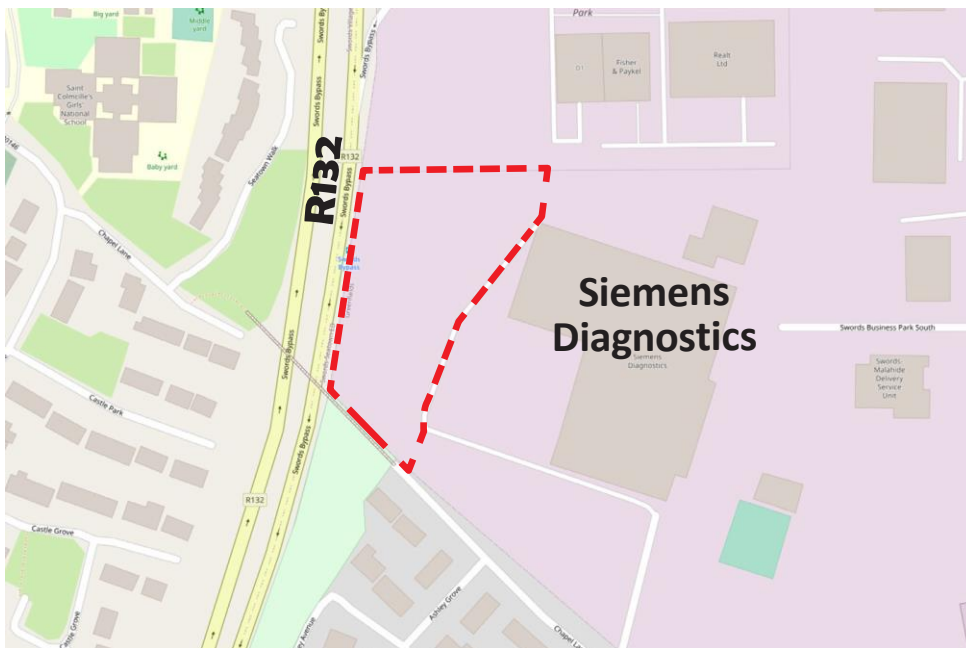
Map 15: Fosterstown Station assessment boundary

The MetroLink route and associated landscaping with necessitate the removal of 99 trees with these grounds. A high percentage of these (>50%) are young oak that were recently established in the north of the site. Two of the higher value impacted trees are a mature sycamore (*Acer pseudoplatanus*) and mature beech (*Fagus sylvatica*). These specimens are both over 17 metres high and dominate neighboring trees in this area.

The requirement to fell trees as outlined here will be mitigated by way of the landscape design development for the proposed Project. The full landscape design can be reviewed in the RO drawing pack that accompanies this application.
