**Inspector Report Discharge Form****314760-22**Lead Reporting Inspe...

File ABP 314760 Continued use and operation of a quarry at Spink, Co. Laois

Photos taken on site 15<sup>th</sup> of March 2024

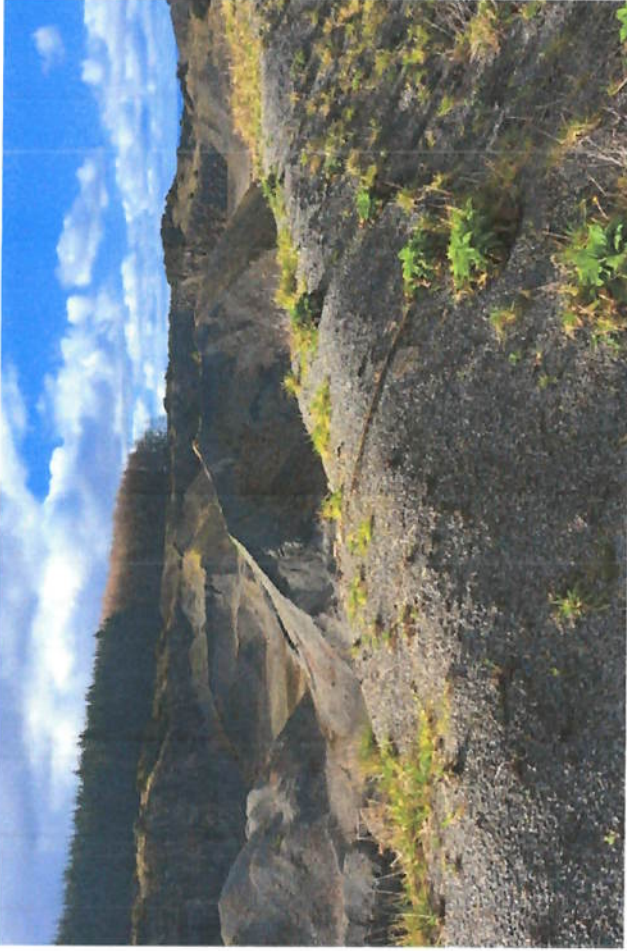
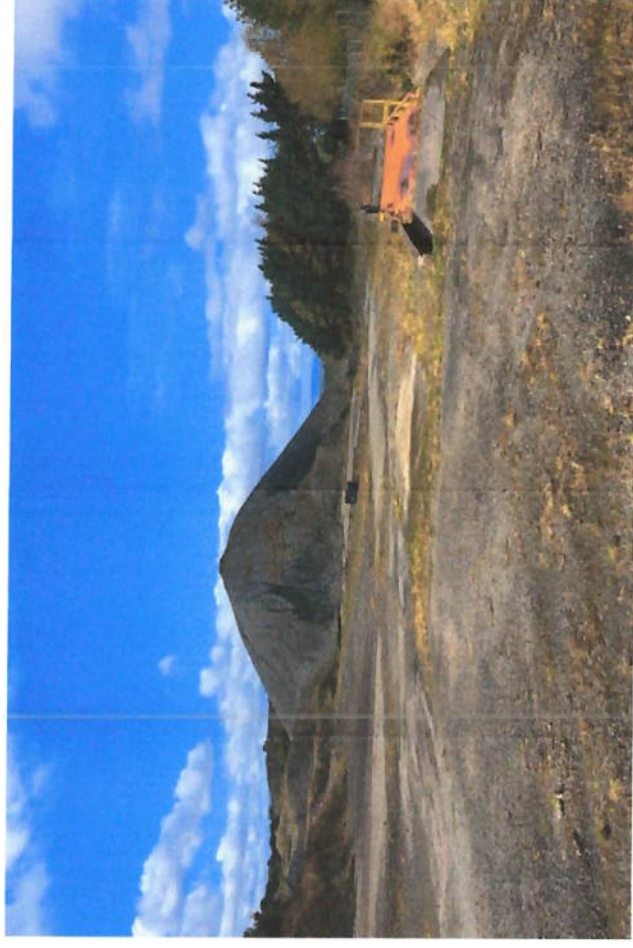
5. Harding standing area where the refuelling will take place. Existing weigh bridge in place. There will be an office and a wheel wash at this location.

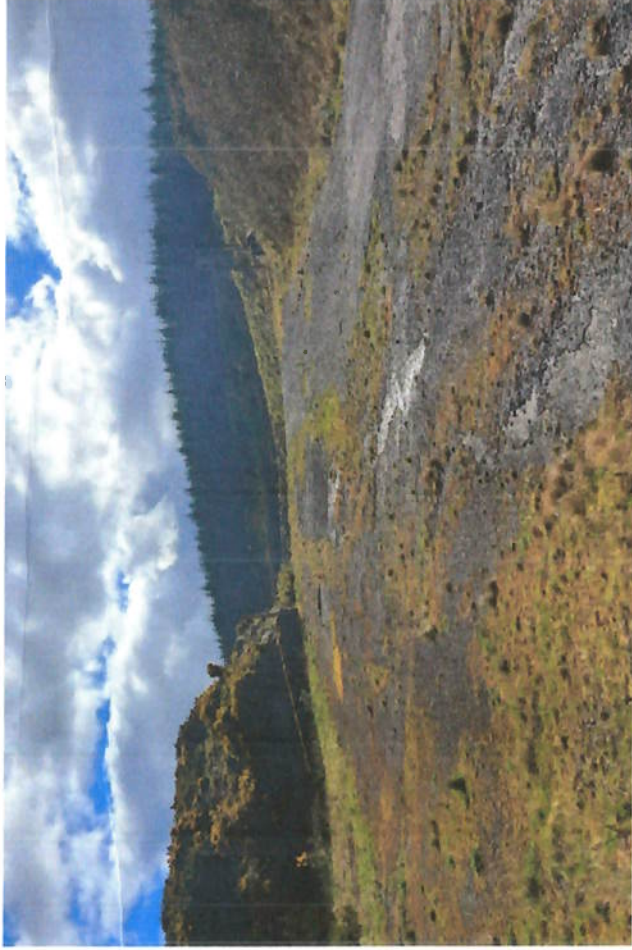
6. A view from the hardstanding area towards the access road to the entrance gate onto the R340

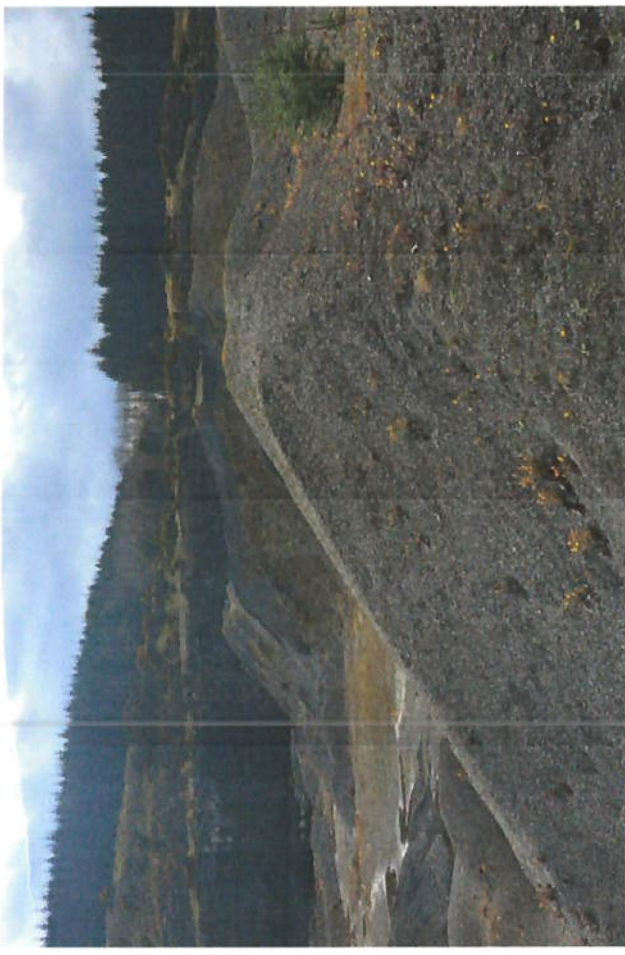
7. Southern quarry face in the background and stockpiles

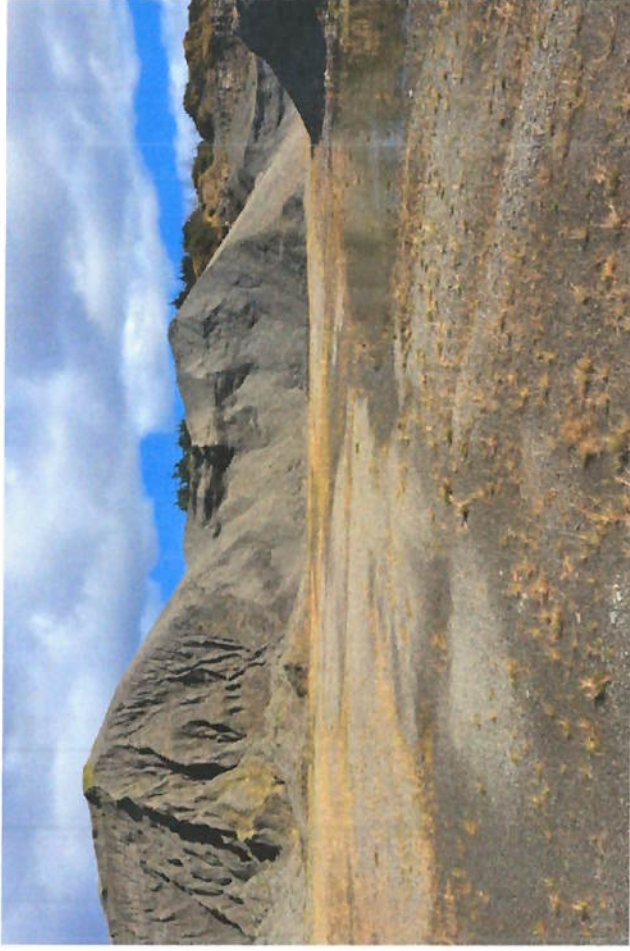
10. Views from the quarry floor facing east

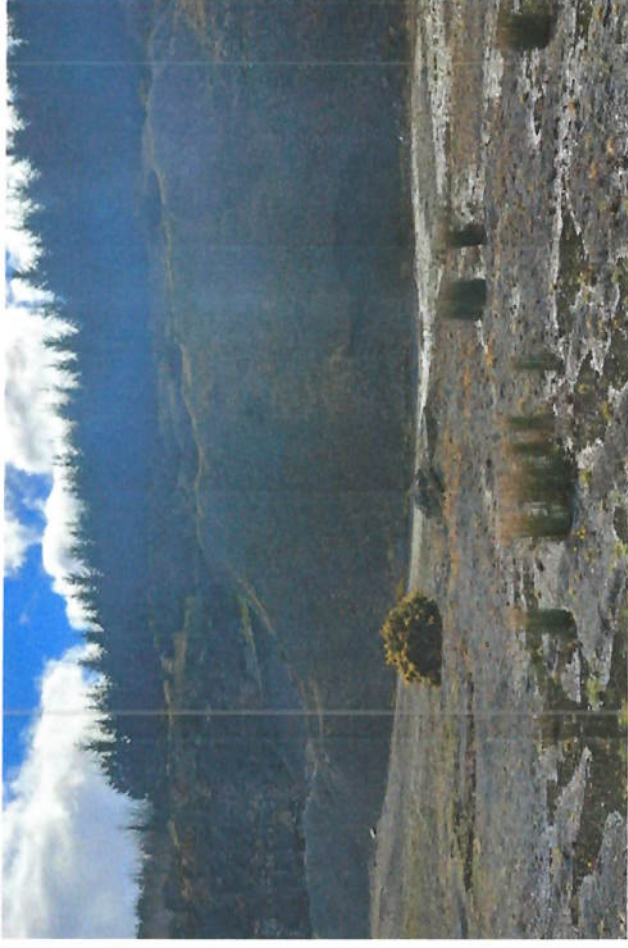
11. From the quarry floor facing south

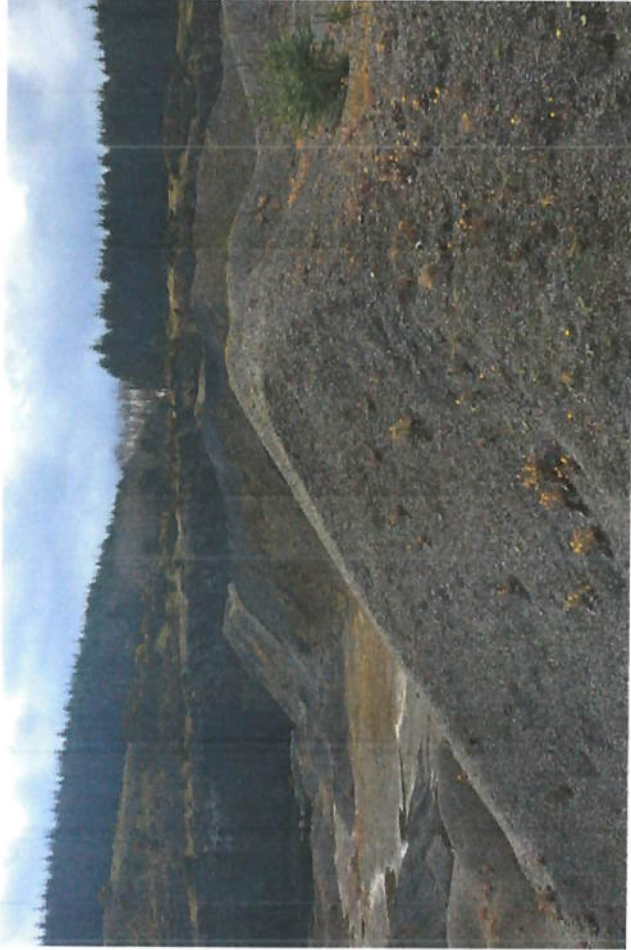
7. View South across the existing quarry

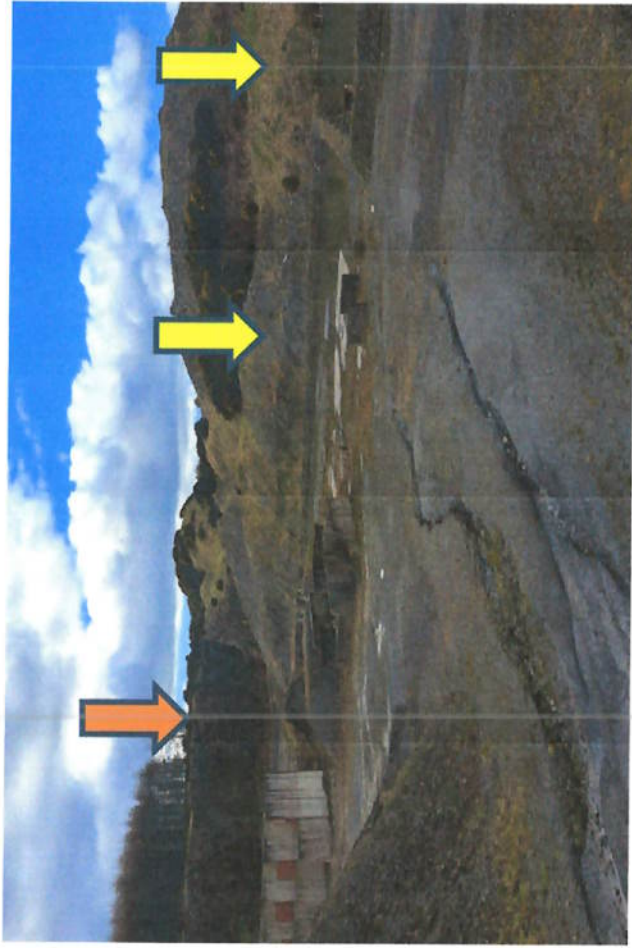
8. Orange is western quarry face. Yellow are the settlement ponds

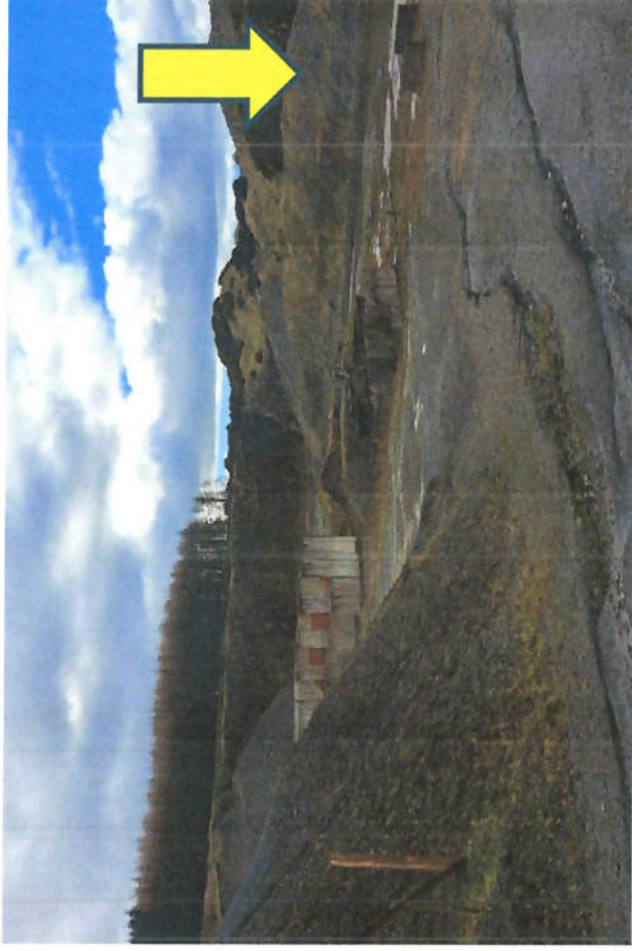
8. Arrow denotes the location of the settlement ponds

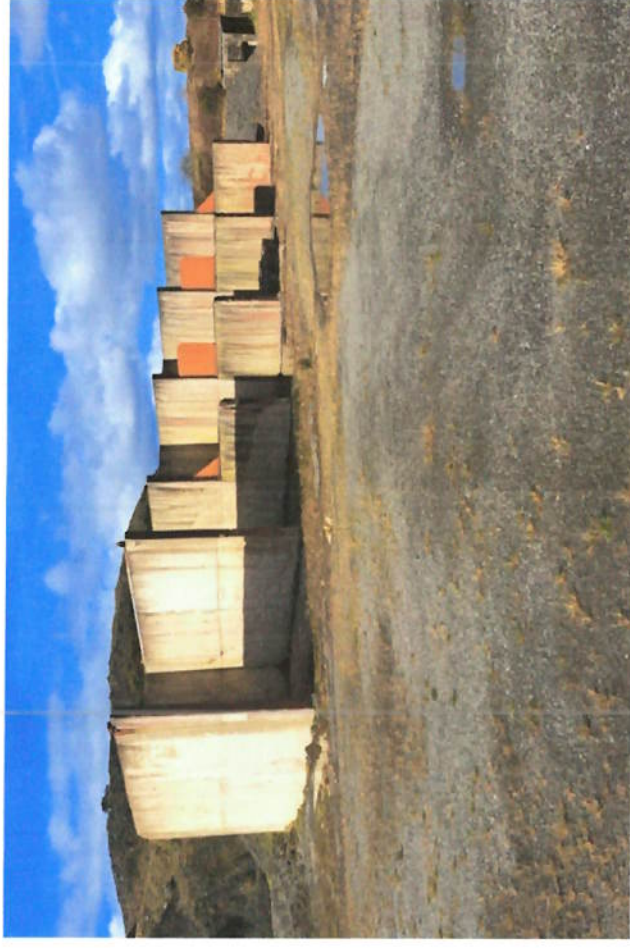
9. Existing aggregate storage bays

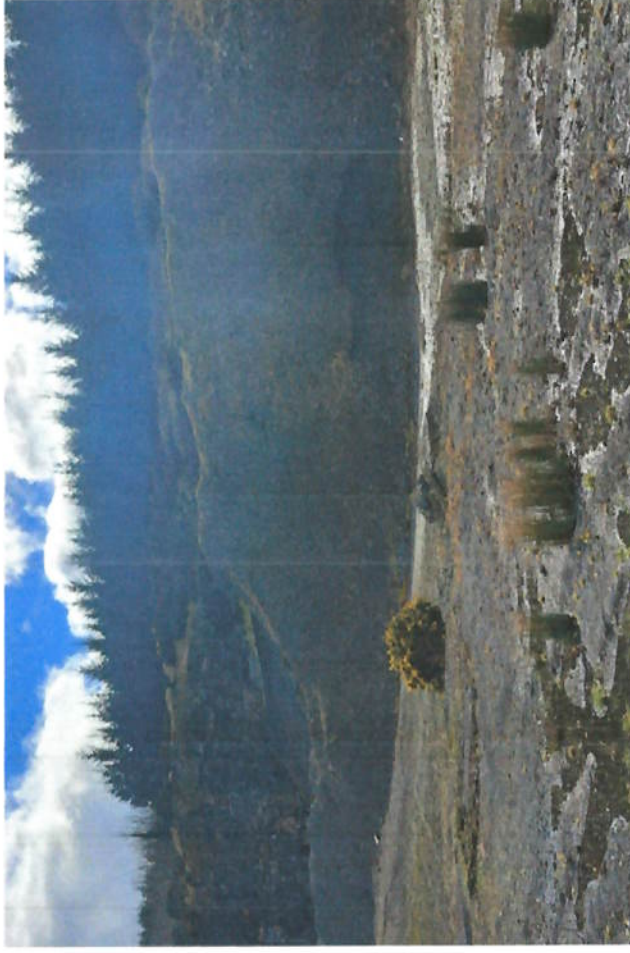
11. Southern quarry face

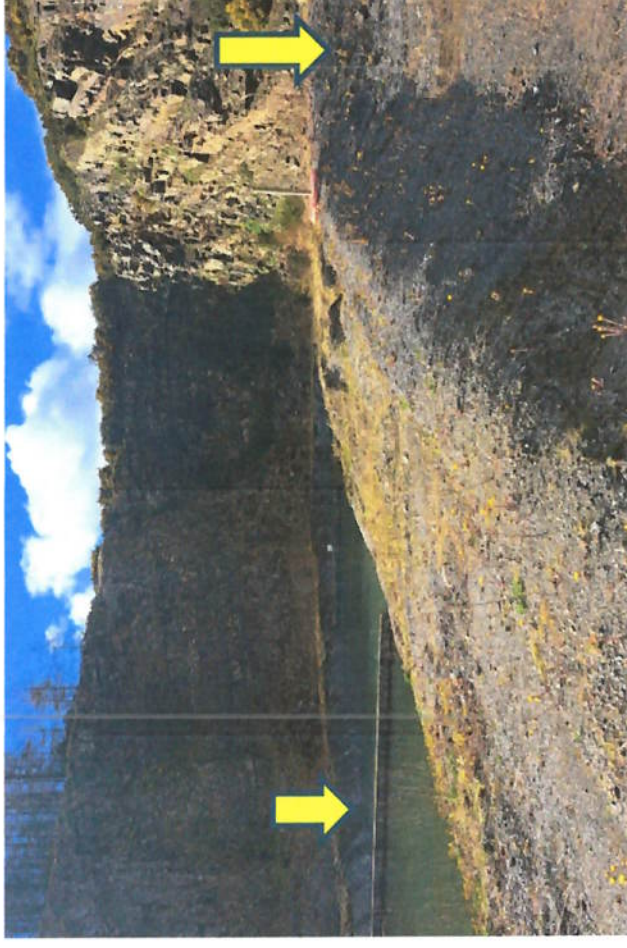
12. Western quarry face. Yellow arrows denote settlement ponds

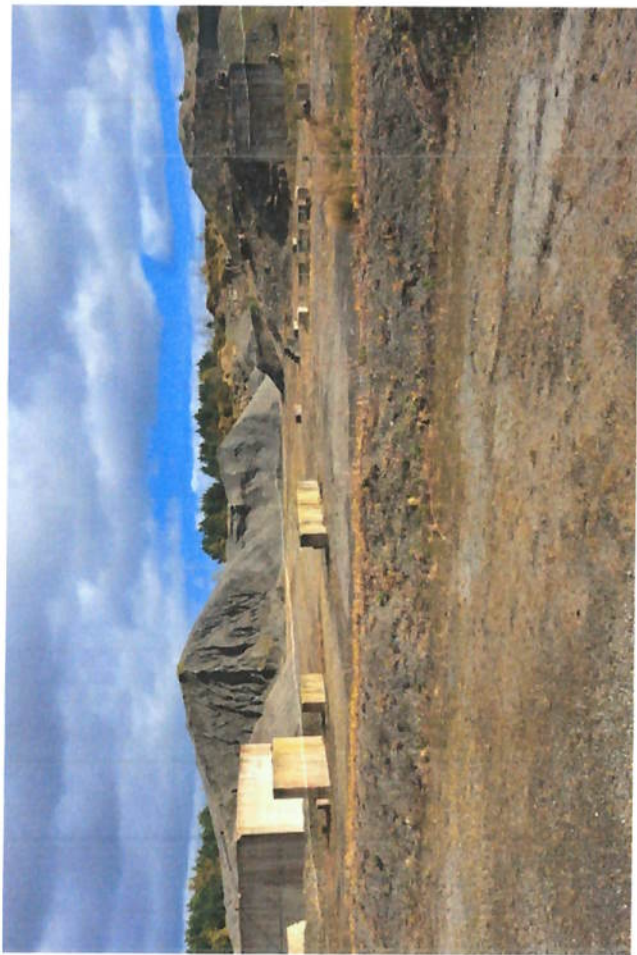
13. View eastwards at the existing settlement ponds fronting the western quarry face

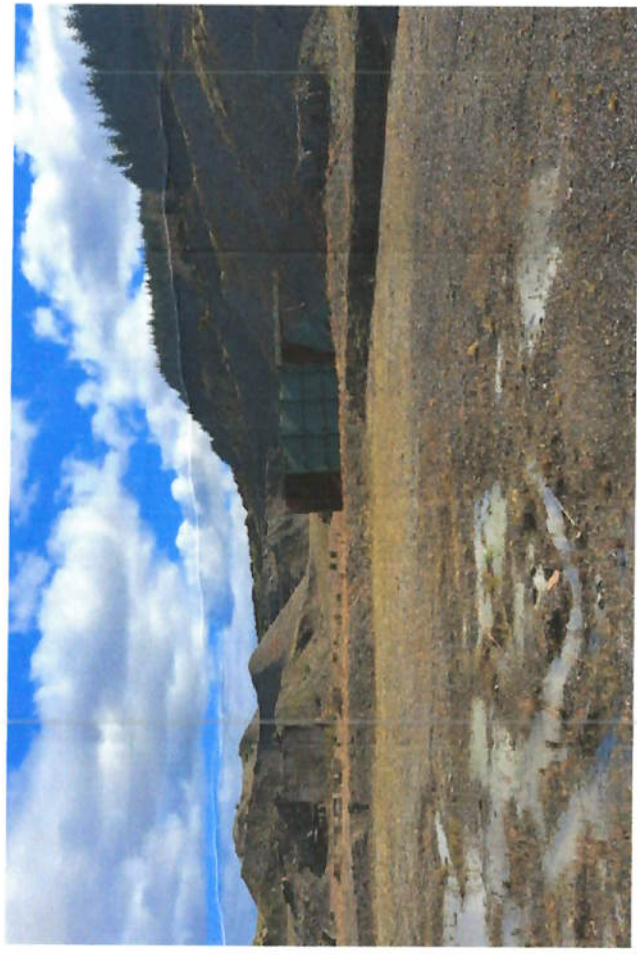
14. View southeast from the settlement ponds at the western quarry face

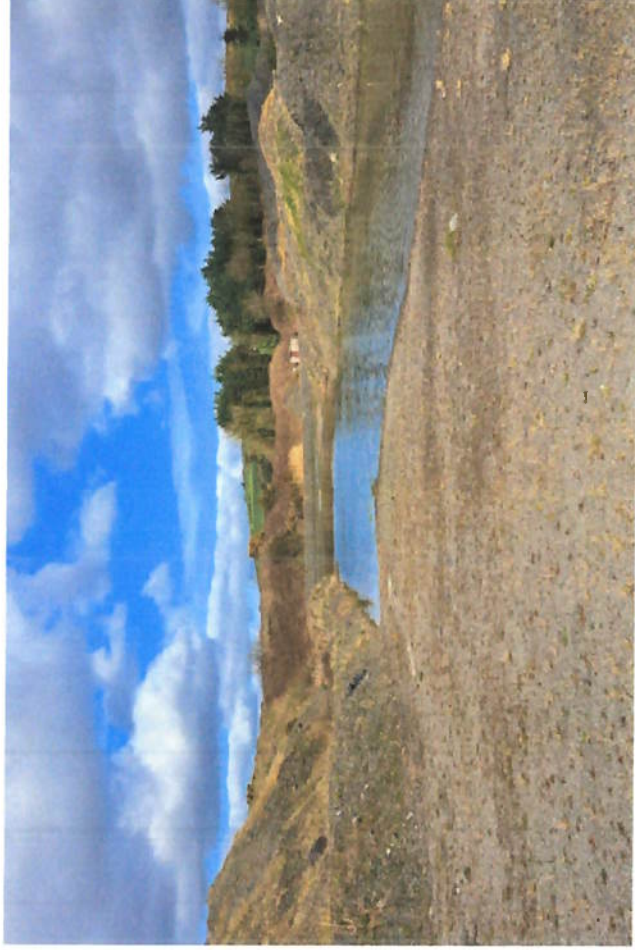
15. View north. There is an overflow from the settlement ponds to the north

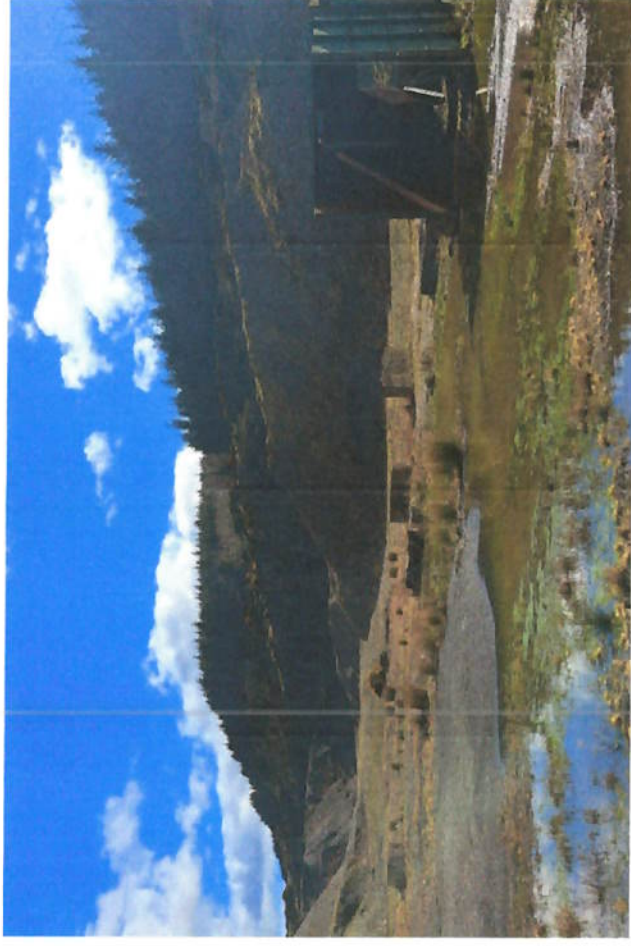
16. View of the southern quarry face

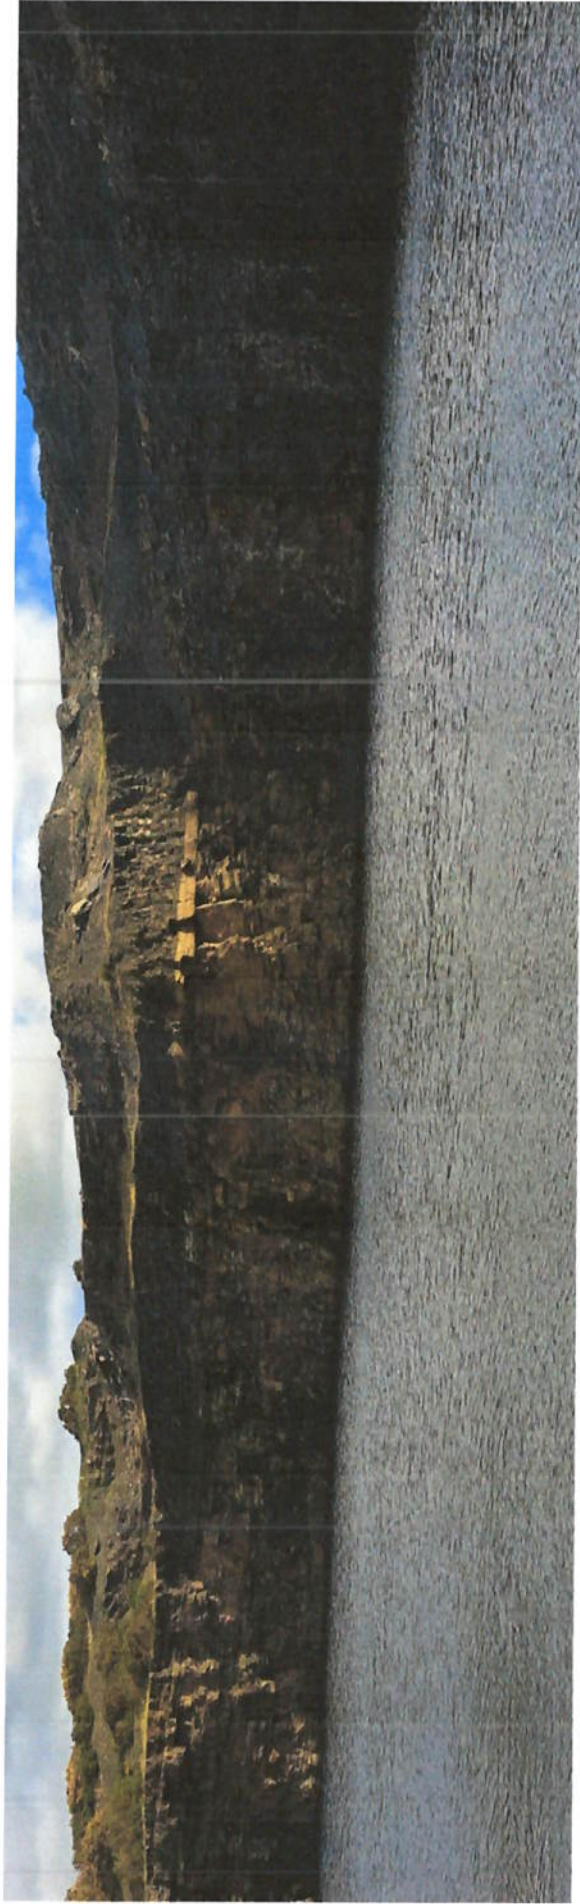
18. Eastern quarry face and sump

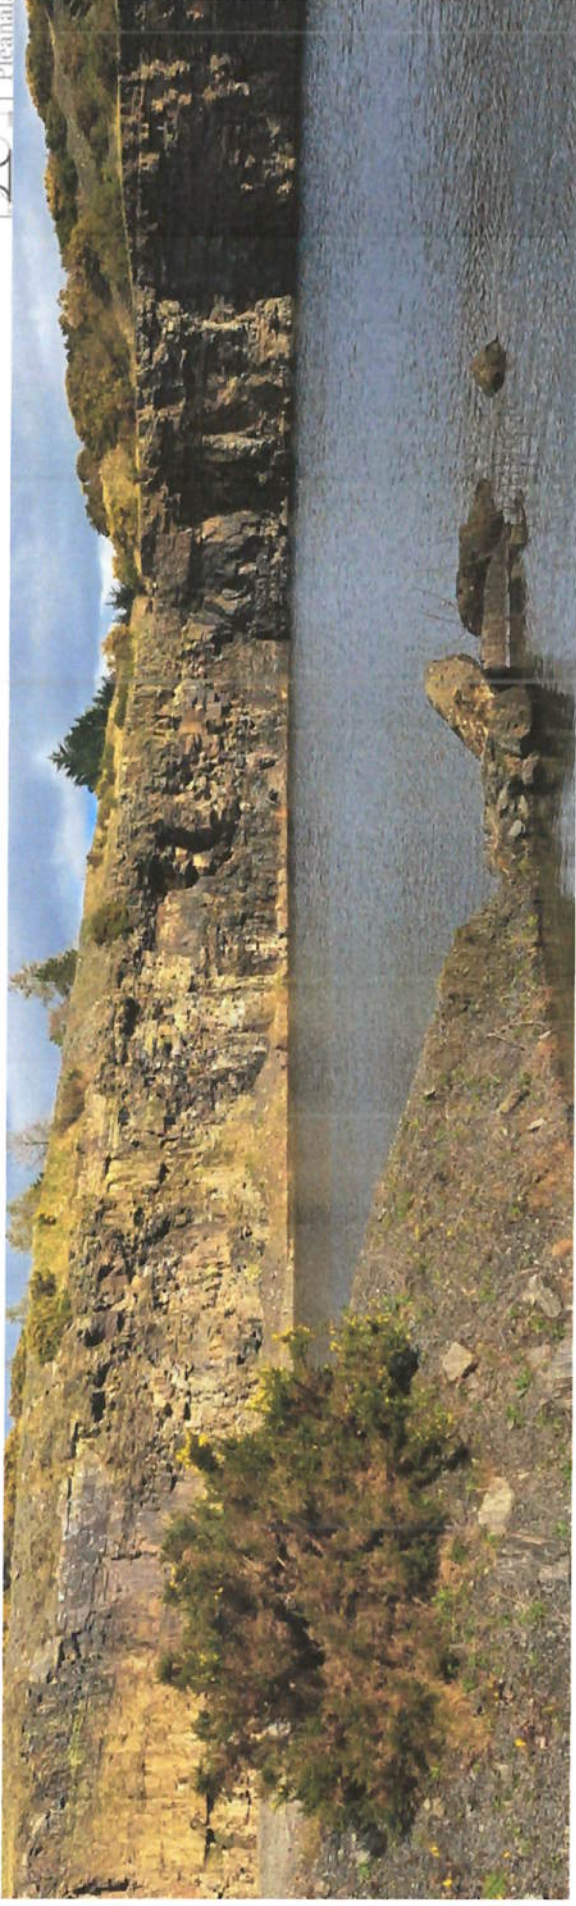
19. Eastern quarry face and sump

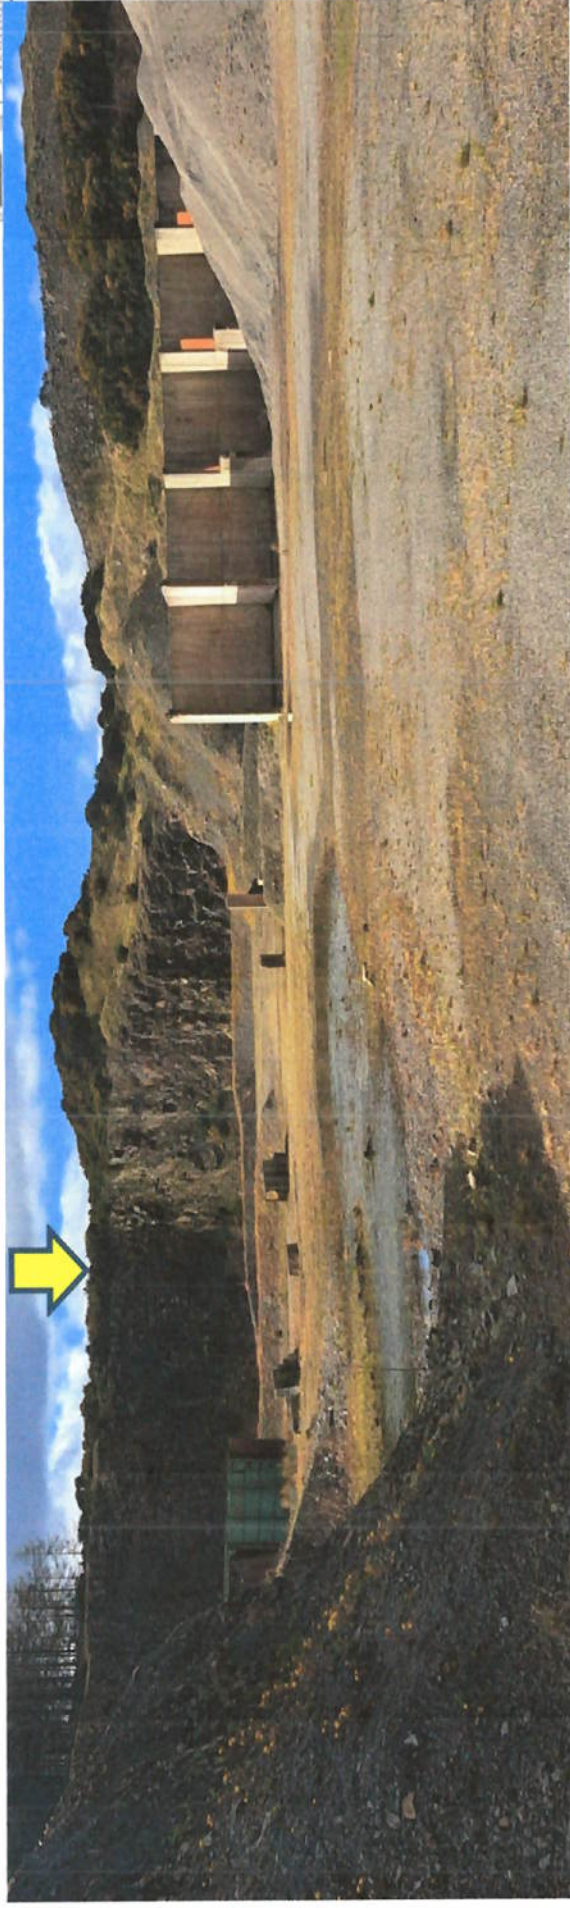
21. View of western quarry face where arrow is pointing

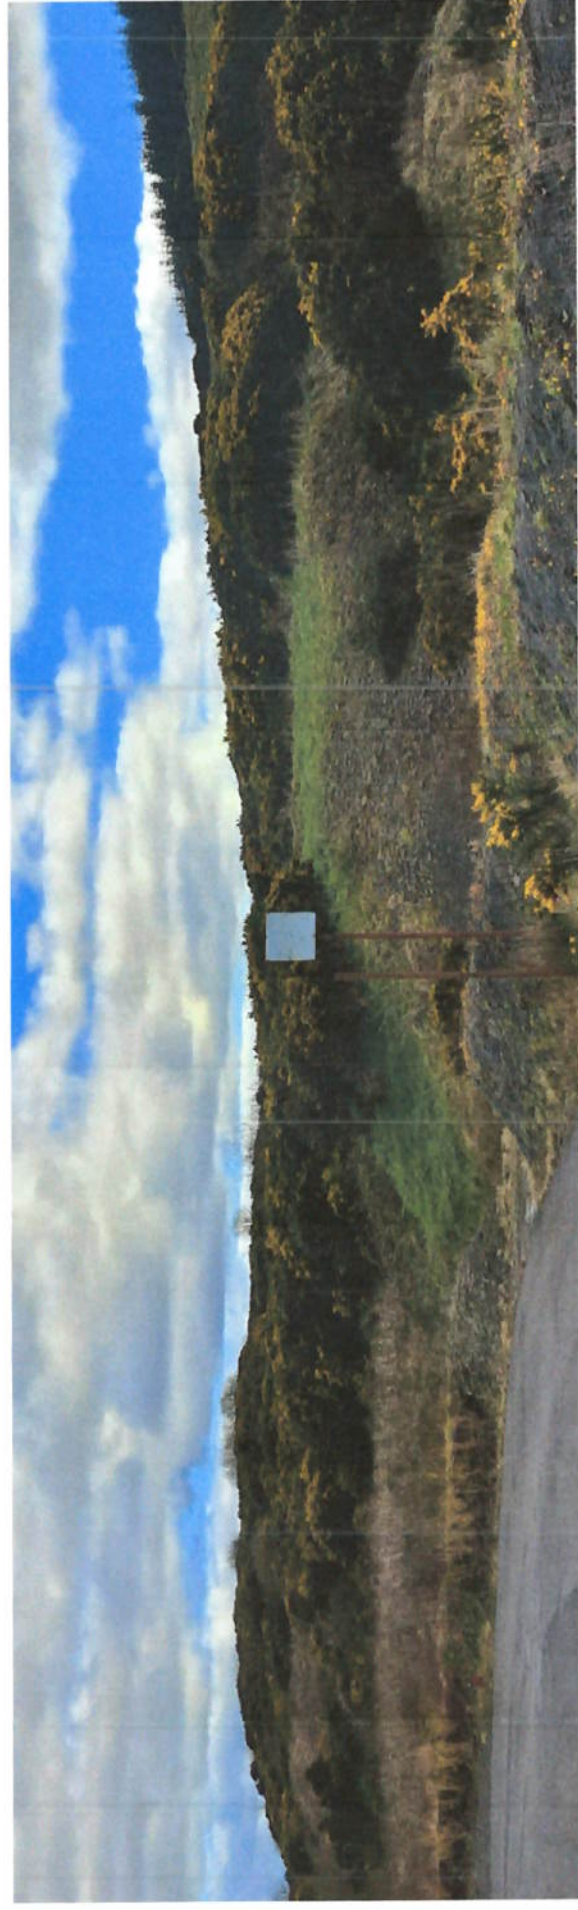
22. Undeveloped eastern portion of quarry currently covered in gorse bushes

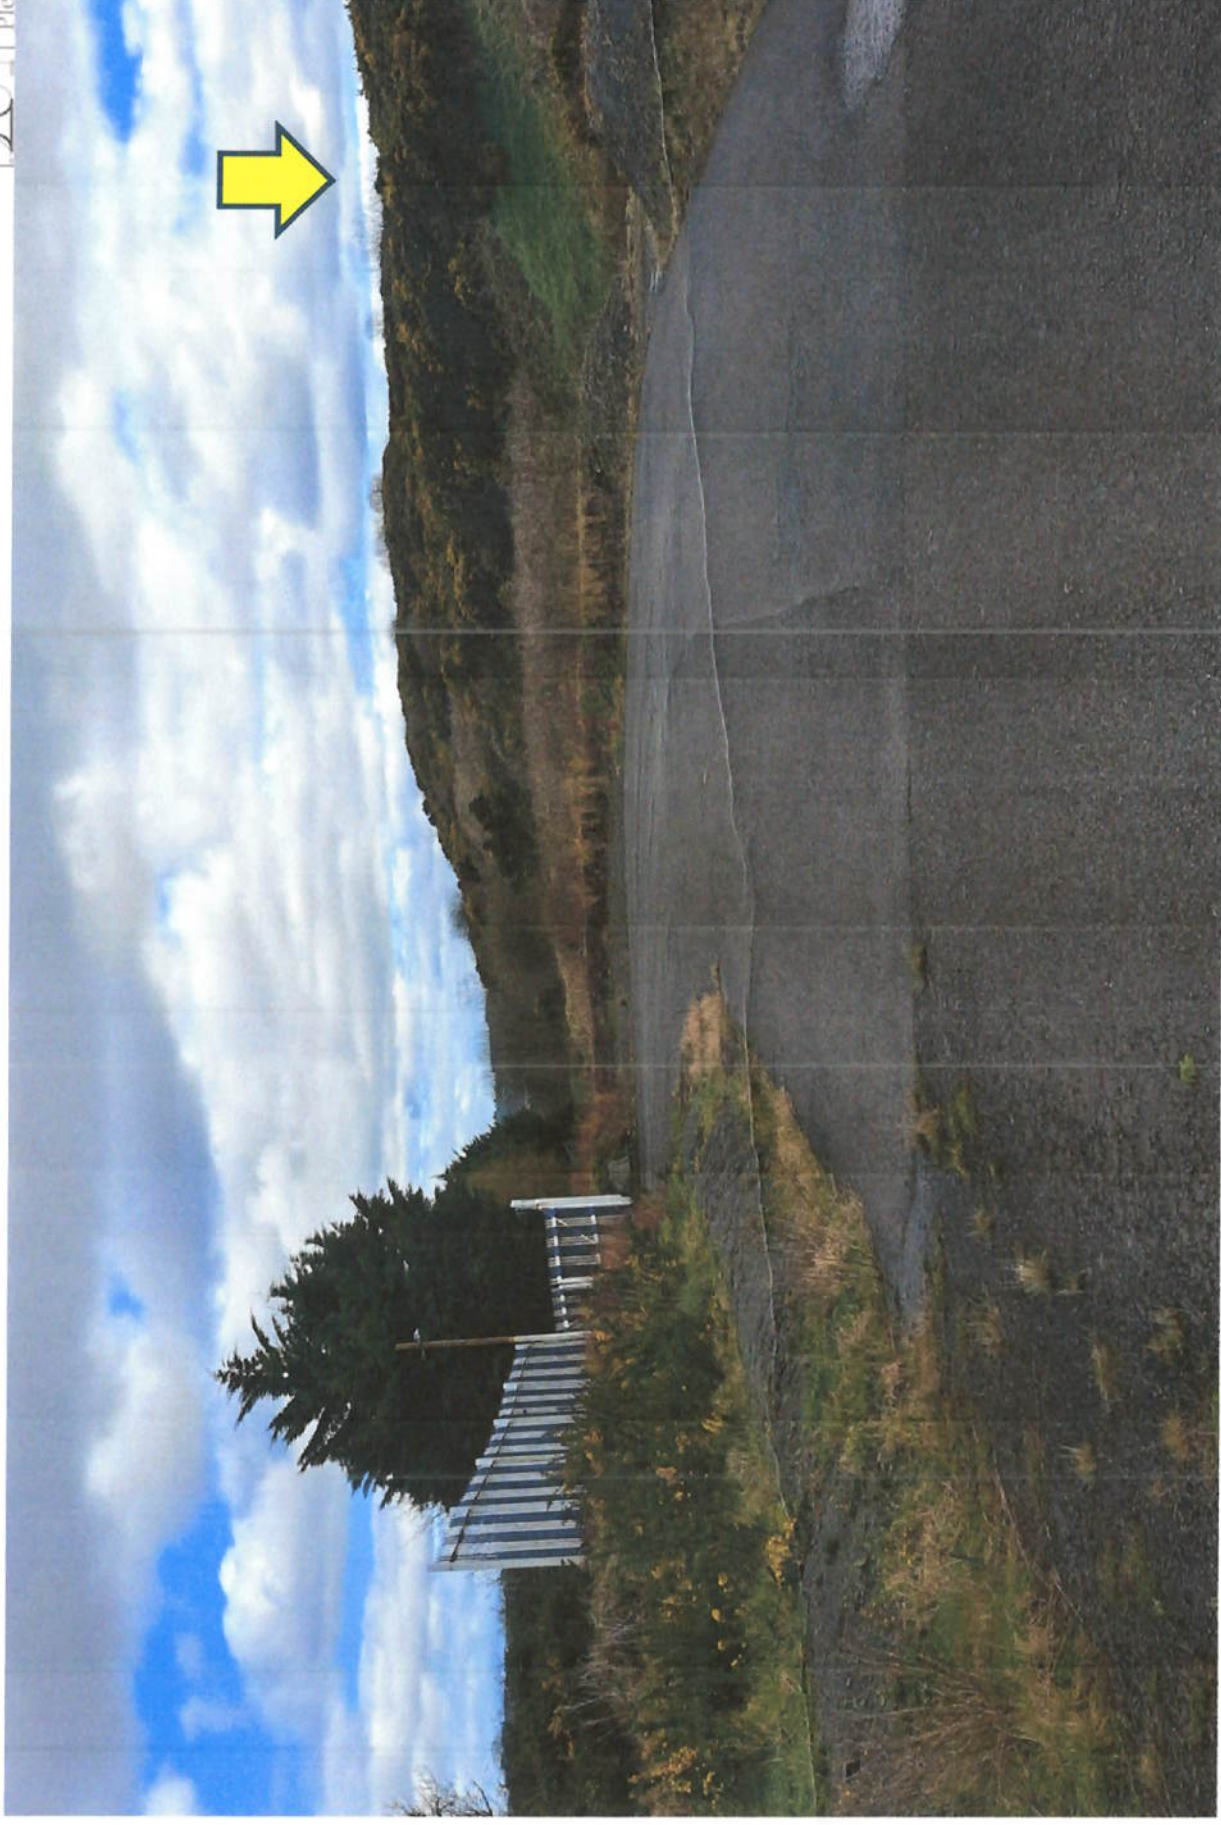
23. Another view of the eastern portion of the quarry which is to be extracted during the lifetime of the quarry

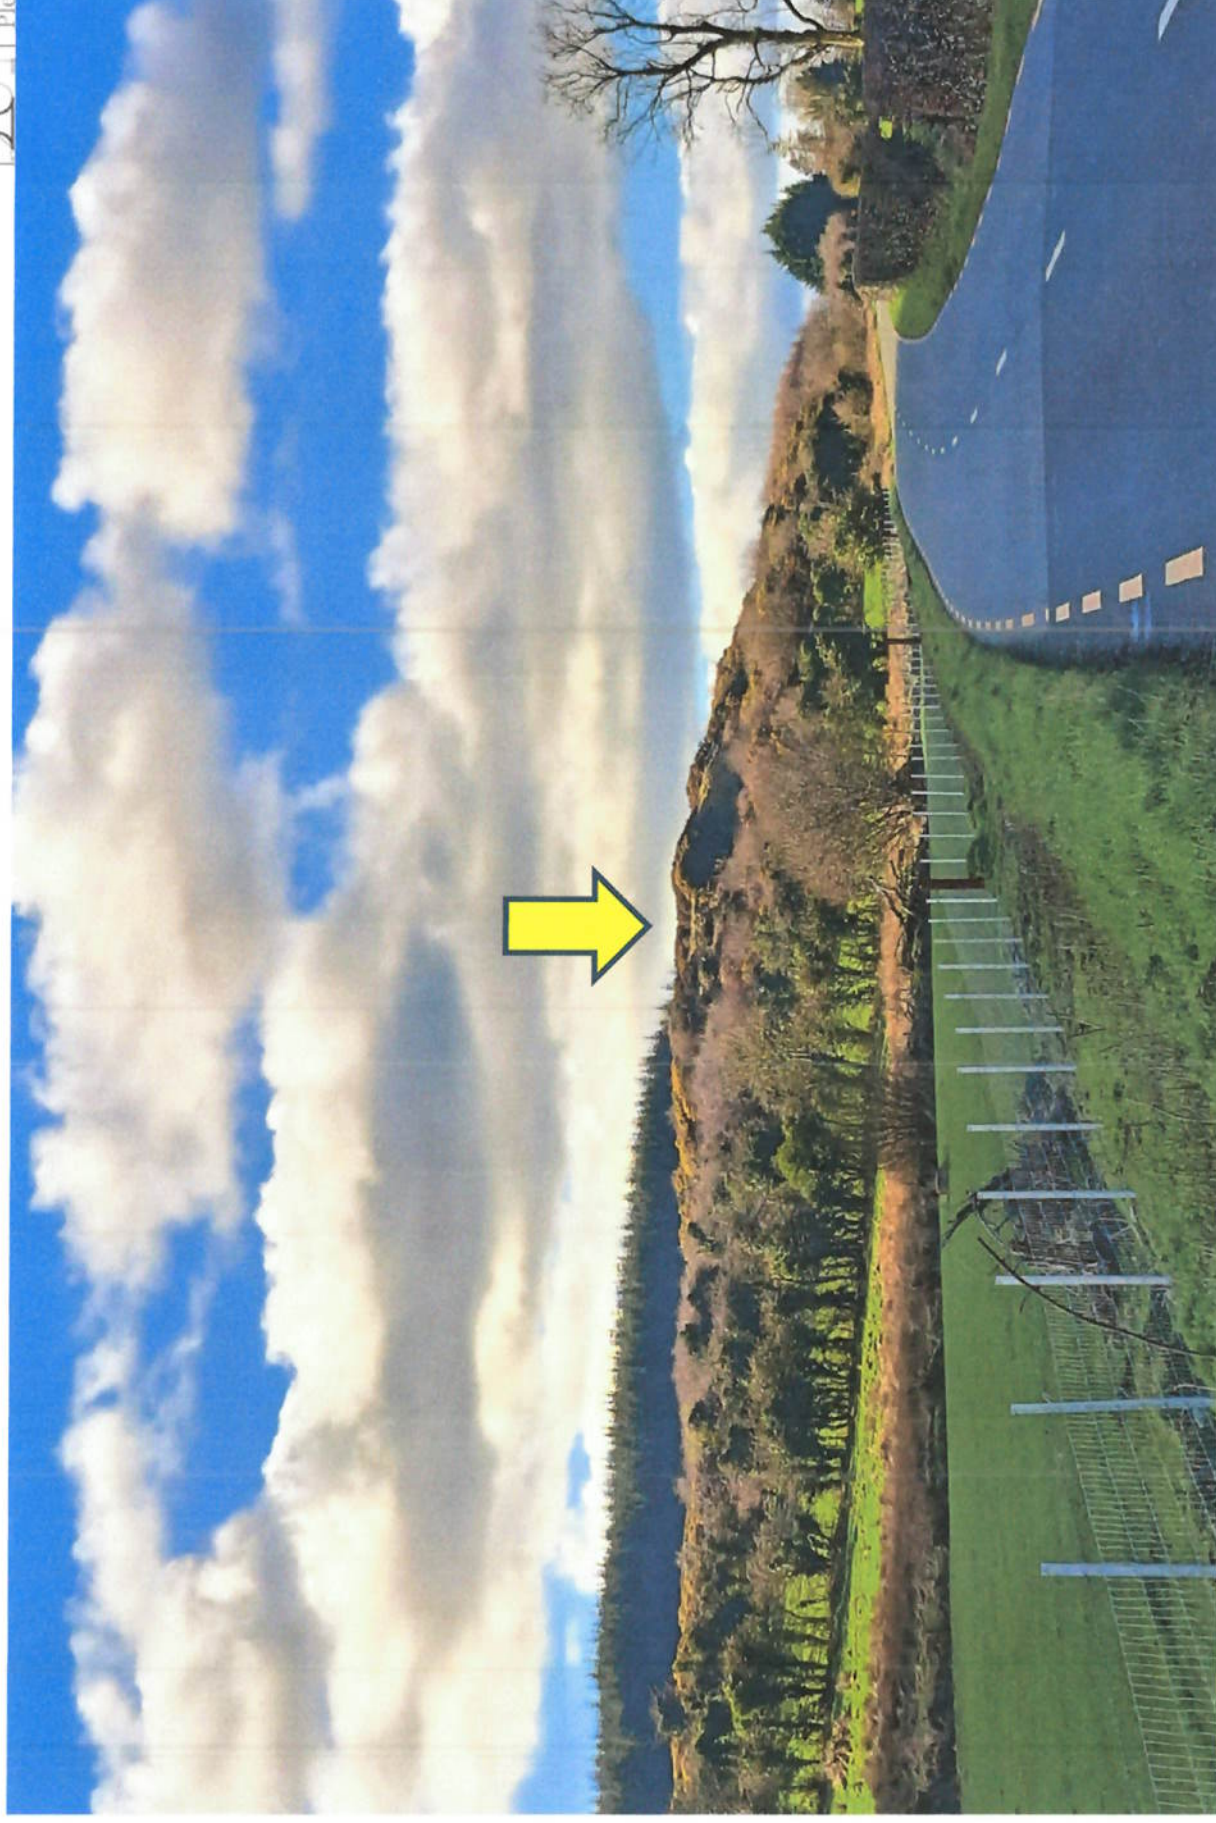
24. The view of the quarry site on approach from the east along the R340

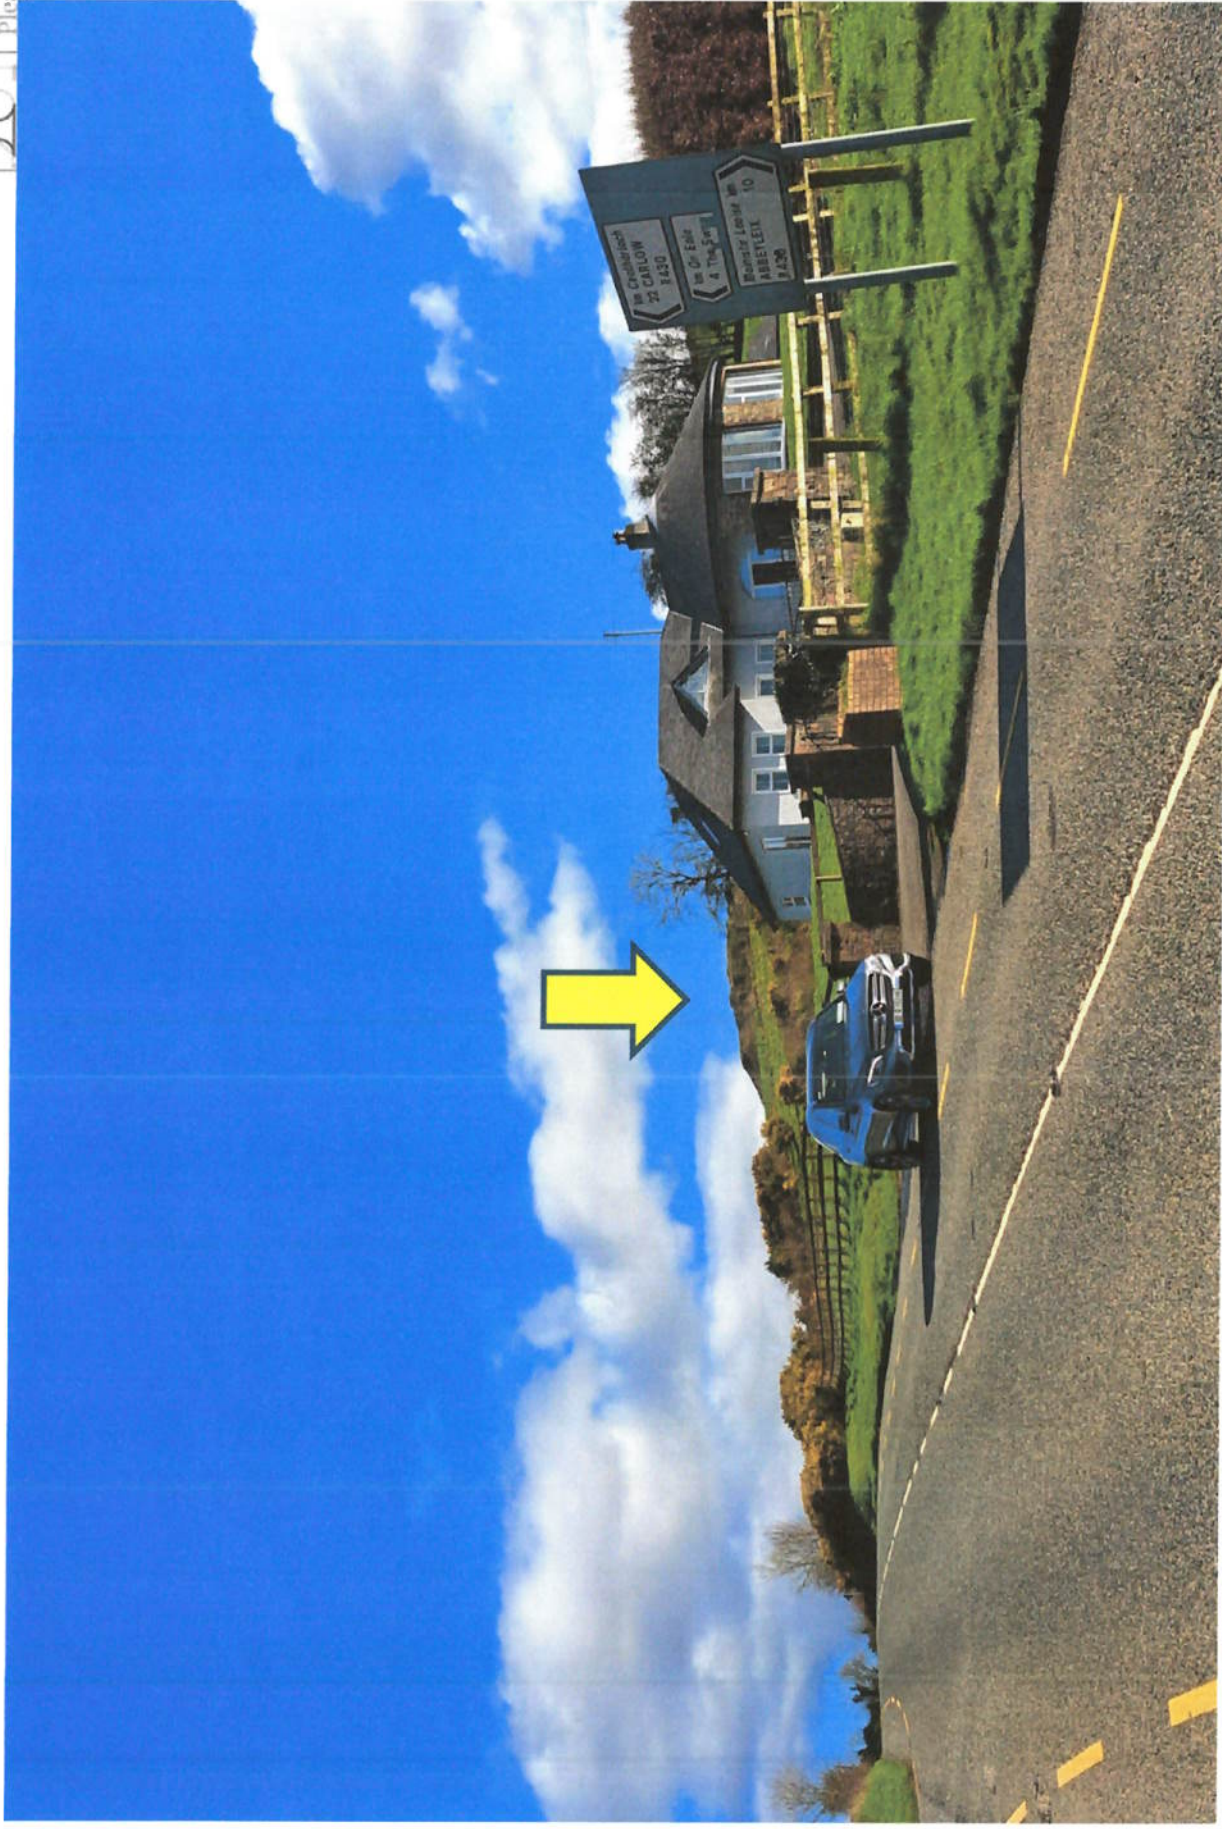
25. A view of the quarry on approach from the west along the R340. Third party appellant's house in the foreground

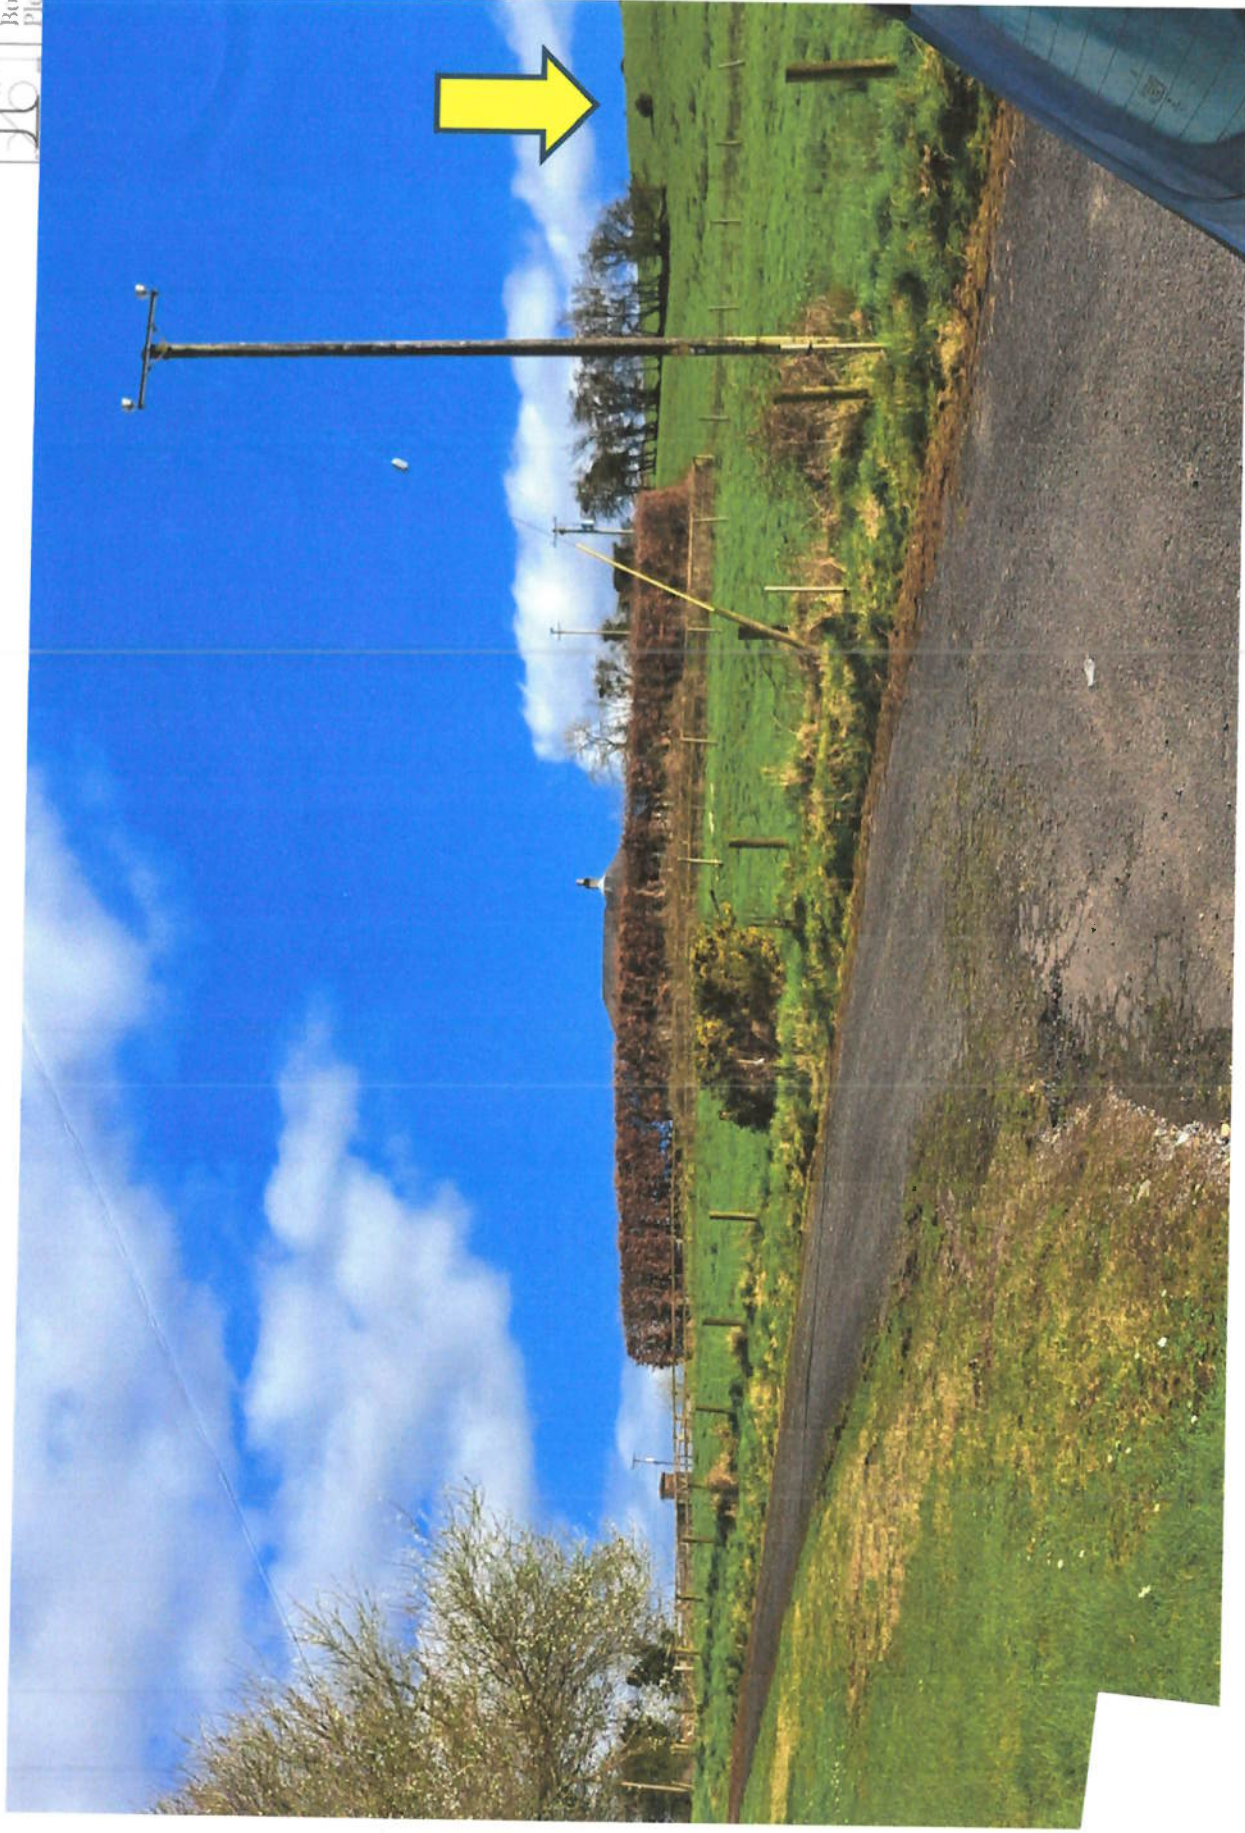
26. A view from the west towards the subject quarry
