# **Firlough WF (FWF) and Hydrogen Plant, Co. Mayo, Co. Sligo**

## **Photographs**

# Appendix 9.4 – Photographs - Plate 13

Subject: Site Photographs of Watercourse Crossings – Drain and river at end of track  
(File Ref. 603676-Hydro-A01-App04—(02))

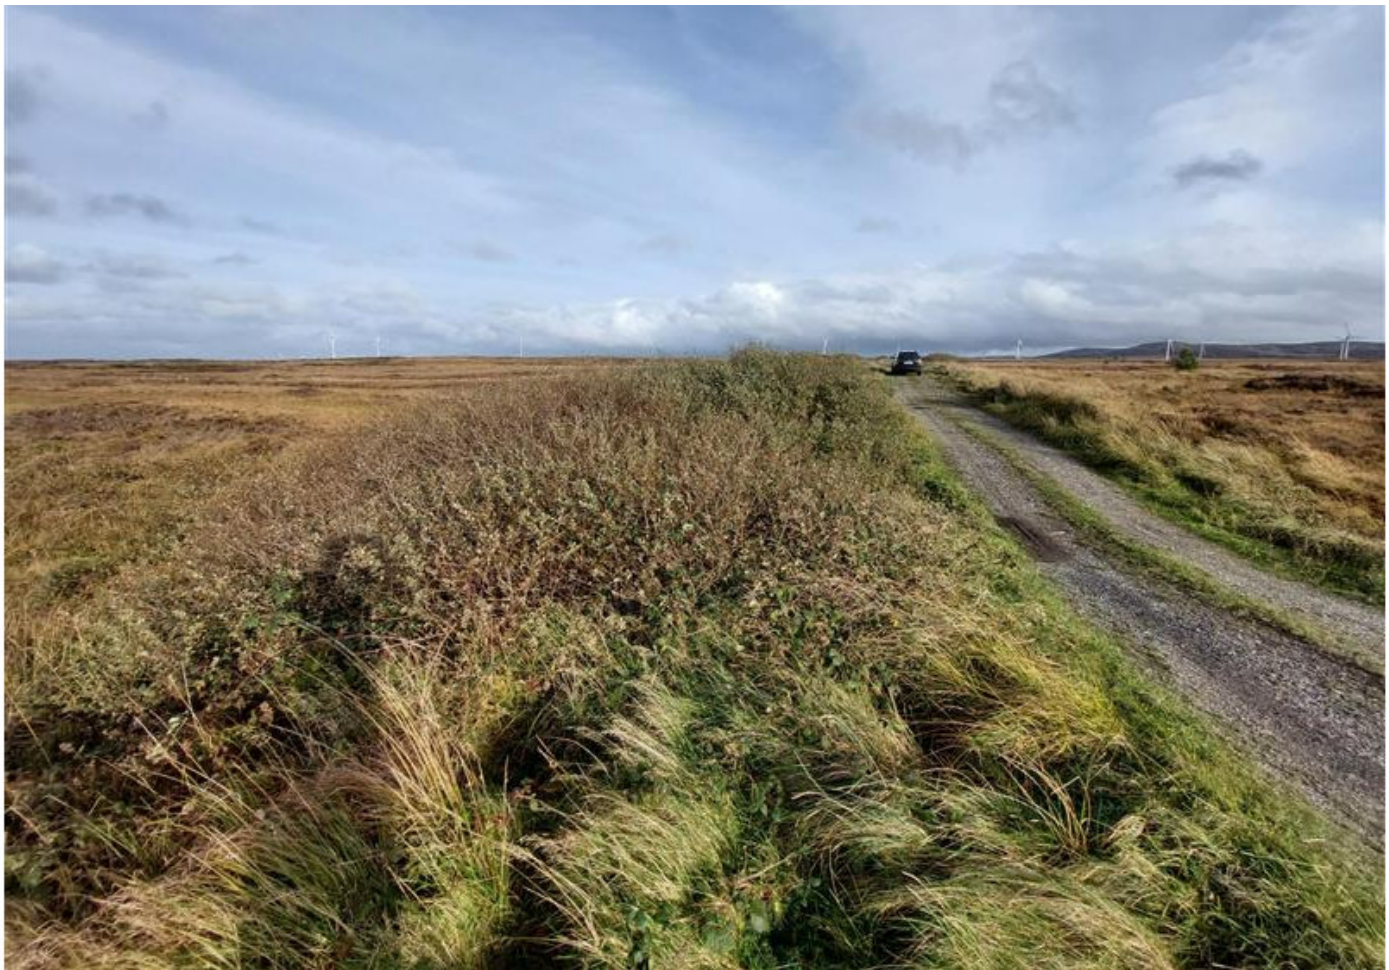
Location of WCC2, looking east. Audible flow from east however drain is difficult to see; deep but overgrown on north side 27/10/2022.

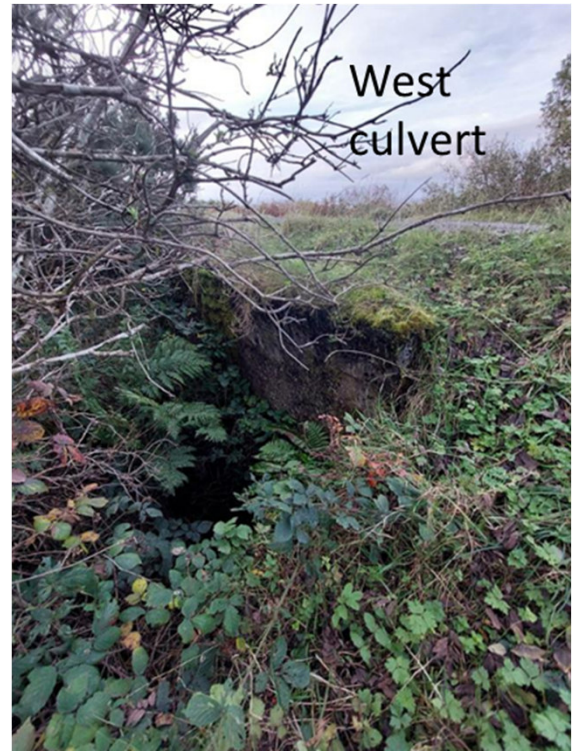
Photo of existing WCC6a, western culvert 27/10/2022.

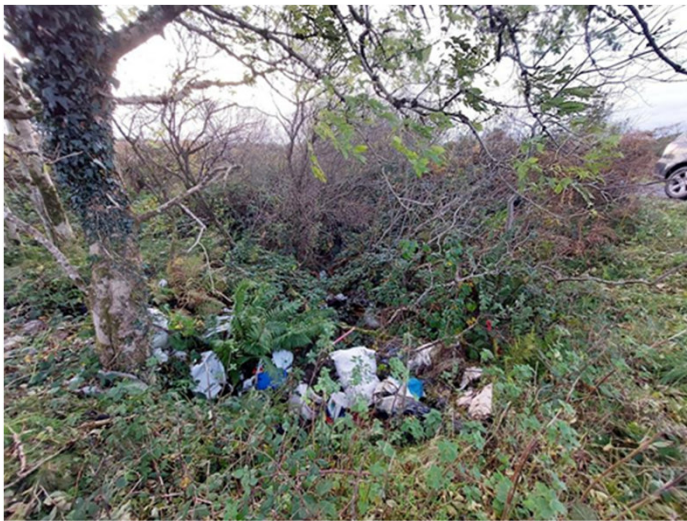
Photo of existing WCC6, southern culvert with rubbish dam 27/10/2022.

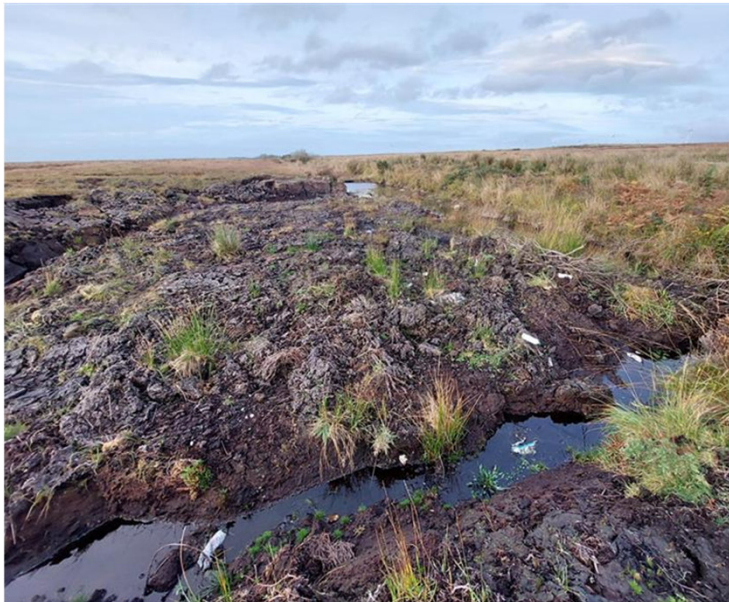
Drainage located northwest of cross roads, flows west, does not seem to be connected to north east

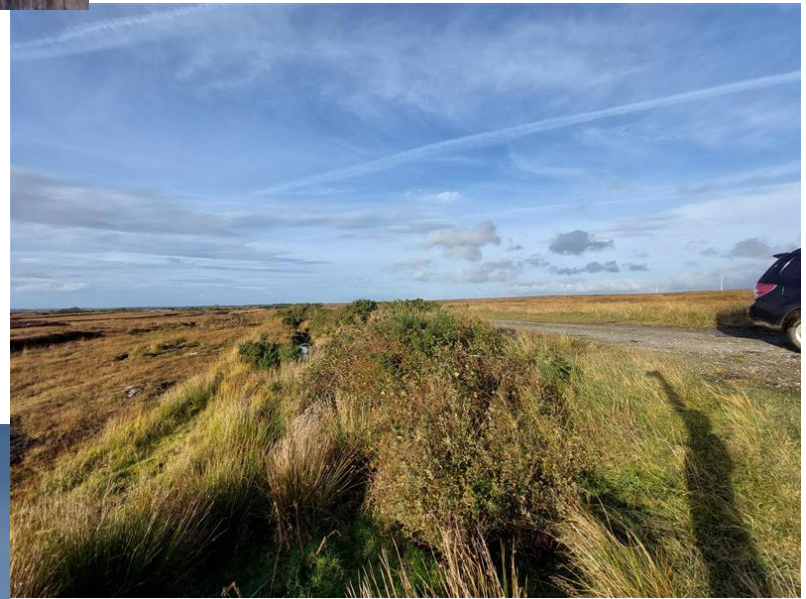
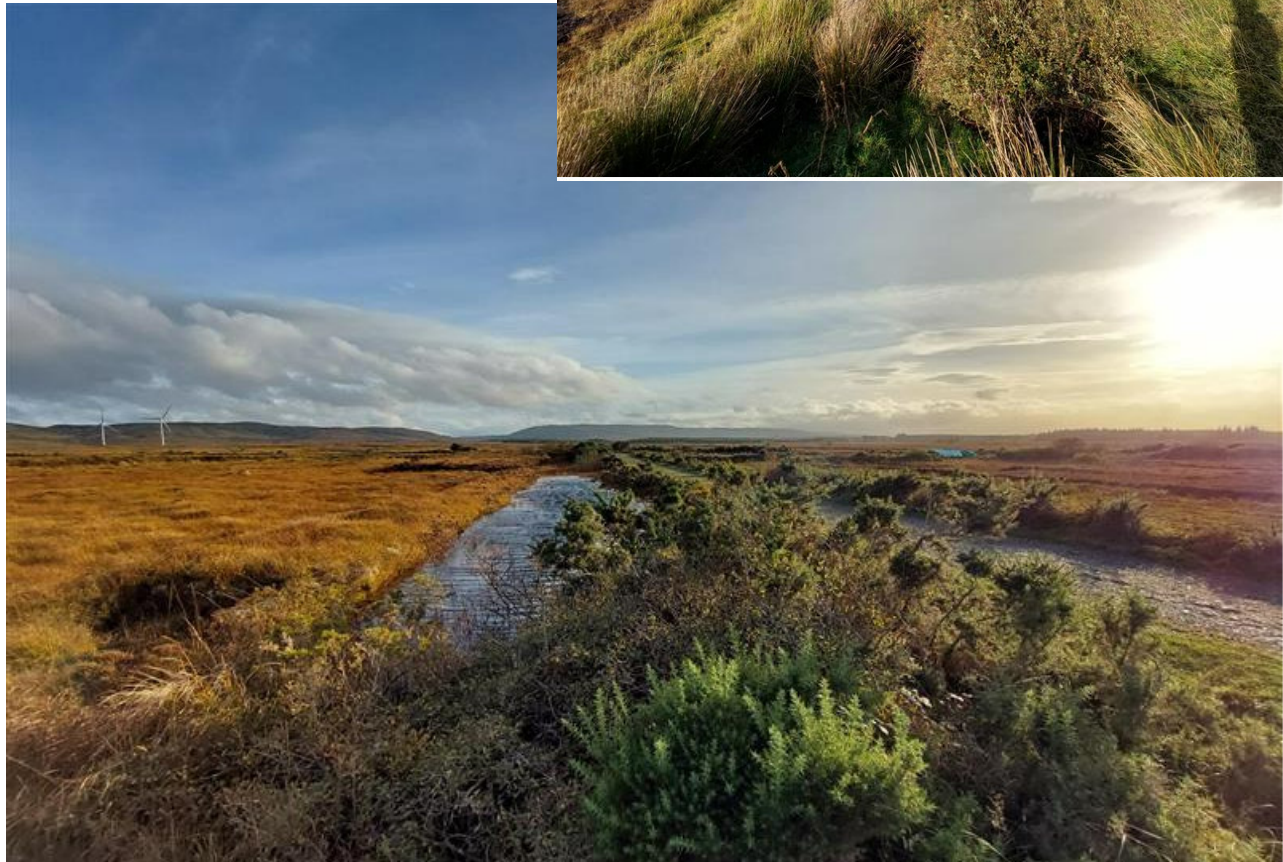
Location of WCC7, no existing culvert, drain runs to north either side of track 27/10/2022.

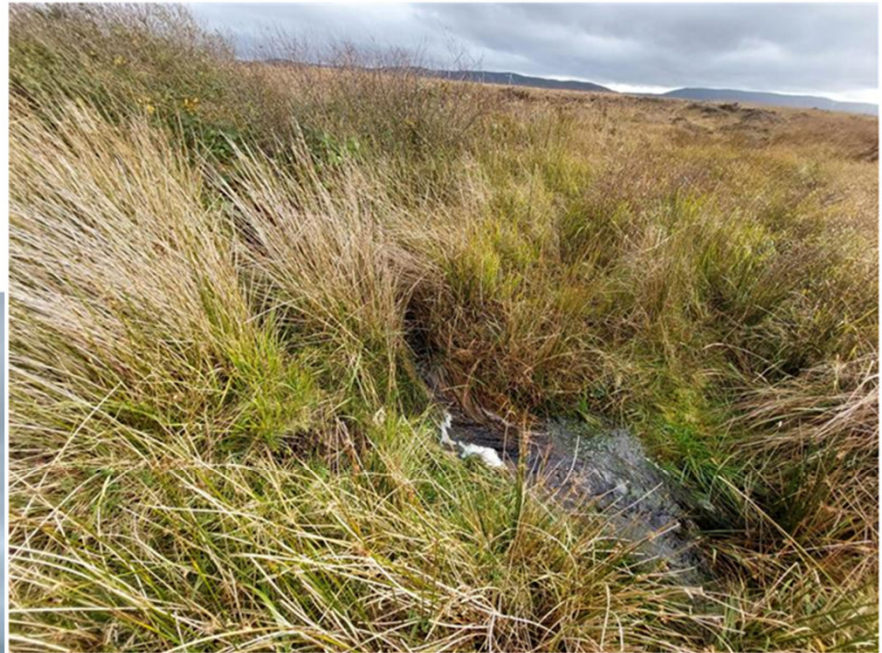
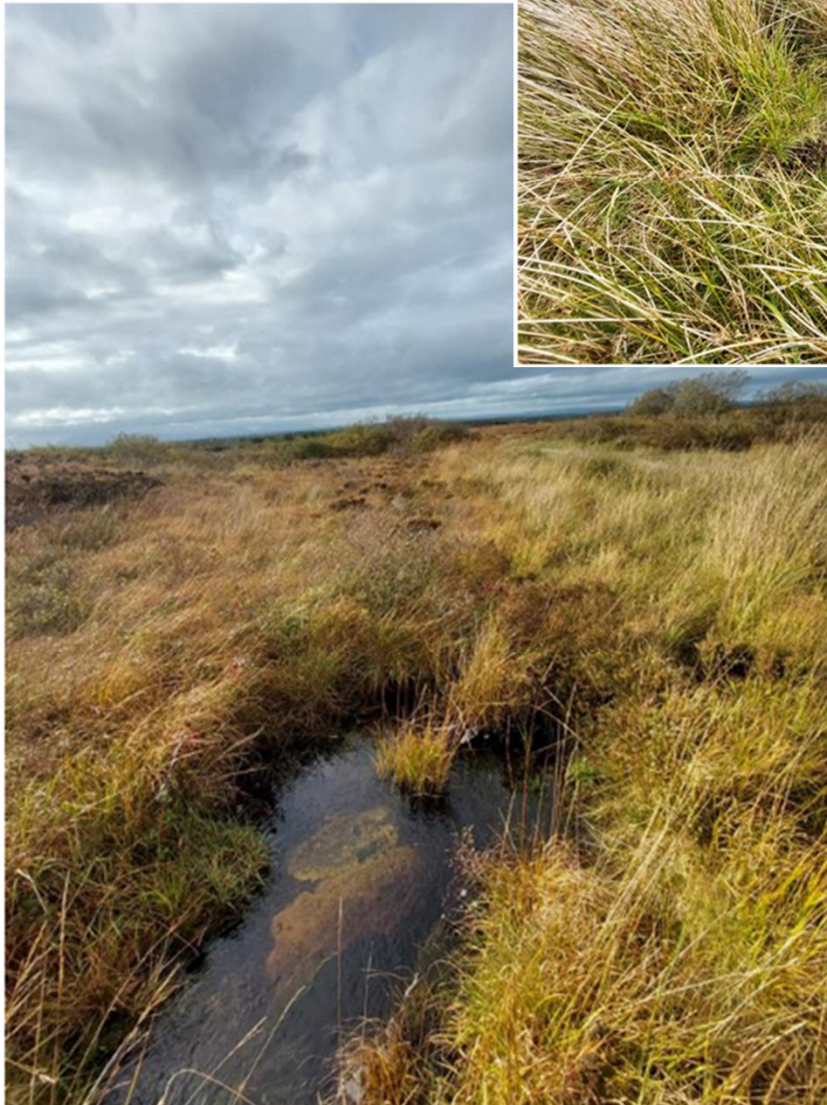
Location of WCC8, looking west on south side of track. Flow estimated to be 3/5 l/sec 27/10/2022.

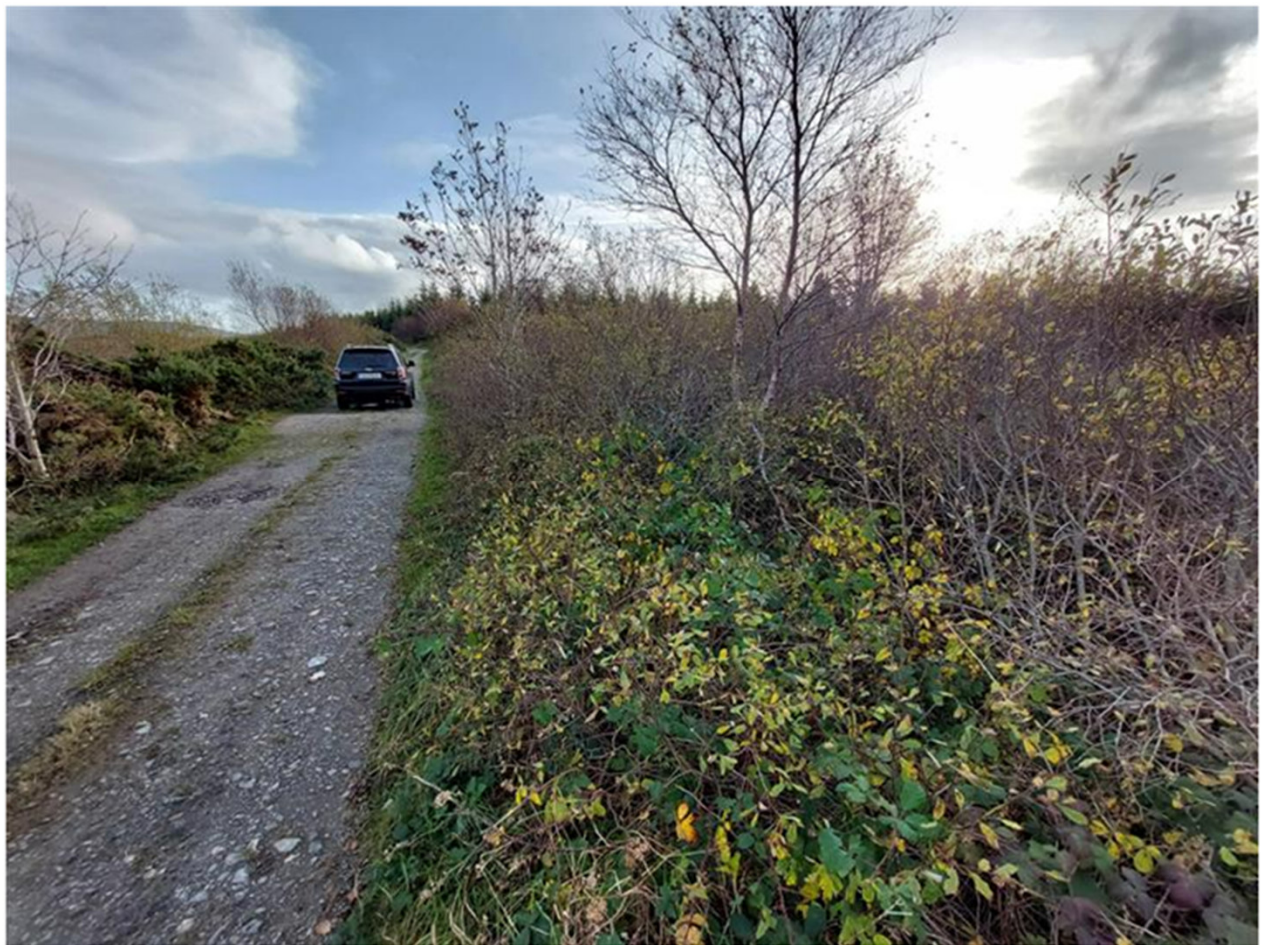
Photo taken looking south , bump in road at car is culvert. Drains converge (north flows south, south flows north to culvert and off to the west 27/10/2022.

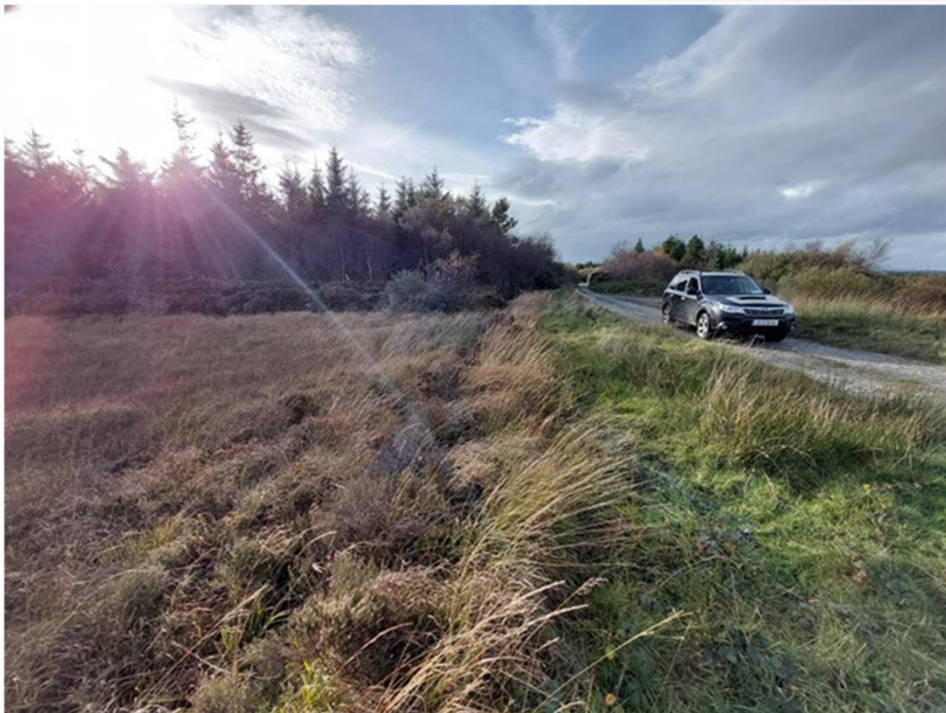
Photo taken looking west, south side of success track, audible flow in drain heard near the corner of forest 27/10/2022.

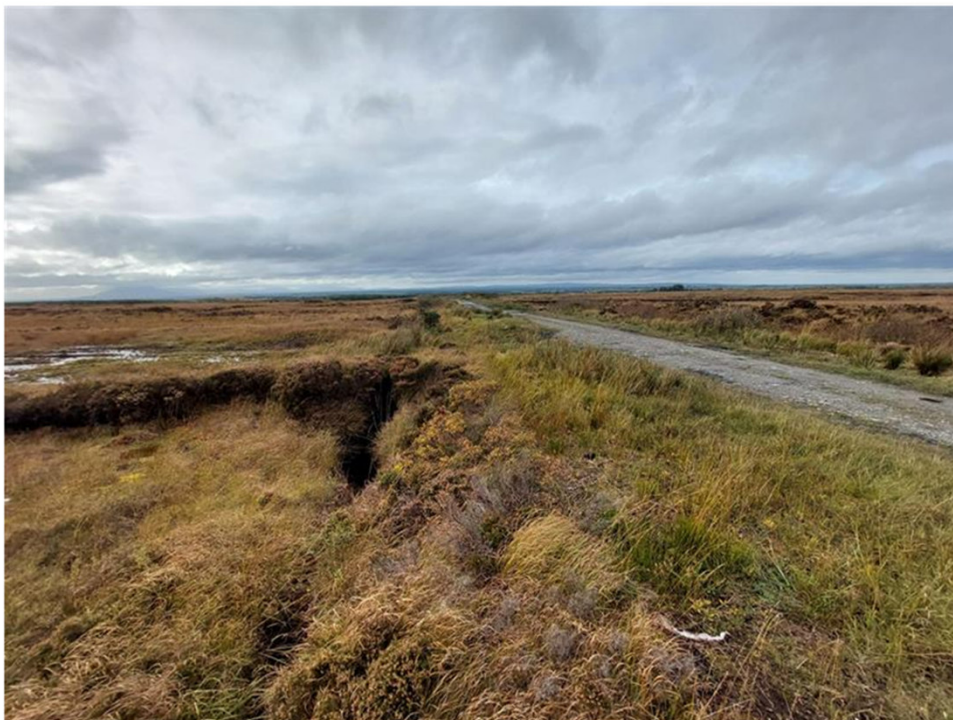
Photo taken looking west on the south side of access track, water flow is audible but not visible  
27/10/2022.

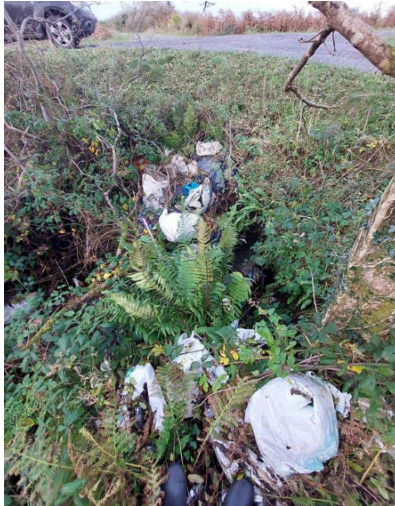
Rubbish dump at southern culvert of identified WCC4 27/10/2022.

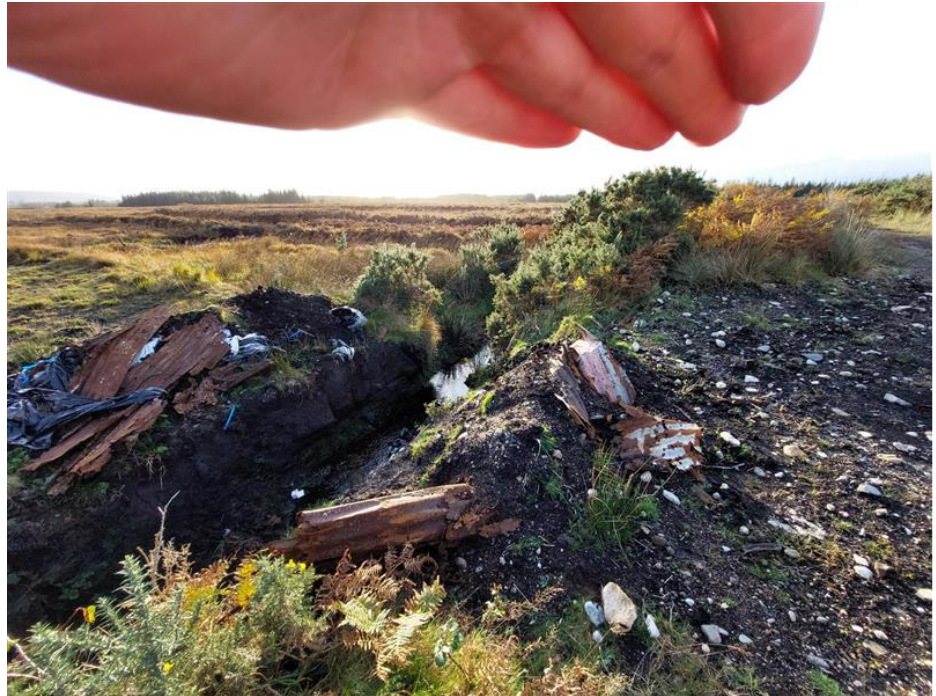
Rubbish and rubble dump north of proposed T3 location and within proposed peat deposition area along main entrance / access track 27/10/2022.

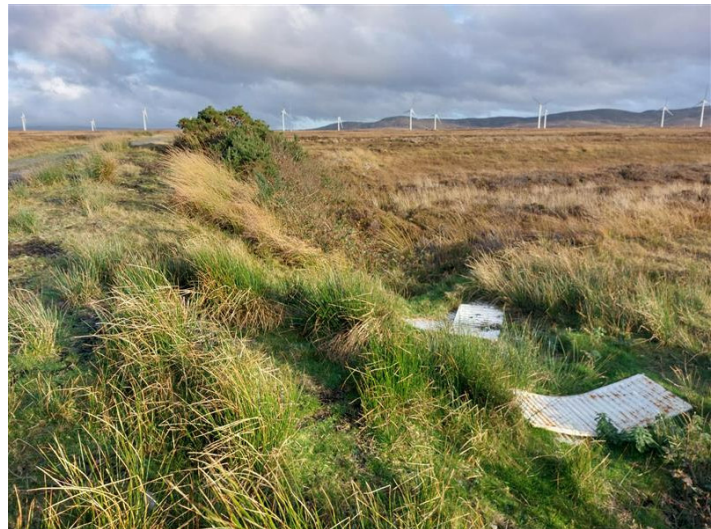
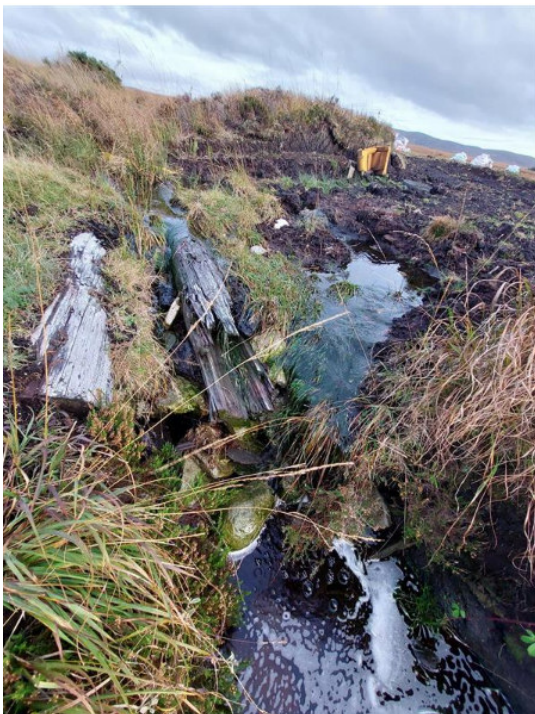
Rubbish dump on cross road southeast of proposed location of T4, southwest of T9, northeast of T3 and northwest of T10 27/10/2022.

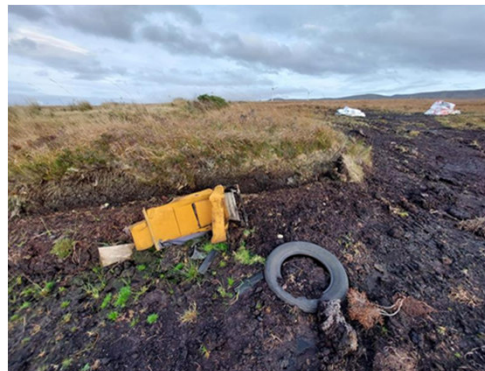
Rubbish dump and pressure to major drain (WCC5) at proposed location of T1 27/10/2022.
