Fig. 3 The boundary wall shared with O'Connell Hall, a Protected Structure and No.43

Fig. 4 The eastern end of the boundary wall is attached to the rear of No.42. The flat roof above the rear extension of No.43 is dressed into the boundary wall.

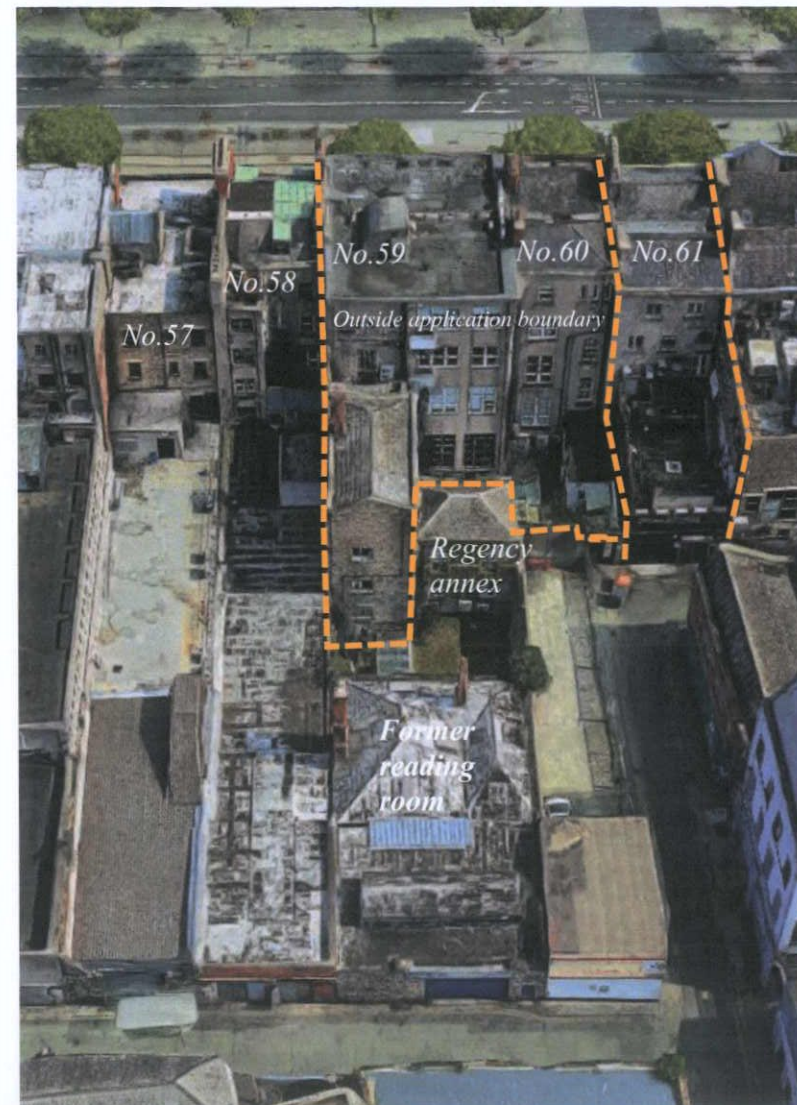
Fig. 5 The southern end of Site 2 (including No.61 O'Connell Street Upper) shares multiple party and boundary walls with neighbouring sites. Indicative position of applicant boundary identified with an orange dashed line for illustrative purposes only.

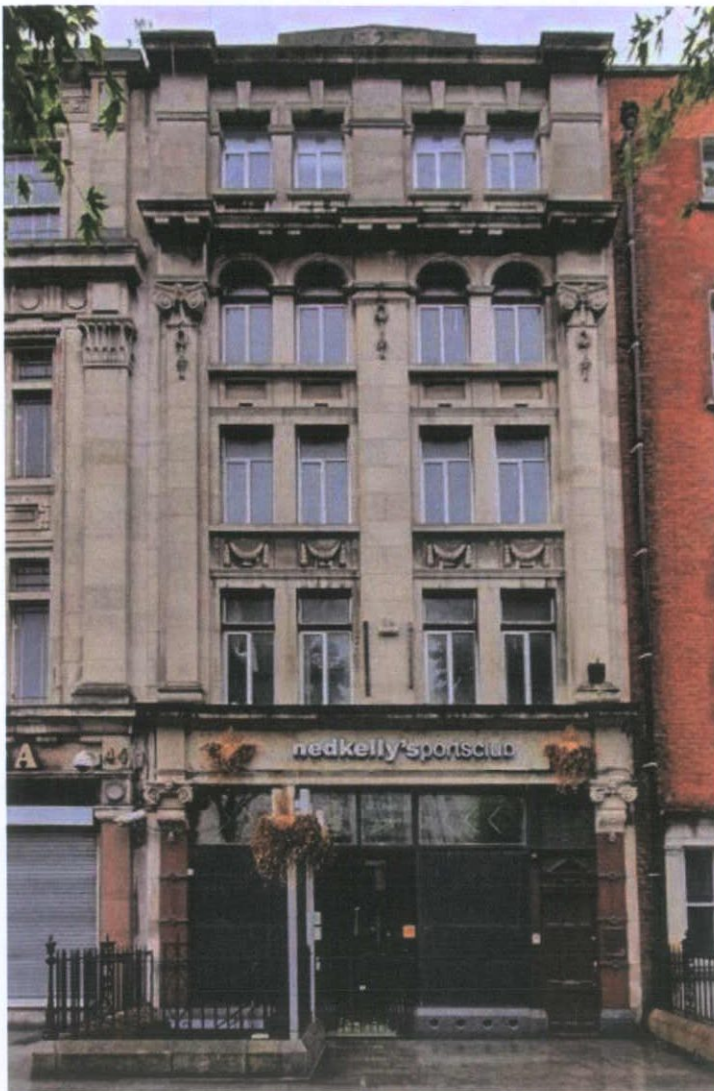
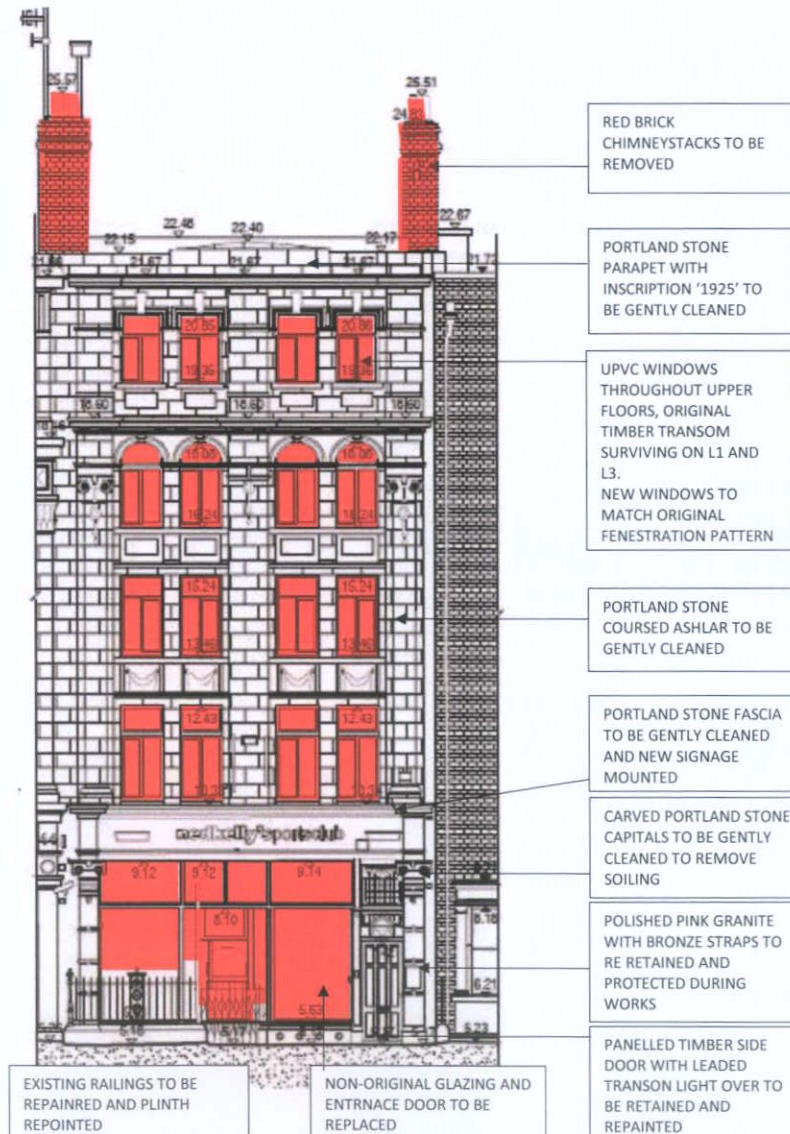
Fig. 6 The façade of No.43 O’Connell Street Upper will be retained and repaired. The new development will be constructed behind the façade. On the upper levels the existing uPVC windows will be removed and timber casements will be installed.

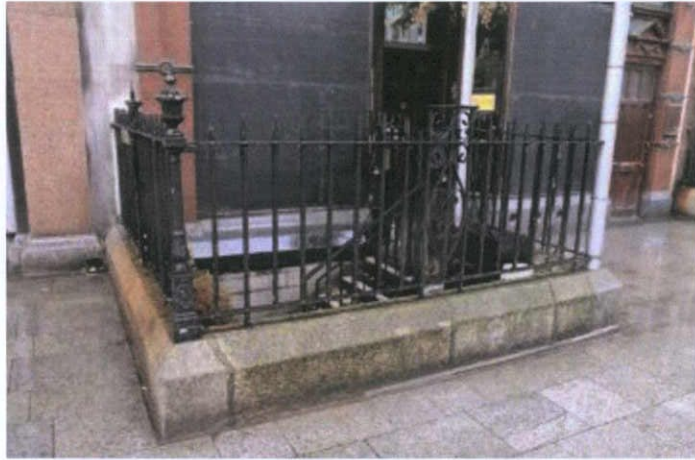
Fig. 8 Modified basement lightwell: wrought iron railings with cast iron urns on cut granite plinth. Railings have been modified and stairs is not original. It is proposed to repair and repaint the ironwork and repoint the granite plinth. The later stairs will be removed.

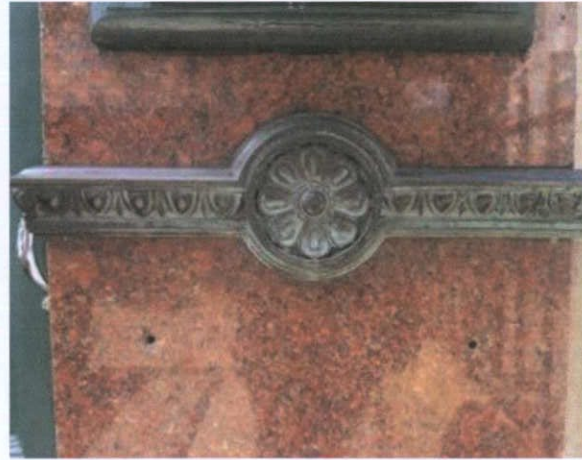
Fig. 9 Detail of decorative bronze fixtures with rosette motif and egg-and-dart straps mounted on pink granite clad pilaster.

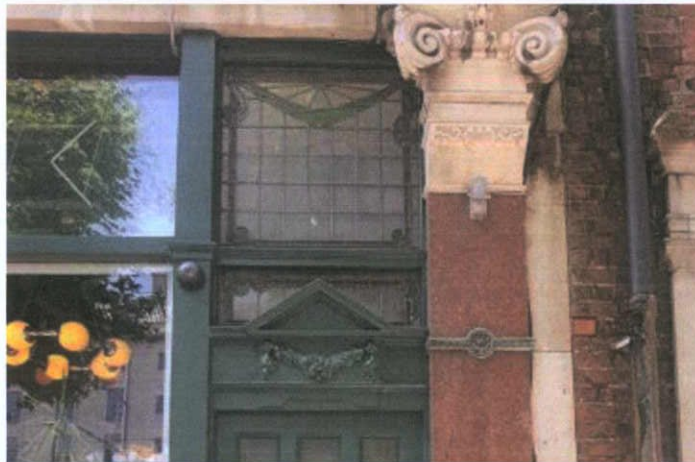
Fig. 11 Original leaded transom light above panelled side door, with carved swag beneath pediment. All original joinery and leaded glazing to be retained, masonry elements will be gently cleaned and original joinery elements repaired and repainted.

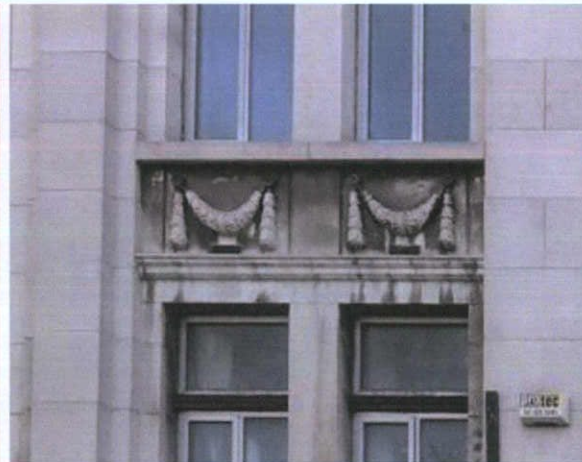
Fig. 12 Recessed bays of paired windows to first and second floors, with carved swag on window apron. Note the original timber transoms surviving on first and third floor level windows otherwise uPVC window frames throughout. Replacement windows proposed to match original, as informed by surviving profiles and historic photographs.

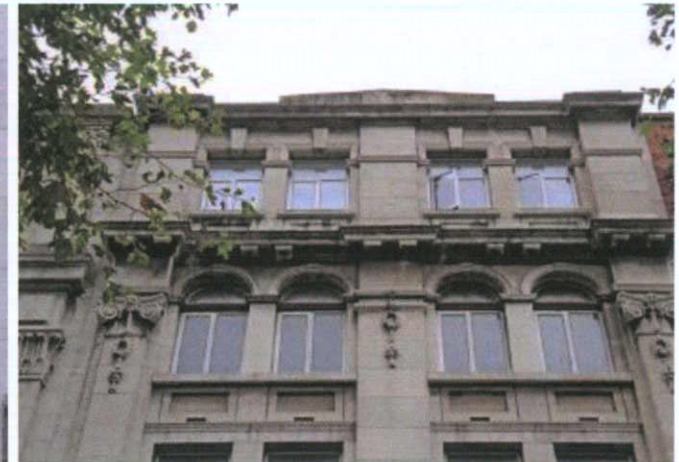
Fig. 13 Pediment parapet featuring the inscription '1925'. Note timber transom and arched head on Level 3, and also Level 1.

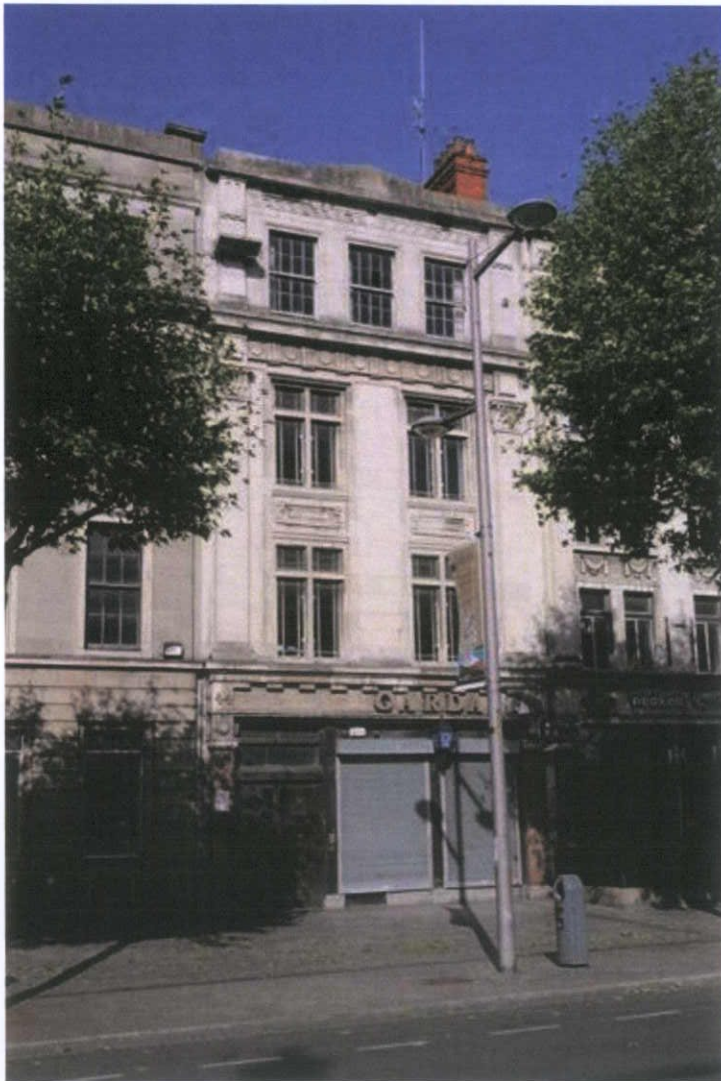
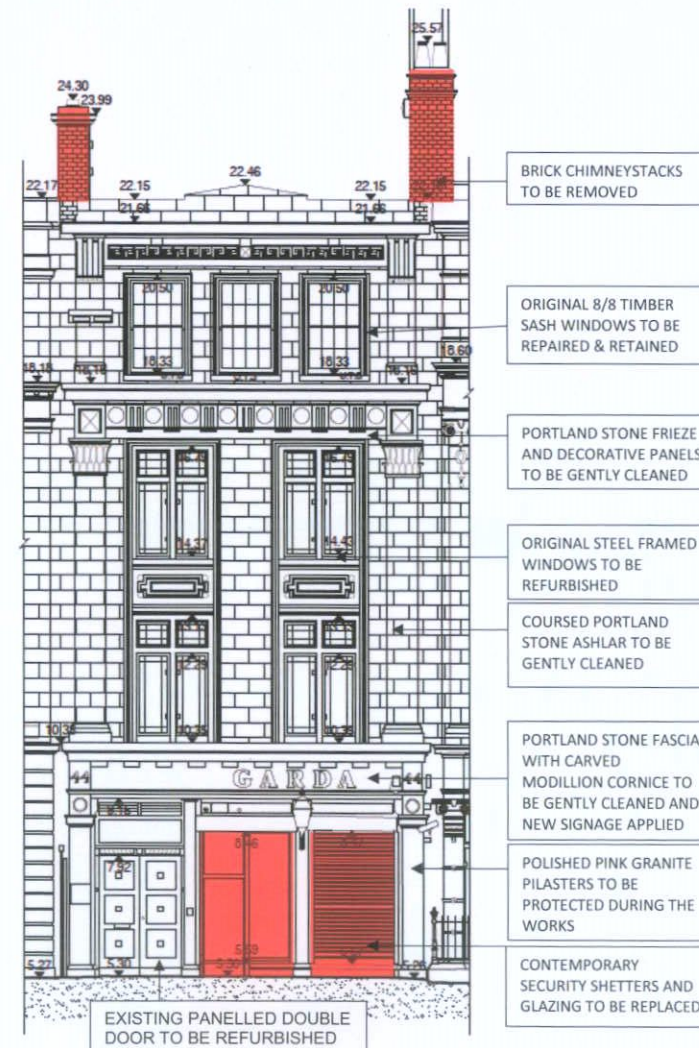
Fig. 14 The façade of No.44 O'Connell Street Upper will be retained and repaired. The new development will be constructed behind the façade.

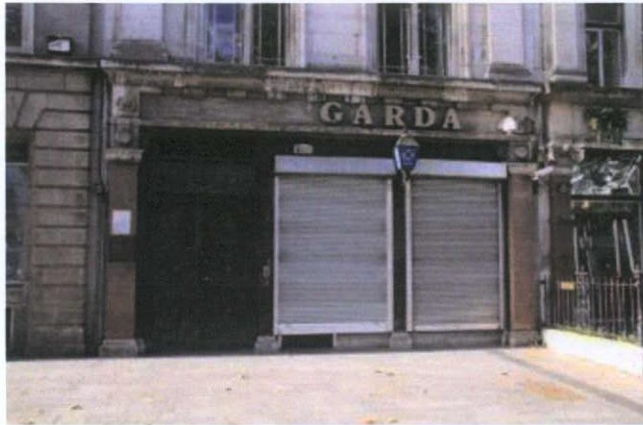
Fig. 16 Original shop front to ground floor, comprising polished pink granite pilasters with stylised capitals. Replacement glazed shop windows set within timber frames over granite stall risers. Later glazing to be replaced. Granite plinth below windows to be removed to facilitate access via new entrance doors.

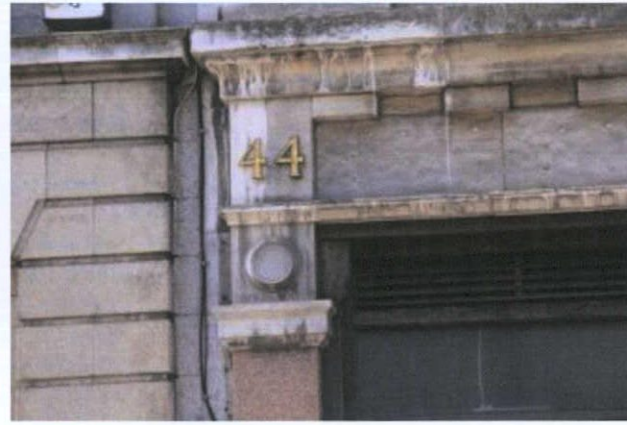
Fig. 17 Detail circular medallions and '44' numbering on frieze above capital and Portland stone frieze with carved modillion cornice. Masonry elements to be gently cleaned.

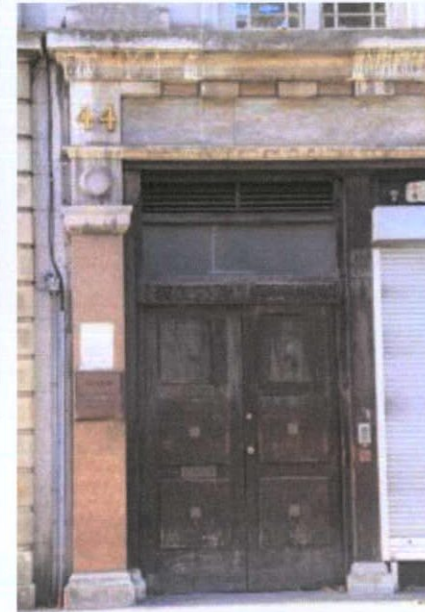
Fig. 17 Double-leaf timber panelled doors to south with raised central studs, carved timber architrave with circular medallion motif and plain glazed transom; ventilated grille over. Existing double door to be retained and repaired.

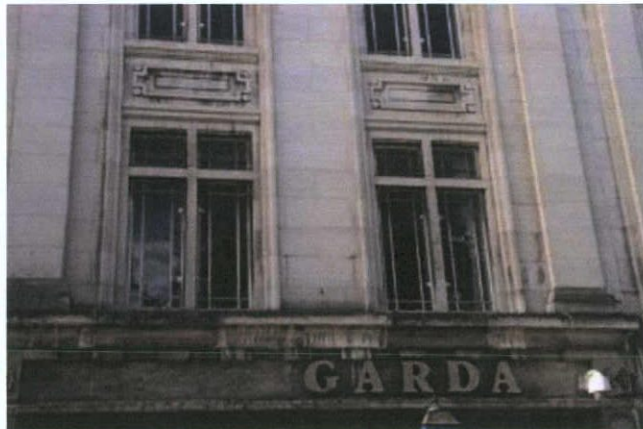
Fig. 18 Steel casement windows with fixed transom lights over to be restored by specialist.

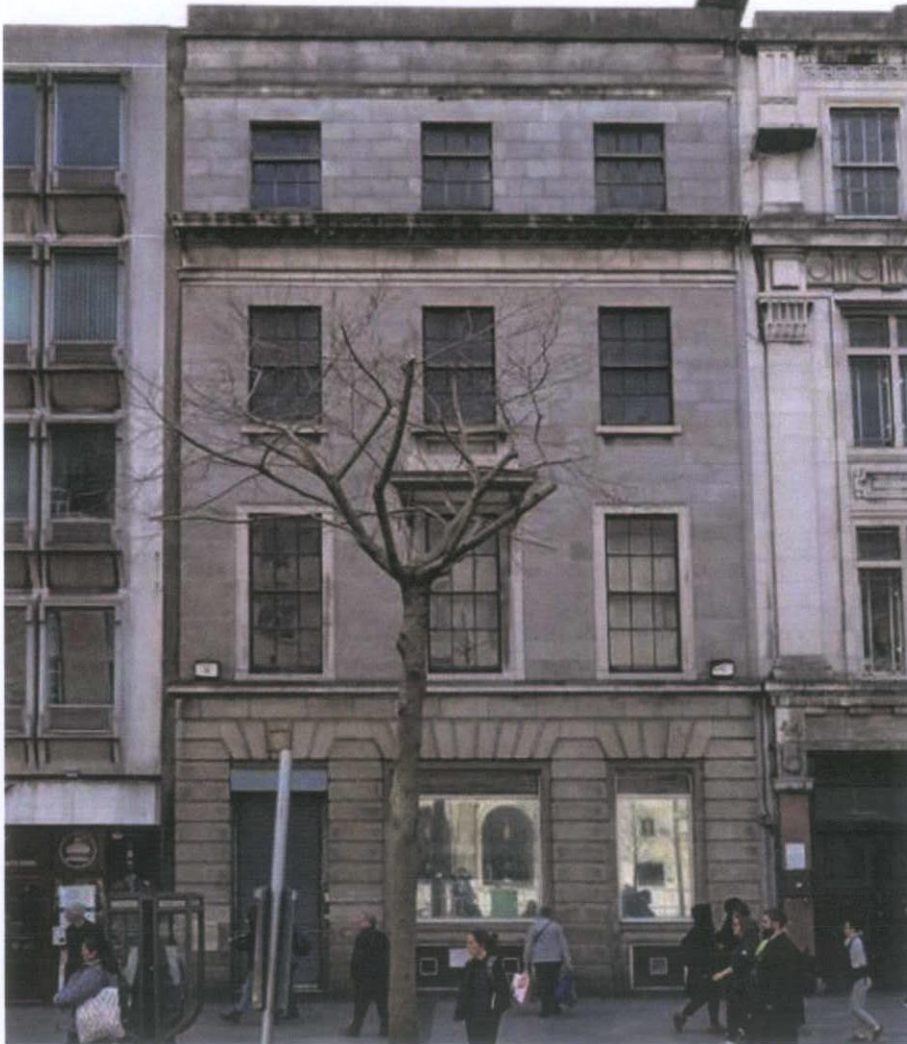
Fig. 21 The façade of No.45 O’Connell Street Upper will be retained and repaired. The new development will be constructed behind the façade.

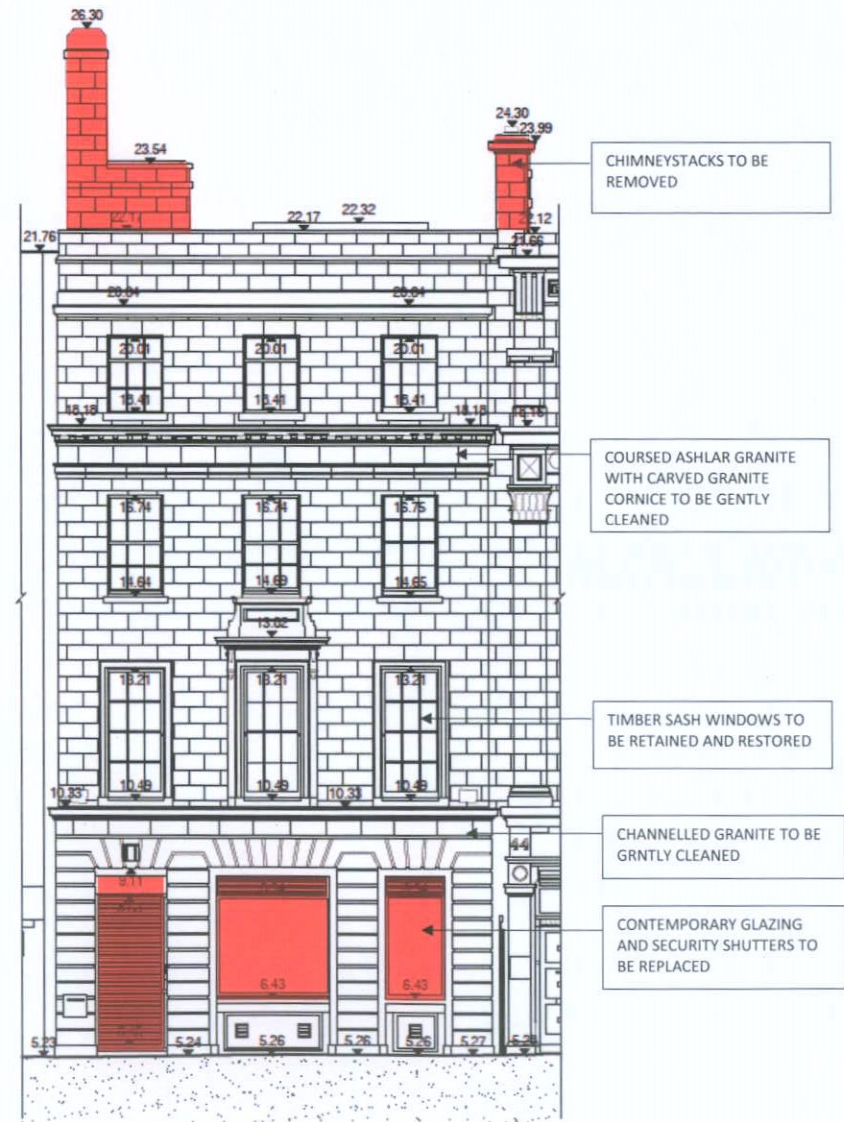
Fig. 22 No.45 O’Connell Street Upper. Note: Drawings are not to scale. The drawings within this report are for illustrative purposes only. Please refer to detailed drawings submitted with the application for accurate dimensions and information.

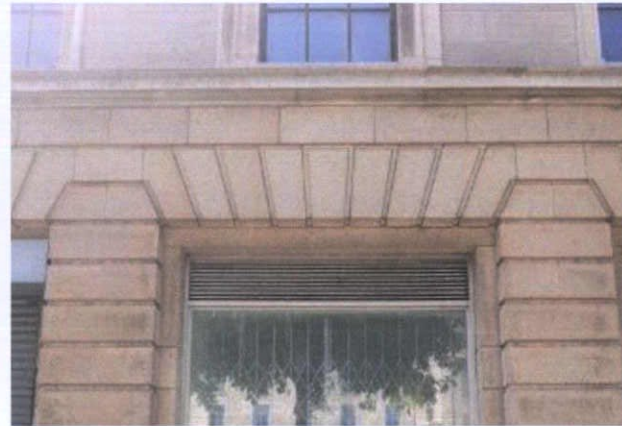
Fig. 24 Square-headed window openings; Late 20th century windows with ventilation grilles over to be replaced.

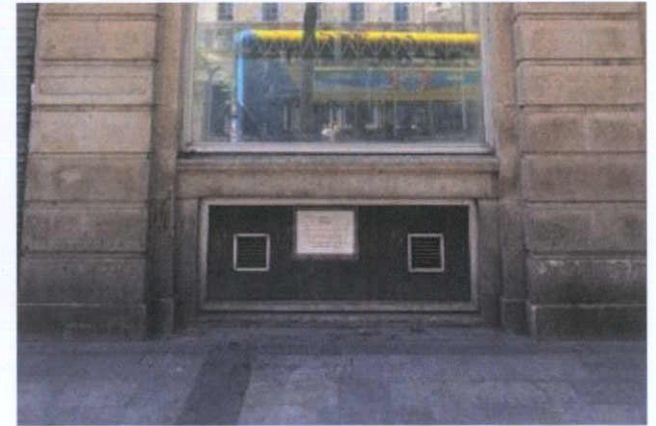
Fig. 25 Late 20th century insert in stall riser, framed in granite. Panel to be replaced. All masonry elements to be retained and gently cleaned down.

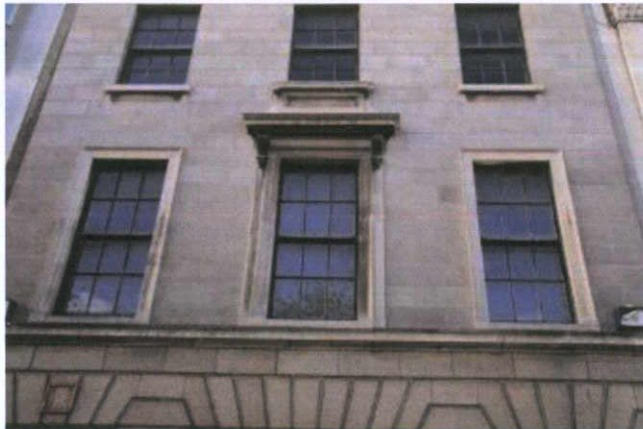
Fig. 26 Carved Portland stone surrounds to first floor, and central ope having carved granite hood moulding supported on corbel brackets; Portland stone sills to second floor, with central window having carved, Portland stone panelled apron. Masonry to be gently cleaned.

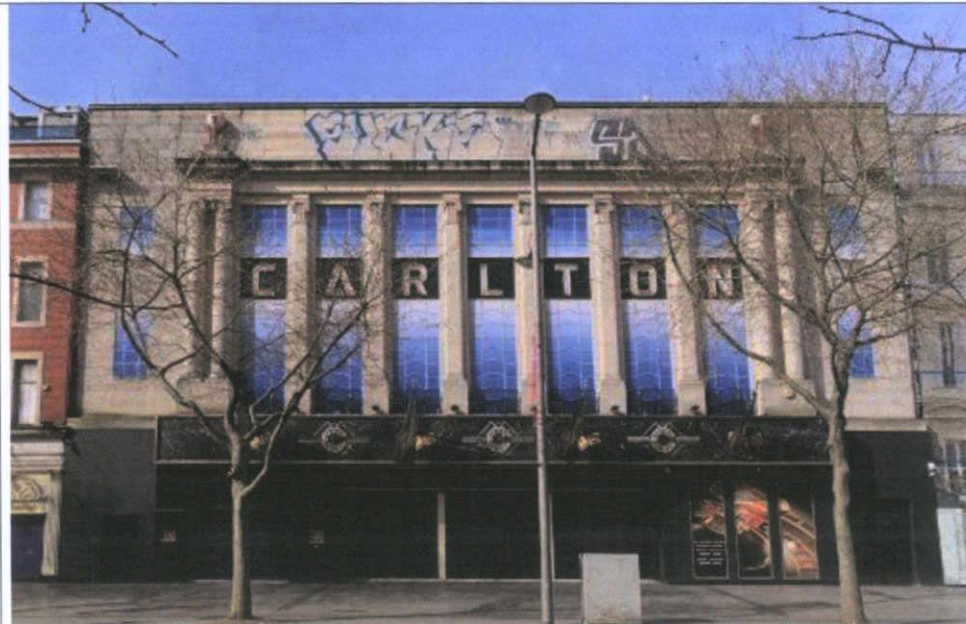
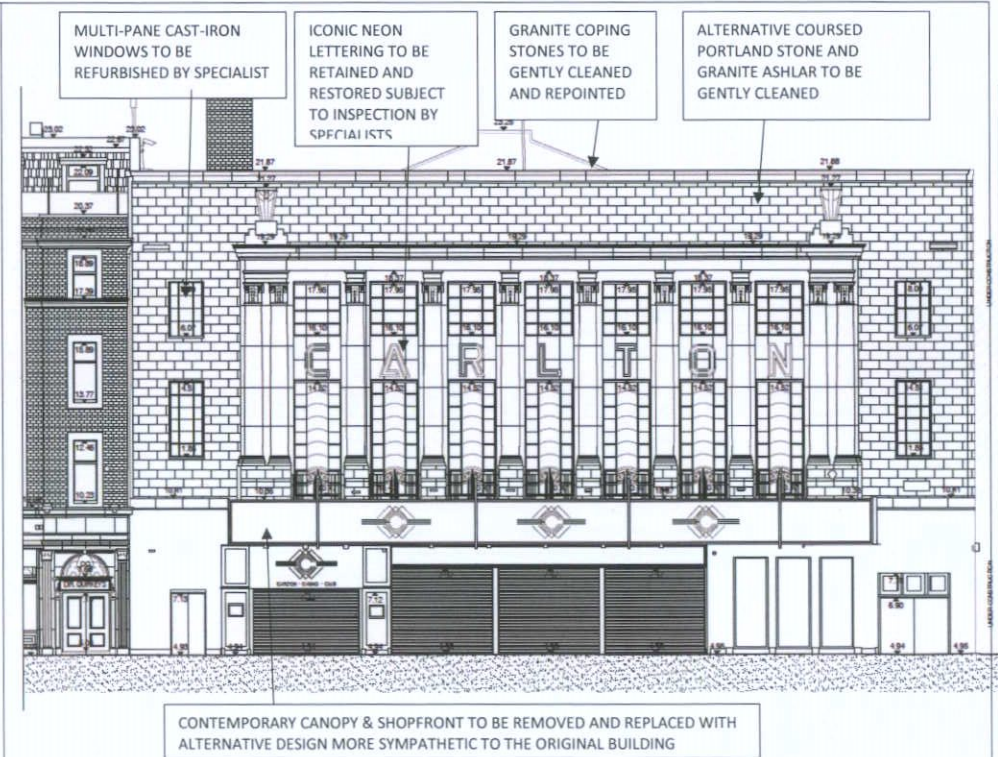
Fig. 29 The façade of No.52-54 O'Connell Street Upper will be retained and repaired. The new development will be constructed behind the façade.

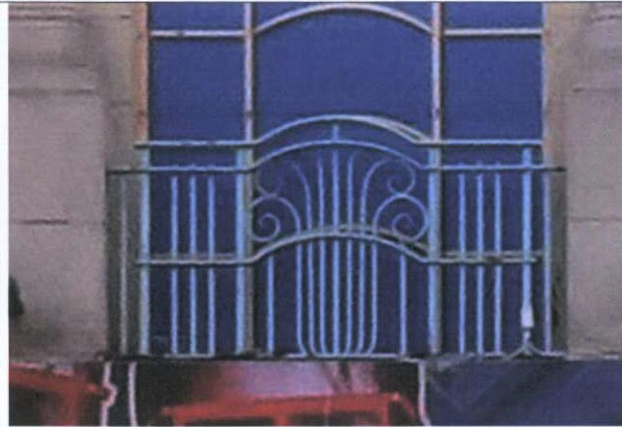
Fig. 31 Decorative railings at first floor level between bays, to be restored and refinished.

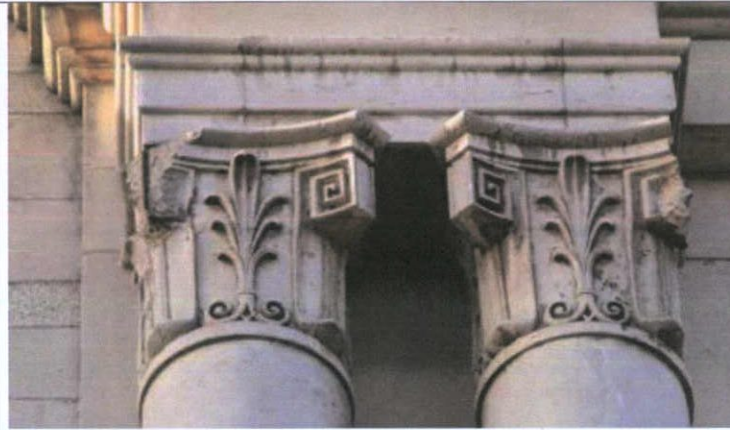
Fig. 35 Example of damage to capitals requiring stone graft repair.

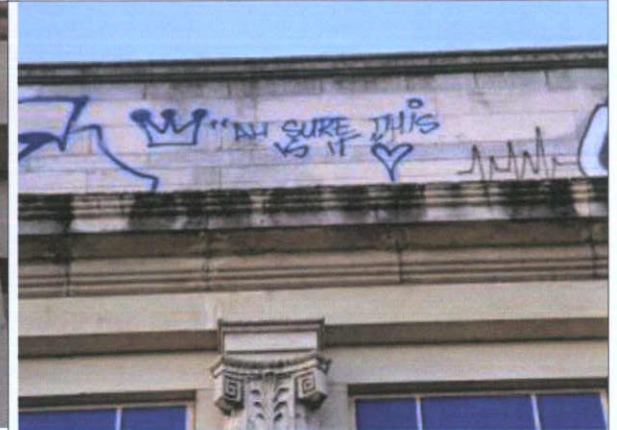
Fig. 36 Detail of graffiti staining to be removed from parapet.

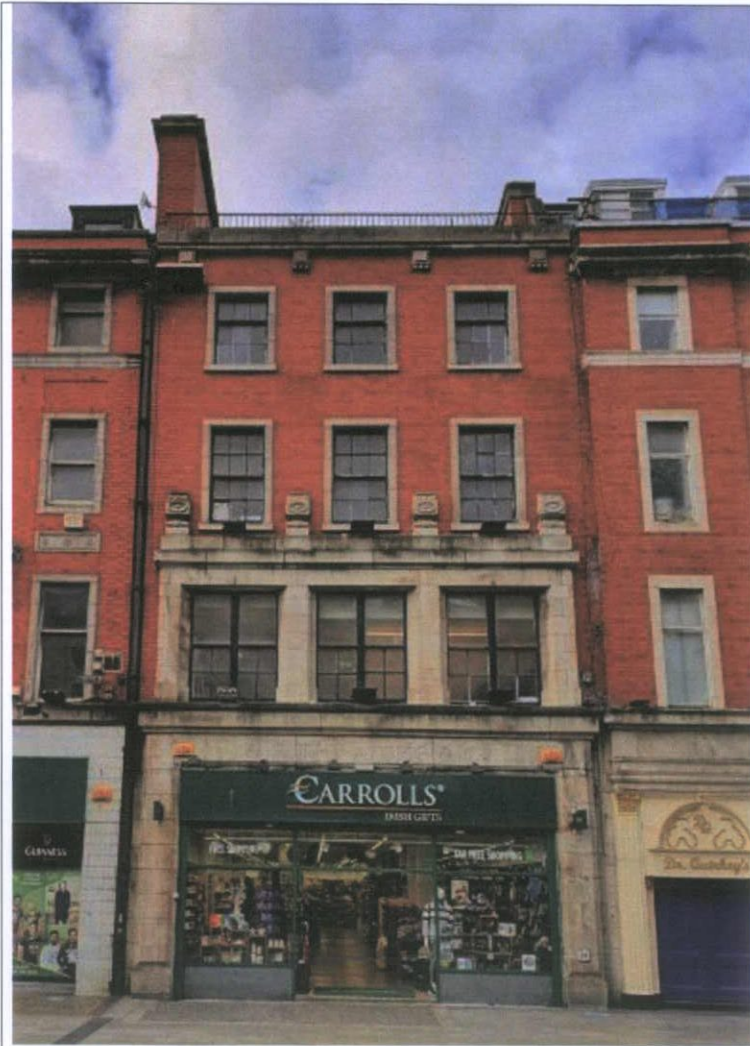
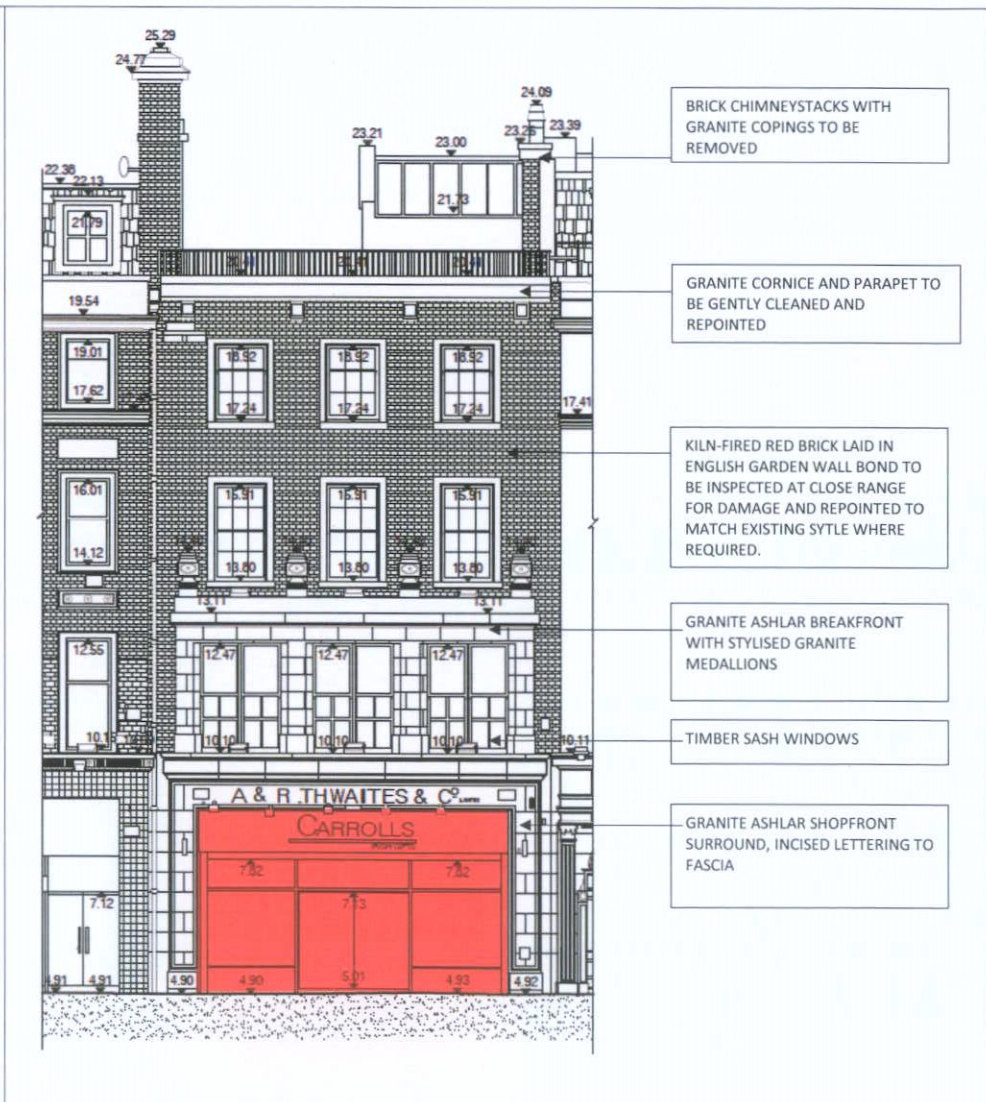
Fig. 37 The façade of No.57 O'Connell Street Upper will be retained and repaired. The new development will be constructed behind the façade.

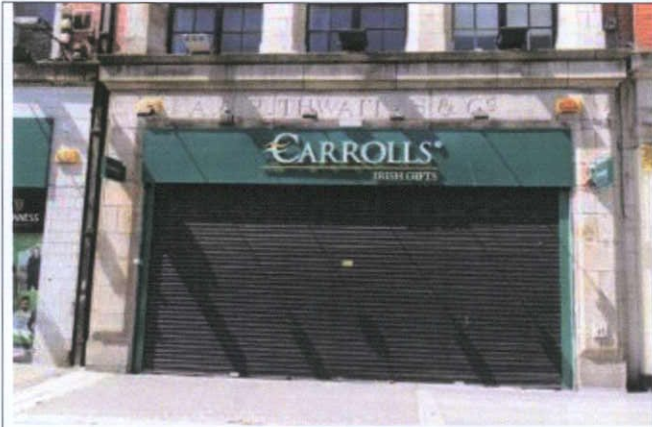
Fig. 39 Granite ashlar shop front with solitary plinths flanking either side of modern shopfront infill; incised lettering to fascia reading, A & R THWAITES & CO

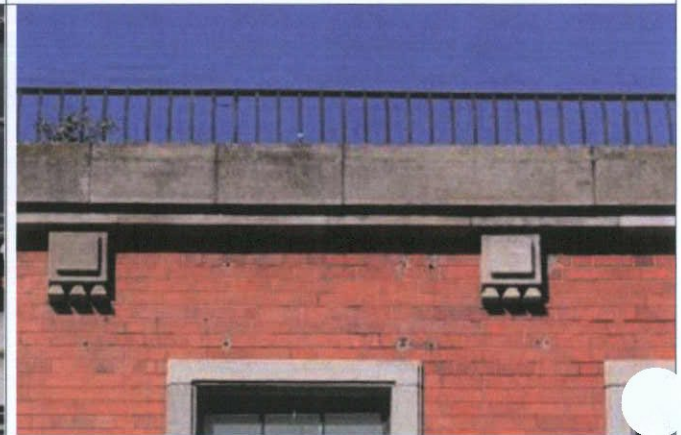
Fig. 44 Parapet railing, damage to brickwork from removed fixings

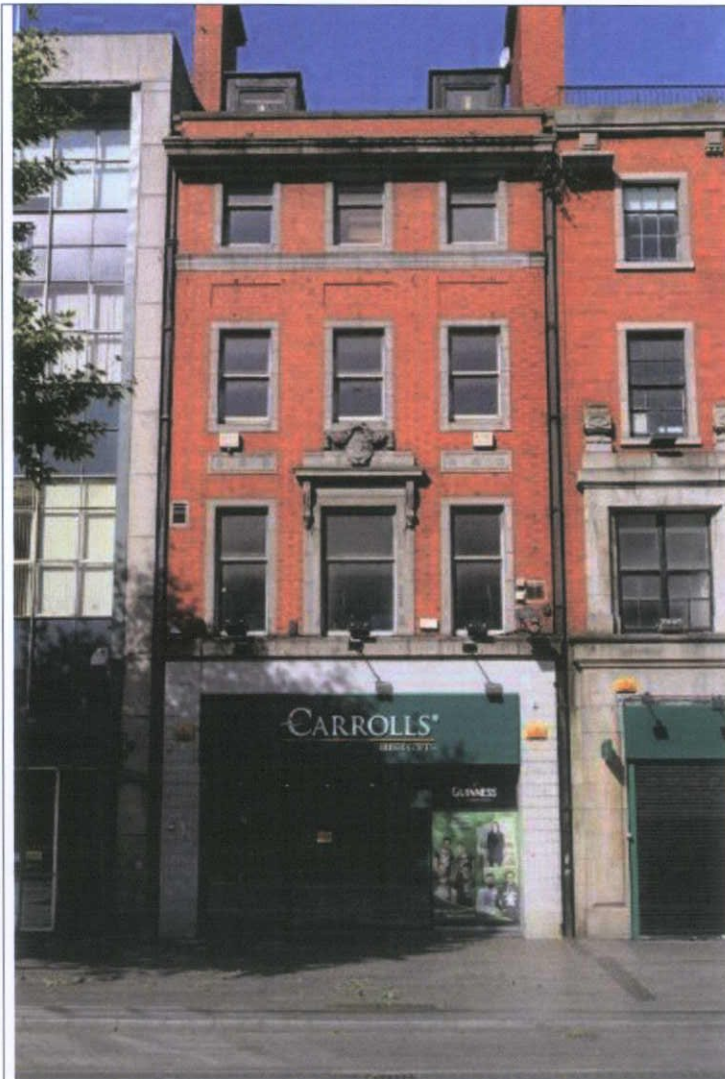
Fig. 45 The façade of No.58 O’Connell Street Upper will be retained and repaired. The new development will be constructed behind the façade.

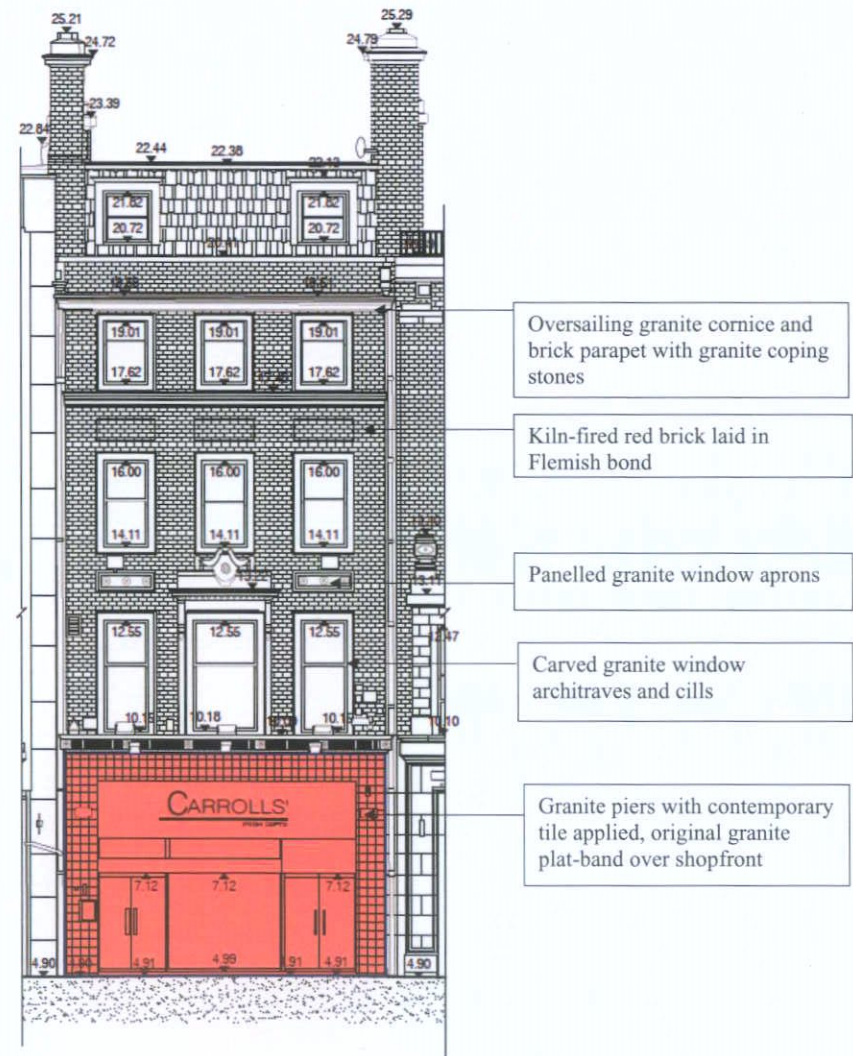
Fig. 46 Note: Drawings are not to scale. The drawings within this report are for illustrative purposes only. Please refer to detailed drawings submitted with the application for accurate dimensions and information.

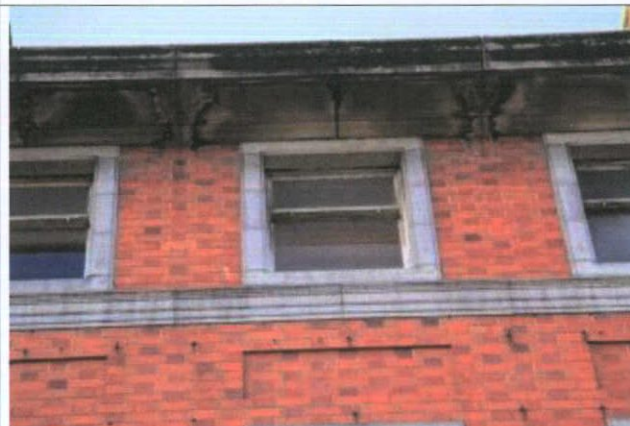
Fig. 51 Granite cornice, with water-staining evident.

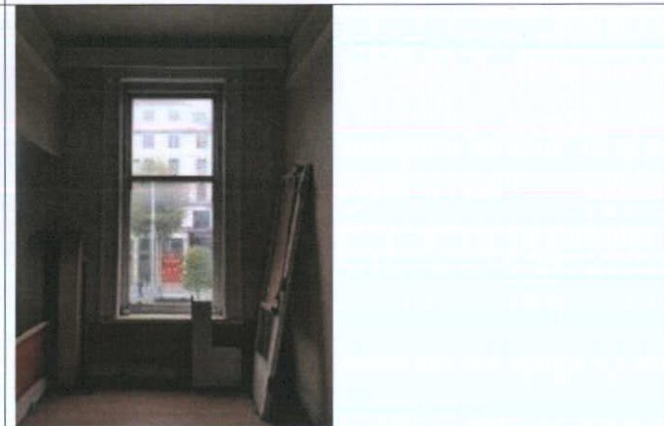
Fig. 52 Timber sash windows with moulded architraves internally and without shutters.

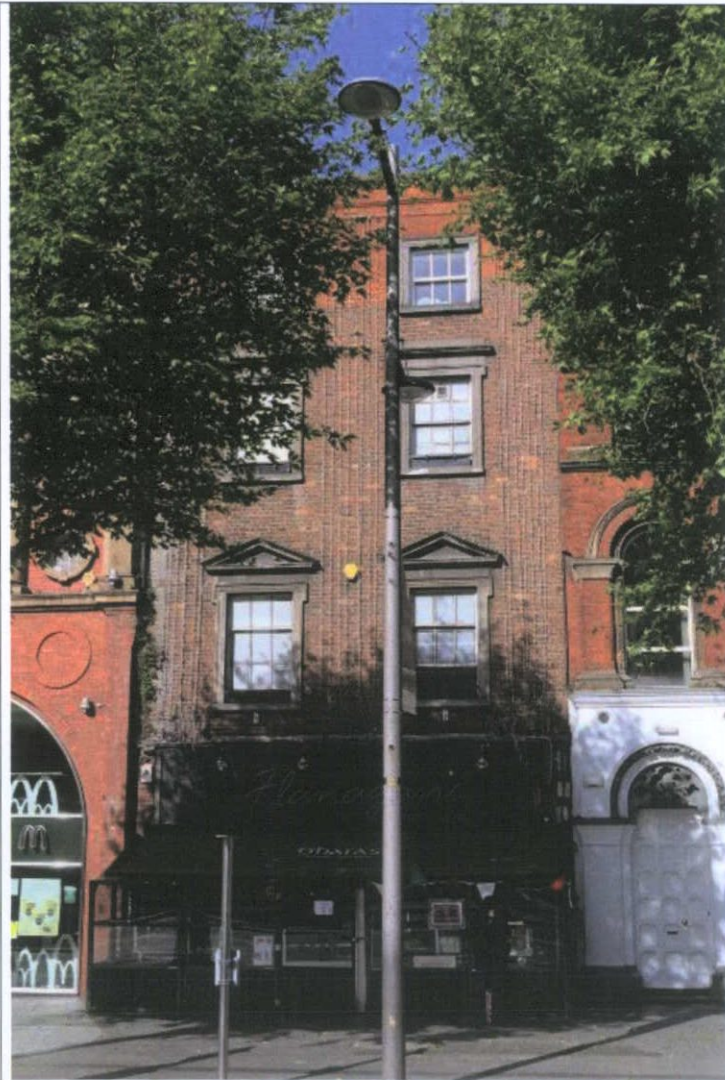
Fig. 53
The upper levels of the existing front façade of No.61 Upper O'Connell Street (a Protected Structure) will be retained and repaired. The later shopfront will be removed and a new, contemporary shopfront installed, incorporating a pedestrian link through the structure from O'Connell Street to Henry Place.

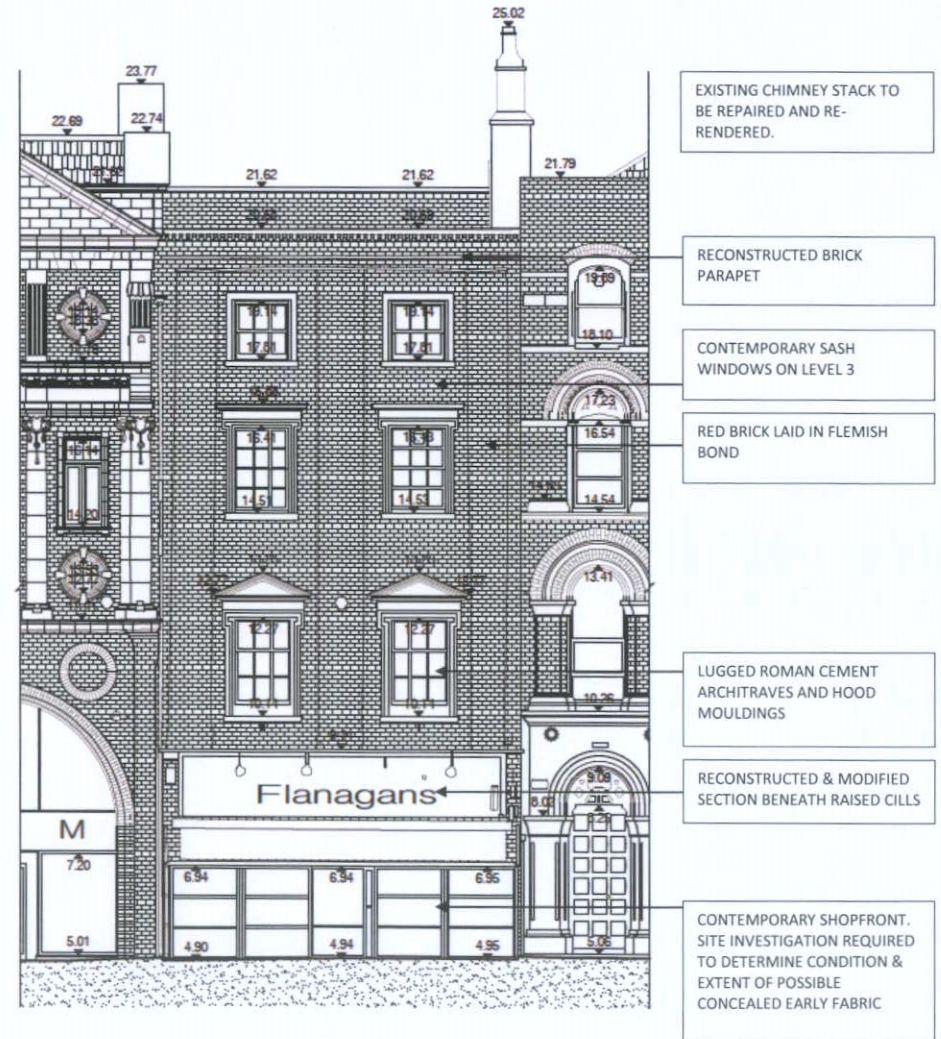
Fig. 54
Illustrative drawings of No.61 Upper O'Connell Street.
Note: Drawings are not to scale. The drawings within this report are for illustrative purposes only. Please refer to detailed drawings submitted with the application for accurate dimensions and information.

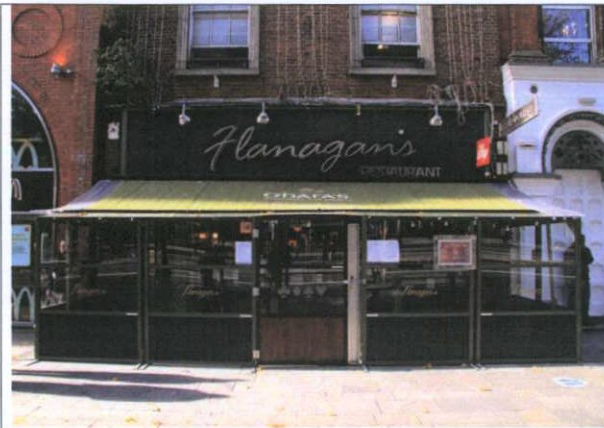
Fig. 55
Contemporary shopfront, with external seating area. Explorative site investigations are required to determine the condition & extent of historic fabric that might be concealed behind the existing shopfront.

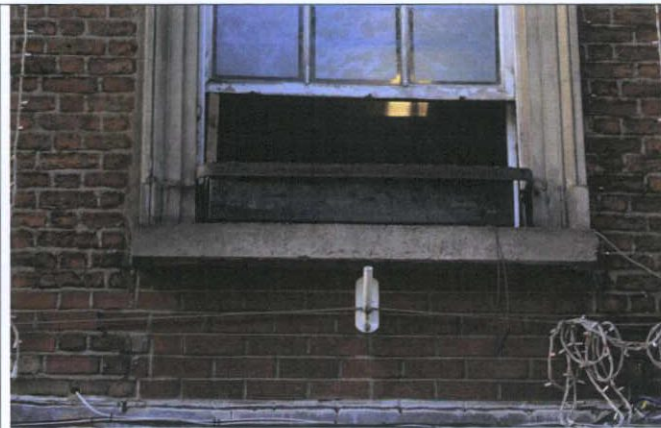
Fig. 56
Note reconstructed / infilled brick below first floor cills. Historic photographs show the design of the earlier windows as having lower cills with scrolling architraves. The first floor windows are not original. The existing composition will be retained and repaired.

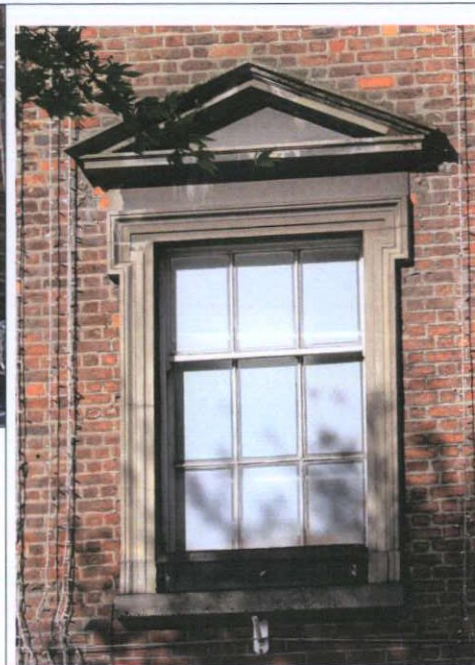
Fig. 57
Level 1 windows: Lugged, Roman cement architraves and hood mouldings, repaired with cement, pedimented to first floor. The architraves will be retained and repaired.

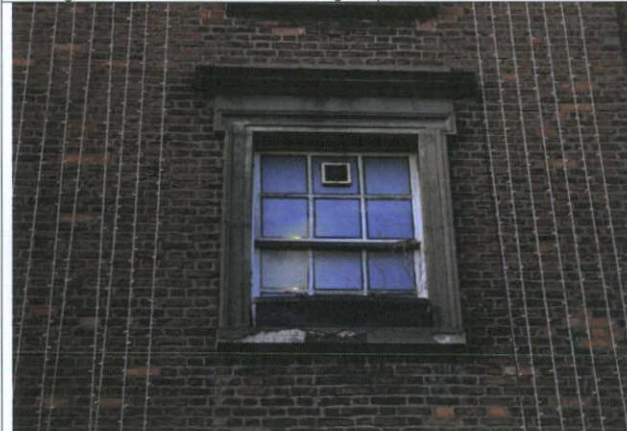
Fig. 58
Level 2 Windows: Moulded Roman cement architraves; granite sills with later rendered finish coat applied, and now failing. The architraves will be retained and repaired.

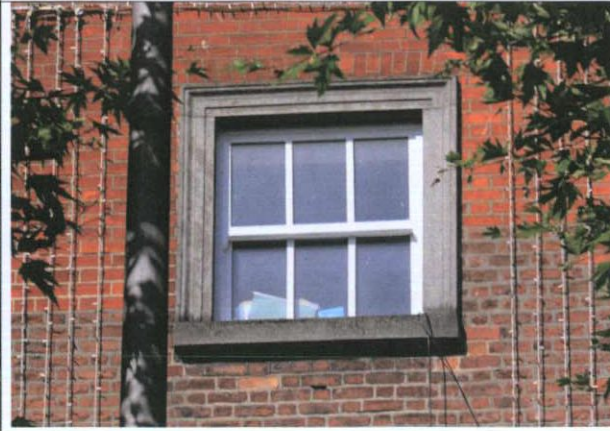
Fig. 59
Level 3 windows: Roman cement architraves. Recent sash windows have been installed at third floor, not matching original window profiles. Historic photos depict the earlier timber sashes as having slimmer profiles with 4 over 4 fenestration pattern. It is proposed to replace the 3rd floor windows with a new timber sash to match the original. Architraves will be repaired.

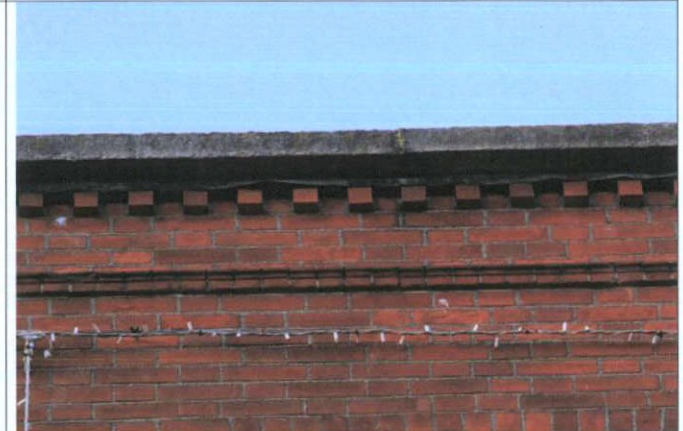
Fig. 60
Detail of the reconstructed parapet, with granite coping on flashing and dentil brick cornice. The brickwork and granite coping will be repointed.

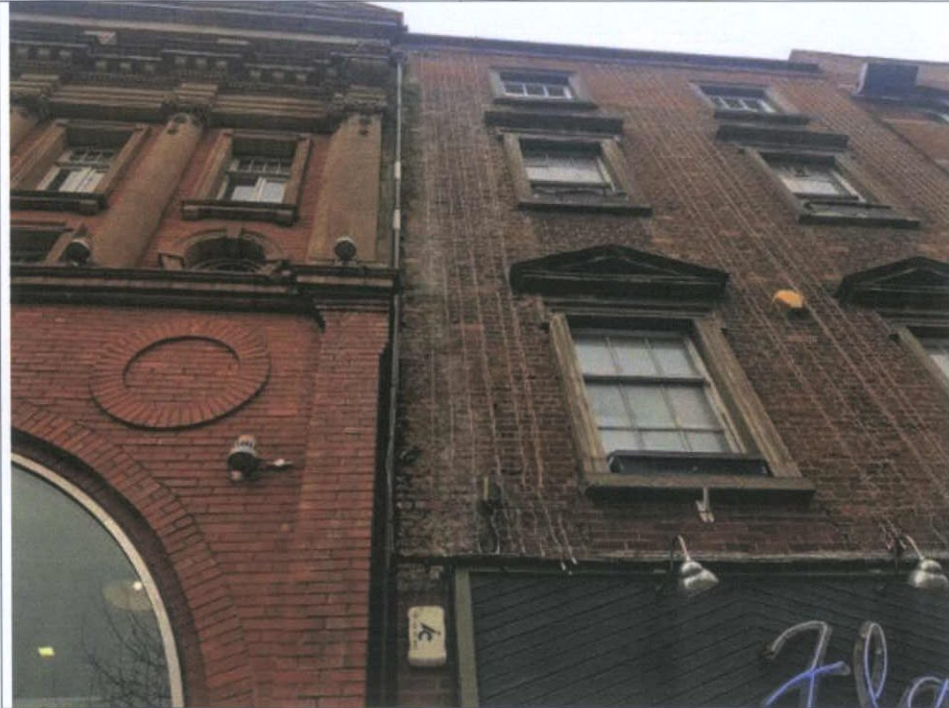
Fig. 61
Detail of eroded pointing and decayed brick behind the rainwater downpipe. The rainwater downpipe will be repaired and replaced to match original profile. Biocide will be applied and vegetation removed. The affected brickwork will require repair and repointing.

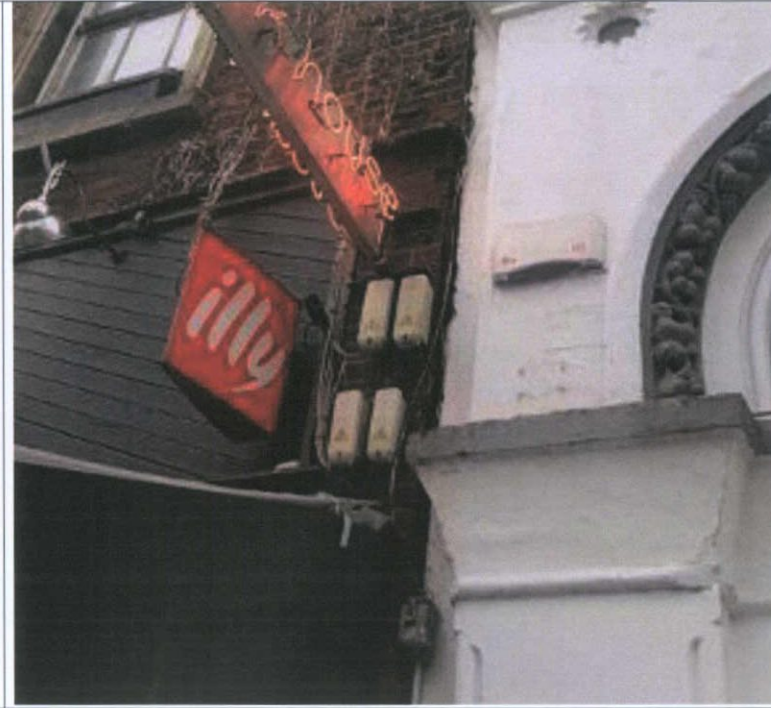
Fig. 62
Detail of contemporary brick positioned in front of the fascia and shopfront. Underlying fabric to be inspected for surviving historic fabric. It is clear from examination of historic photographs that the early 20th century shopfront has either been significantly altered or previously altered.
