East Meath - North Dublin Grid Upgrade Environmental Impact Assessment Report (EIAR): Volume 3

Appendix A10.3 – Watercourse Data

EirGrid

March 2024

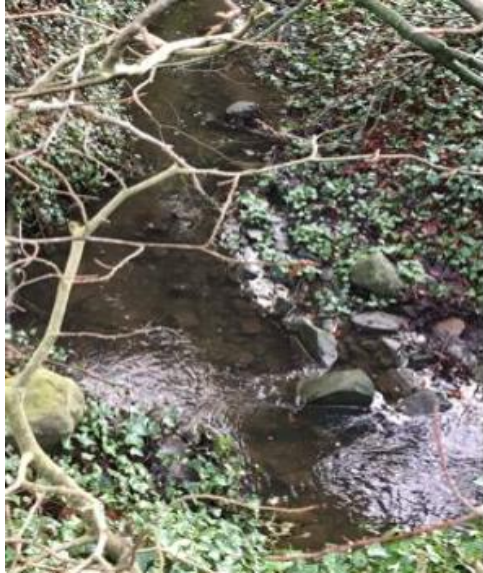
EIAR Naming Convention	Waterbody Name	
WB01	TOLKA_020

EIAR Naming Convention	Water Body Name	Approximate Chainage	Location NGR	XY Coordinates (ITM)	Lat and Long	WFD Status	Field Survey Visual Assessment	Ecological Sensitivity Category	Survey	eDNA Survey Notes	eDNA Results	Aquatic Invasives
WB01	TOLKA_020	1,250	N 94742 47221	694685, 747244	53.466729, -6.5739546	Moderate	Potential for eel. Trout (sub-optimal), brook lamprey (possible) and WCC. No spawning gravels. Associated ditch crosses road. Downstream section ditch runs to the left of the road. Overdeep, approx. 30cm wide and 5cm deep. Likely ephemeral. No outfall seen. No fish (salmon, trout) likely. No WCC likely. Upstream section more ditch like than downstream and less likely to host fish.	Local (Higher Value)	no eDNA surveys carried out	N/A	N/A	None
WB02	DUNBOYNE STREAM_010	2,175	N 94483 46404	694426 746427	53.459436, -6.5780991	Poor	Watercourse width about 1.5m overall with mixed flows and substrates and depths. Highly polluted. Mostly shaded over length and no macrophytes seen. Potential for invertebrates and WCC. Otter possible but unlikely due to pollution. Culvert/bridge apron unpassable for all fish.	Local (Higher Value)	no eDNA surveys carried out	N/A	N/A	None

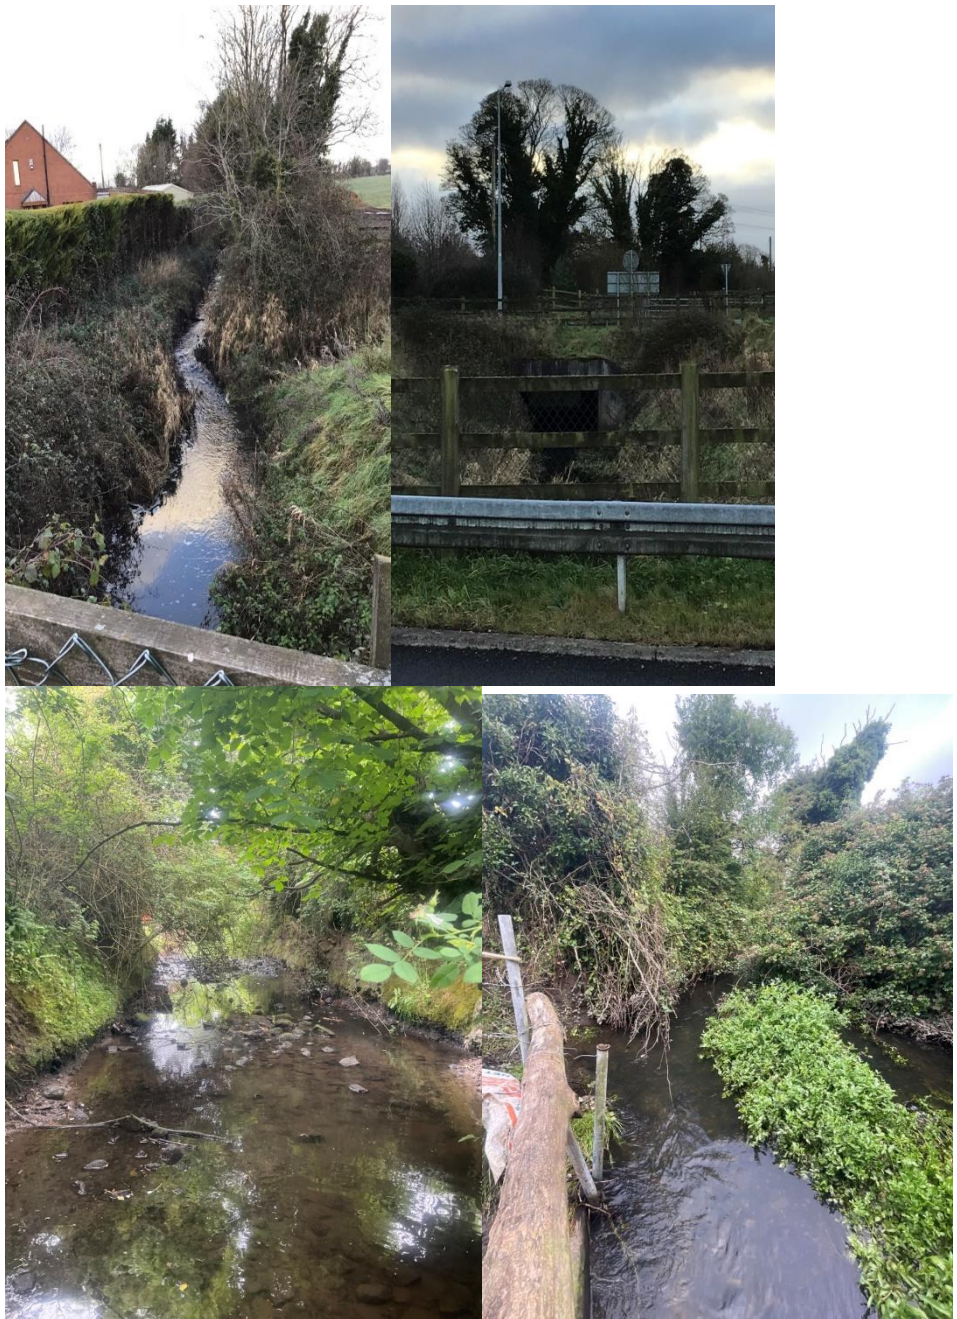
EIAR Naming Convention	Waterbody Name	
WB03	DUNBOYNE STREAM_010

DD05	Drainage ditch	9,100	N 99022 43376	698964, 743399	53.431403 -6.5107316	N/A	Shallow, overgrown, shadowed by vegetation, dry, not possible not possible to visually assess due to H&S considerations.	Local (Lower Value)	no eDNA surveys carried out	N/A	N/A	None
WB03	DUNBOYNE STREAM_010	10,800	O 00537 42674	700479, 742698	53.424811, -6.4881675	Poor	Approx 3m wide, 0.5m deep but hard to see clearly from road, little overhanging vegetation moderate flow, culverted under roundabout. Description from slightly upstream: River: 3m wide, moderate flow, deep (can't see bottom), riparian vegetation: bramble, canary reed grass, Hawthorn, thistle, ash, nettles. Description from 170m upstream: no turbidity, 15% run, 5% riffle, 60% glide, 20% pool, bank Covered in vegetation, lined by treeline and hedgerow, mostly ivy and mosses on banks. Roots visible. Water cress present. Algae on rocks, mosses. Bank height 250cm, undercutting and erosion present, 20% silt, 5% sand, 10% gravel, 30% pebble, 15% cobble, 5% boulder, 15% overlying silt, channel width 550cm, wet width 500cm, >75% shading, gradient channel.	Local (Higher Value)	eDNA survey carried out	Sample taken 09.08.2023 Sample ID: CP1021WC3 Sample Location: 53.4269009, -6.4901190	Minnow, three-spined stickleback No WCC	None

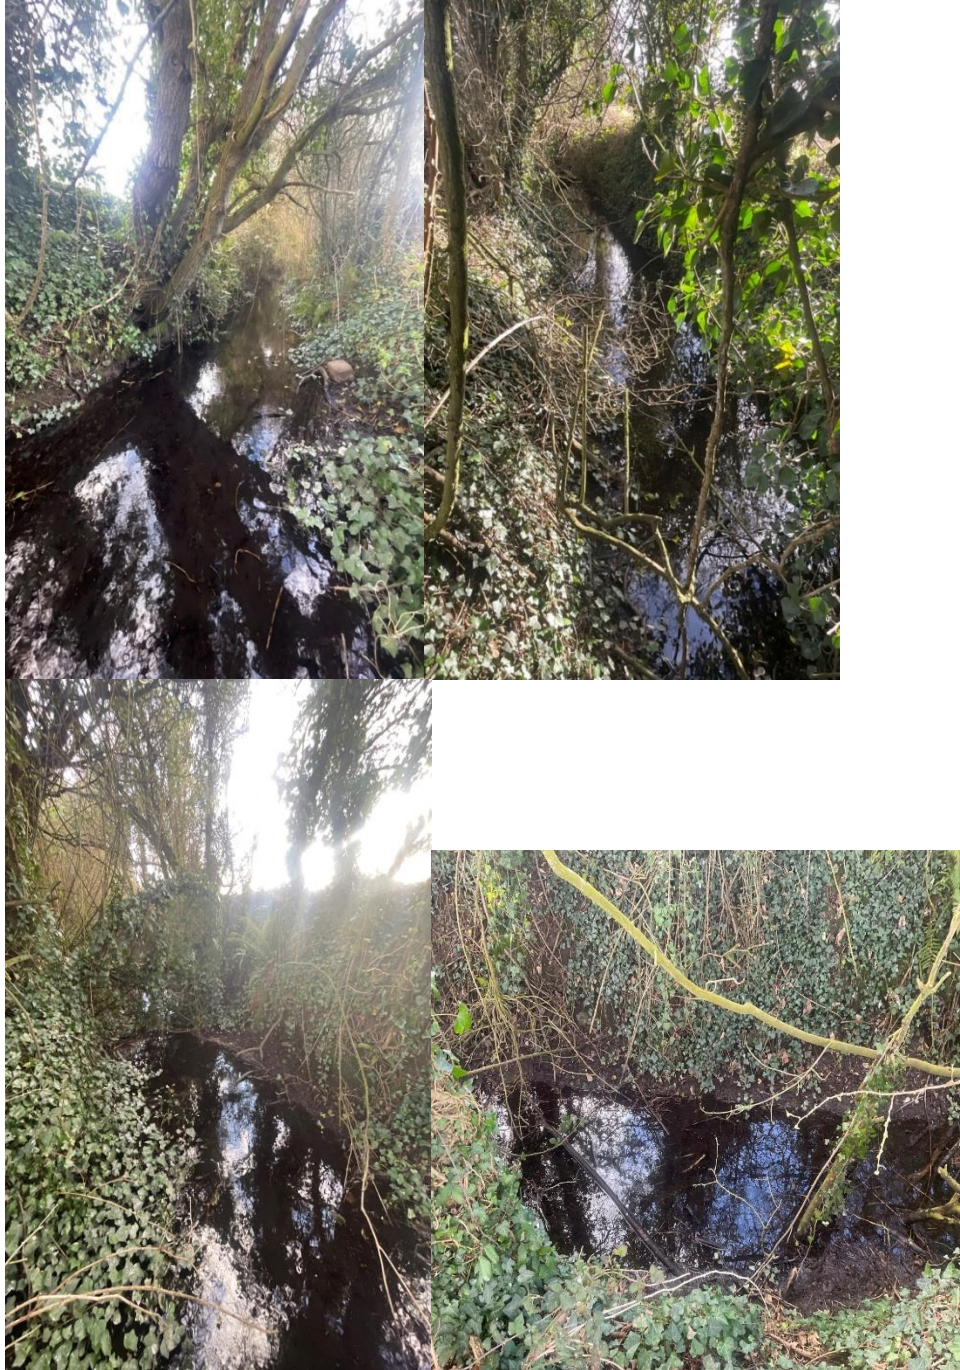
EIAR Naming Convention	Waterbody Name	
WB04	TOLKA_020

WB04	TOLKA_020	11,640	O 01119 43261	701061, 743285	53.429973, -6.4792265	Moderate	Need access on other side of bypass to see all of it. Only surveyed north of bypass. 10cm water depth, 2.5m bank height, 2.5m channel width, 2m wet width, predominantly silt substrate composition with organic matter present, no turbidity, mainly glide and pool composition, heavily shaded by trees and scrub, no floodplain connectivity, minimal undercutting present, no erosion seen, ivy and tree roots visible. Adjacent to sheep grazing field. 10% run, 65% glide, 25% pool. 60% silt, 20% sand, 5% gravel, 15% overlying silt, >75% shading.	Local (Higher Value)	eDNA survey carried out	Sample taken 09.08.2023 Sample ID: CP1021WC4 Sample Location: 53.4308718, -6.4799618	Three-spined stickleback No WCC	None
WB05	TOLKA_020	12,550	O 01655 43968	701597, 743991	53.436221, -6.4709366	Moderate	Accessed from field to south of watercourse, not visible from rail carpark north of watercourse due to fencing. 50cm water depth, 2m bank height, 4.5m channel width, 4m wet width, predominantly silt substrate composition with some gravel, pebble, and organic matter present, some turbidity, mainly glide with some pools and runs, heavily shaded by trees and scrub in most parts but some open sections, no floodplain connectivity, undercutting present, no erosion seen, tree roots	Local (Higher Value)	eDNA survey carried out	Sample taken 09.08.2023 Sample ID: CP1021WC5 Sample Location:	Minnow, stone loach, three-spined stickleback, trout, lamprey spp. (river or brook)	None

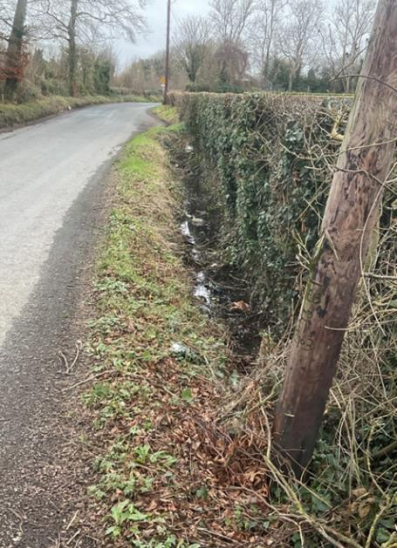
EIAR Naming Convention	Waterbody Name	
DD10	Drainage ditch

DD10	Drainage ditch	14,950	O 03051 44509	702993, 744532	53.440810, - 6.4497597	N/A	North side of road: 0.5m wide, organic matter, bank height 1m.	Local (Higher Value)	no eDNA surveys carried out	N/A	N/A	None
DD11	Drainage ditch	15,000	O 03114 44494	703056, 744517	53.440663, - 6.4488168	N/A	North side of road: 40cm wide, 1m bank height, dry, overgrown, hedgerow and grassy verge, low ecological value.	Local (Lower Value)	no eDNA surveys carried out	N/A	N/A	None
DD12	Drainage ditch	15,000	O 03114 44494	703056, 744517	53.440663, - 6.4488168	N/A	South side of road: 2m wide, 15cm deep, bank height 2m, overshadowed by vegetation, no flow, low - moderate ecological value.	Local (Higher Value)	no eDNA surveys carried out	N/A	N/A	None
DD13	Drainage ditch	15,125	O 03228 44468	703170, 744491	53.440404, - 6.4471096	N/A	Dry. 0.5m wide, bank height 0.5m, overgrown.	Local (Lower Value)	no eDNA surveys carried out	N/A	N/A	None

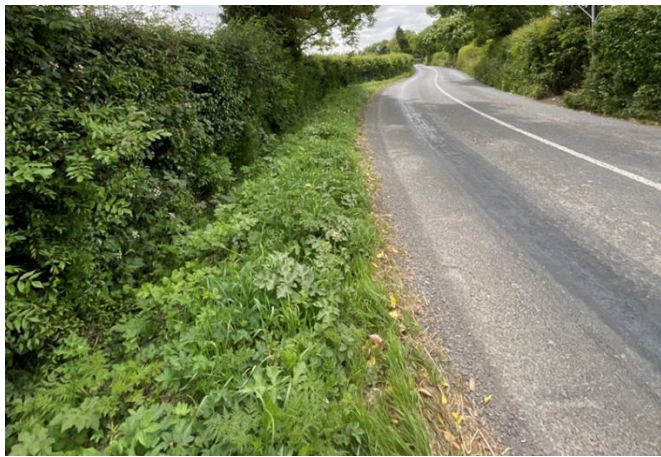
DD14	Drainage ditch	15,490	O 03522 44671	703464, 744694	53.442173, - 6.4426206	N/A	Dry. Approx 1m deep, 0.5m wide, filled with vegetation.	Local (Lower Value)	no eDNA surveys carried out	N/A	N/A	None
DD15	Drainage ditch	15,640	O 03609 44793	703551, 744816	53.443252, - 6.4412715	N/A	0.5m wide, overgrown m bank height 0.5m, dry, low ecological value. Same on opposite side of road.	Local (Lower Value)	no eDNA surveys carried out	N/A	N/A	None
DD16	Drainage ditch	15,780	O 03677 44919	703619, 744942	53.444370, - 6.4402070	N/A	Ditch runs behind hedgerow for most of this section of road but is present on the road side of the hedgerow in this mapped section. Completely dry, overgrown, grassy verge and hedgerow either side, 0.5m wide, 1m deep, low ecological value.	Local (Lower Value)	no eDNA surveys carried out	N/A	N/A	None
WB06	PINKEEN_010	16,100	O 03952 45039	703894, 745062	53.445394, - 6.4360298	Moderate	Viewed from field to north of watercourse however view there obstructed by scrub, accessed via garden south of it. 25cm water depth, 2m bank height, 2m average channel width but widens up to approx. 5m at points, 1.7m average wet width, predominantly silt substrate composition with pebble as well as small amounts of sand, gravel, cobble, boulder, and organic matter present, no turbidity, mainly glide with some pools and runs, heavily shaded by trees, scrub and herbaceous vegetation but some open sections, no floodplain connectivity, minimal undercutting present, no erosion seen, tree and ivy roots visible. Landowner said river name came from "Pinkeen" fish being present in it previously. Pinkeens are small fish such as minnow and stickleback. 15% run, 65% glide, 20% pool. 55% silt, 5% sand, 5% gravel, 20% pebble, 5% cobble, 5% boulder, 5% overlying silt, 50-75% shading. BRP in cracks in bridge in garden.	Local (Higher Value)	eDNA survey carried out	Sample taken 09.08.2023 Sample ID: CP1021WC6 Sample Location: 53.4454301, - 6.4359310	Three-spined stickleback, otter No WCC	None

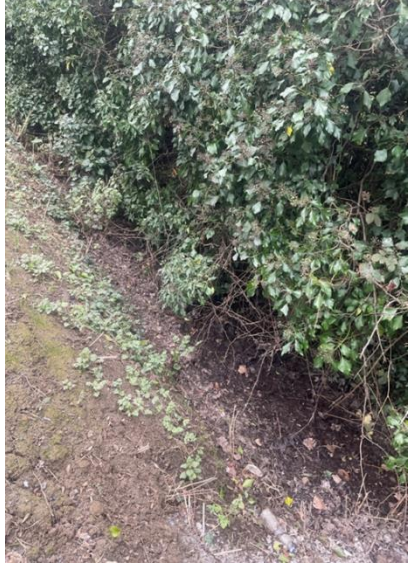
EiAR Naming Convention	Waterbody Name	
DD17	Drainage ditch

DD17	Drainage ditch	16,225	O 04019 45043	703961, 745066	53.445417, - 6.4350204	N/A	Damp, 0.5m wide, bank height 1.5m, overgrown, overshadowed by hedgerow in parts, low ecological value.	Local (Higher Value)	no eDNA surveys carried out	N/A	N/A	None
WB07	PINKEEN_010	16,350	O 04095 44965	704027, 745069	53.445431, - 6.4340264	Moderate	Viewed from fields both north and south of crossing point Flowing south, 30cm water depth, 2.5m bank height, 3m channel width, 2.5m average wet width, predominantly silt substrate composition with some gravel, pebble, cobble and artificial substrate present too, organic matter present, no	Local (Higher Value)	eDNA survey carried out	Sample taken 09.08.2023 Sample ID: CP1021WC7	Three-spined stickleback No WCC	None

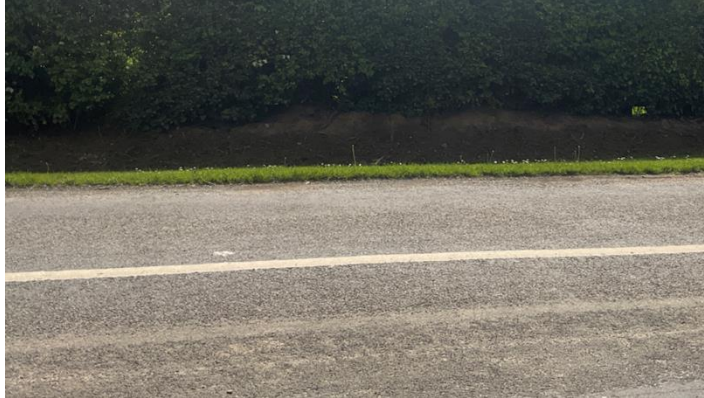
EIAR Naming Convention	Waterbody Name	
DD19	Drainage ditch

DD19	Drainage ditch	17,190	O 04847 44989	704789, 745012	53.444768, - 6.4225803	N/A	Dry. Overgrown, shallow, hedgerow adjacent, low ecological value.	Local (Lower Value)	no eDNA surveys carried out	N/A	N/A	None
DD20	Drainage ditch	17,400	O 05003 45089	704945, 745112	53.445635, - 6.4201998	N/A	Dry, 0.5m wide, 1m bank height, organic matter in ditch, hedgerow one side, grassy verge the other, low ecological value.	Local (Lower Value)	no eDNA surveys carried out	N/A	N/A	None
DD21	Drainage ditch	17,550	O 05084 45192	705026, 745215	53.446544, - 6.4189467	N/A	0.5m wide, 0.5m bank height, overgrown, grassy verge on road side, hedgerow on other side, low ecological value.	Local (Lower Value)	no eDNA surveys carried out	N/A	N/A	None
DD22	Drainage ditch	17,610	O 05121 45242	705063, 745265	53.446986, - 6.4183733	N/A	Ditch starts on south side of road, slightly damp, overgrown, 0.5m wide, bank height 0.5m, low ecological value. Ditch deepens slightly on north side of road, damp, overgrown, width 0.5m, bank height 0.5m, low ecological value.	Local (Lower Value)	no eDNA surveys carried out	N/A	N/A	None

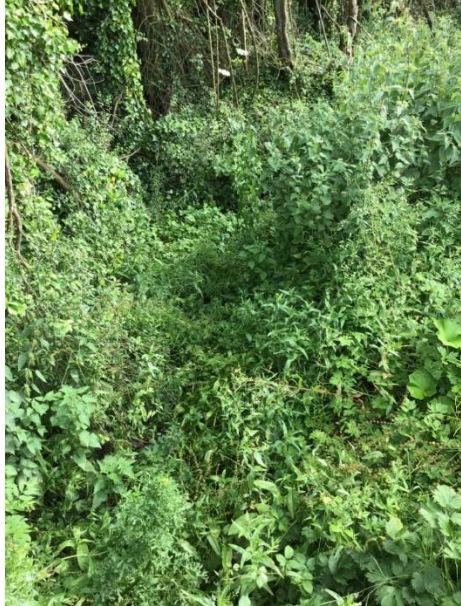
EIAR Naming Convention	Waterbody Name	
WB09	WARD_010

WB09	WARD_010	18,200	O 05634 45422	305634, 245422	53.4485, - 6.4106	Poor	Watercourse is mapped on EPA mapper but was not visible during field surveys. Likely culverted under road at this point. Further north of the crossing point seemed to be linked to ditch along field. Further south of crossing point it links up with Watercourse 9b which then flows towards Watercourse 10. Ditch north of crossing point completely filled with vegetation and dry, 1m wide, 2m bank height, lined by cut back hedgerow and bare ground, no flow, filled with organic matter and cuttings, no ecological value. Ditch south of crossing.	Local (Lower Value)	no eDNA surveys carried out	N/A	N/A	None
WB10	WARD_010	18,200	O 05653 45452	705594, 745475	53.448766, - 6.4103043	Poor	Viewed from woodland north of crossing point 25cm water depth, 5m bank height, 3m channel width, 2.8m wet width, predominantly silt and pebble substrate composition with gravel and cobble substrate present too, some organic matter present, no turbidity, mainly glide with a significant amount of riffles and runs, moderate flow, heavily shaded by trees as within woodland, as well as scrub, no floodplain connectivity, undercutting present, low amounts of erosion seen, tree and ivy roots visible. 30% run, 25% riffle, 40% glide, 5% pool. 25% silt, 5% sand, 15% gravel, 25% pebble, 15% cobble, 5% artificial, 10% overlying silt. >75% shading Rhododendron recorded along watercourse. Bridge with BRP within watercourse	Local (Higher Value)	eDNA survey carried out	Sample taken 09.08.2023 Sample ID: CP1021WC9 Sample Location: 53.4490245, - 6.4098697	Three-spined stickleback No WCC	None

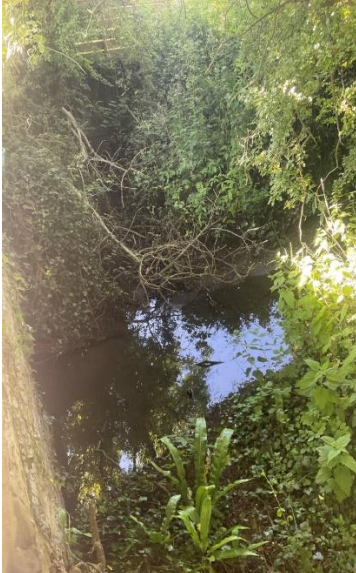
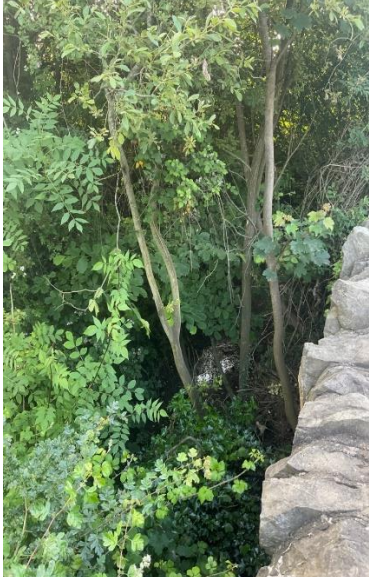
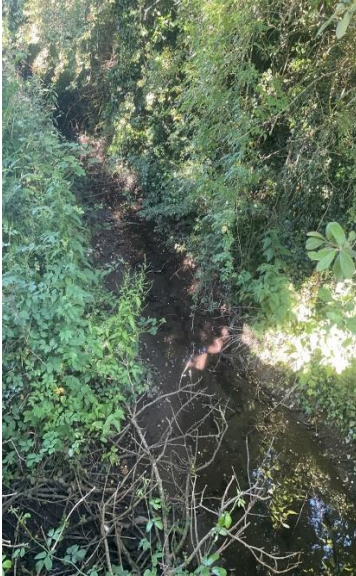
EIAR Naming Convention	Waterbody Name		
WB12	WARD_020

WB12	WARD_020	20,450	O 07317 44650	707259, 744673	53.441226, -6.3855333	Moderate	Land access needed. Crossed by route 3 times in 350m. Water depth 10cm, no turbidity, 0% run, 0% riffle, 25% glide, 75% pool, 0% torrent, 0% cascade, 0% slack, bank lined by trees, scrub, herbaceous vegetation, ivy creeping in, quite bare. 200cm bank height, no floodplain connectivity, no undercutting, no erosion, roots present, overhanging vegetation present (trees, scrub), 50% silt, 10% sand, 10% gravel, 5% pebble, 25% overlying silt. Channel width 350cm, wet width 150cm, >75% shading.	Local (Higher Value)	eDNA survey carried out (where 11a/b/c meet)	Meeting point: Sample taken 10.08.2023 Sample ID: CP1021WC11 Location: 53.4415688, -6.3820998	Results of sample at meeting point: Three-spined stickleback No WCC	None
WB13	WARD_020	20,650	O 07378 44541	707320, 744564	53.440235, -6.3846528	Moderate	Low flow, 2-3m wide, sheltered by overhanging vegetation, no amphibian potential but moderate ecological potential (commuting otter potential). Depth 30-40cm.	Local (Higher Value)	eDNA survey carried out (2 samples - at 11b and where 11a/b/c meet)	Sample taken 10.08.2023 Sample ID: CP1021WC11b Sample Location: 53.4404226, -6.3846911 Meeting point: Sample taken 10.08.2023 Sample ID: CP1021WC11 Location: 53.4415688, -6.3820998	Three-spined stickleback No WCC Results of sample at meeting point: Three-spined stickleback No WCC	None

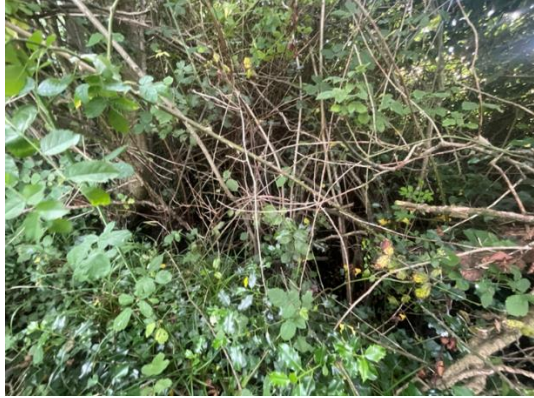
WB14	WARD_020	20,850	O 07489 44351	707431, 744374	53.438505, -6.3830477	Moderate	Assessed on both sides of route, not a watercourse, a ditch with no ecological value. North of route description: Dry ditch, mostly inaccessible due to dense hedgerow. 2.5m drop, littered with leaves and little veg. Entirely shaded, 1.5m wide. No flow, no ecological potential. South of route description: Not visible, approx. 1.5m high, 1m wide, likely dry, completely covered by vegetation, likely contains runoff from field, low ecological value.	Local (Lower Value)	eDNA survey carried out (where 11a/b/c meet)	Meeting point: Sample taken 10.08.2023 Sample ID: CP1021WC11 Location: 53.4415688, -6.3820998	Results of sample at meeting point: Three-spined stickleback No WCC	None
DD25	Drainage ditch	21,300	O 07758 44011	707700, 744034	53.435396, -6.3791174	N/A	Approx 2-3m height, slightly damp, wet depth approx. 5cm, 1m wide, overshadowed by hedgerow, no flow visible, dumping present, organic matter, low ecological potential. Contains watercress and greater willowherb, duckweed, water starwort. Potential to be amphibian breeding habitat.	Local (Higher Value)	eDNA survey carried out	Attempted to sample on 10.08.2023 but could not as vegetation was too overgrown to access water. Had amphibian breeding potential	Could not sample, vegetation too overgrown	None

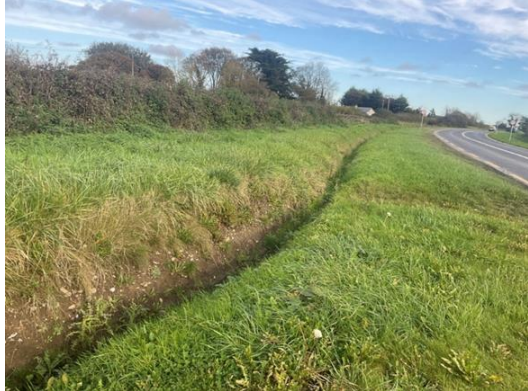
EIAR Naming Convention	Waterbody Name	
DD32	Drainage ditch

DD32	Drainage ditch	31,040	O 15747 44696	715688, 744719	53.439858, - 6.2587003	N/A	both sides of road, >0.5m wide, vegetated banks.	Local (Higher Value)	no eDNA surveys carried out	N/A	N/A	None
WB22	SLUICE_010	31,780	O 16415 44423	716356, 744446	53.437259, - 6.2487527	Poor	Surveyed downstream but not at crossing point (looks to be culverted under road). Downstream description: width 1m, depth >0.5m, slow current, moderate pollution (on golf course), Majority in woodland, shaded by vegetation, juvenile stickleback, fine gravel substrate so poor for spawning, approx. 50cm wet width, sand gravel pebble with small number of cobbles. Stepped at artificial pond so would impede fish movement. It was 80% silt, 5% overlying silt and 5% sand. 20% pool and 80% glide. It was 95% shaded with bramble, ash, hawthorn, winter heliotrope, nettle and male fern.	Local (Higher Value)	eDNA survey carried out	Sample taken 10.08.2023 Sample ID: CP1021WC23 Sample Location: 53.4376308, - 6.2364498	European eel, three-spined stickleback No WCC	None
