PEAT STABILITY RISK ASSESSMENT

Peat Stability Risk Assessment (PSRA) for Kilgarvan Wind Farm Repowering

Client	MKO
Document Ref.	22022-R-01-PSRA-02
Project Title	Kilgarvan Wind Farm Repowering
Date	11/01/2024

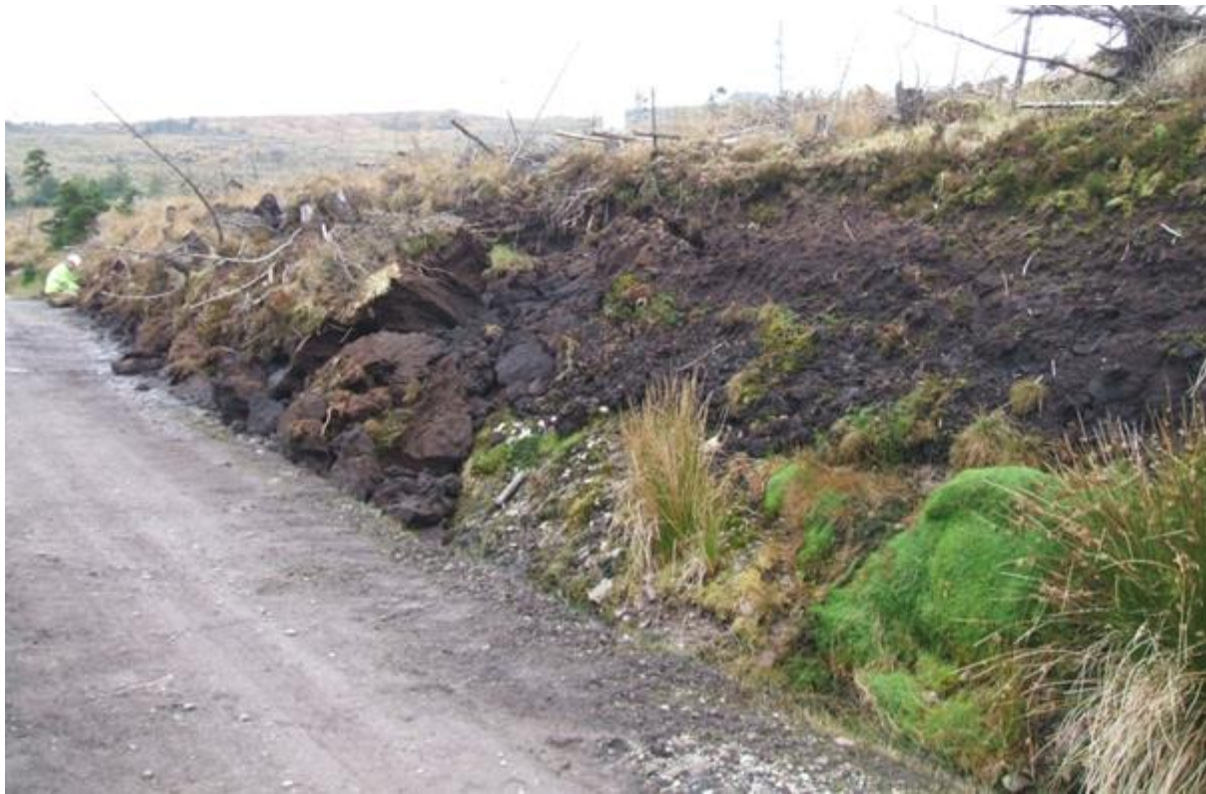
A peat slide event occurred at the site of the Existing Kilgarvan Wind Farm in 2012. A forensic report outlining the potential causes mitigation and remediation of this landslide event is outlined in a forensic report “*Geotechnical site assessment Report for Kilgarvan Windfarm*” by Applied Ground Engineering Consultants (AGEC Ltd) in October 2012. According to the report, the landslide was caused by several contributing factors mainly an excessive volume of rainfall over a short period of time, the unmanaged release of drainage water onto a peat surface, and a steep road cutting. The findings of the AGEC 2012 report and the subsequent GDG inspection of the failure area are summarised in Sections 2.8.1 and 3.1 respectively. Figure 1-2 shows a photo of the impacts of the 2012 landslide in the immediate aftermath of the failure.

Figure 1-2: Photo of effects of 2012 landslide (AGEC, 2012)

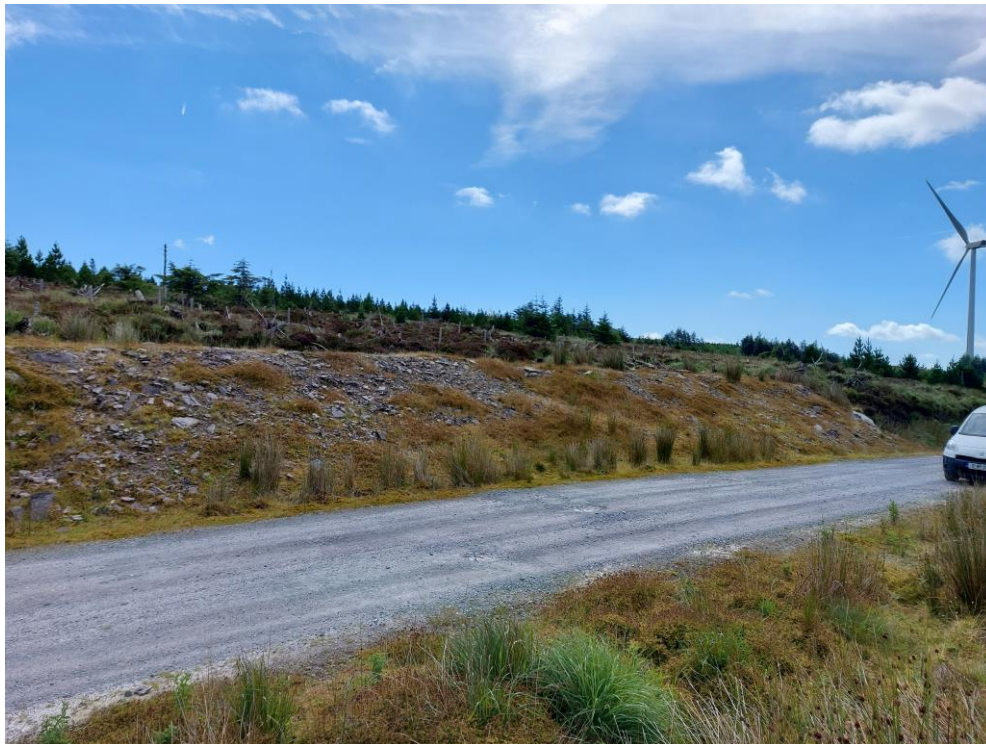
Figure 3-3: Photo of stone buttress at 2012 peat failure location.

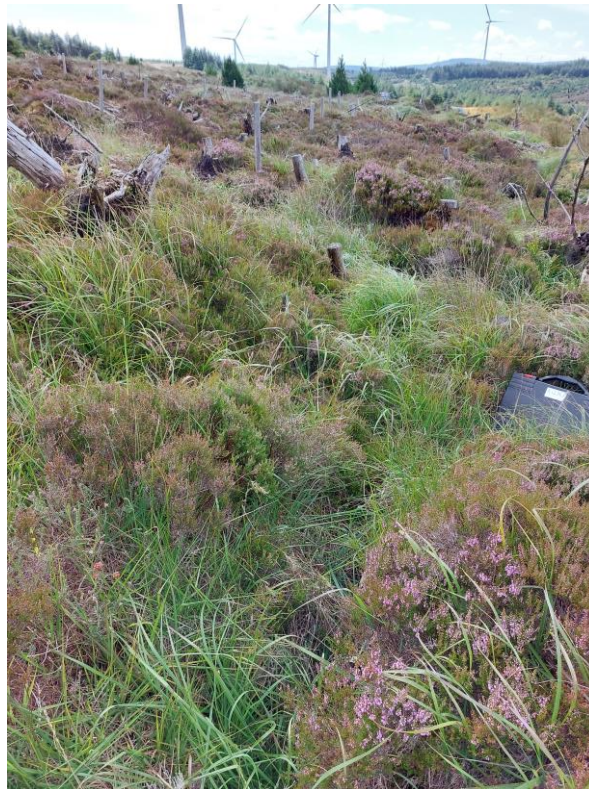
- Some evidence of surface peat cracking and deformation was visible in the area uphill of the stone buttress. It is not apparent if these surface cracks are recent or from the original peat failure.
- Timber posts thought to be monitoring posts were present at the site (Figure 3-4). These are generally spaced approximately 5m apart and appear relatively straight and without large deviation. However, some rows were incomplete and missing posts. It is not defined if these are monitoring posts or if they were installed for another reason such as tree planting or fencing.
- Vegetation is present in the area of the failure and evidence of the failure or subsequent movements may have since disappeared due to vegetation regrowth/coverage.

Figure 3-4: Peat surface cracks. Note monitoring posts in background of photo.

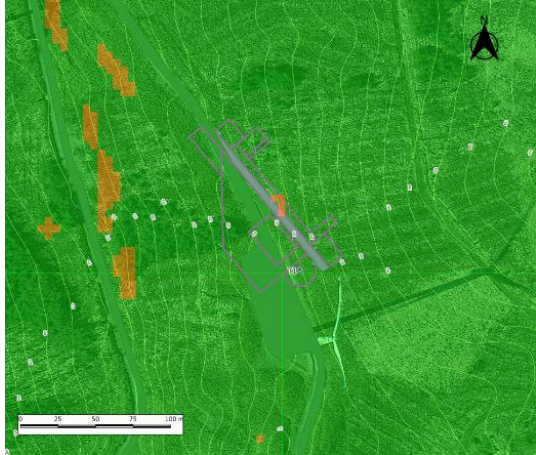
Location	Risk and mitigation	Undrained surcharged FoS analysis
T1	<p>The area at the hardstand for T1 suggests a FoS <1.3 with the application of a surcharge. This instability is caused by local variation in the slope in an area of little to no peat (>0.5m depth). Having inspected the site during a site walkover, this is not all considered to be a true risk area. The area surrounding Turbine 1 is thought to be suitable for construction and diligent peat reinstatement.</p>

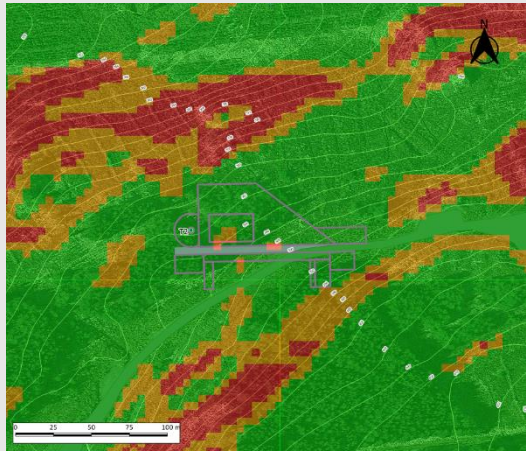
T2	<p>The area at the hardstand for T2 suggests a FoS <1.3 with the application of a surcharge. The low FoS results here are caused by a localised area of deep peat (~2m). Much of the hardstand area is proposed for excavate and replace, so should be stabilised by excavating to a bearing strata. The area downslope of the T2 hardstand indicates a Factor of safety results <1.3 and <1.0 with surcharge. This is due to a steep gradient and variable peat depths of 0m to 1.2m. This area could be vulnerable to propagated landslide with a large clear fetch area. However, the area 10m E of the hardstand and turbine area suggest placement of 1m of peat material is suitable. The area surrounding Turbine 2 is thought to be suitable for construction and diligent peat reinstatement.</p>

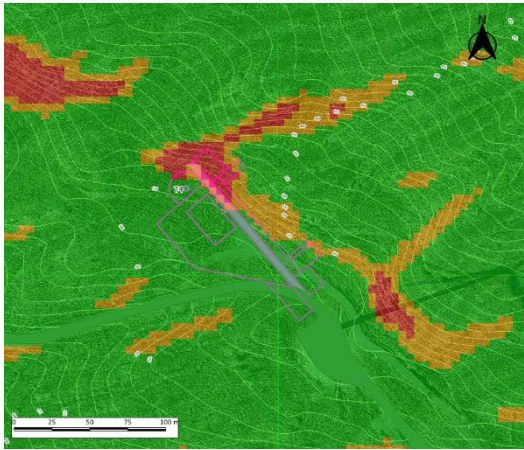
Location	Risk and mitigation	Undrained surcharged FoS analysis
T4	<p>The area at the hardstand for T4 suggests a FoS <1 with the application of a surcharge, and a FoS of <1.3 without surcharge. The lower FoS results here are caused by an existing localised steep bedrock slope face to the north of the hardstand, and a localised area 1.7m to 2m of peat in the northern margins of the hardstand area. The peat here is topographically contained within areas of bedrock outcrop and existing founded road. The peat in these areas will be excavated to a competent stratum for the construction of the hardstand platform, thus eliminating the hazard.</p>

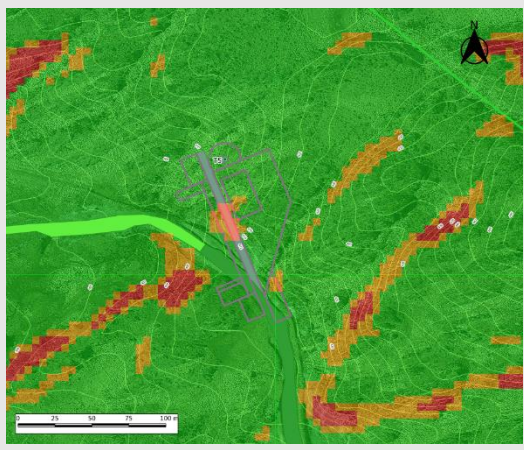
T5	<p>The area at the hardstand for T5 suggests a FoS <1.3 with the application of a surcharge. The lower FoS results here are caused by a localised bedrock ridge with steeply sloping sides. Having inspected the site during a site walkover, this is not all considered to be a true risk area. The area surrounding Turbine 5 is thought to be suitable for construction and diligent peat reinstatement.</p>

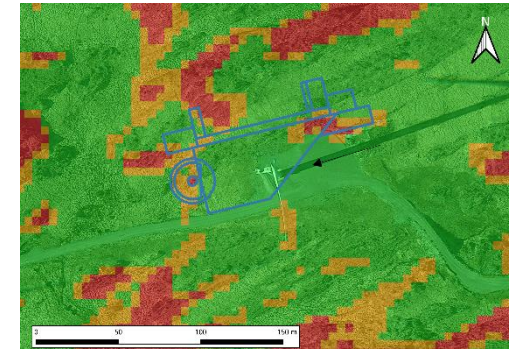
T6	<p>The area around the T6 turbine foundation is highly sensitive, indicating a factor of safety of <1 with the application of surcharge in a small number of pixels. The area of instability is indicated by locally thick peat coverage and steep slopes to the west of the existing hardstand area. The area west of the turbine is a locally deep</p>

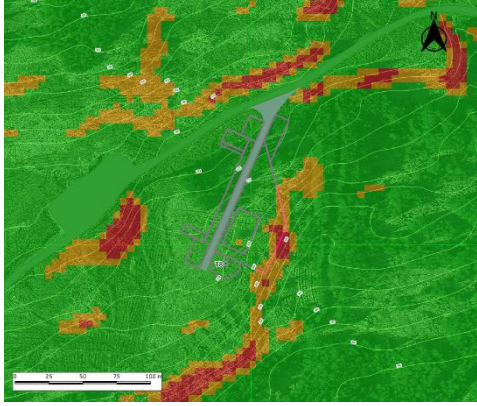
Location	Risk and mitigation	Undrained surcharged FoS analysis
T8	<p>The area at the eastern section of the hardstand for T8 suggests a FoS <1 with the application of a surcharge. The low FoS results here are caused by a localised area of deep peat (~1.9m), and a locally steep slope, which a site walkover confirmed was largely bedrock at the surface. The peat in these areas will be excavated to a competent stratum for the construction of the hardstand platform. Due to the steep nature of the topography, the storage of peat material should be restricted at the eastern, downslope side of the T8 turbine and hardstand area.</p>

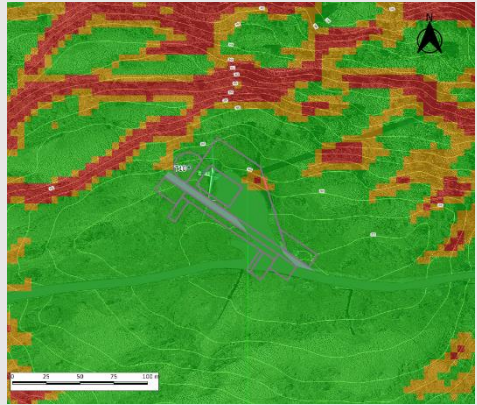
T10	<p>The area at the northeastern edge of the hardstand for T10 suggests a FoS of <1 with the application of surcharge. The low FoS results here are caused by local peat depths of ~1m, along with a locally steep bedrock slope. The hardstand area is predominantly located on the existing turbine hardstand and surrounding shallow bedrock. Due to the steep nature of the topography, the storage of peat material should be restricted at the northern slopes of the T10 turbine and hardstand area.</p>

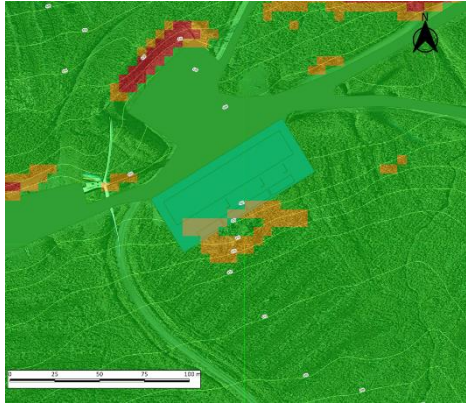
Location	Risk and mitigation	Undrained surcharged FoS analysis
Eastern temporary construction compound	<p>The southern section of the eastern construction compound suggests a FoS of <1.3 with the application of surcharge. The lower FoS results here are caused by a localised bedrock and engineered fill slope from the existing road and hardstand. Having inspected the site during a site walkover, this is not all considered to be a true risk area. The area surrounding the eastern temporary construction compound is thought to be suitable for construction and diligent peat reinstatement.</p>

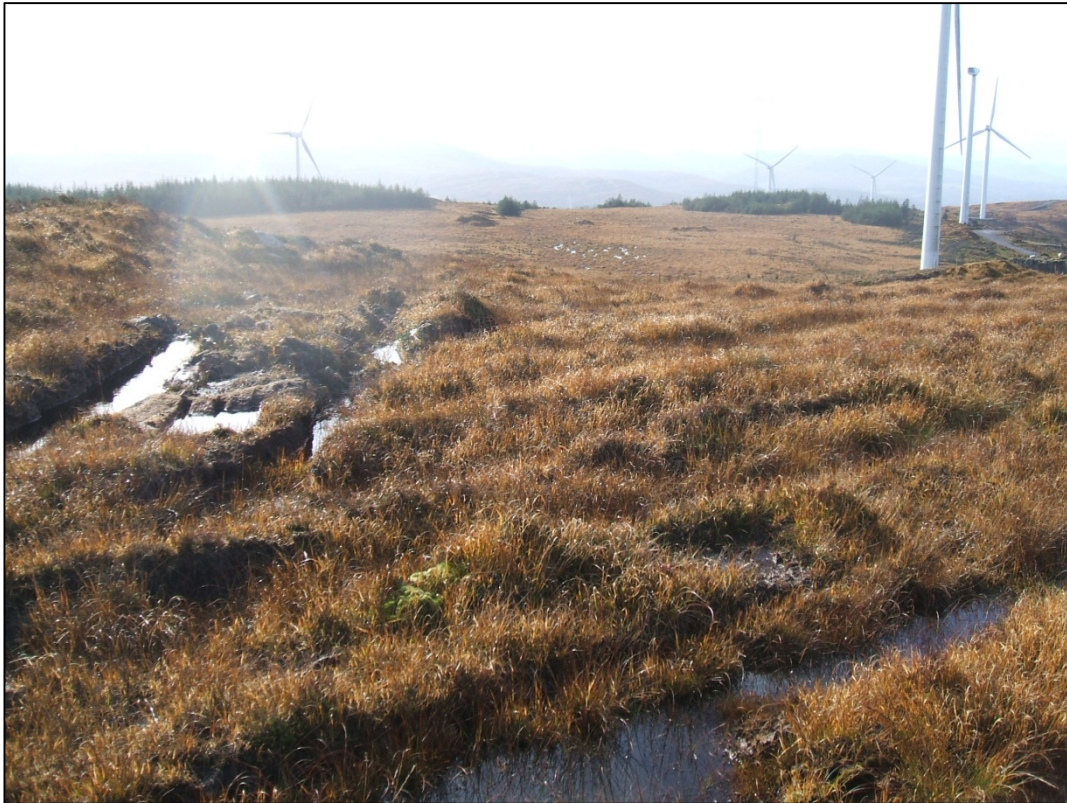
Photo 3 Mechanically cut peat northwest of turbine T3

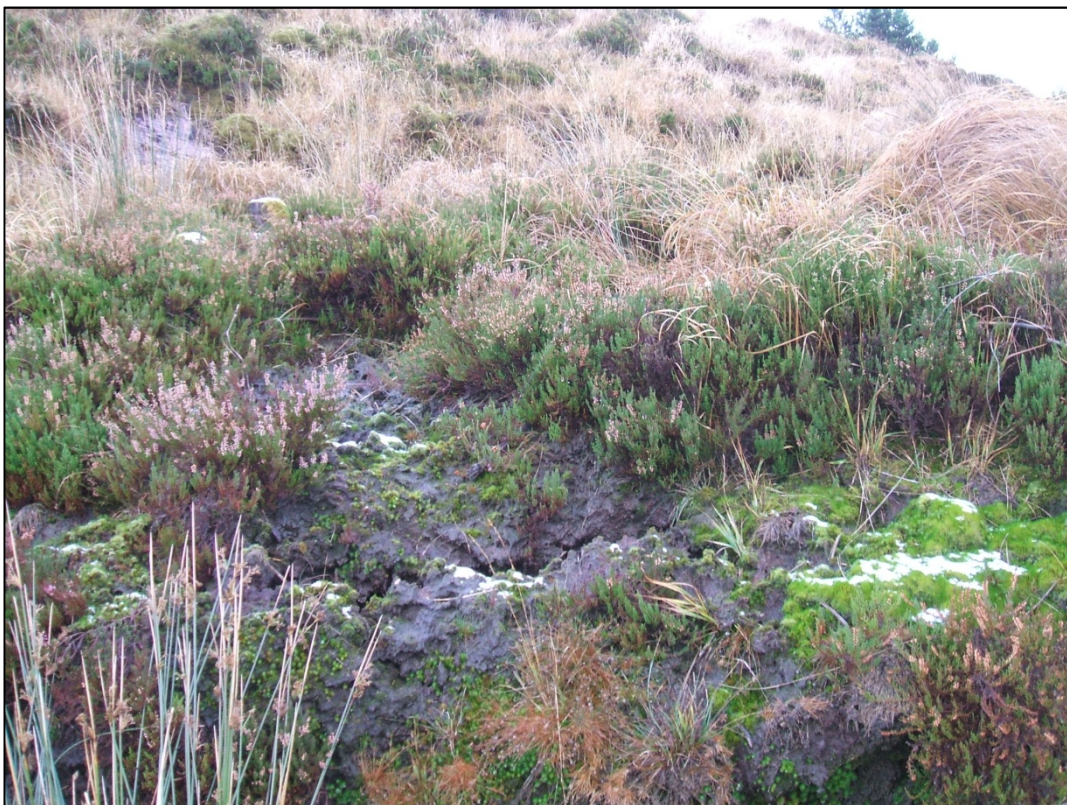
Photo 10 Localised relict tension cracks south of turbine T17

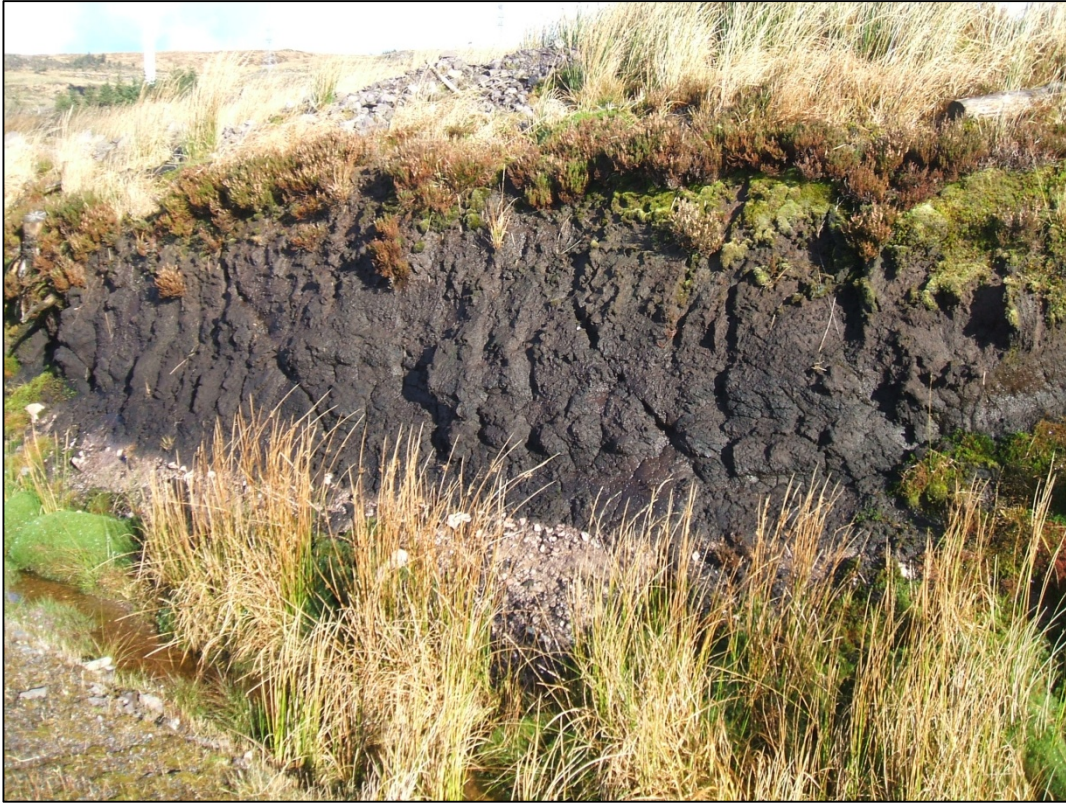
Photo 11 Overly steep peat excavation face alongside road cutting

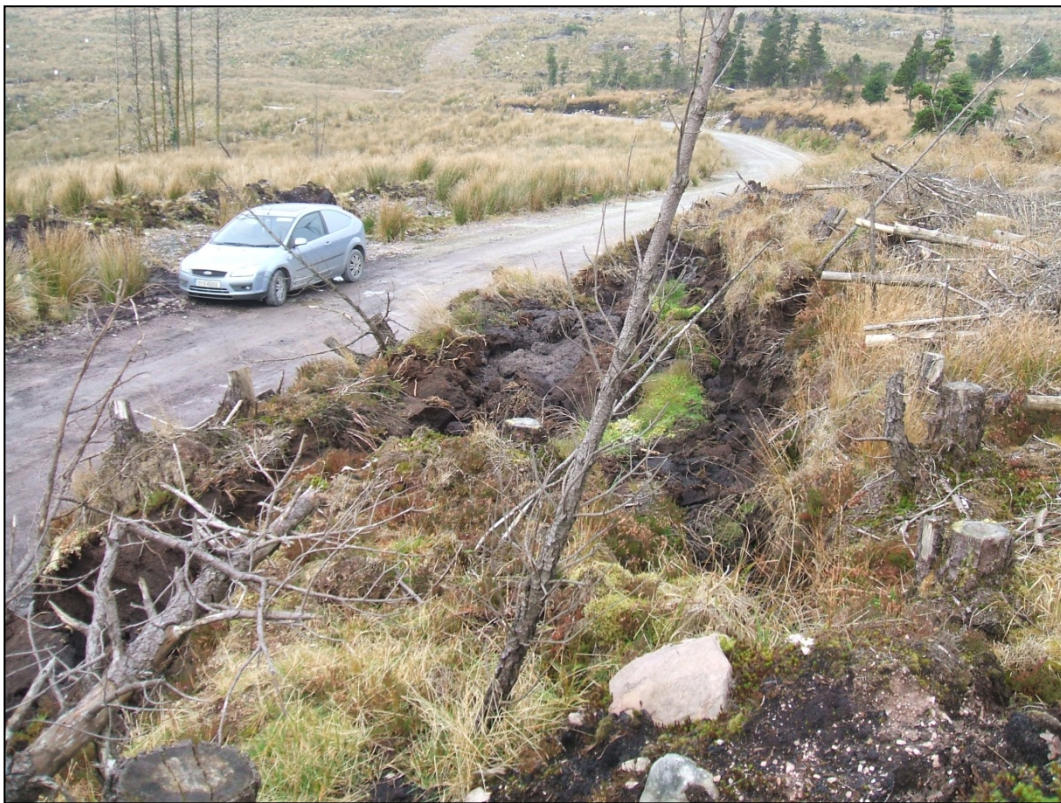
Photo 2 Overview of peat failure area

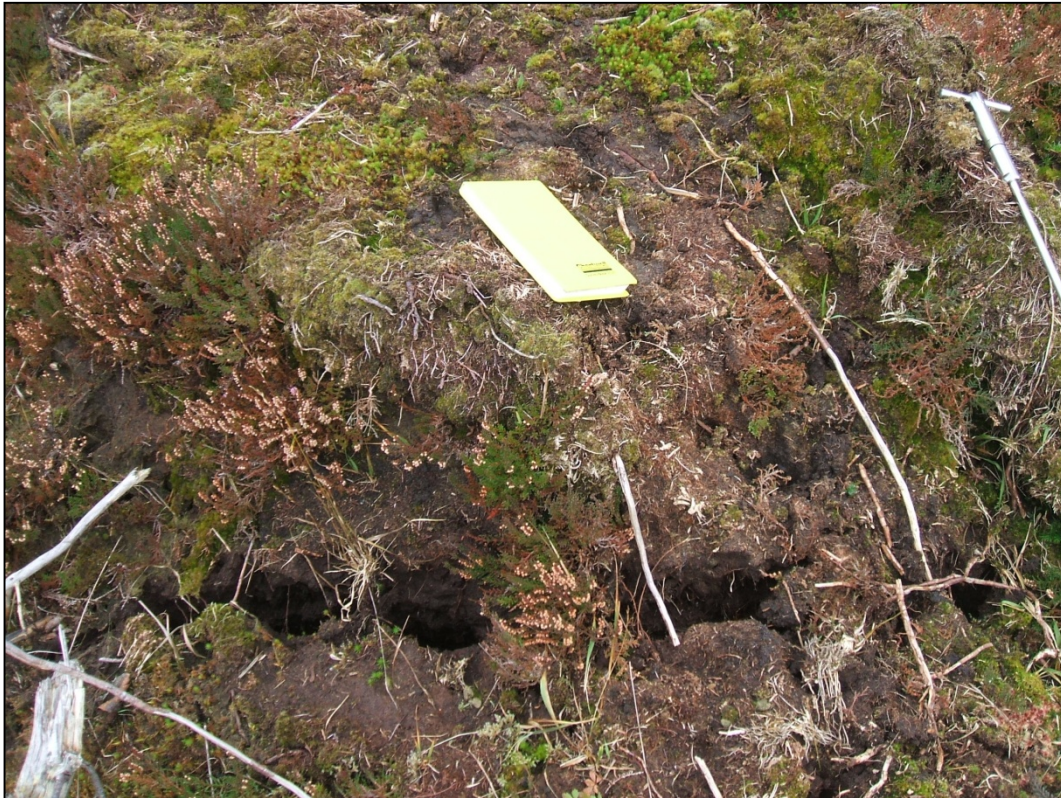
Photo 3 Tension cracks in the peat surface about 10m behind the failure scar

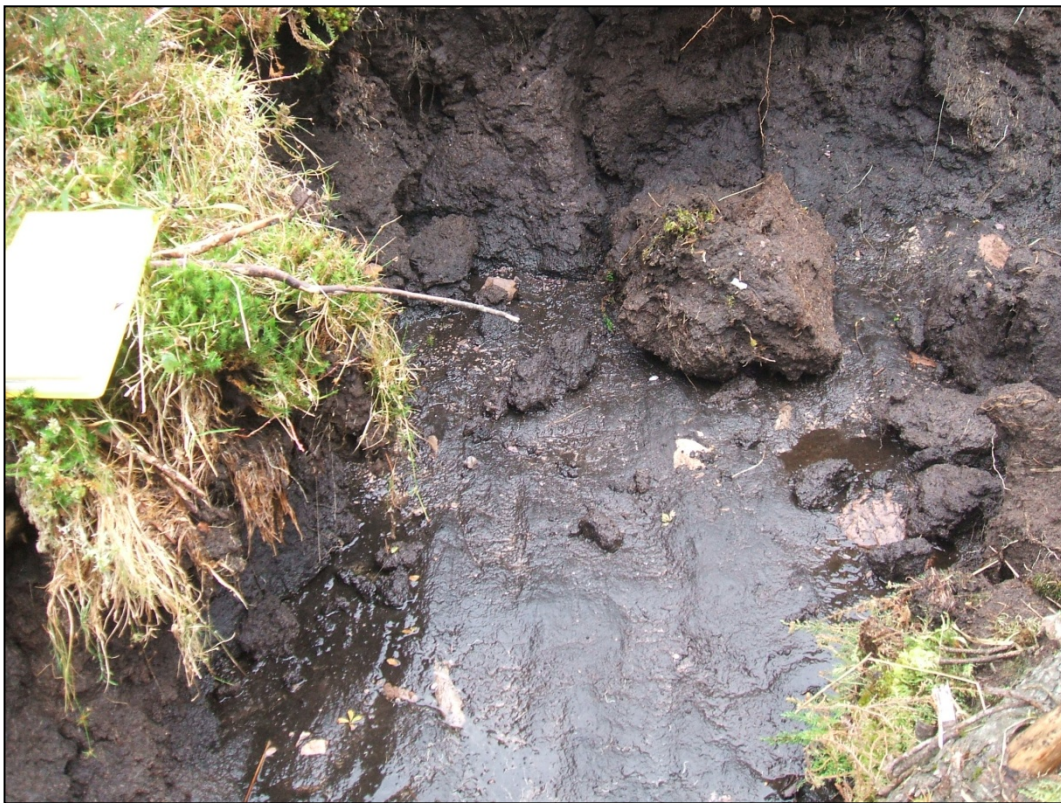
Photo 4 Basal shear surface of the failure

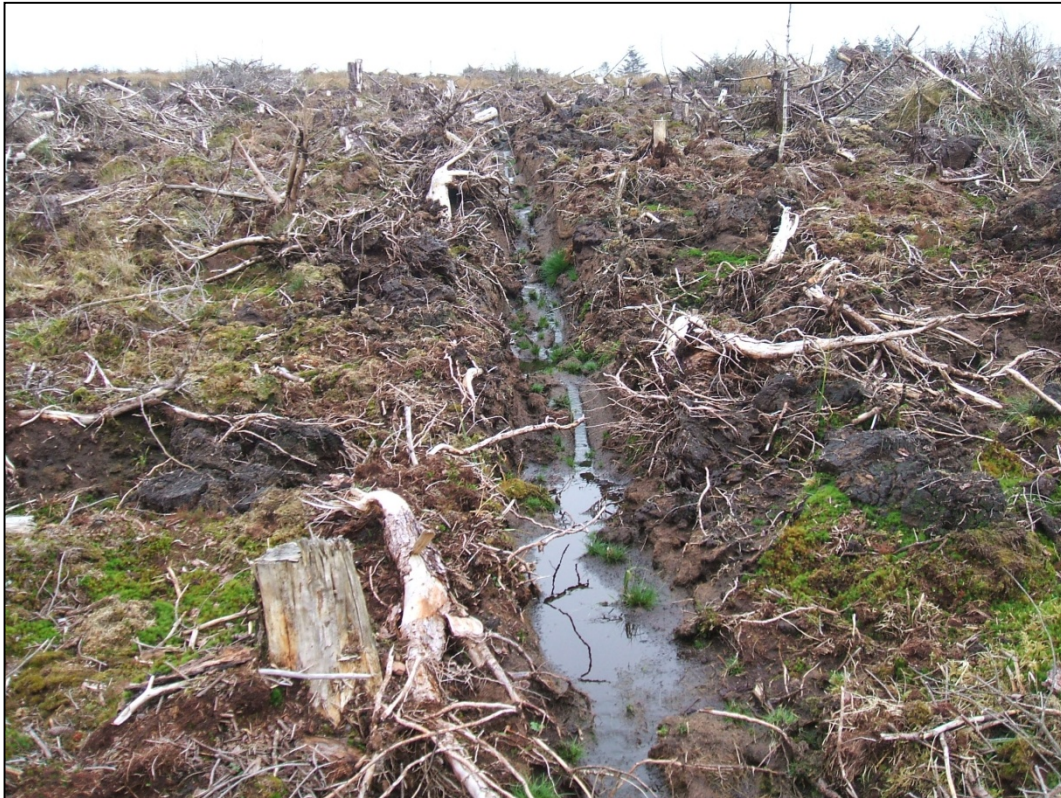
Photo 5 Slope v-ditches within the peat above the failure

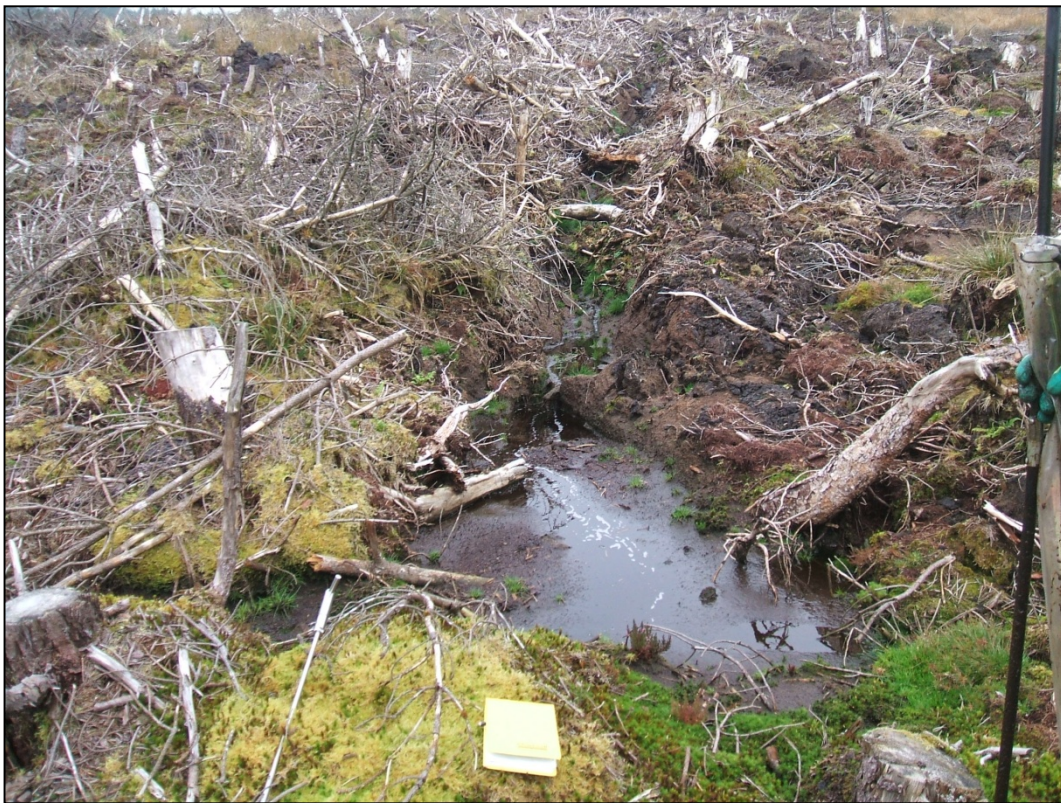
Photo 6 Ponding of water at end of slope v-ditches above the failure
