Appendix 12.2

1. Hydromorphology Assessment

This appendix to the EIAR consists of an impact appraisal of the proposed Google Ireland GIL DC3 Datacentre, hereafter referred to as the Proposed Development, under the heading of Water.

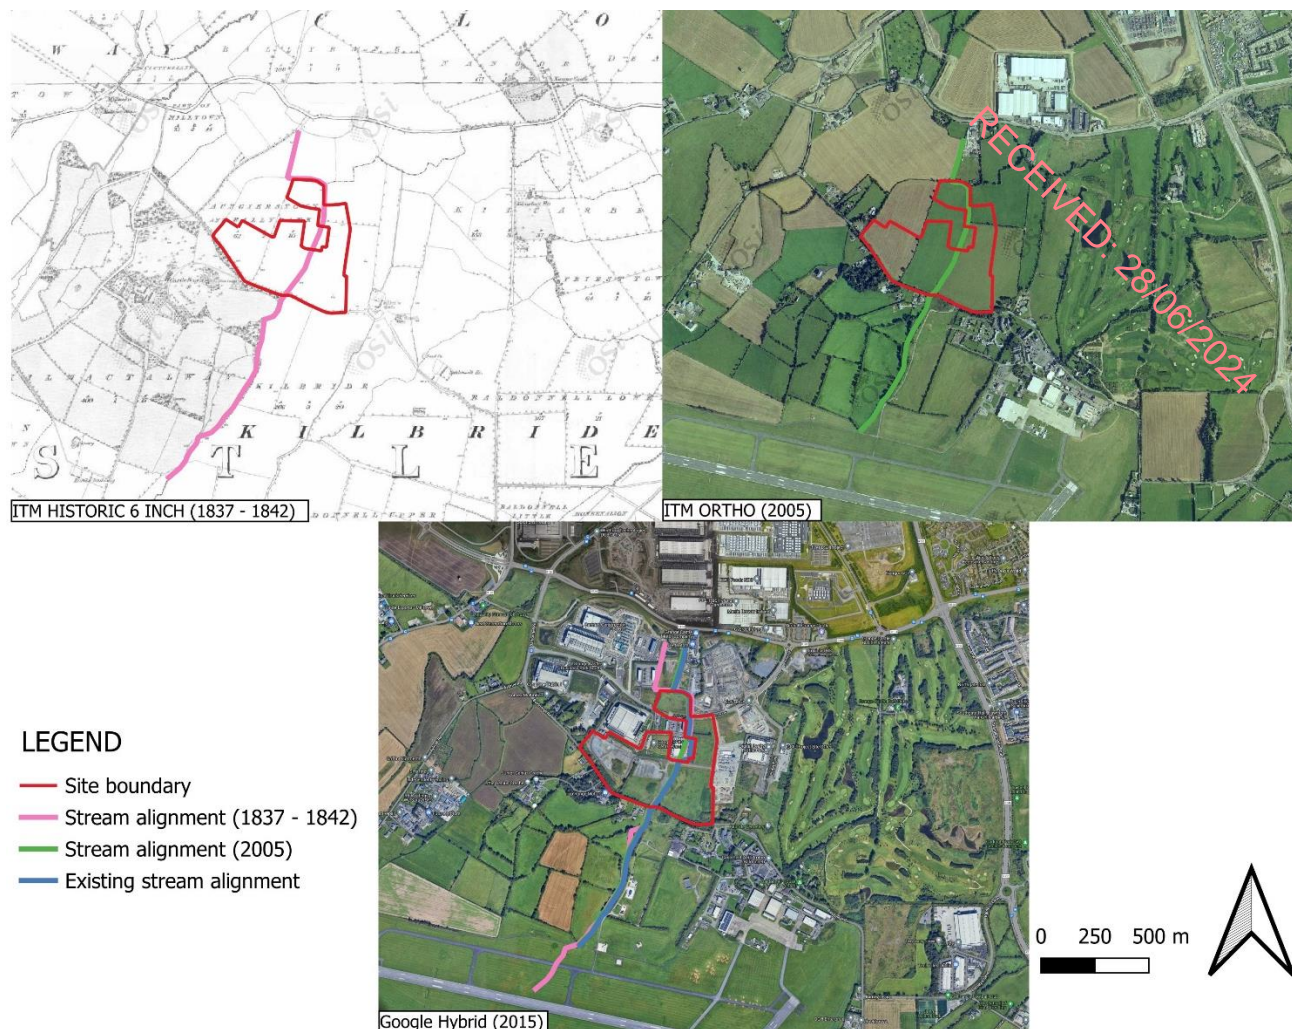
Maps from 1837 to 1842 indicate that the on-site watercourse has been artificially straightened and re-sectioned for agricultural purposes. It should be noted that no aerial imagery is available prior to this period (Figure 1.11). The tributary flowed along agricultural field drains and farm boundaries before joining Baldonnell Stream. By 1995, the development of the airport disrupted the watercourse longitudinal continuity, introducing a physical barrier to natural flow. In 2008 the area started experiencing significant industrial development, in 2009 the current DC building site required the watercourse to be culverted. It can be concluded that this tributary has been modified from its natural state for almost 200 years. By confining it into an unnatural drainage ditch profile and by culverting it, natural lateral and longitudinal connectivity in the river has been greatly reduced. In turn, this will result in the loss of natural processes (flow, hydromorphology and associated features/habitats), and prohibit their recovery/restoration.

Figure 1.11: Historical imagery. Source: OSI and Google Imagery

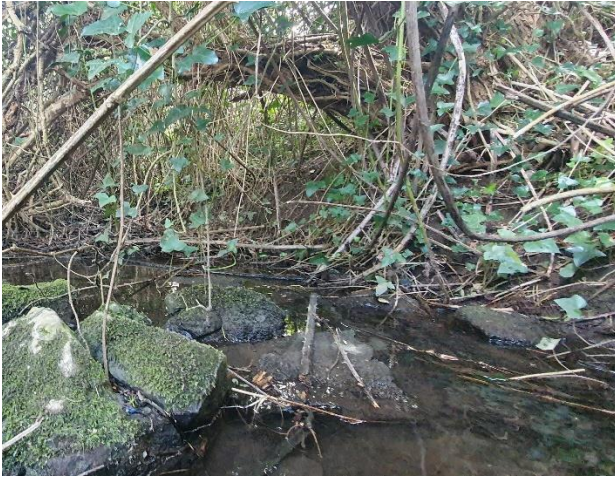
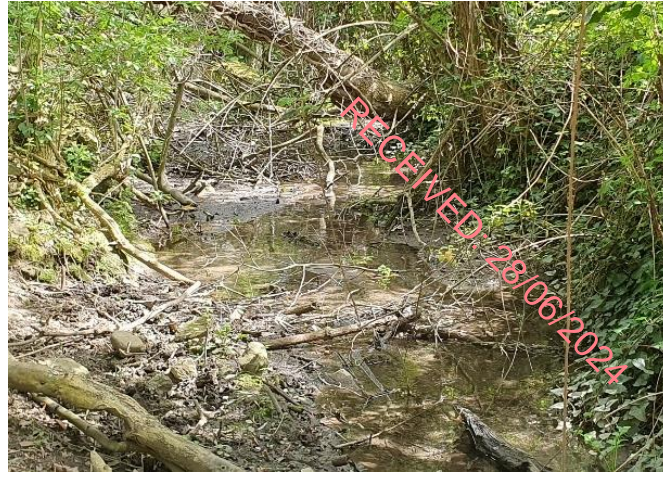
Figure 1.13: Example of on-site and downstream off-site channel form.

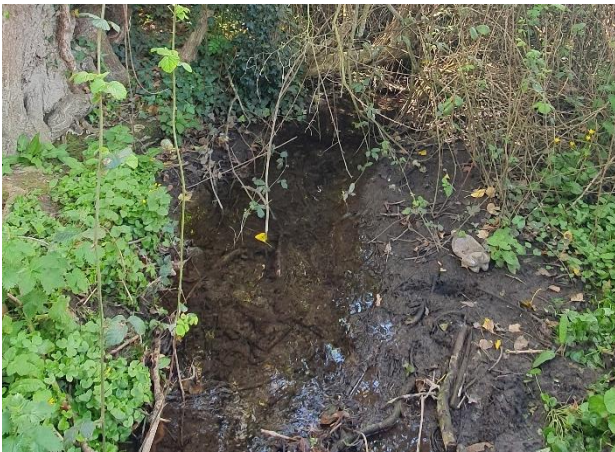
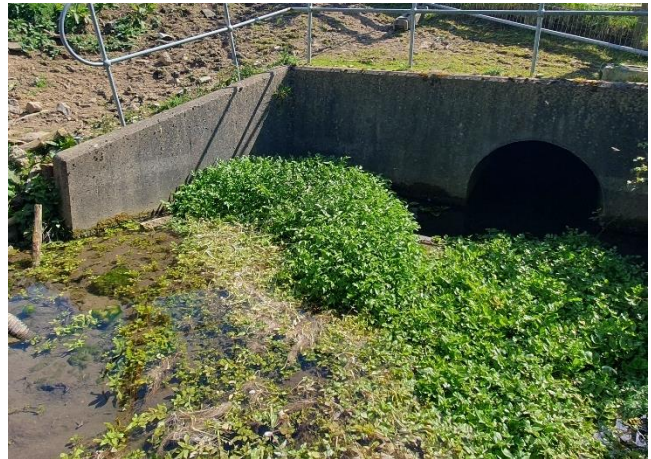
2. Channel vegetation	NA	2	NA	2	NA	2	The riparian vegetation along the stream is mainly composed of bramble and thistle, as well as some large trees including oak, ash, willow, and hawthorn. A dense canopy cover significantly reduces light penetration, creating over-shading conditions. No evidence of vegetation management is present (Figure 1.14). Additionally, the banks feature extensive invasive species such as nettles and non-natives such as sycamore.

Figure 1.14: Example of on-site and downstream off-site channel vegetation.

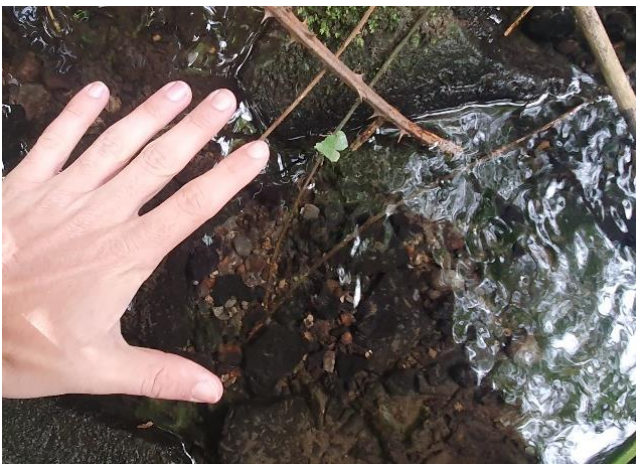
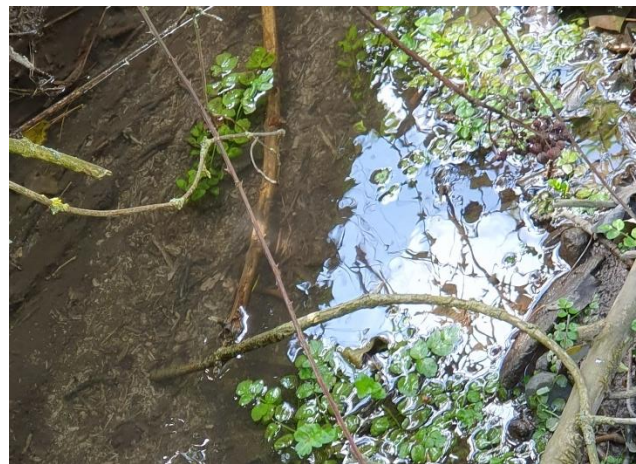
3. Substrate condition	NA	1	NA	1	NA	1	The watercourse presents evidence of anthropogenic changes in the channel bed such as: Masonry blocks, concrete rubble, tipping (rubbish), oil spillage, trash debris and channel bed protection (concrete) at some locations (Figure 1.15). There is also a high percentage of fines and silt which is what is expected for this river type. Despite this the cleanliness of the water (from a visual assessment) seems moderate.

Figure 1.15: Example of on-site and downstream off-site substrate condition.

- Substrate condition will be improved through introduction of substrate to the culvert and open channel, ensuring the transition from the open channel to culvert has bed protection and ensuring there are opportunities for promoting deposition of fines along the open channel. Substrate can build over time so the design will promote this. Inclusion of berms along the channel will also allow for natural accumulation of fines over time.

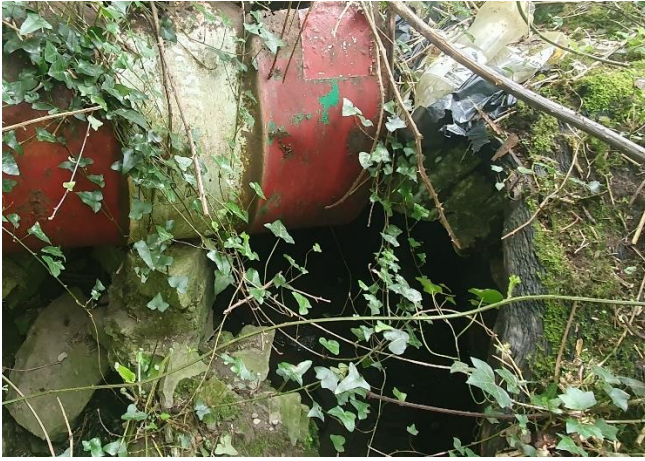
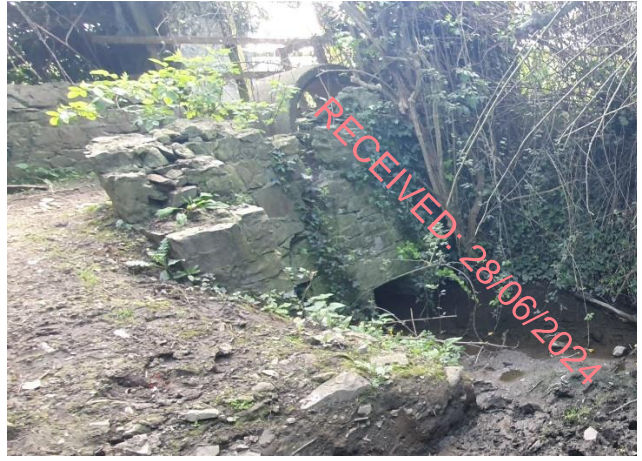
Figure 1.16: Example of on-site and downstream off-site barriers to connectivity.

4. Barriers to continuity	<p>In-stream barriers, such as culverts, disrupt the stream's longitudinal connectivity, impacting water flow velocities, sediment, and fish migration. Overall, culverts appear inadequate for managing high flood conditions</p> <p>Lateral connectivity has been altered by channel straightening during agricultural development.</p> <p>RHAT Score (Existing): 1</p>	<p>There is limited potential for improving longitudinal continuity due to the culverted sections in the Proposed Development, which will still pose a barrier for fish to swim upstream.</p> <p>Culverts have been adequately designed to handle high flood events.</p> <p>RHAT Score (Post-design measures): 1</p>

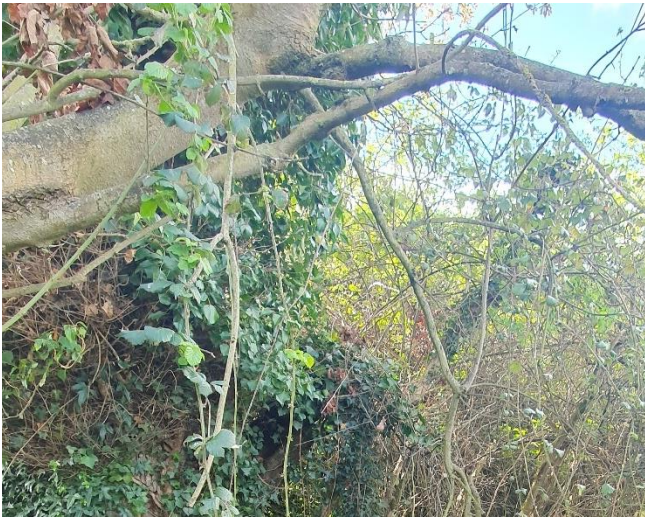
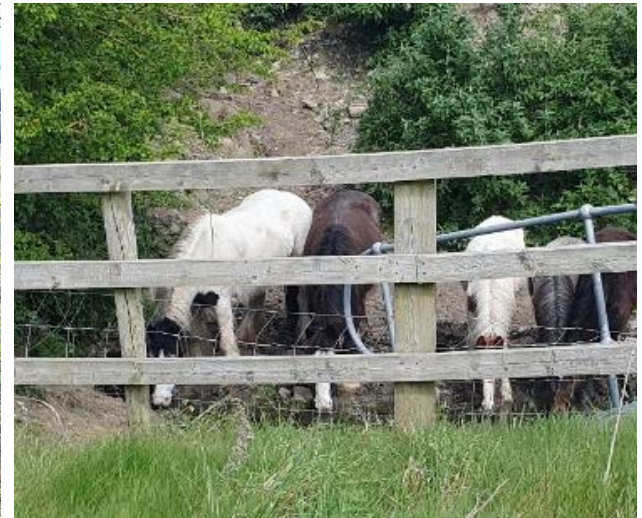
5. Bank structure & stability L/R	L	0.5	L	0.5	L	0.5	The open channel shows clear evidence of extensive alteration to bank structure. The channel was embanked at some point during the 1800's as part of the channel straightening carried out during the agricultural development of the area. A 5 m section of the channel bank is concreted at the entrance of the on-site reach (Figure 1.17). A 10 m section of the right bank (facing downstream) of the downstream off-site reach appears very degraded, likely due to frequent poaching by horses. Horses seem to access the river to drink water without designated entry points.
	R	0.5	R	0	R	0

Figure 1.17: Example of on-site and downstream off-site bank structure and stability.

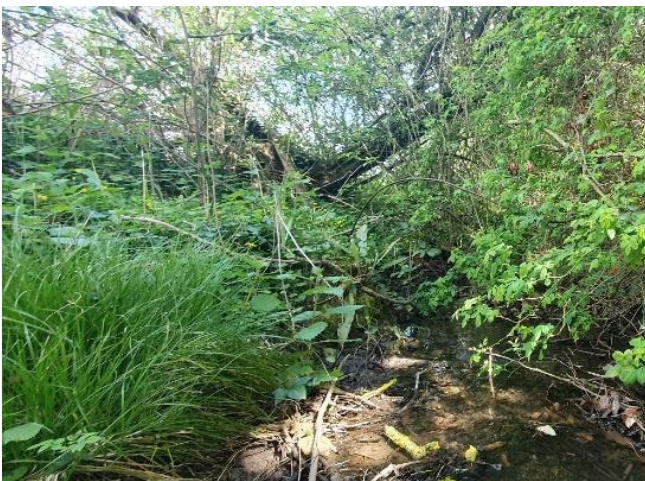
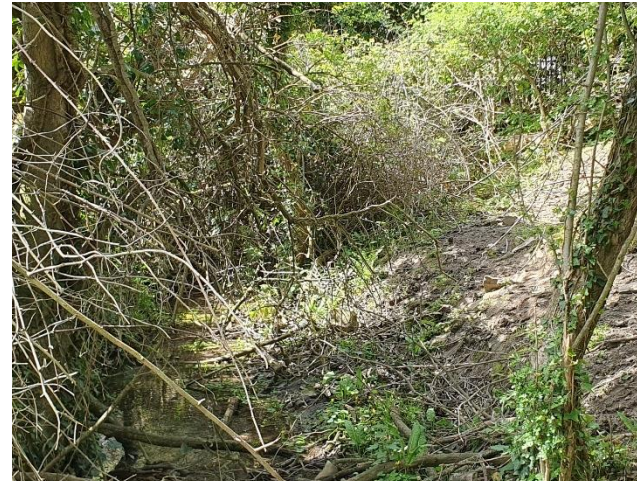
6. Bank vegetation L/R	L	0.5	L	0.5	L	0.5	Both riverbanks are densely populated with brambles and thistles, which are invasive species that are outcompeting endemic plants (Figure 1.18). Additionally, evidence of invasive nettles and non-native sycamores was observed. Some large trees, such as oak, ash, willow, and hawthorn, were also present. Overhanging branches extend across the channel, contributing organic matter, but in certain areas, they create excessive shading. There is no indication of recent/active vegetation management. There is evidence of rabbit presence along the banks of the river, in the form of burrows.
	R	0.5	R	0.5	R	0.5

Figure 1.18: Example of on-site and downstream off-site bank vegetation.

6. Bank vegetation L/R	<p>Both riverbanks are overrun by invasive plants like brambles and thistles, competing with native species. Evidence of invasive nettles and non-native sycamores was also noted.</p>	<p>Native grasses with dense root systems are proposed for the banks, with no trees. Tree planting is limited due to constraints with surrounding land use (the airport).</p>

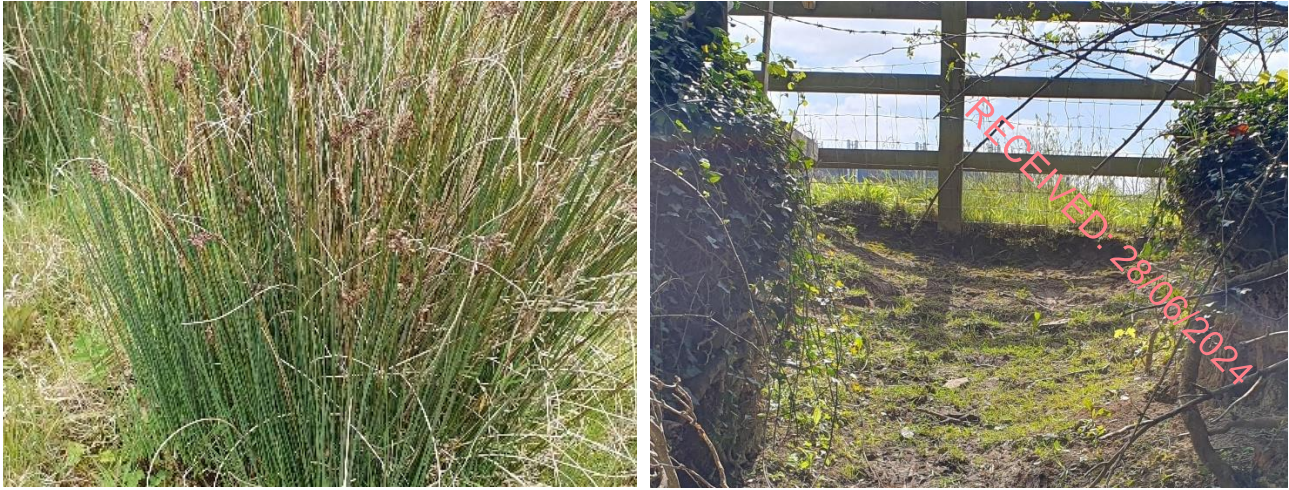
Figure 1.19: Example of on-site and downstream off-site riparian vegetation.

7. Riparian land use L/R	The land use within the riparian area is mainly rough pasture. There is also a man-made gravel area and a private property. RHAT Score (Existing): Left bank = 0.5 Right bank = 0.5	The potential for improving riparian land use within the site is limited. Currently, there is a man-made gravel area and rough pasture; under the Proposed Development, it will be replaced by the new building, rough pasture and native vegetation. RHAT Score (Post-design measures): Left bank = 0.5 Right bank = 0.5

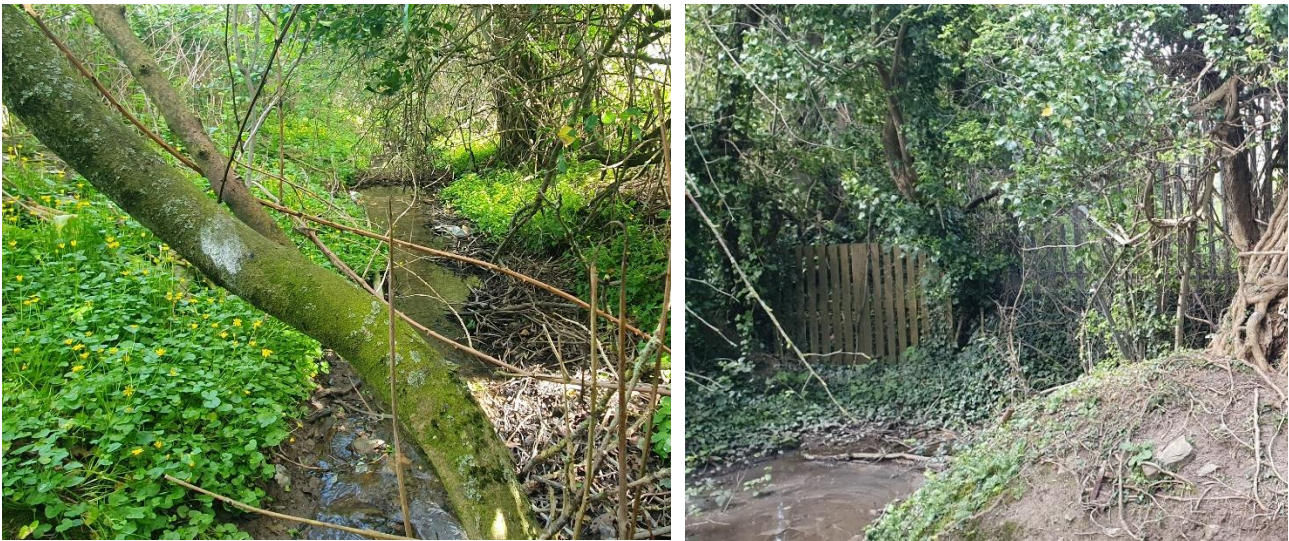
8. Floodplain connectivity L/R	L	0	L	0	L	0	During the 1800s, agricultural development led to the embankment of the stream, reducing its lateral connectivity. Recent urban development further disrupted this connectivity by fencing (Figure 1.20) downstream areas. As a result, the stream may no longer overtops its banks during high flows. Under natural conditions, rivers should overtop their banks approximately every 1 to 2 years during bankful flood events. This lateral connectivity no longer occurs in the modified stream system.
	R	0	R	0	R	0	
TOTAL	NA	8	NA	7.5	NA	7.5

Figure 1.20: Example of on-site and downstream off-site floodplain connectivity.
