Arboricultural Report

Tree Survey,
Arboricultural Impact Assessment &
Arboricultural Method Statement

**The Old Rectory
Mountshannon
Co. Clare**

220710-PD-11

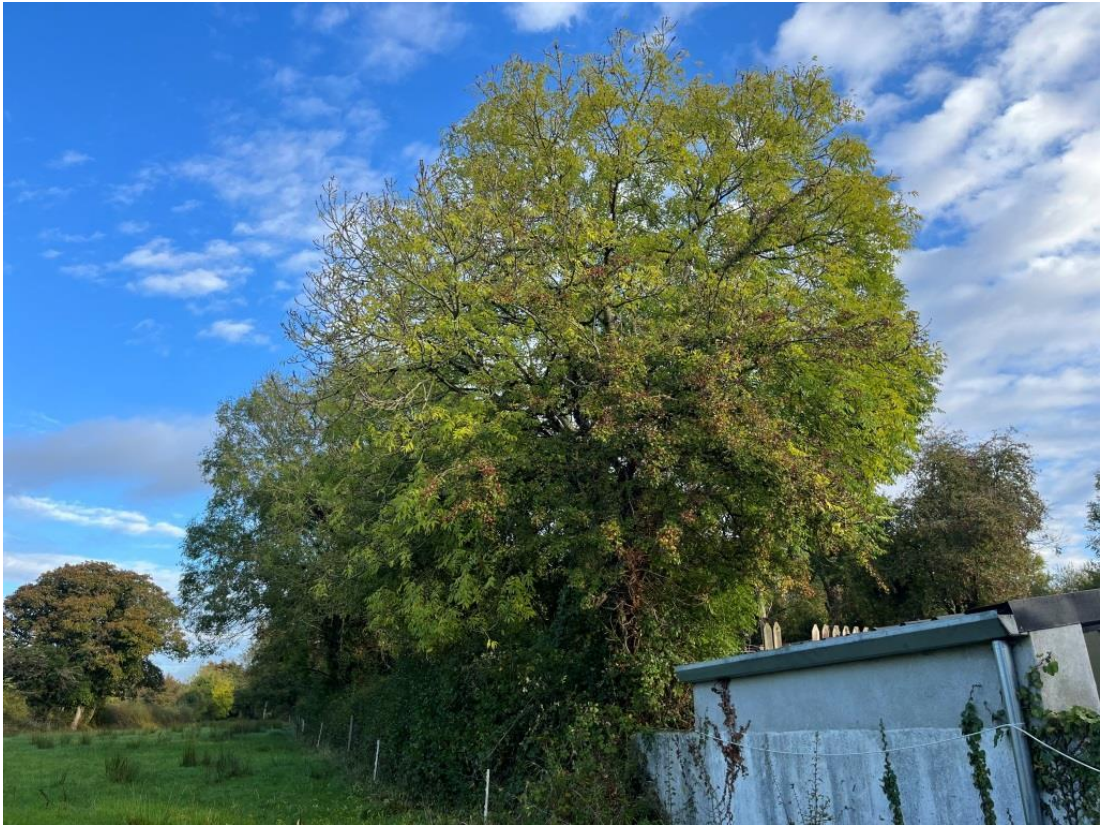
Photo 1: View of the eastern tree and native hedge line (T849 and H910)

- 6.3 In addition, the retention of two hedgerows H910 and H911 must be reviewed onsite prior to work commencing. Construction works are required close to the centreline of these hedgerows and their retention may not be achievable considering the changes in site level required. If the removal of these hedgerows is necessary, they must be approved by the Local Planning Authority prior to works commencing and a new hedgerow planted along the same boundary to mitigate their loss.

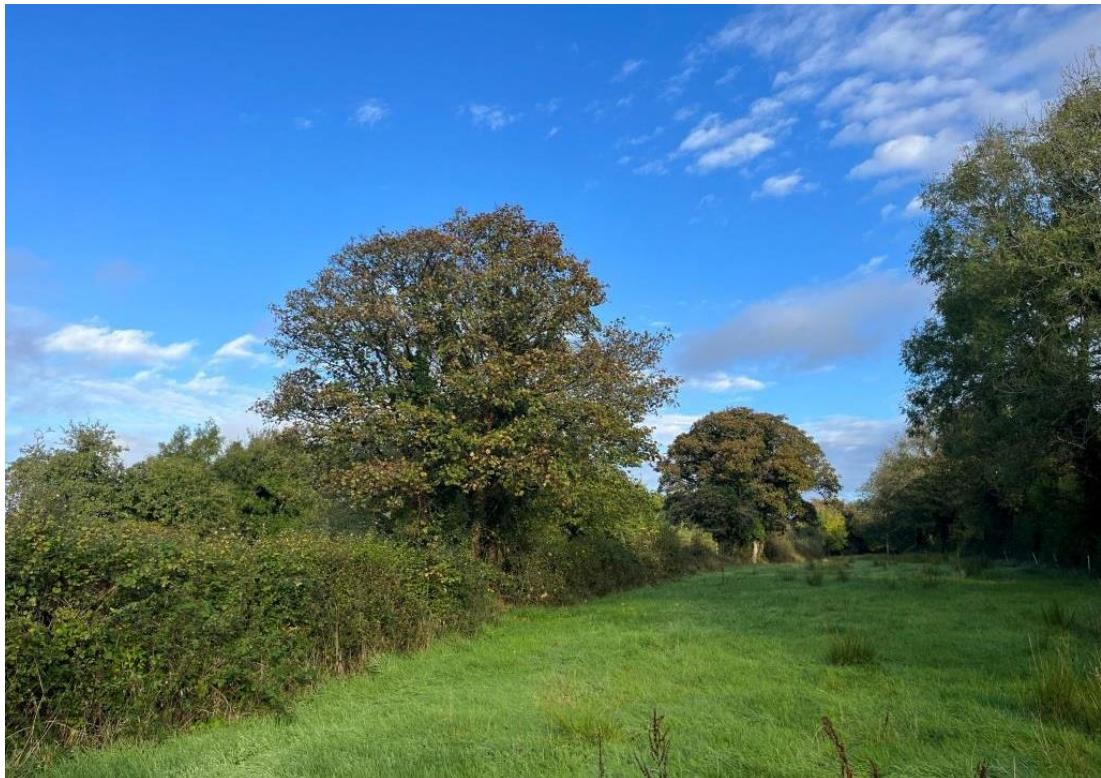
Photo 2: View of the central hedgerow (H914 & H915) and sycamore trees (T902, T905, T906).

Tree T905	1 Acer pseudoplatanus (Sycamore)	10.0	34 COM	3	4.5		4.0		3.0		4.0		2.0		Early Mature	Structural condition Fair. Physiological condition Fair. Competition - Adjacent trees. Deadwood - Minor. Fork - Weak with included bark. Ivy or climbing plant.	13/10/2022	54.3	4.2	20-40	C2

Tree ID	No. Species	Height (m)	Stem diameter (cm)	No. of Stems	CROWN SPREAD (m)								Crown clearance (m)	L.B. (m)	Life stage	Condition Notes	Survey date	RPA (m ²)	RPR (m)	Life expectancy (yrs)	BS Category
Tree T906	1 Acer pseudoplatanus (Sycamore)	10.0	42 COM	2	1.5		3.5		4.5		4.0		2.0		Early Mature	Structural condition Fair. Physiological condition Fair. Competition - Adjacent trees. Deadwood - Minor. Ivy or climbing plant.	13/10/2022	81.4	5.1	20-40	C2
Tree T907	1 Salix caprea (Goat Willow/Great Sallow)	4.0	16 COM	8	4.0		3.0		2.0		3.0		0.0		Semi Mature	Structural condition Fair. Physiological condition Fair. Fork - Weak with included bark. Multi-stemmed. Natural regeneration.	13/10/2022	13.0	2.0	10-20	C2
Tree T908	1 Acer pseudoplatanus (Sycamore)	5.0	20 COM	4	3.0		3.0		3.0		3.0		0.0		Semi Mature	Structural condition Fair. Physiological condition Fair. Inappropriate retention costs. Natural regeneration. Structural impact - Evident / observed.	13/10/2022	18.1	2.4	0-10	U

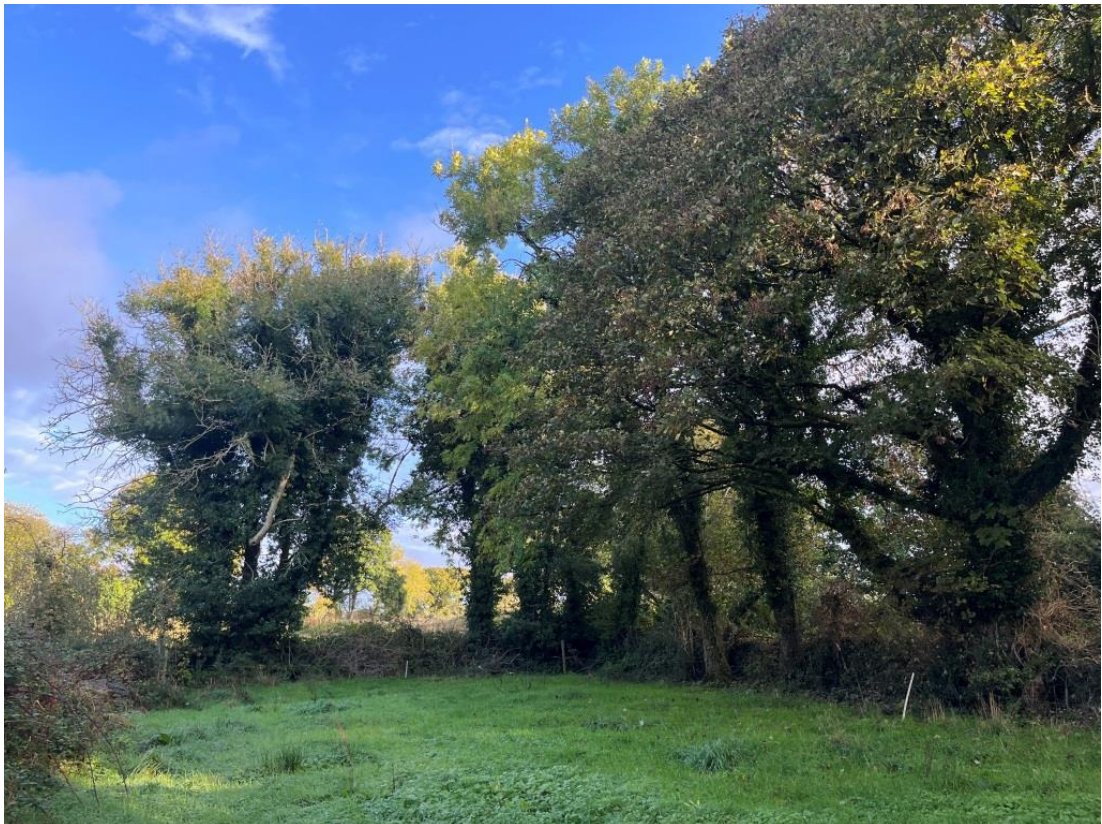
Photo 4: View of the northern corner of the site showing the existing ash and sycamore trees (T870 to T874).

Tree T870	1 Acer pseudoplatanus (Sycamore)	15.0	90	1	7.0		7.0		6.0		7.5		3.0		Mature	Structural condition Fair. Physiological condition Fair. Branch - Suspended. Epicormic growth - Base. Ivy or climbing plant. Pruning wounds - Decayed. Tree partially growing on stone wall.	13/10/2022	366.4	10.8	20-40	B2
Tree T871	1 Acer pseudoplatanus (Sycamore)	17.0	51	1	6.0		7.0		3.5		3.5		2.0		Early Mature	Structural condition Fair. Physiological condition Fair. Competition - Adjacent trees. Deadwood - Minor. Ivy or climbing plant. Suppressed crown - Minor. Unbalanced crown - Minor.	13/10/2022	117.7	6.1	40+	B2
Tree T872	1 Fraxinus excelsior (Ash)	17.0	49	1	6.0		4.0		4.0		6.5		3.0		Early Mature	Structural condition Fair. Physiological condition Poor. Competition - Adjacent trees. Die-back - Throughout crown. Deadwood - Major. Ivy or climbing plant. Suppressed crown - Minor. Unbalanced crown - Minor. Tree is infected with ash dieback.	13/10/2022	108.6	5.9	10-20	C2

Tree ID	No. Species	Height (m)	Stem diameter (cm)	No. of Stems	CROWN SPREAD (m)								Crown clearance (m)	L.B. (m)	Life stage	Condition Notes	Survey date	RPA (m ²)	RPR (m)	Life expectancy (yrs)	BS Category
					N	NE	E	SE	S	SW	W	NW									
Tree T873	1 Fraxinus excelsior (Ash)	16.0	80	1	6.0		7.0		5.5		4.0		3.0		Mature	Structural condition Fair. Physiological condition Fair. Die-back - Upper crown. Deadwood - Minor. Decay / structural defect - Suspected. Fungal fruiting body - structural decay suspected. Fork - Weak with included bark. Ivy or climbing plant. Unbalanced crown - Minor. Tree is infected with ash dieback. Tree growing on top of wall.	13/10/2022	289.5	9.6	10-20	C2
Tree T874	1 Fraxinus excelsior (Ash)	16.0	90 COM	4	9.0		6.0		7.0		7.5		3.0		Late Mature	Structural condition Fair. Physiological condition Poor. Coppice stool - Coppice origin / Mature stems. Die-back - Throughout crown. Deadwood - Major. Ivy or climbing plant. Pruning wounds - Decayed. Tree is infected with ash dieback. Tree is partially growing on wall.	13/10/2022	366.4	10.8	10-20	C2

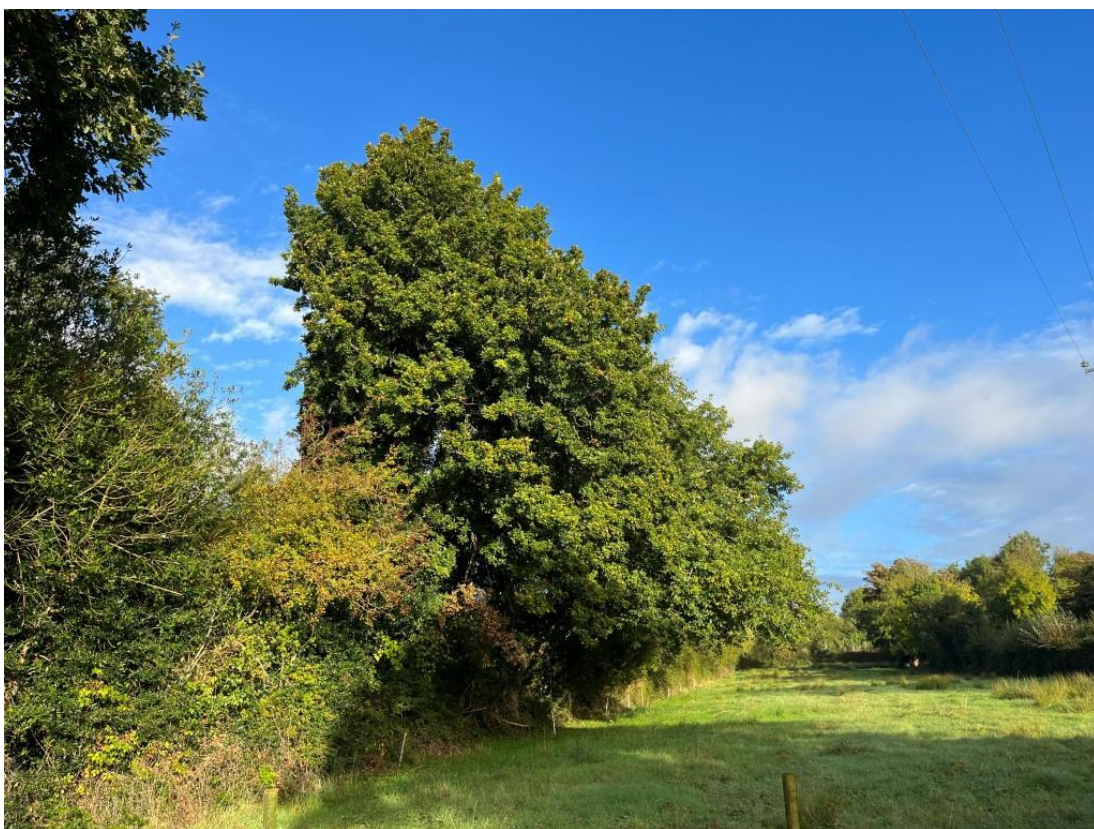
Photo 6: View of the oak trees T892 to T894 located along the western boundary.

Tree T893	1 Quercus robur (English Oak)	17.0	90	1	8.0		11.5		6.0		4.0		2.0		Mature	Structural condition Fair. Physiological condition Good. Decay / structural defect in crown limb / limbs - Minor. Deadwood - Minor. Ivy or climbing plant. Poor past pruning. Shedding limb / limbs - Historic. Unbalanced crown - Major. The tree is growing on top of the bank and has been reduced back on the neighbouring side.	13/10/2022	366.4	10.8	20-40	B2

Tree ID	No. Species	Height (m)	Stem diameter (cm)	No. of Stems	CROWN SPREAD (m)								Crown clearance (m)	L.B. (m)	Life stage	Condition Notes	Survey date	RPA (m ²)	RPR (m)	Life expectancy (yrs)	BS Category
					N	NE	E	SE	S	SW	W	NW									
Tree T894	1 Quercus robur (English Oak)	19.0	100	1	7.0		8.0		7.0		4.0		3.0		Mature	Structural condition Fair. Physiological condition Good. Access to inspect base - Restricted / obscured. Branch - Suspended. Deadwood - Minor. Fork - Weak with included bark. Ivy or climbing plant. Poor past pruning. Unbalanced crown - Minor. The tree is growing on top of the bank and has been reduced back on the neighbouring side.	13/10/2022	452.4	12.0	20-40	B2
Tree T895	1 Quercus robur (English Oak)	19.0	90	1	7.0		5.0		4.0		5.0		3.0		Mature	Structural condition Fair. Physiological condition Good. Access to inspect base - Not possible. Deadwood - Minor. Ivy or climbing plant. Poor past pruning. Unbalanced crown - Minor. The tree is growing on top of the bank and has been reduced back on the neighbouring side. Unable to inspect tree closely due to dense undergrowth.	13/10/2022	366.4	10.8	20-40	B2
