# **Appendix G**

## Arboricultural Impact Assessment

Summary table		
Site Name:	Galway BusConnects: Dublin Road	
Project Reference:	5402	
Site Address:	Dublin Road (R338), East of Moneenageisha to Doughiska Junction	
Nearest Postcode:	H91 YTR6	
Location:	Start of Route - <a href="#">Google maps link</a> End of Route - <a href="#">Google maps link</a>	
Local Authority:	Galway City Council	
Statutory Controls:	Tree Preservation Order	Conservation Area
	None advised - To be further checked	N/a
Soil Type: (Source: Geological Survey Ireland - © 2023)	Superficial/Drift	Bedrock
	None recorded	Burren Formation - Limestone. The formation is typified by pale-grey packstones and wackestones
Proposed Developmentdrawing:	Proposed General Arrangement Plan: <i>BCGDR-BTL-GEO_GA-XX-DR-CR-00001_00011_General_Arrangement</i>	
Notes:	N/a	
Report Author:	Richard Hyett <i>MSc, BSc (Hons), MICFor, MArborA</i>	
Date of Issue:	2nd December 2024

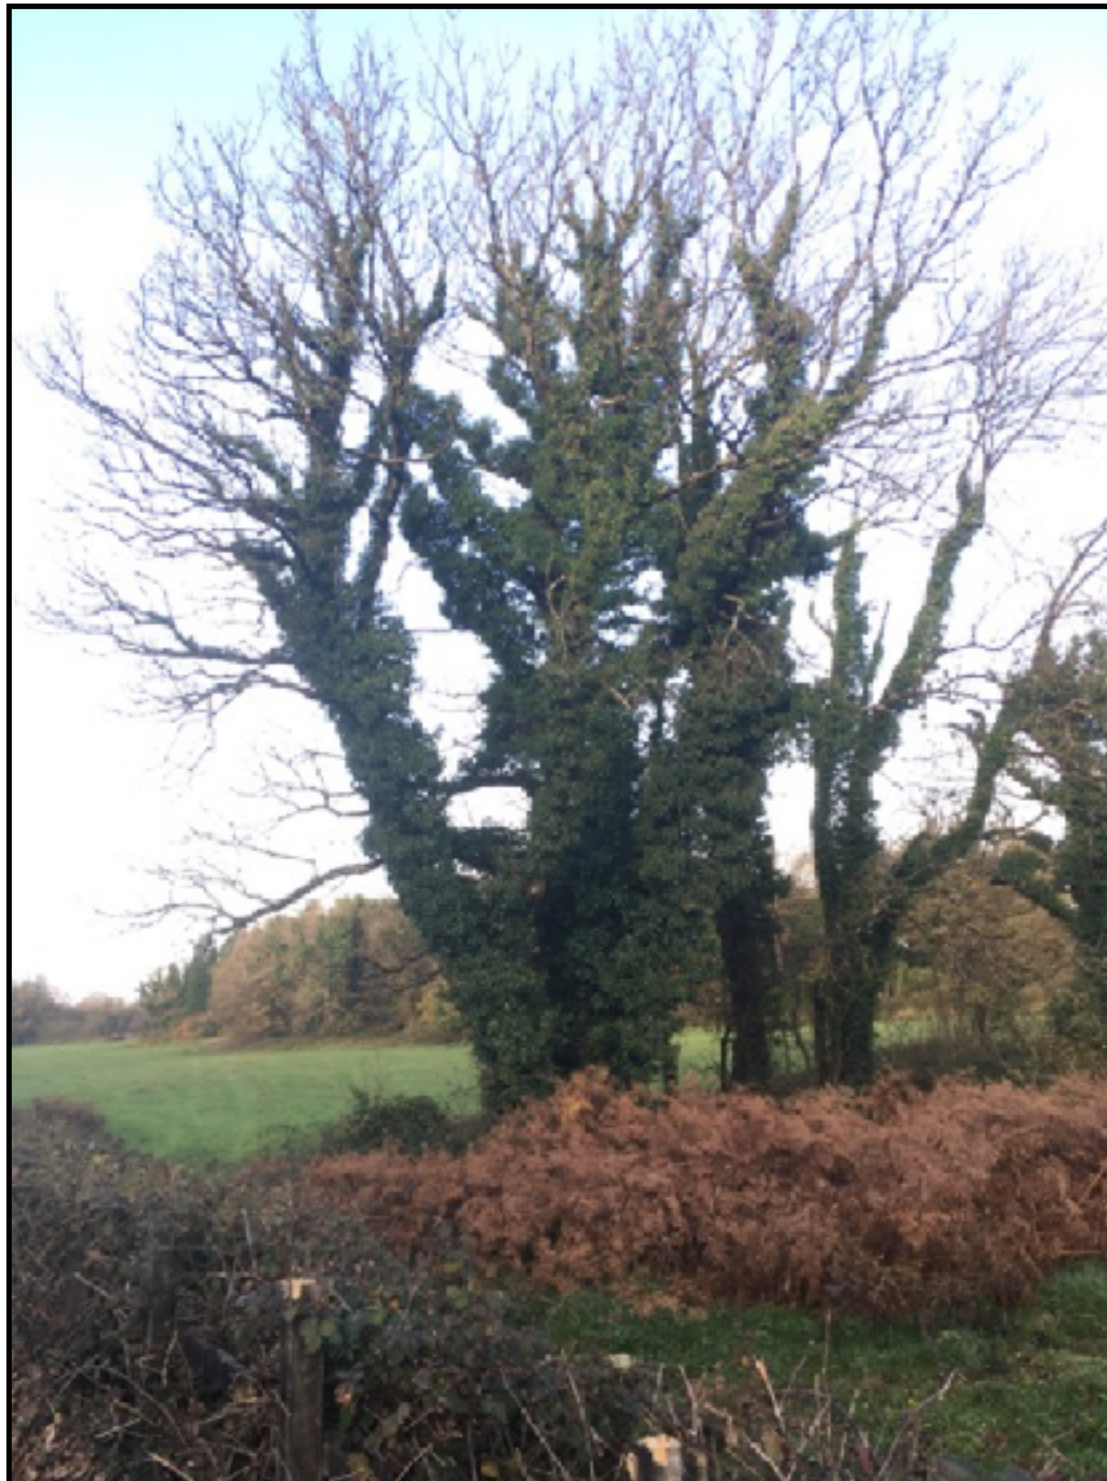
*Photoview 4: looking north-west to T1456. T1457, T1458 (All now Category C and U). The edge of the woodland area within Merlin Hospital grounds can be seen in the background. These trees are prominent when viewed by users of the R338, however all trees are in an established state of decline. Given the condition of these trees they should not be seen as a significant constraint to the scheme.*

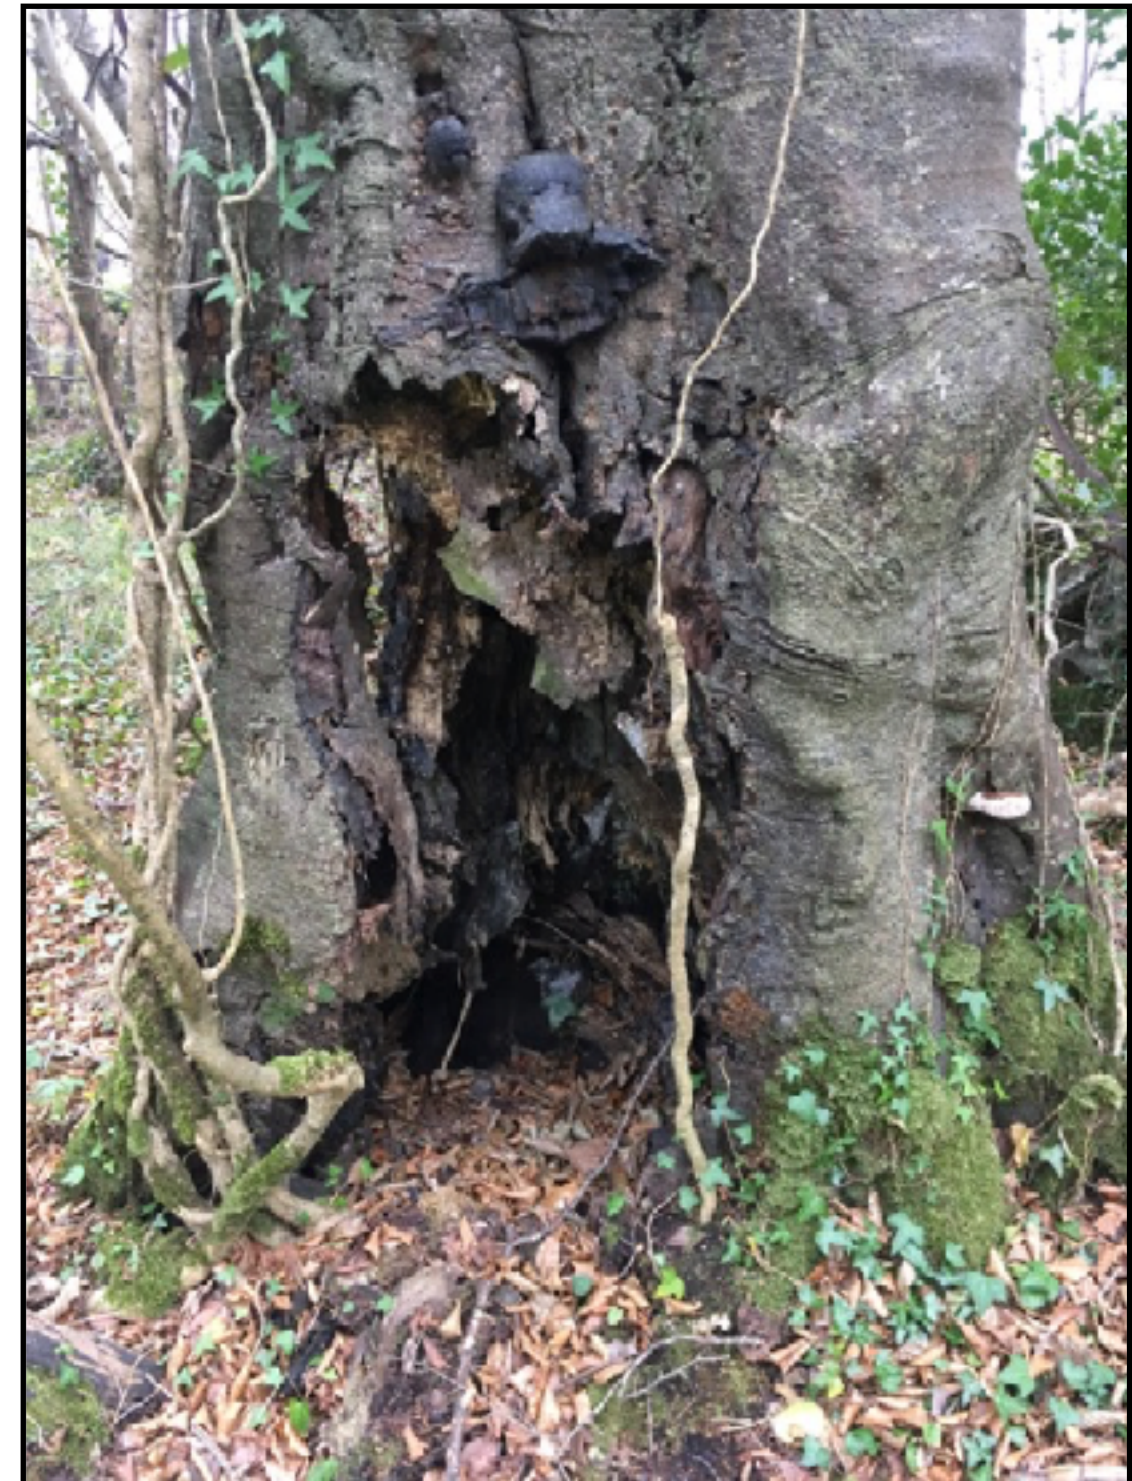
*Photoview 5: The significant basal decay of T1669 (Category C) located in the woodland area of the Merlin Hospital grounds to the north-west of Galway Crystal. The tree is remote from the current Highway alignment and despite being a large tree of potential ecological value it may not pose a constraint to the proposal in terms of tree quality or RPA. However, the potential for this tree to pose an unacceptable risk to the highway improvements (e.g. new cycle lanes or footways) needs to be considered.*

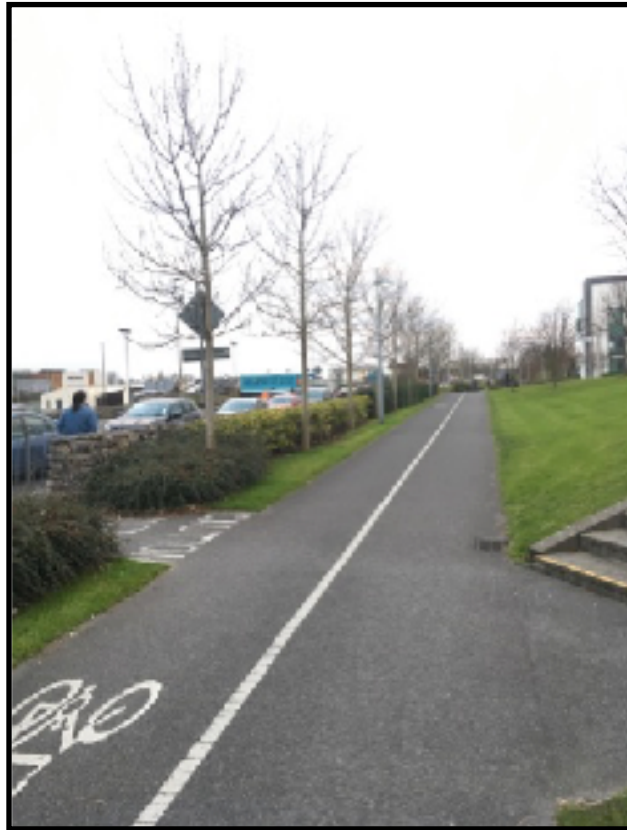
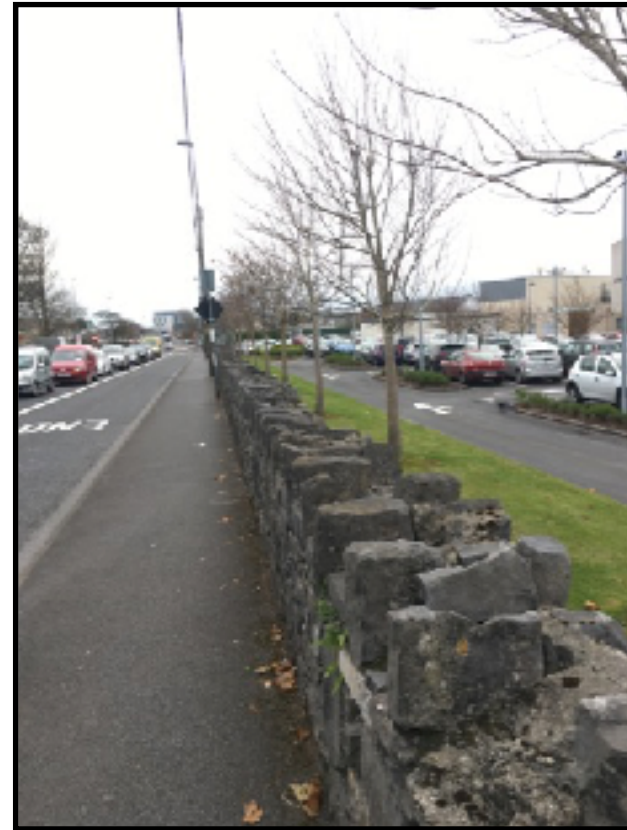
*Photoview 6 and 7: looking west along the ATU boundary with the R338 and existing cycleway and west along the Bon Secours boundary. Both images show the relatively recent institutional planting. Most of the trees on the ATU Frontage are in an acceptable condition but others are succumbing to Ash Die Back disease (ADB). Over time it is likely that all of these ash trees (T1710 to T1742) will succumb to ADB. .*

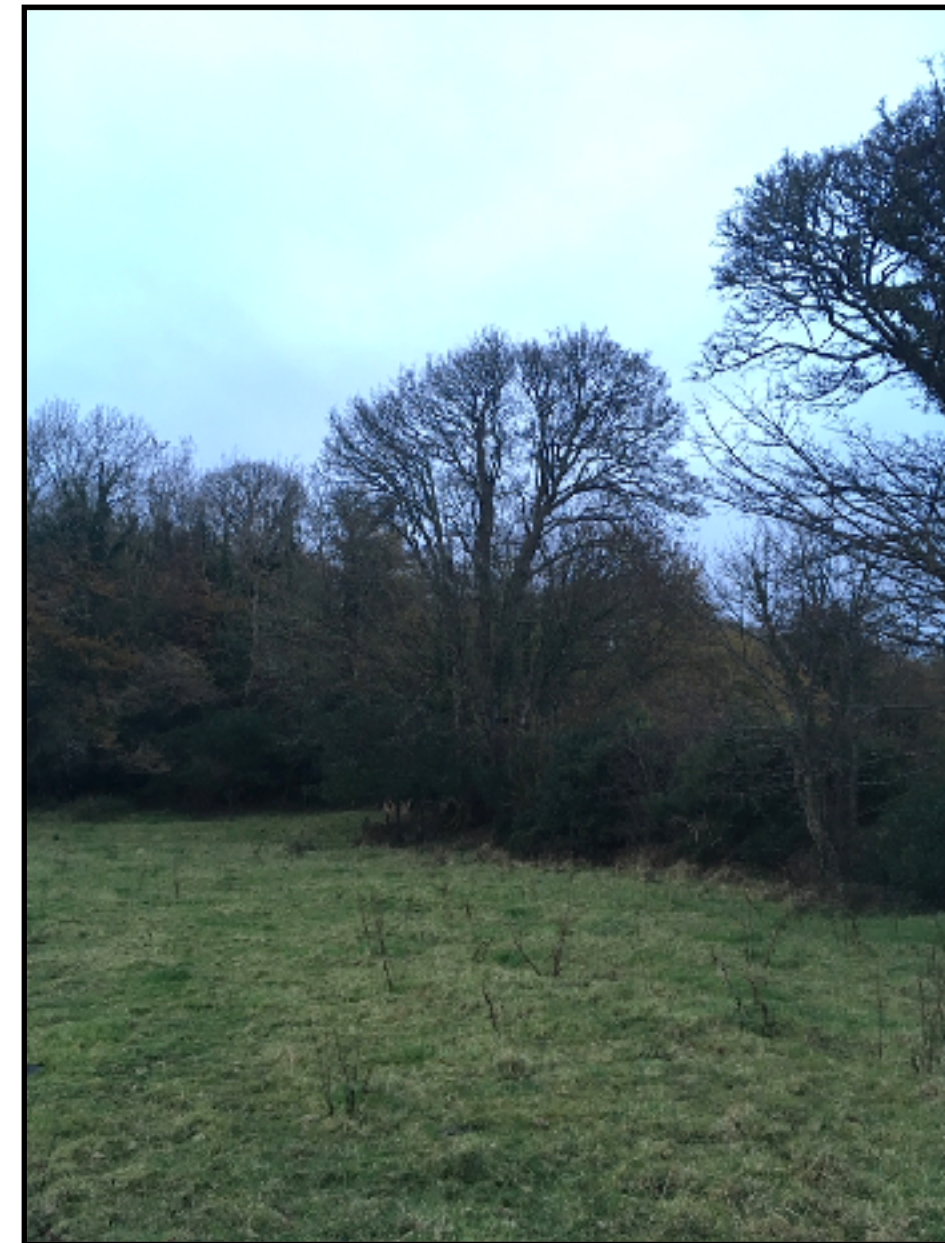
*Photoview 8: Looking north towards T2050 (Category A). The tree is located close to the woodland edge in Merlin Hospital grounds and is good specimen tree. Whilst its presence requires appropriate consideration in the Proposed Development it is likely to be remote from the proposed works.*
