Appendix 9.4 Ballina FRS – River Moy and Tributaries Photograph File

River Moy

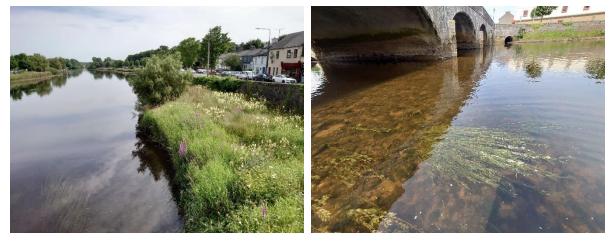
Site M1 FS1 / Annex I habitat 6430 on RHS downstream of Lower Bridge + instream habitat (22 July 2021)

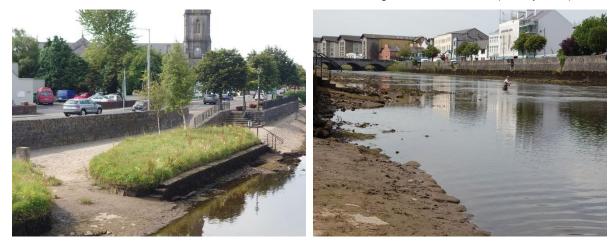
Site M2 Bankside and instream habitat at low tide (22 July 2021)

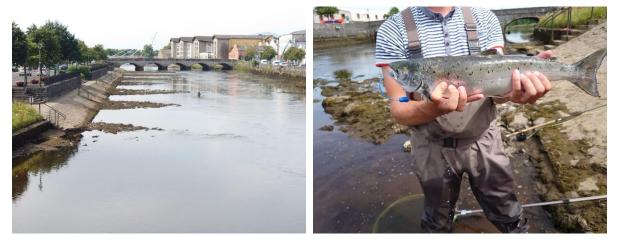
Sites M3/4 Cathedral Pool with boulder deflectors visible at low tide on the Cathedral Road side – salmon migration route / fishing area (22 July 2021)

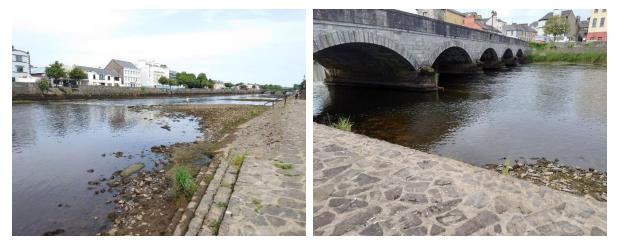
Site M5/6 Cathedral Pool - Existing bank defences and instream habitat with deflectors (low tide) (22 July 2021)

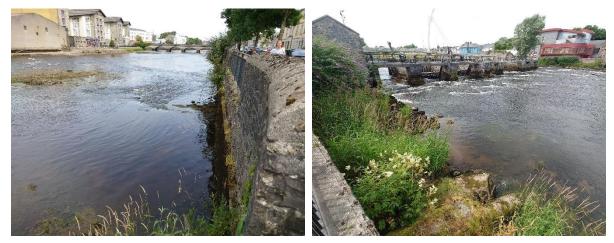
Site M7/8 Ridge pool - views downstream and upstream towards Salmon Weir (22 July 2021)

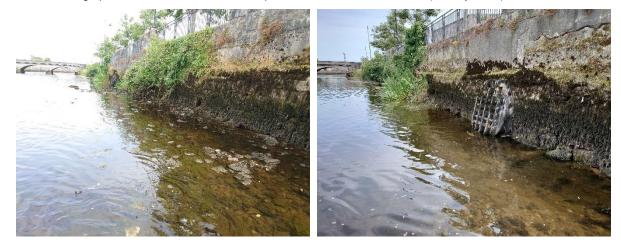
Site M9/10 Existing river walls on Ridgepool RHS and non-return culvert flap (22 July 2021)

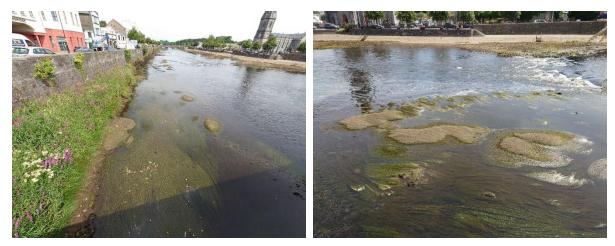
Sites M11/12 Emmett Street (LHS) view downstream and close up of instream habitat with dominant pondweed (22 July 2021)

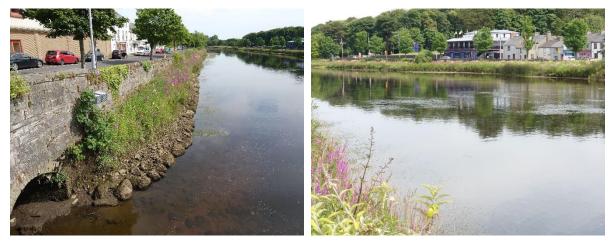
Site M13 Knockenelo Stream northernmost culvert confluence, with LHS existing wall & view across to RHS (22 July 2021)

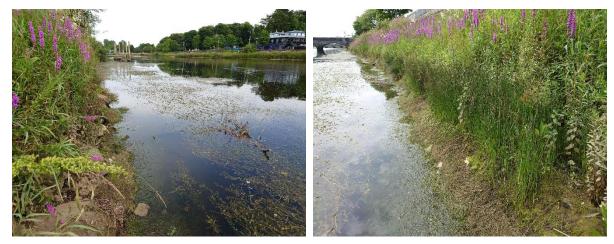
Site M14 LHS instream and bankside habitat (22 July 2021)

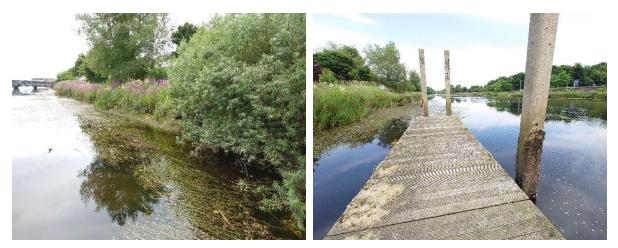
Site M15 Upstream / downstream views from pontoon floating dock (22 July 2021)

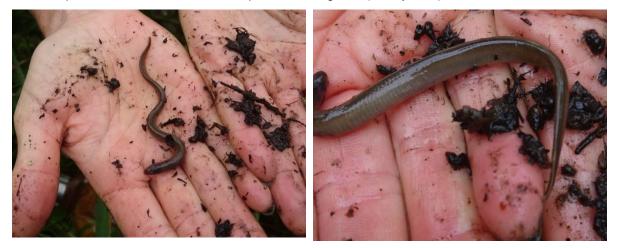
Site M15 Lamprey ammocoete with close-up of trunk myomeres (12 July 2022)
