1.0 INTRODUCTION

Layde Consulting was appointed by Carlin Planning Ltd to undertake a series of bat activity surveys and potential roost assessments for a proposed Regeneration Scheme within Monaghan town, extending to lands at the rear of Dublin Street North. This report summarises the key findings in relation to identified bat species within the study area and provides further recommendations as necessary.

1.1 Site Overview & Development Proposals

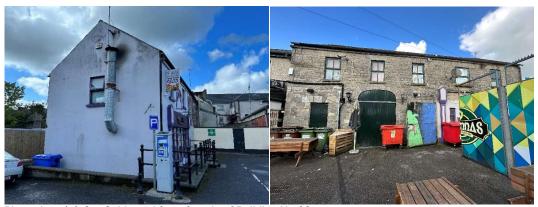
An inspection was carried out for the outside of the property, which is currently used as a commercial hot food takeaway at ground floor level, and store / staff facilities at first floor level (see Photoplates 1 & 2). Other than a crack on the exterior plasterwork along the external gable end (facing towards The Diamond car park), there were no obvious PRF's that would likely be used for roosting bats. On inspection of the external plasterwork along the gable end, the damage is only superficial and is unlikely to be used even by an individual opportunistic bat. An external service hole is provided for pipework, but it appears to be robustly blanked off, with little opportunity for ingress. Therefore, the site was considered to have negligible bat roost suitability.

Permission was sought on a number of occasions to gain access into the building in order to carry out an internal survey, however staff members would not permit access without the permission of the building owner, who could not be contacted. Therefore, no internal survey was carried out for the building, and all external surveys could only be carried out from ground level positions.

Photoplate 1 & 2 - Gable and front facade of Building No.62c

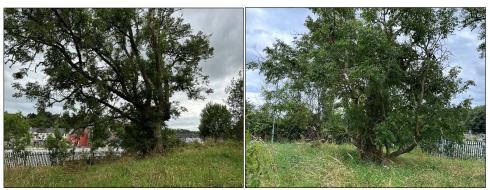
Photoplates 26 & 27 - Ash tree T29 (left) & T28 (right) with significant basal rot, scheduled for felling

Both trees exhibited open cracks and basal rot in places of deadwood, although both trees are in direct influence of artificial street lighting and flood lighting. Neither were considered to provide sufficient shelter and protection for regular usage as a bat roost, or to be able to support a large number of bats, and the appropriate conditions for light, temperature, humidity etc were not considered suitable for bat roosting. Based on the PRF's identified from visual inspection, the overall bat roost potential was considered to be low. As such a bat activity survey was carried out for both trees on the 26th August 2024, as summarised below in Table 14. The surveys were carried out by 2No. personnel at each tree from either side and using Elekon M2 Batlogger units.
