## Ballyfeeny Green Energy Project

## Environmental Impact Assessment Report Volume III

### Appendix 8.3 – Photolog September 2025

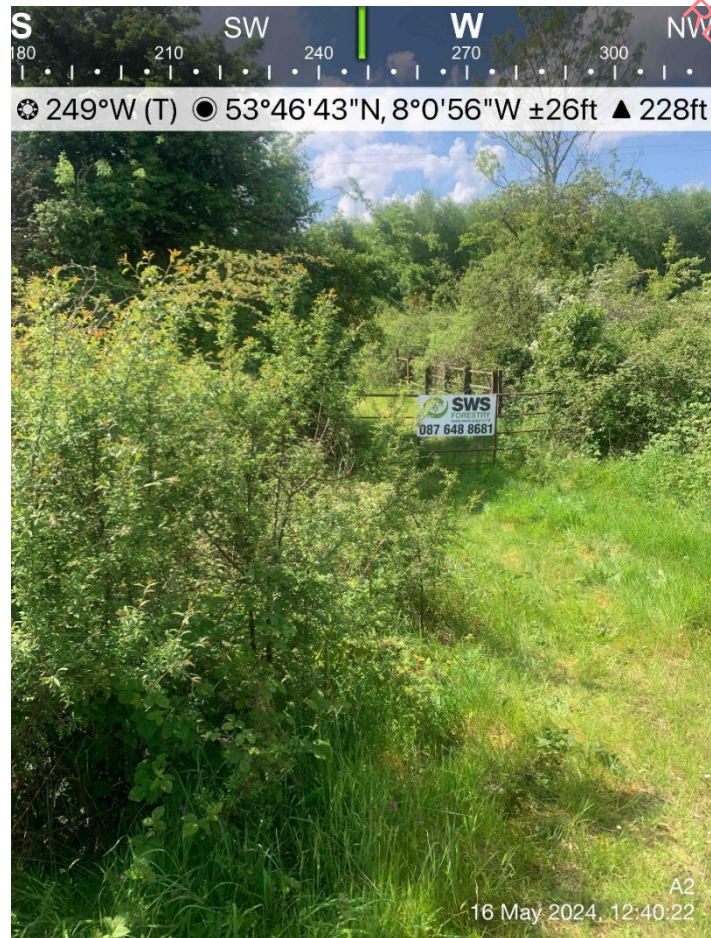
**Photo 1: A2 area heavily overgrown**

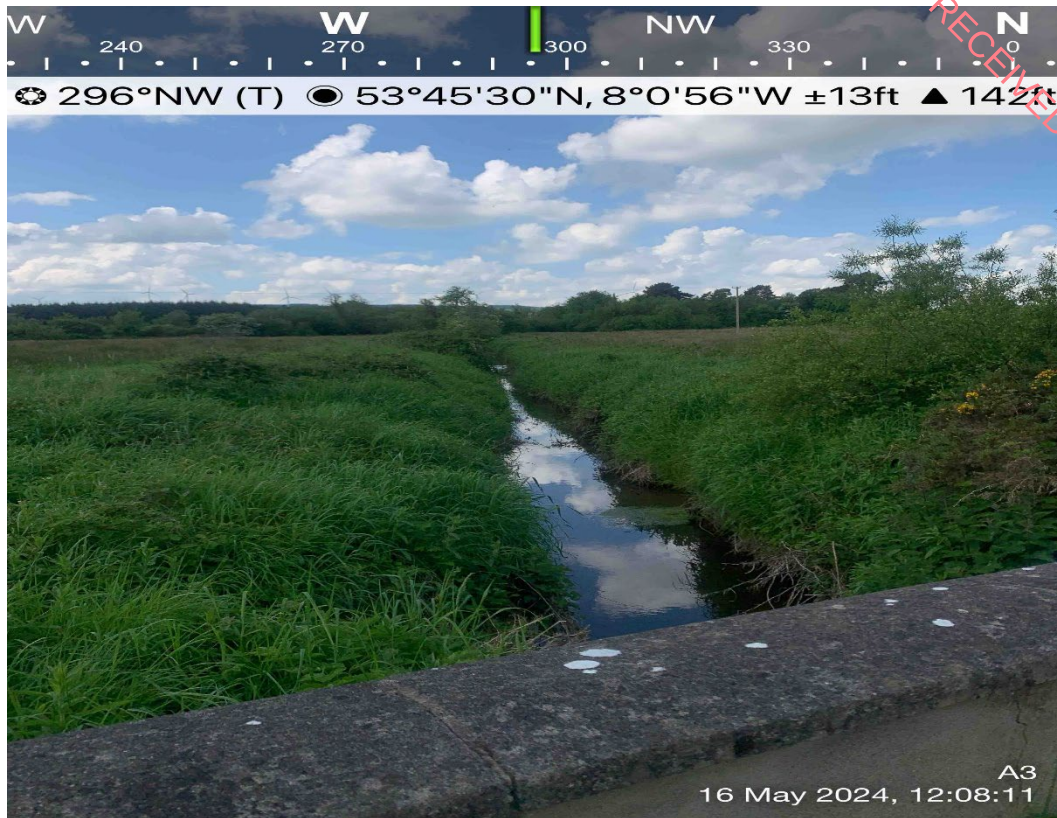
**Photo 3: A3 clear stream through an area of grassland – easily accessed**

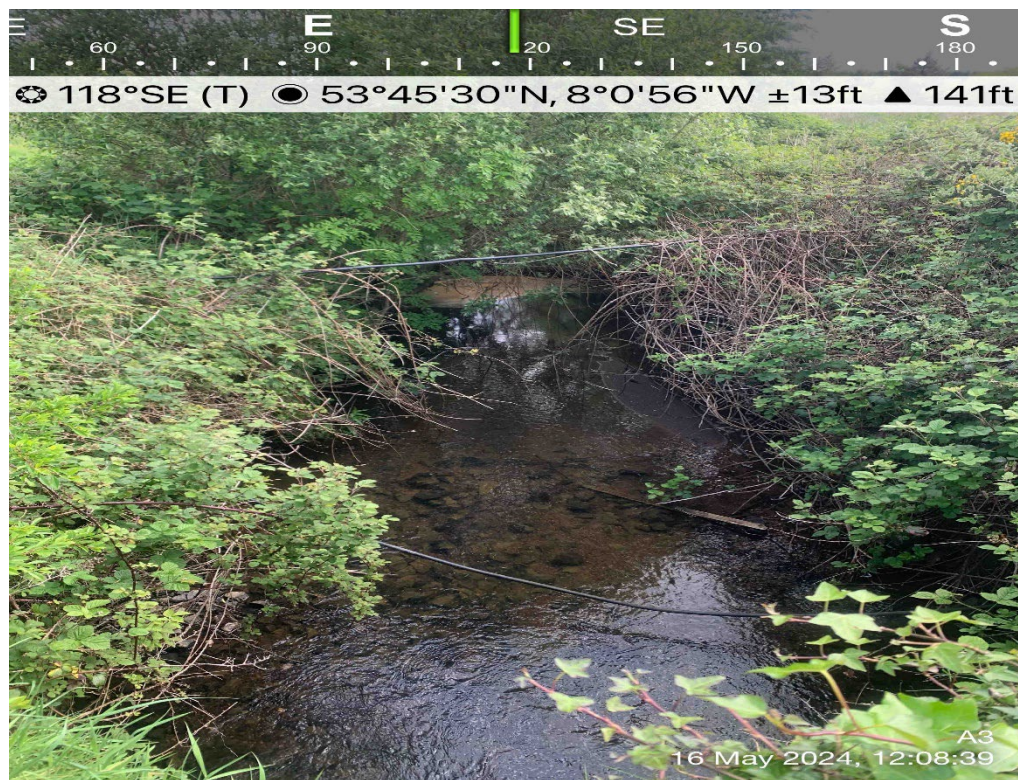
**Photo 4: A3 sample clear and odourless**

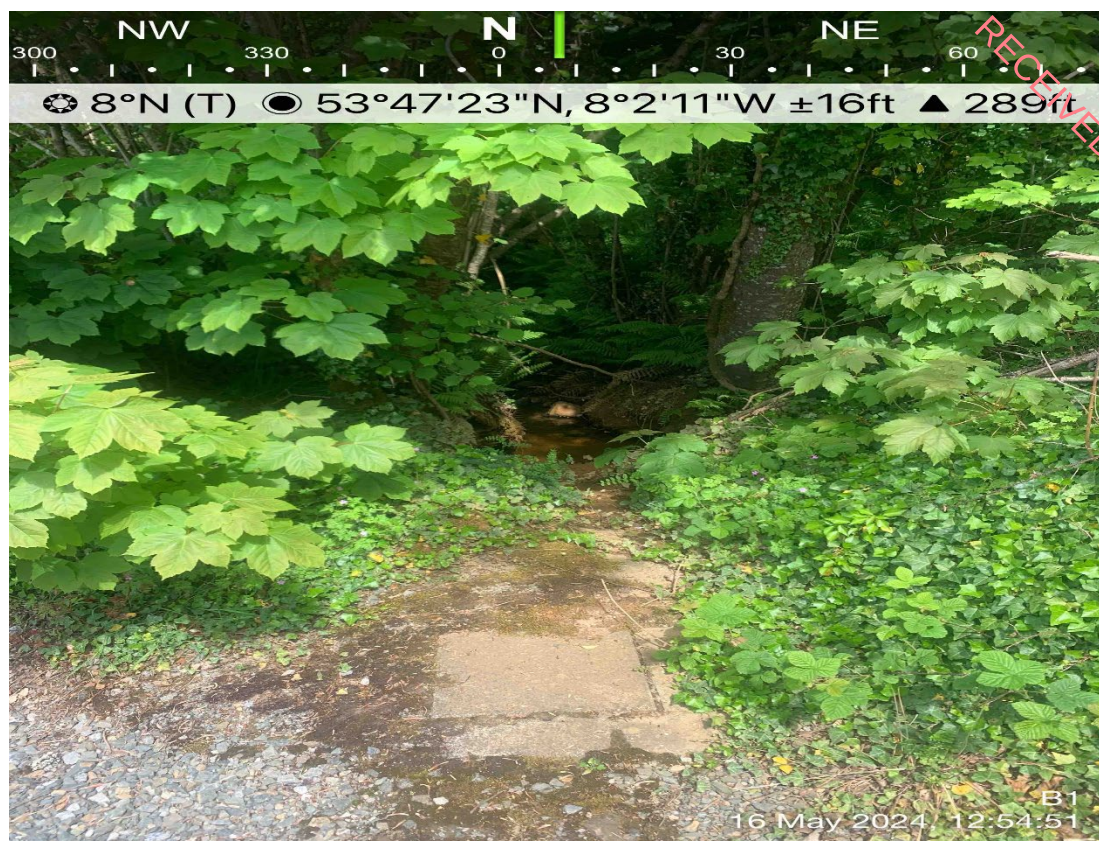
Photo 5: B1 area overgrown

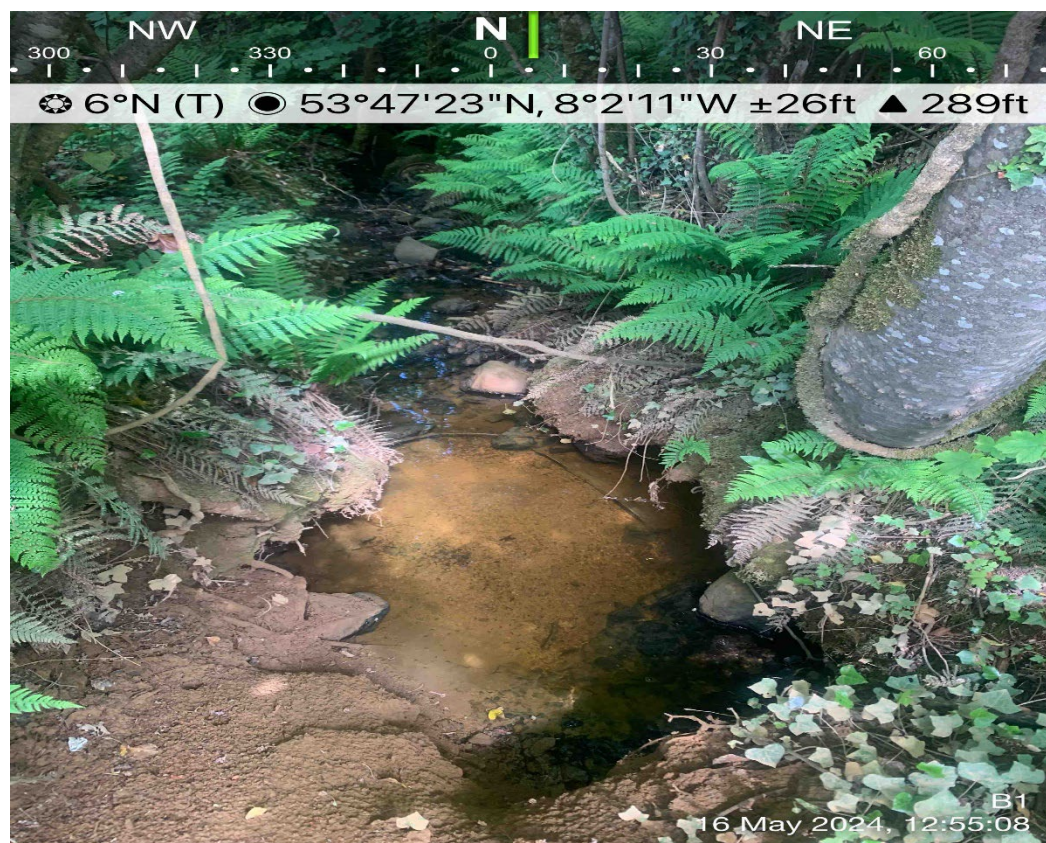
Photo 6: B1 sample clear and odourless

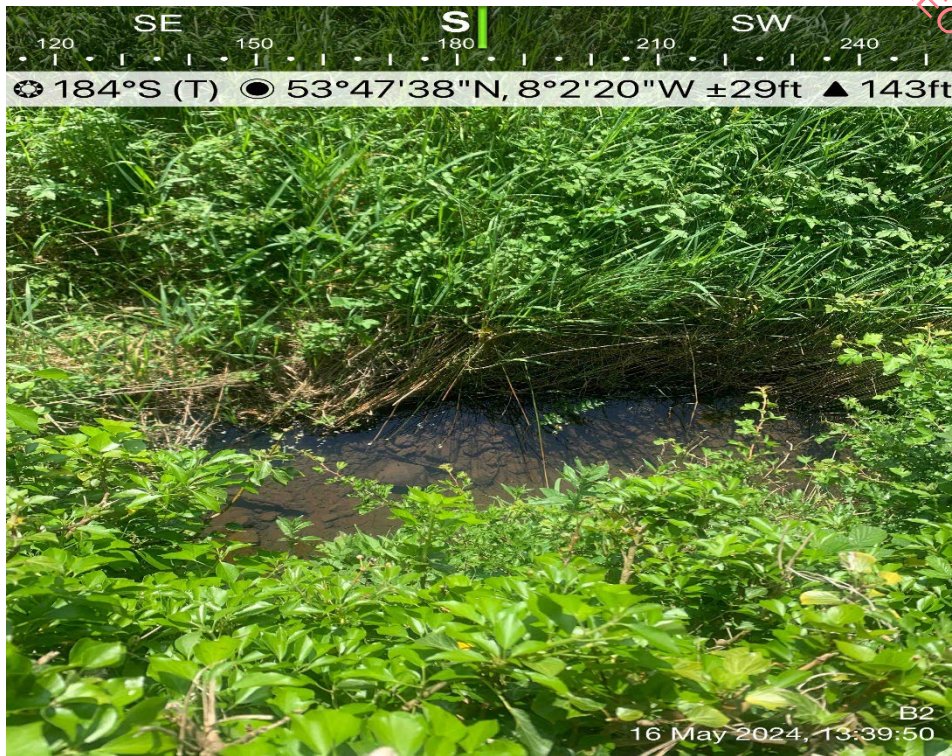
**Photo 7: B2 area overgrown. This sample was visually clear and odourless**

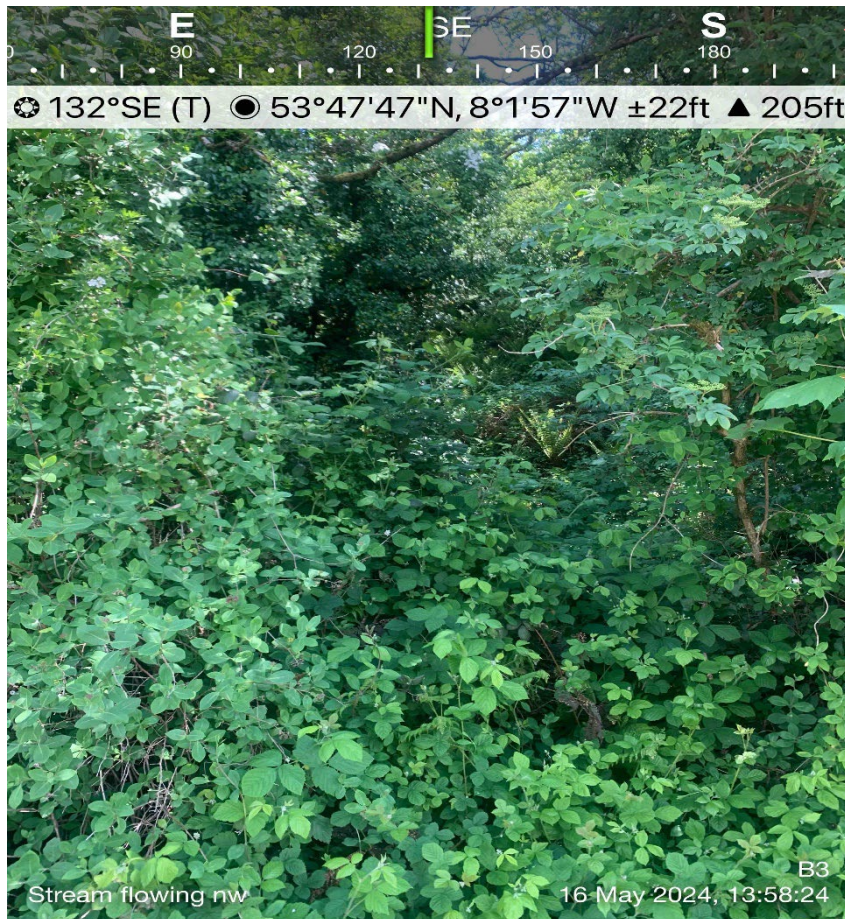
**Photo 9: B3 This sampling point was not easily accessible and was heavily overgrown**

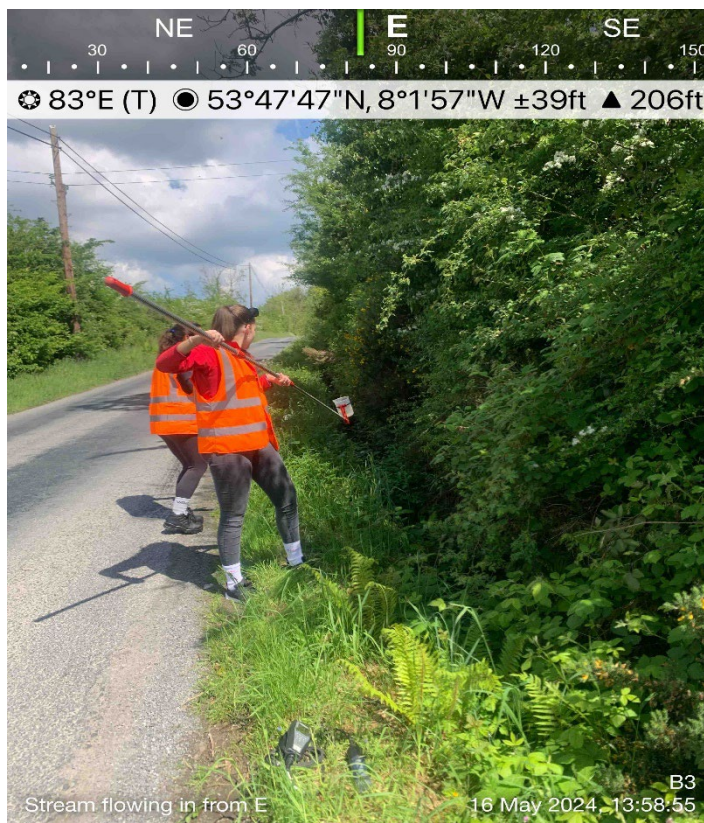
**Photo 10: B3 This sample was visually clear and odourless**

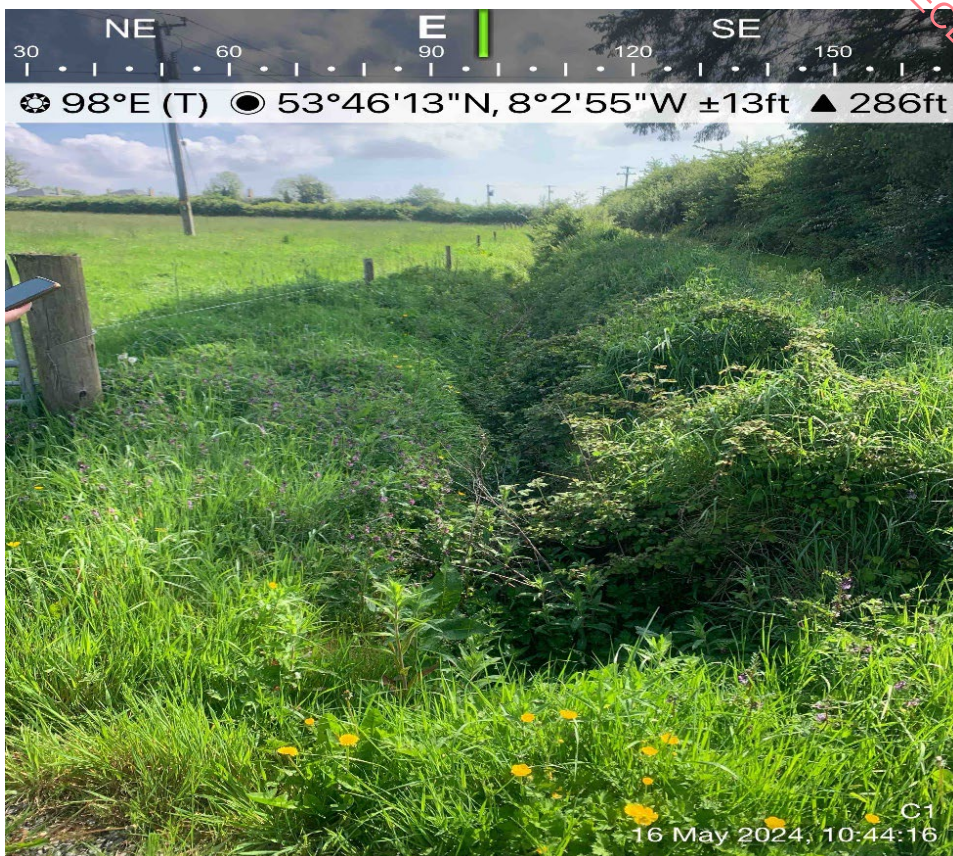
**Photo 11: C1 This sampling point was overgrown with briars crossing the stream. The electric fencing would suggest this stream is adjacent to agricultural farmlands.**

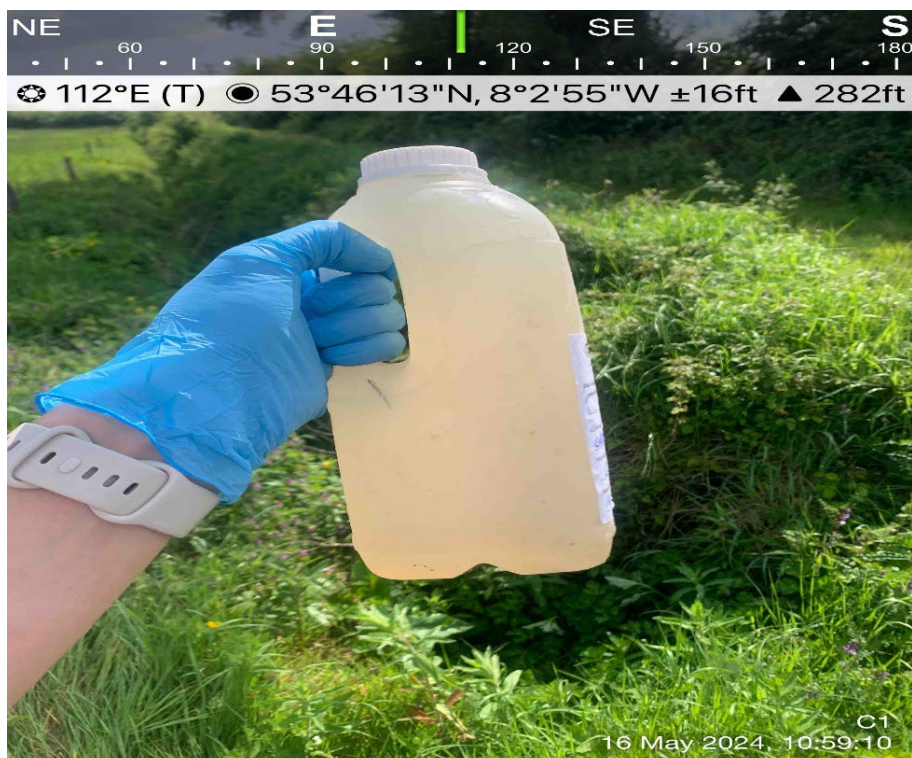
**Photo 12: C1 This sample appeared to be clear with a yellow hue and was odourless**

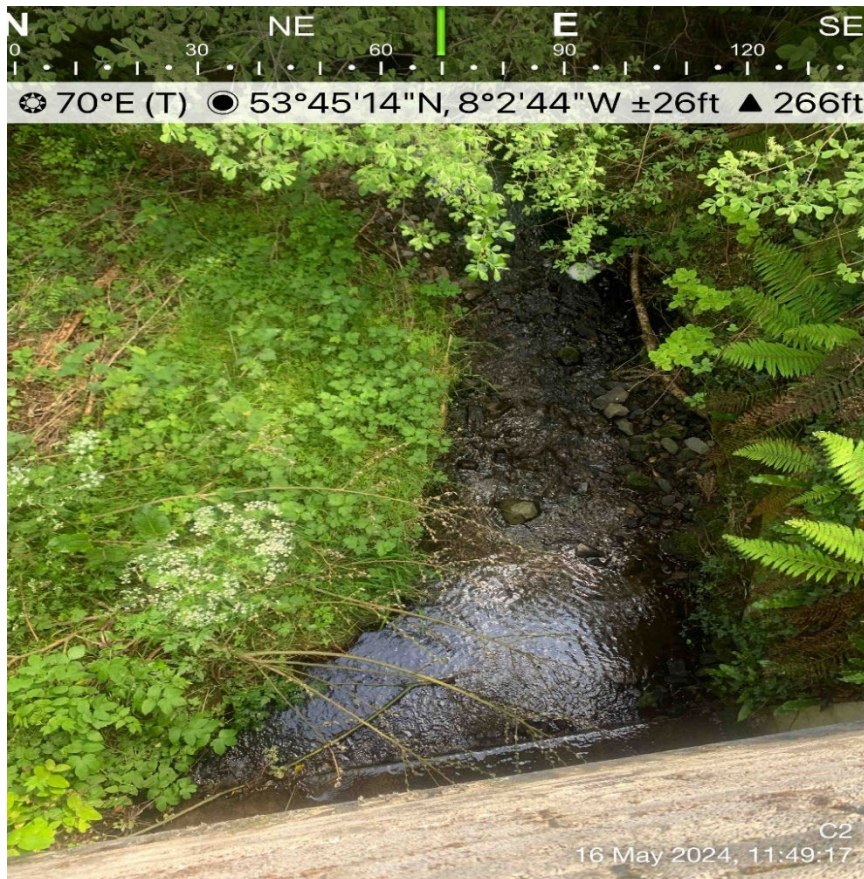
**Photo 9: C2 This sample was odourless and visually clear**
