APPENDICES 5.10

Report of Geophysical Survey
Dun Laoghaire Cruise Project
At Dun Laoghaire Harbour, Co. Dublin
Licence Number: 13R73

Report of Geophysical Survey
Dun Laoghaire Cruise Project
At Dun Laoghaire Harbour, Co. Dublin
Licence Number: 14R0049

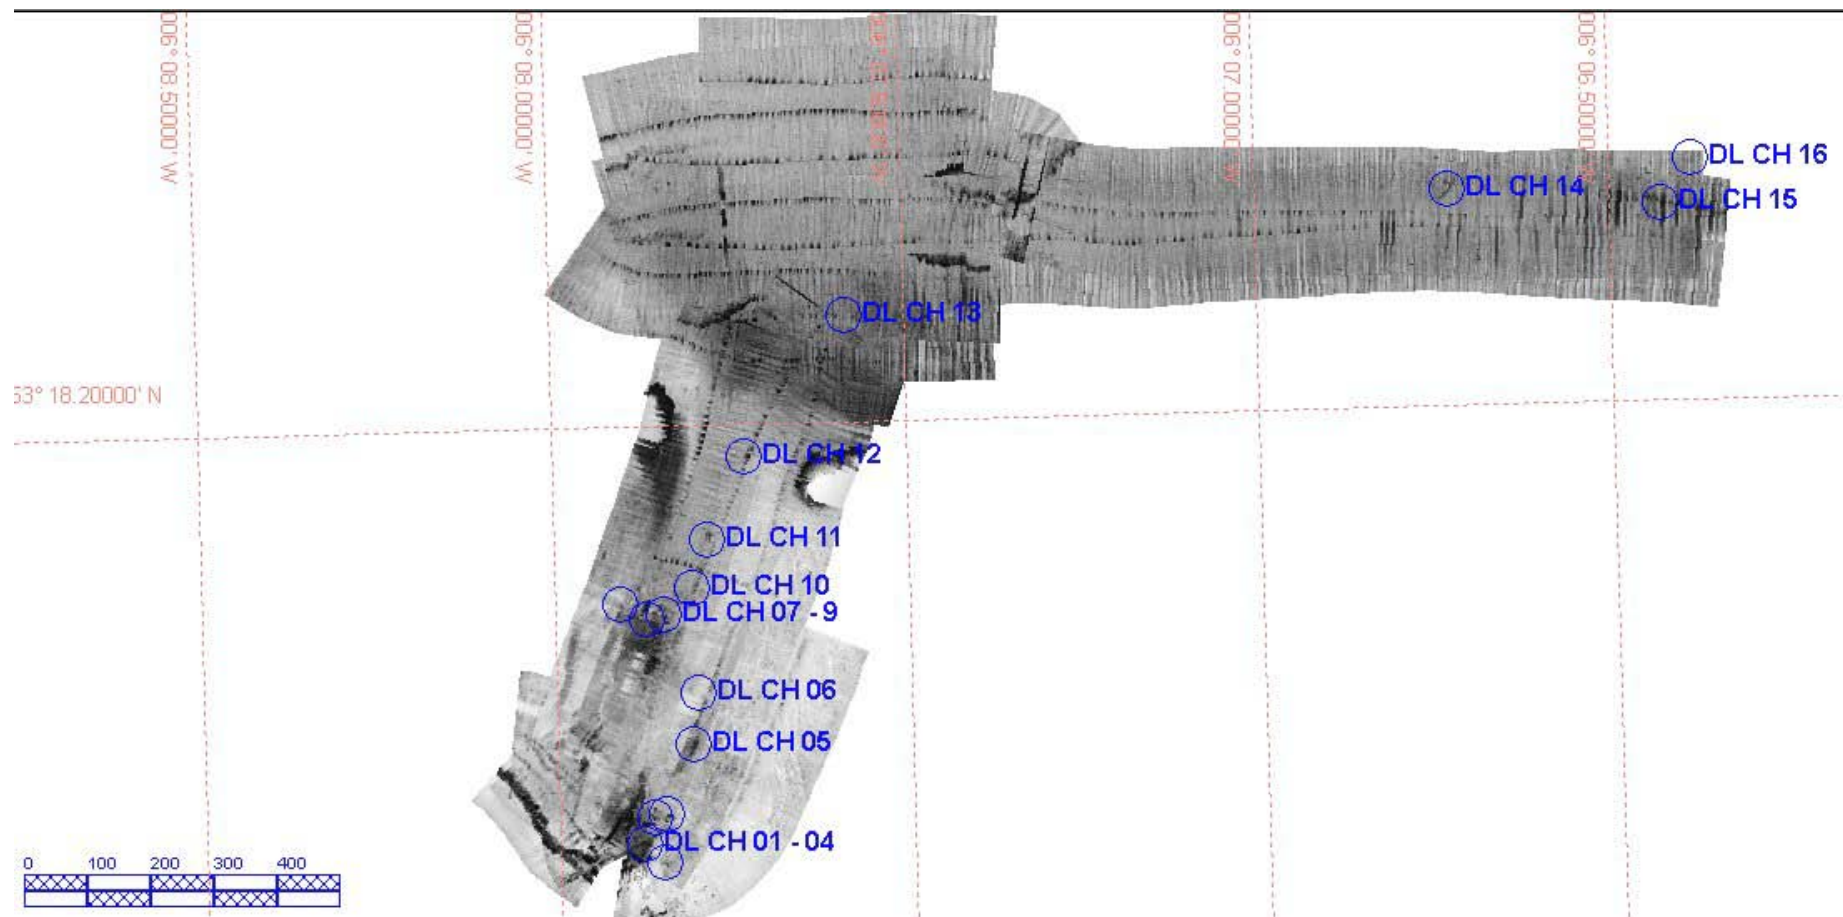
Figure 4. Side Scan Sonar Contacts

It is subsequently recommended that the magnetic anomalies and the side scan sonar contacts are investigated to determine their nature, age and extent. This should be undertaken by a team of archaeological divers, subject to the approval of the Department of Arts, Heritage and Gaeltacht.

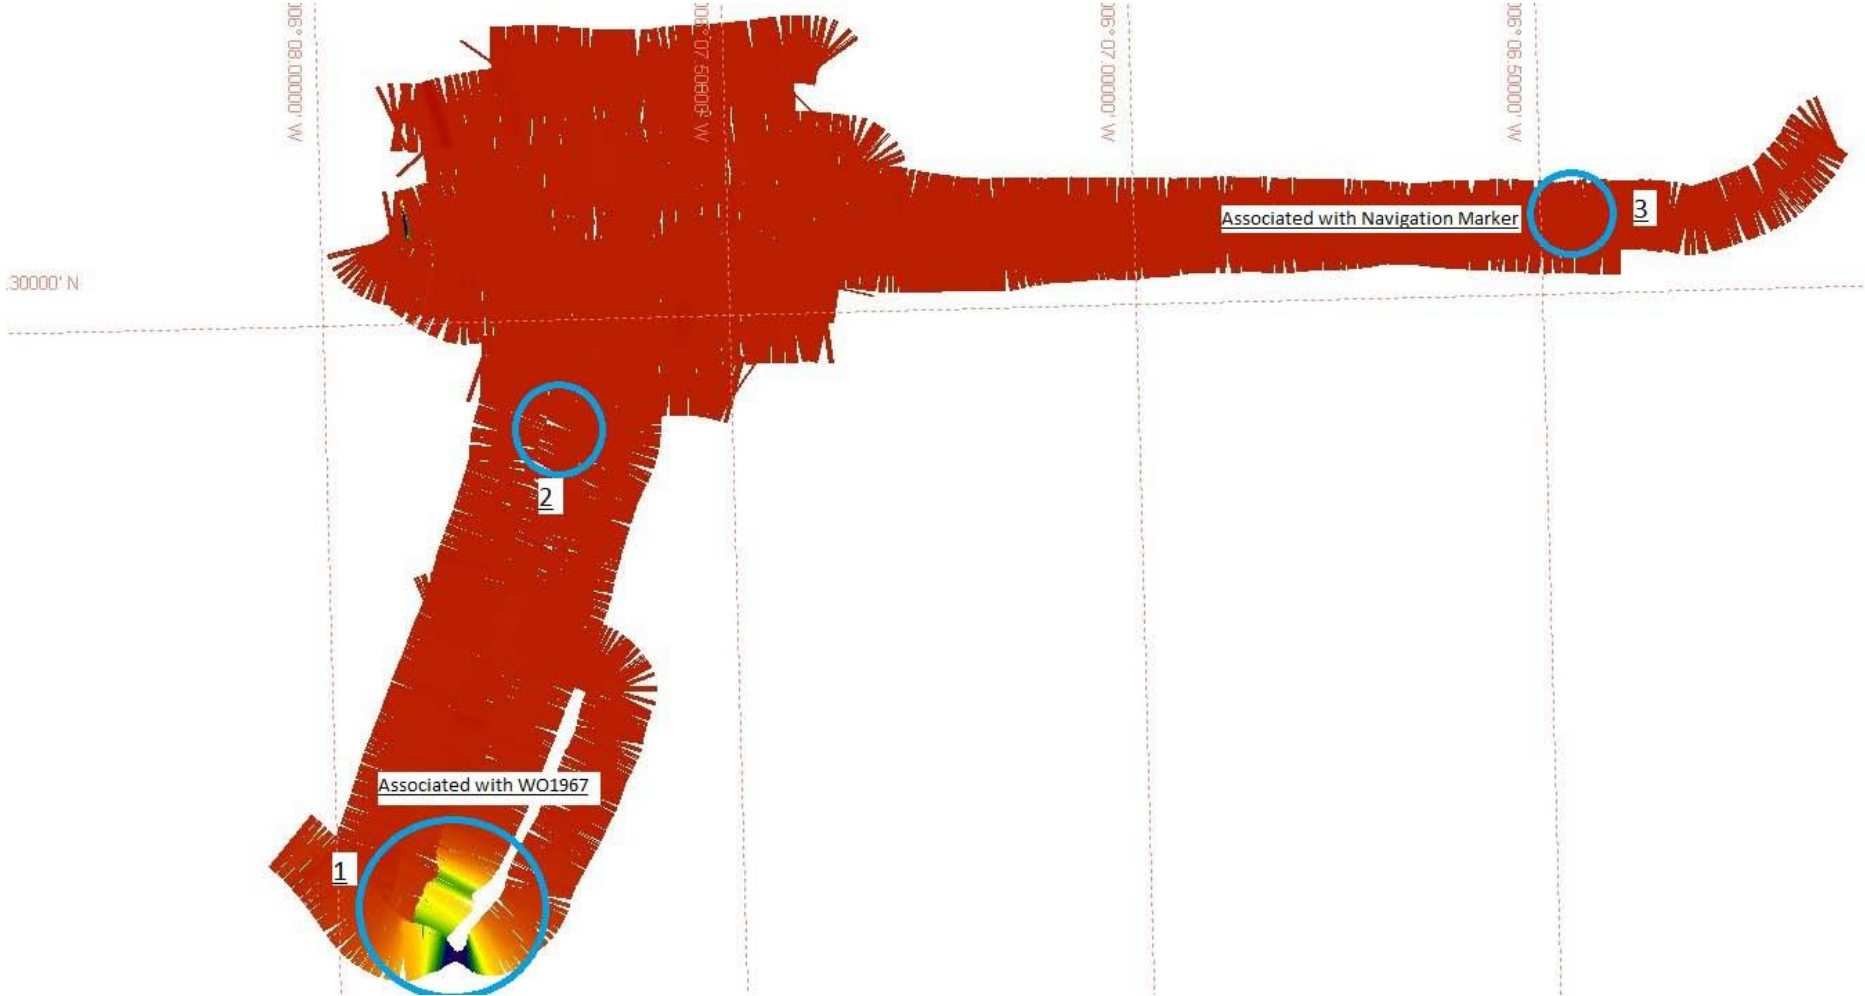
Figure 5. Magnetometer Data showing location of the three main anomalies.

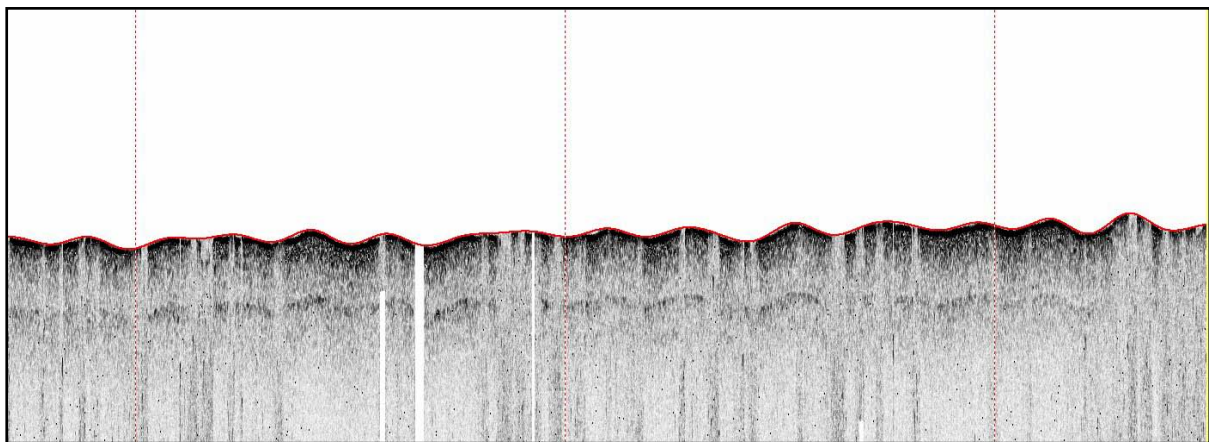
In the main harbour area, the sub bottom profiler indicated the presence of a strong surface reflector with a possible sub horizon noted 2.5-3.2m below. This sub horizon was generally noted as a uniform horizon throughout much of the inner harbour survey area, however it did ascend and descend in places. The horizon appeared to mask the current bed level in many places but it was noted to undulate in certain areas, thus indicating that it was not a multiple reflector. No evidence of the recorded shipwreck WO1967 was noted in the sub bottom profiler record. The absence of evidence for the wreck remains can be attributed to a number of reasons:

Plate 6. Sub Bottom Profiler section through harbour area

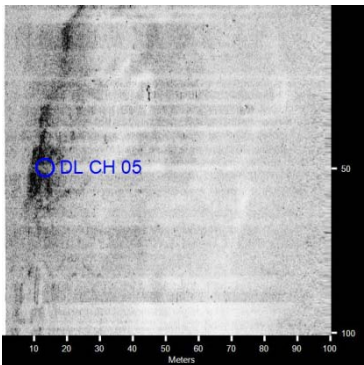
<p>DL CH 05</p> <ul style="list-style-type: none"> • Sonar Time at Target: 5/22/2014 12:47:29 PM • Click Position 53.2988385418 -6.1301625805 (WGS84) 0.0000000000 0.0000000000 (NAD27LL) 53.2988385418 -6.1301625805 (LocalLL) (X) 724638.45 (Y) 729246.87 (Projected Coordinates) • Map Projection: IREN95.IrishTM • Acoustic Source File: E:\Dunleary Sidescan and MagData\DunlearySidescan\20140522124252.jsf • Ping Number: 35016 • Range to target: 86.91 Meters • Fish Height: 13.09 Meters • Heading: 181.790 Degrees • Event Number: 0 • Line Name: 20140522124252 • Water Depth: 0.78 Meters 	<p>Dimensions and attributes</p> <ul style="list-style-type: none"> • Target Width: 0.00 Meters • Target Height: 0.00 Meters • Target Length: 60.93 Meters • Target Shadow: 0.00 Meters • Mag Anomaly: • Avoidance Area: • Classification1: Unknown • Classification2: • Area: • Block: • Description: Unknown undualtion on seafloor. Image appears to indicate slight seafloor depression

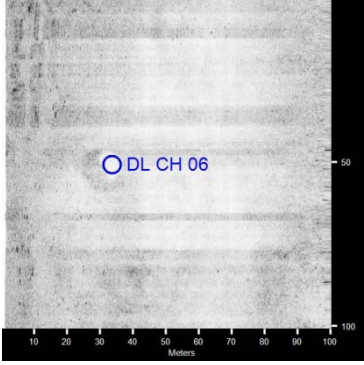
<p>DL CH 06</p> <ul style="list-style-type: none"> • Sonar Time at Target: 5/22/2014 12:46:58 PM • Click Position 53.2995445018 -6.1300202997 (WGS84) 0.0000000000 0.0000000000 (NAD27LL) 53.2995445018 -6.1300202997 (LocalLL) (X) 724645.88 (Y) 729325.66 (Projected Coordinates) • Map Projection: IRENET95.IrishTM • Acoustic Source File: E:\Dunleary Sidescan and MagData\DunlearySidescan\20140522124252.jsf • Ping Number: 34792 • Range to target: 66.60 Meters • Fish Height: 14.35 Meters • Heading: 179.290 Degrees • Event Number: 0 • Line Name: 20140522124252 • Water Depth: 0.78 Meters 	<p>Dimensions and attributes</p> <ul style="list-style-type: none"> • Target Width: 0.00 Meters • Target Height: 0.00 Meters • Target Length: 6.70 Meters • Target Shadow: 0.00 Meters • Mag Anomaly: • Avoidance Area: • Classification1: Unknown • Classification2: • Area: • Block: • Description: Unknown seafloor conical shaped depression

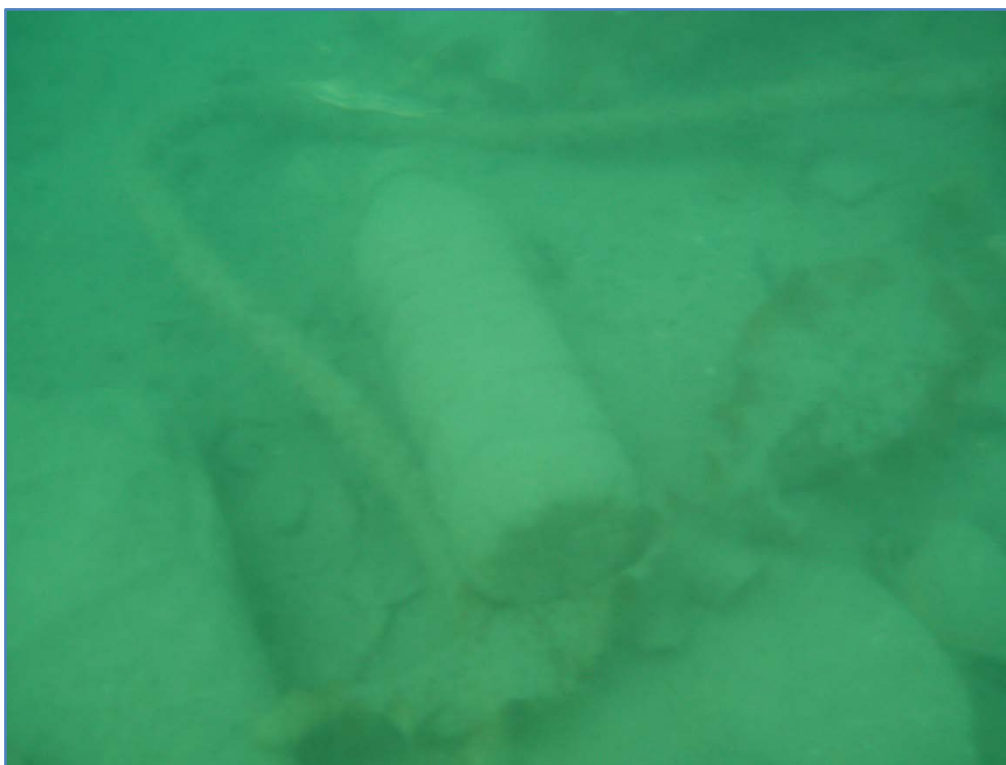
The remains noted at the location of WO1966 appear to be those of recorded shipwreck remains. As such they should be afforded protection. Although the surface expression of the wreck is low, there is potential that further more intact remains and associated materials may be contained beneath the

Plate 1. Large Bottle with Twisted metal at site of wreck WO1966

Determination of the full extent of the wreck site and whether sections of the wreck WO1966 extend into the development zone was not possible during the dive inspection survey. It would only be possible through the excavation of pre-development archaeological test trenches.

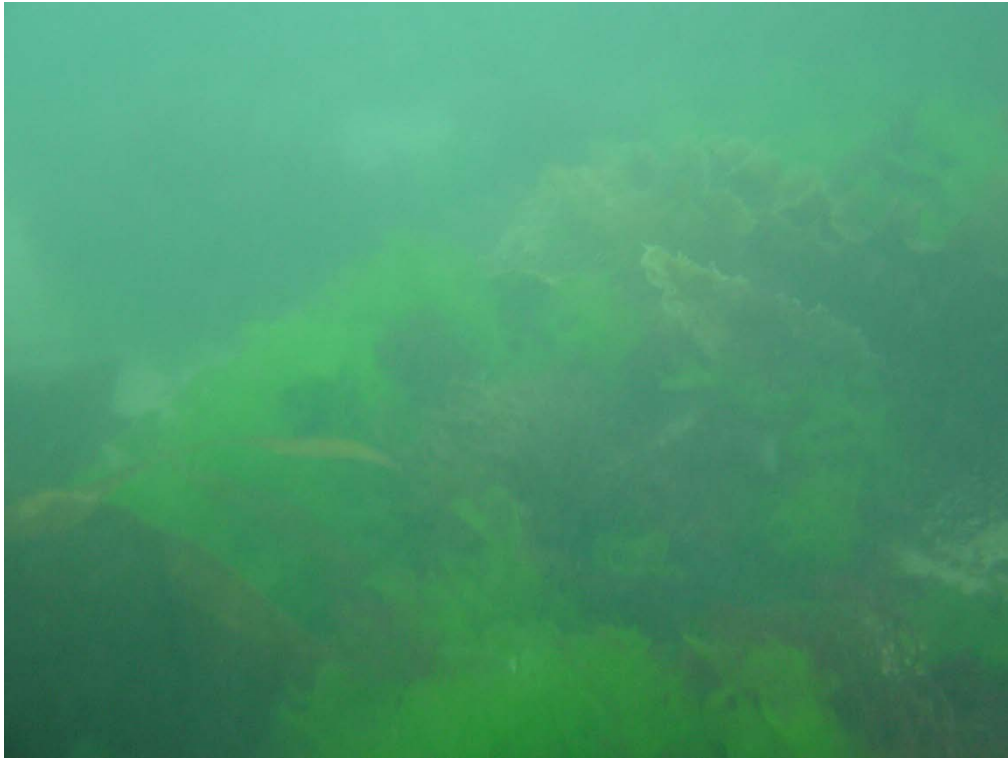
Plate 2. Weed encrusted metallic bars at site of wreck WO1966

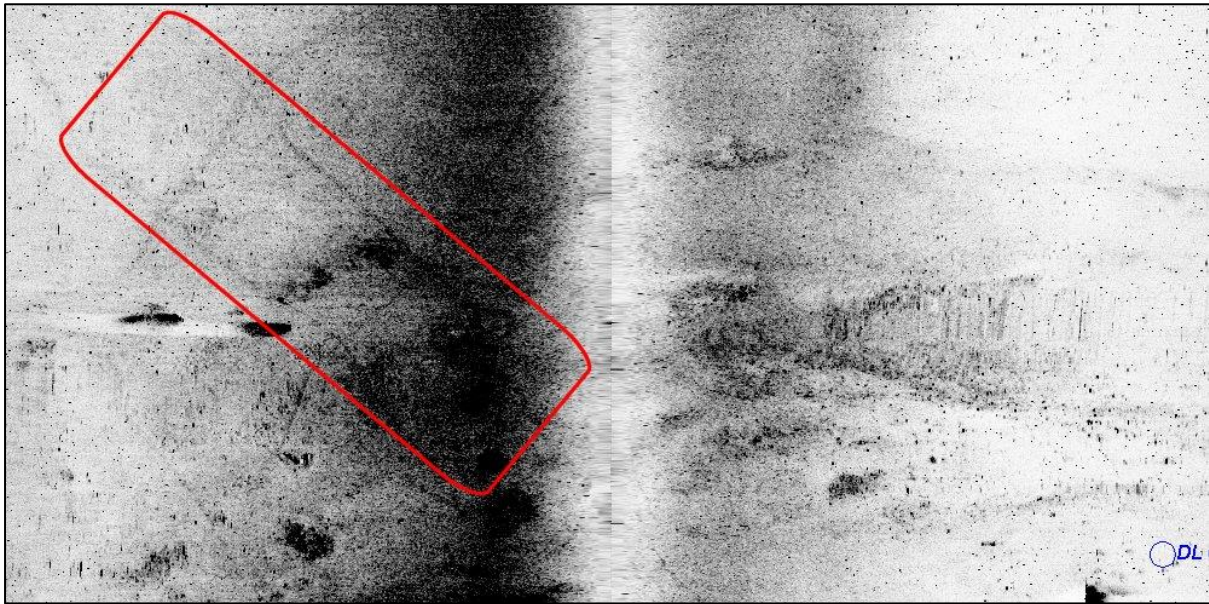
Plate 4. Extract from Survey line 3 showing trawl lines

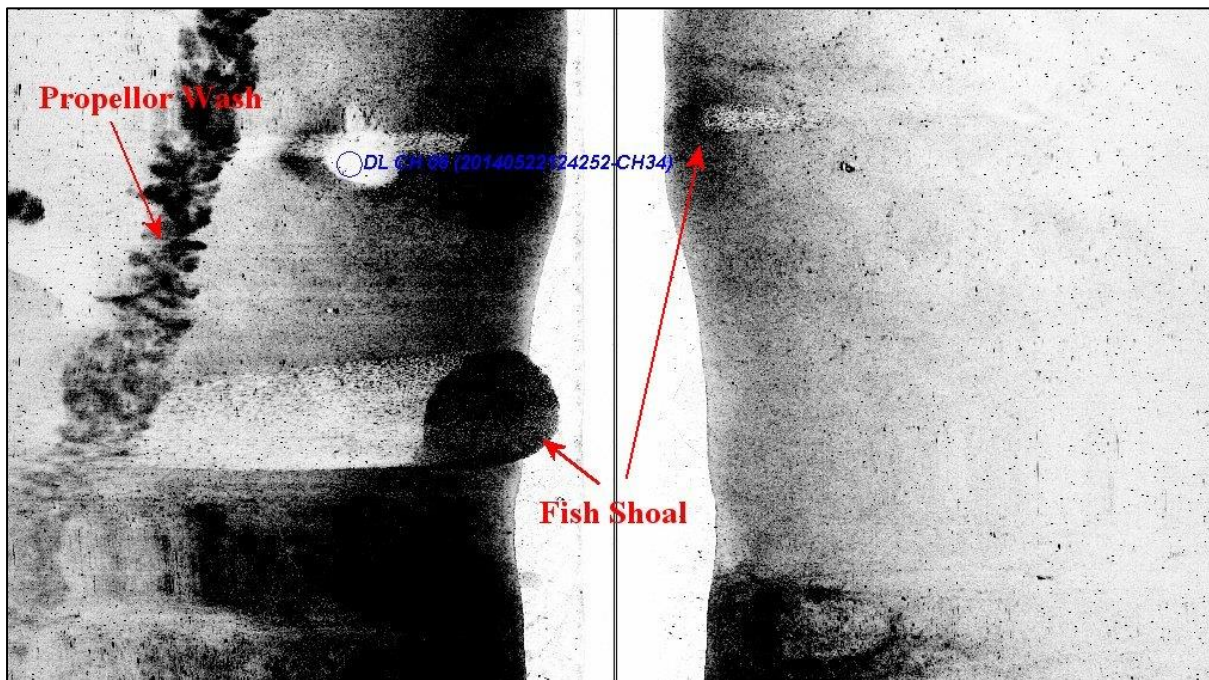
Plate 5. Extract from Line 8 showing Feature DL CH 06 plus natural features

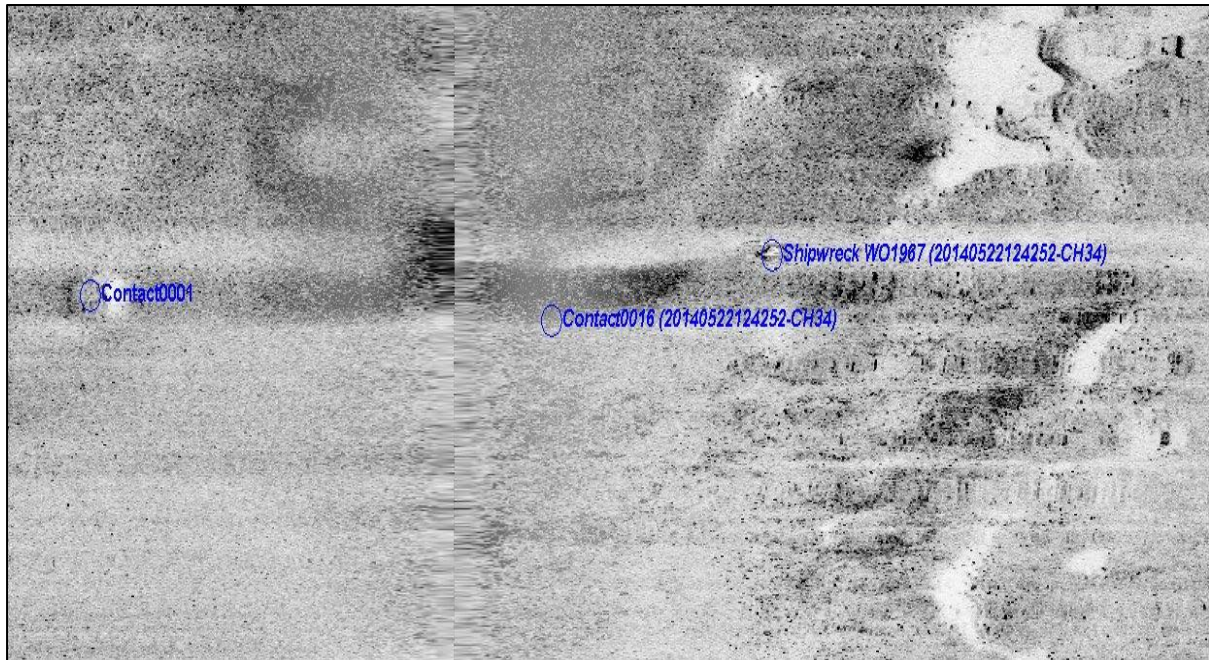
Plate 6. Contacts thought to be related to WO1967 from first geophysical survey, seabed shows notable scouring in this area.

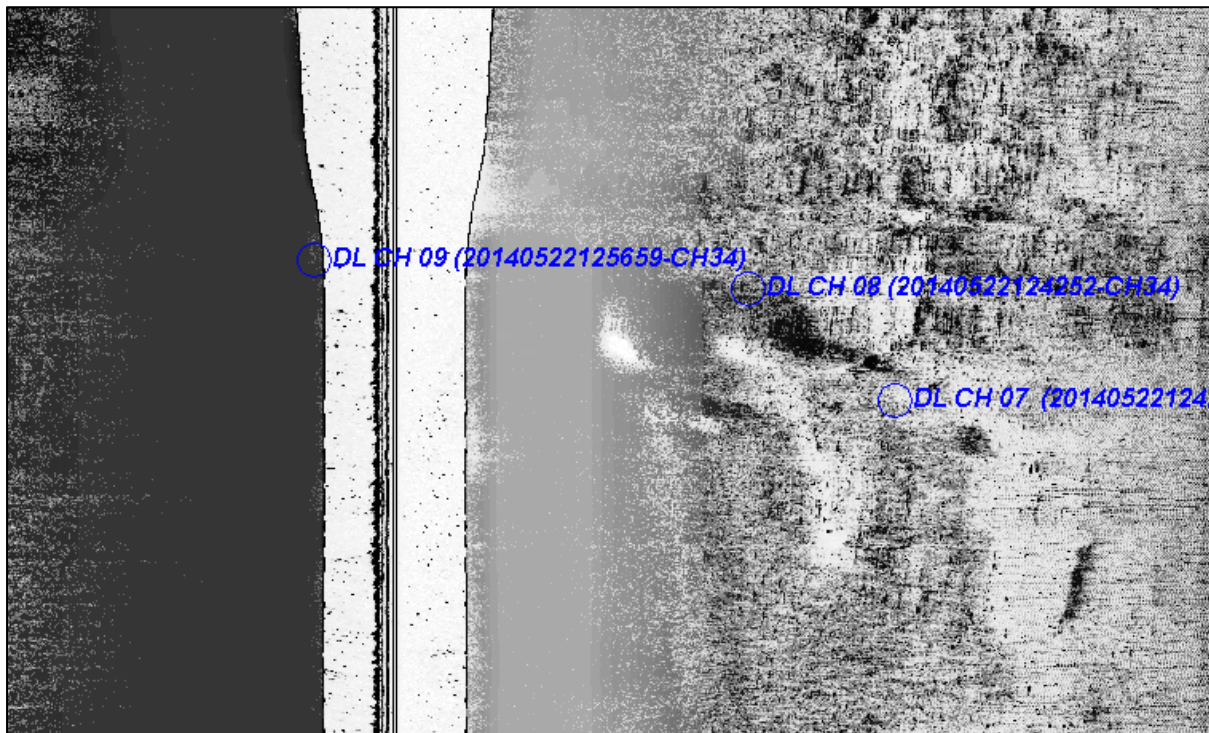
Plate 7. Sonar contacts DL CH 07 – DL CH 09, in same location as contacts from previous geophysical survey, note less scouring of seabed.

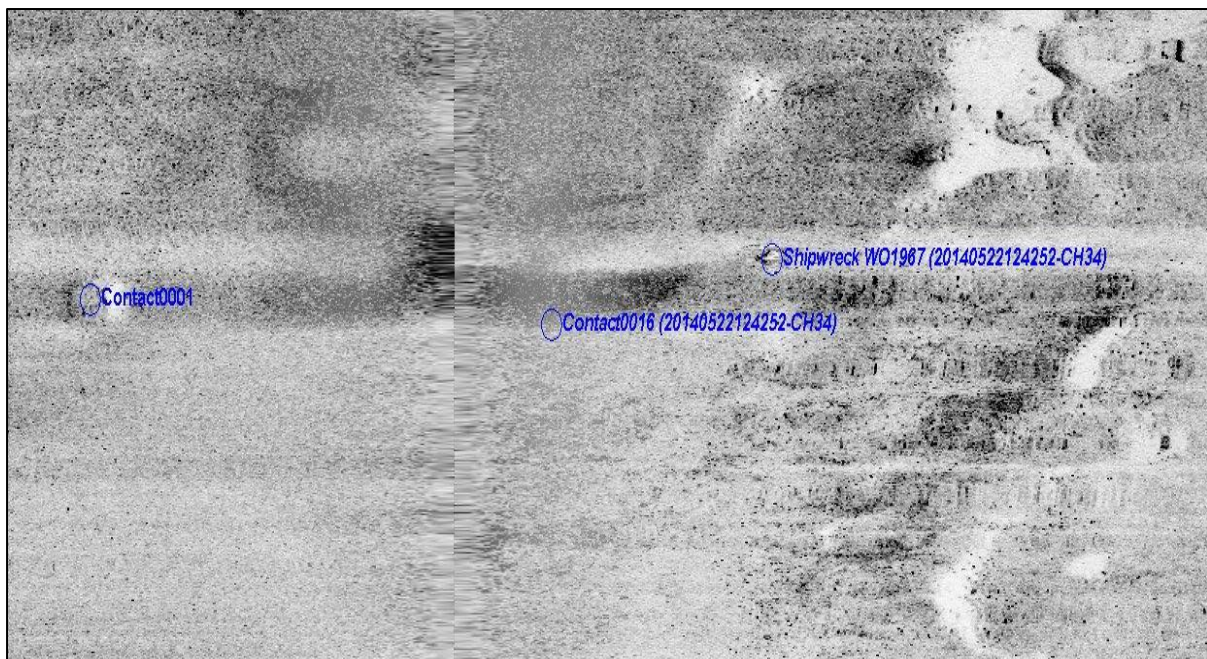
Plate 8. Contacts thought to be related to WO1967 wreck site, geophysical survey No.1.

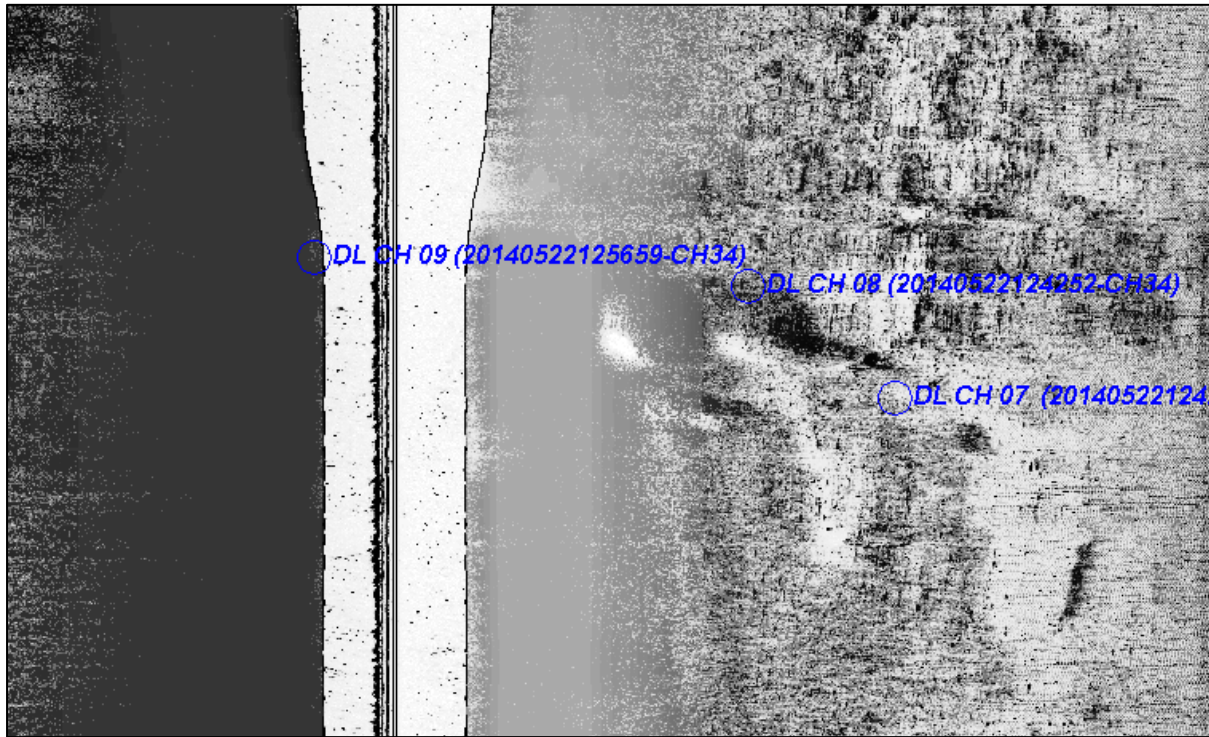
Plate 9. Same contacts as seen in plate 8, geophysical Survey No.2.
