## N6 Galway City Ring Road

**Karst Survey Report**

Reference: GCOB-4-03-0-6.2.8\_010

Issue 4 | 28 March 2025

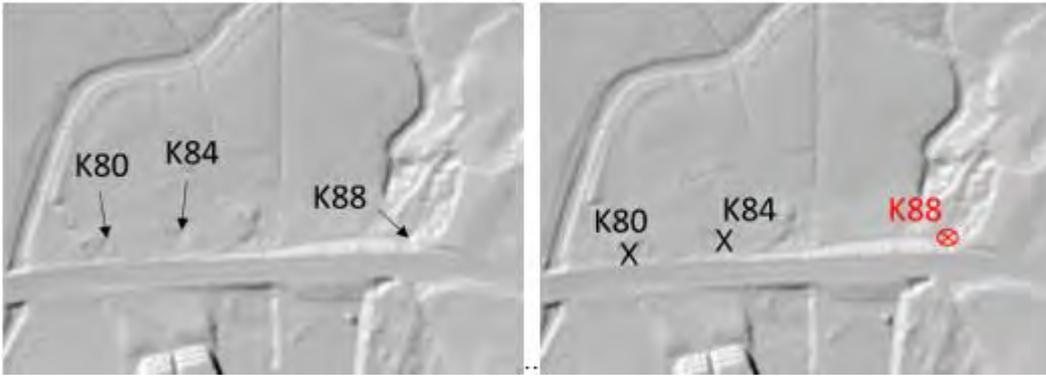
Figure 2a shows the lidar image of three potential enclosed depression identified from the desk study. During the site visit K88 was confirmed to be an enclosed depression, however, onsite inspection K80 and K84 were found to be mounds and therefore classified as not karst (Figure 2b).

**Figure 2a (left) lidar image showing three potential enclosed depressions identified from the desk study, 2b (right) the field survey confirmed enclosed depression K88 (red circle) but also proved that K80 and K84 (black crosses) were not karst**

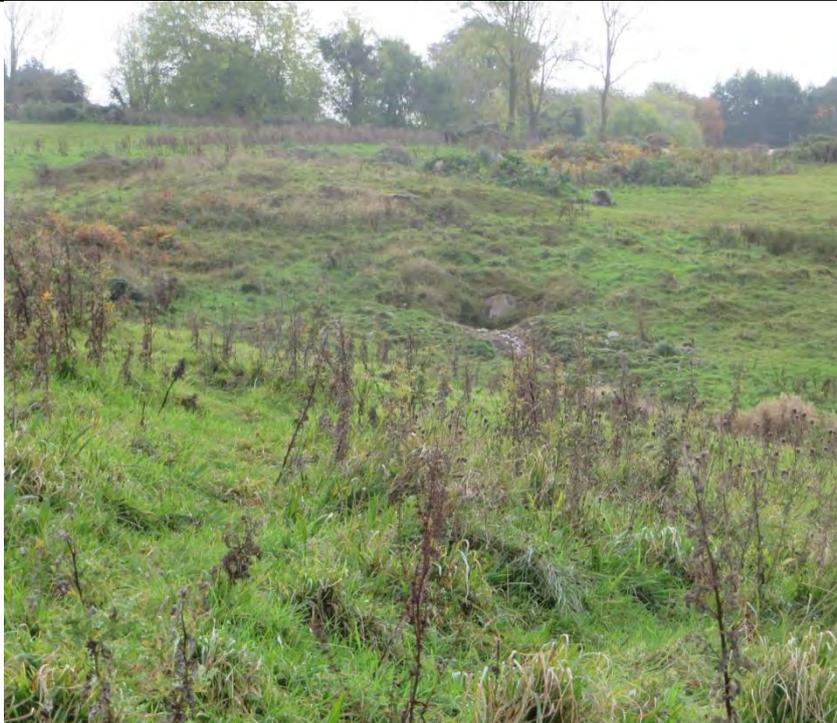
<b>Feature ID</b>	<b>K10</b>
<b>Feature type</b>	Enclosed depression
<b>Coordinates</b>	527301, 728143
<b>Source</b>	Field Survey
<b>Field survey date</b>	20/10/2014
<b>Field survey status</b>	Confirmed
<b>Water present</b>	No
<b>Additional Information</b>	1 m diameter small enclosed depression, base contains loose rocks
<b>Site photos</b>

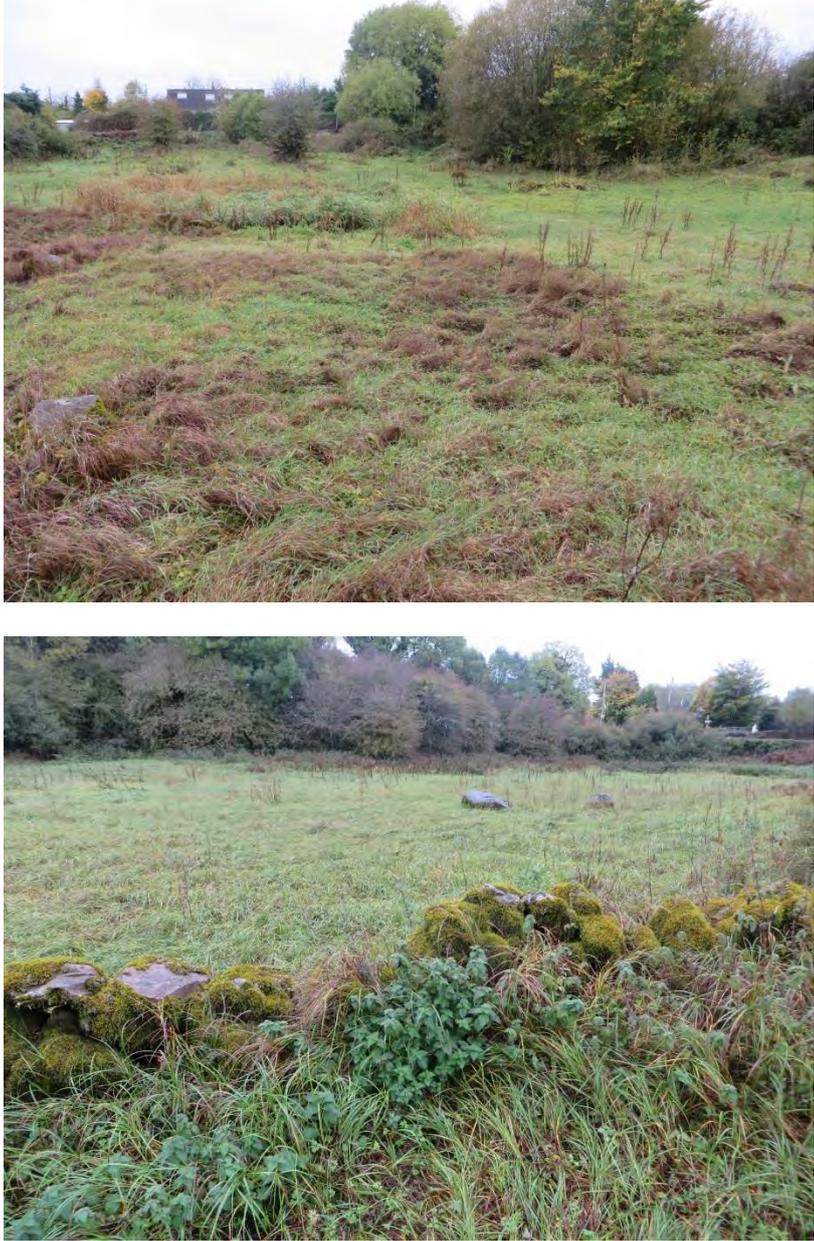
Other sources: aerial photography	
<b>Field survey date</b>	17/10/2014	11/11/2014
<b>Field survey status</b>	Confirmed	Confirmed
<b>Water present</b>	No	Yes Electrical conductivity: 481 uS/cm Temperature: 9.8 °C pH: 7.64

<b>Water elevation</b>	10.42 mAOD
<b>Additional Information</b>	A plug hole was not found
<b>Site photos</b> 17/10/2014

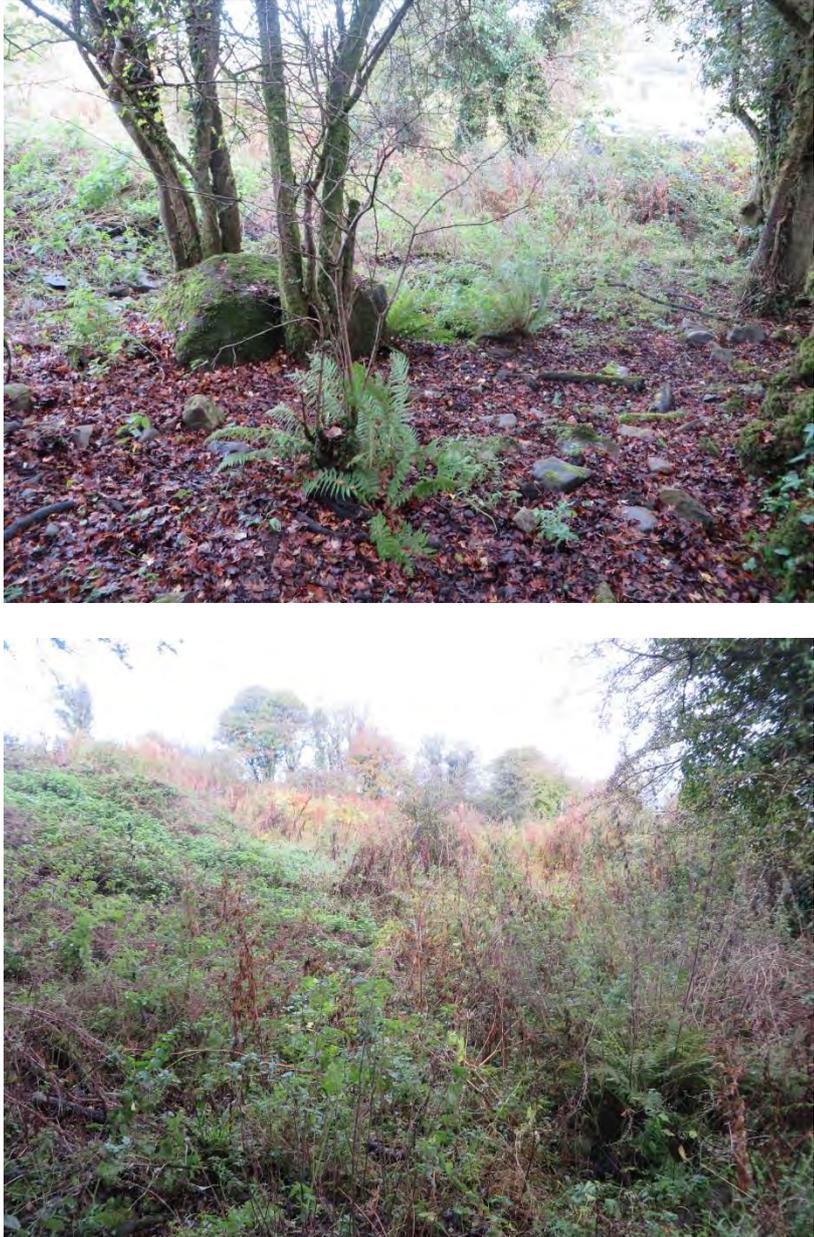
<b>Feature ID</b>	<b>K70</b>
<b>Feature type</b>	Enclosed depression
<b>Coordinates</b>	530671, 728317
<b>Source</b>	Field Survey
<b>Field survey date</b>	21/10/2014
<b>Field survey status</b>	Confirmed
<b>Water present</b>	No
<b>Additional Information</b>	15 x 3 m diameter enclosed depression Possibly filled in depression
<b>Site photo</b>

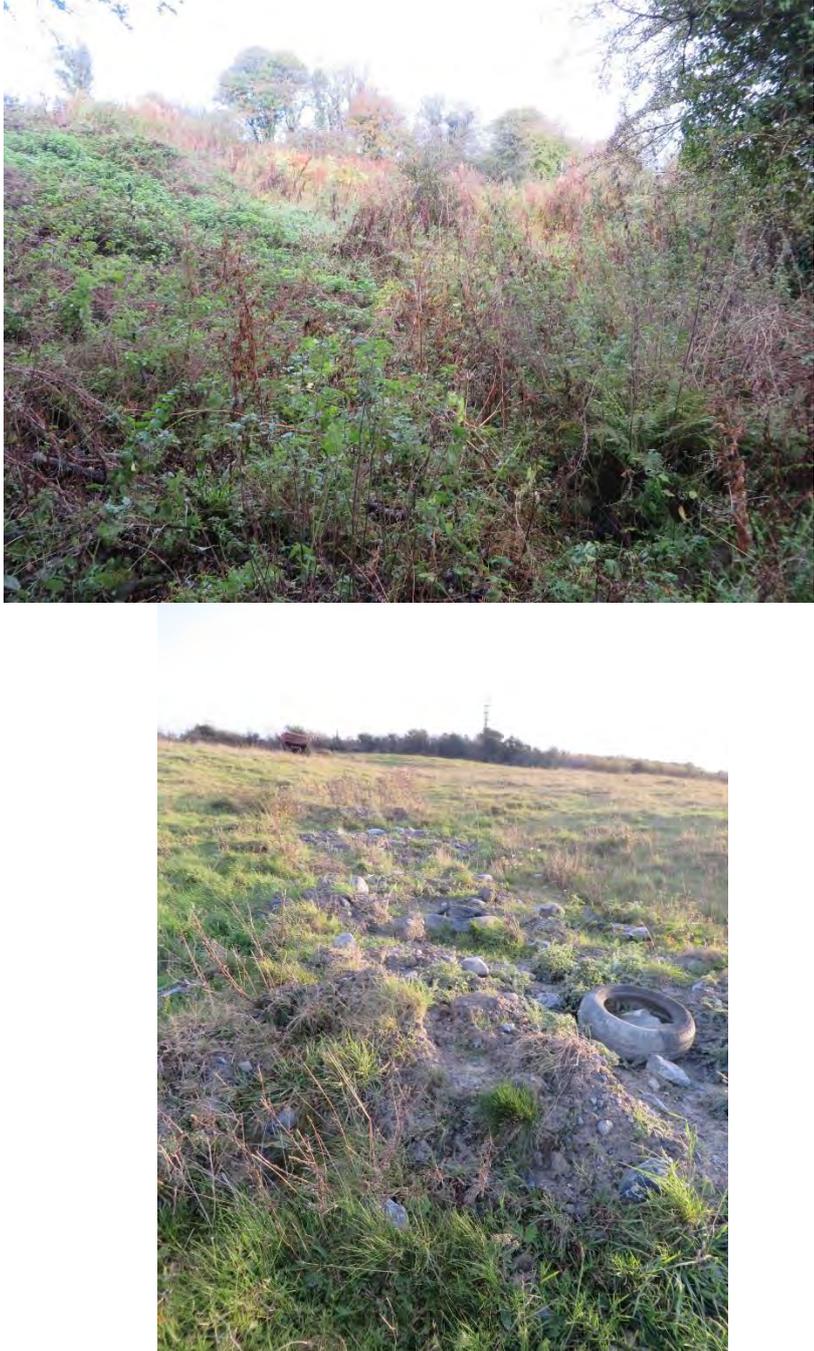
<b>Feature ID</b>	<b>K71</b>
<b>Feature type</b>	Enclosed depression
<b>Coordinates</b>	530694, 728662
<b>Source</b>	Field Survey
<b>Field survey date</b>	16/10/2014
<b>Field survey status</b>	Confirmed
<b>Water present</b>	No
<b>Additional Information</b>	2m by 4m along slope line Small depression near top of slope contains exposed rock
<b>Site photo</b>

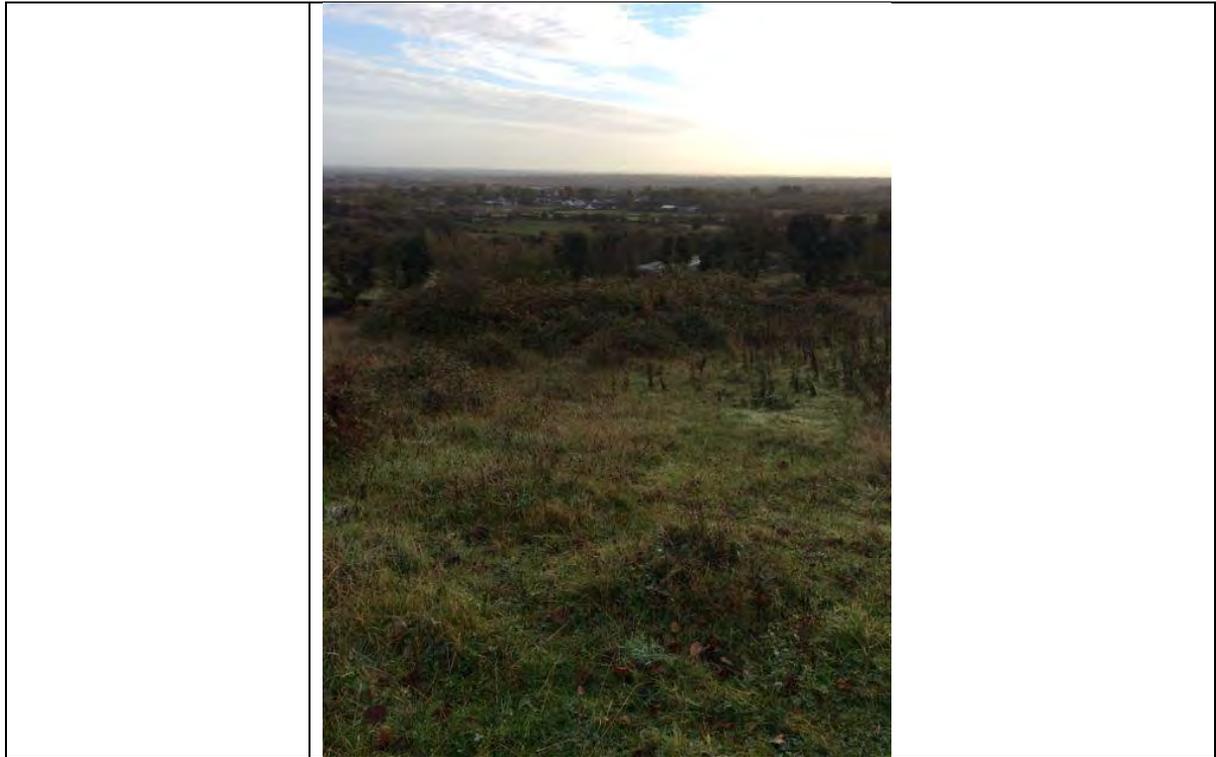
<b>Feature ID</b>	<b>K85</b>
<b>Feature type</b>	Enclosed depression
<b>Coordinates</b>	531456, 729194
<b>Source</b>	Field Survey
<b>Field survey date</b>	16/10/2014
<b>Field survey status</b>	Confirmed
<b>Water present</b>	No
<b>Additional Information</b>	10 m diameter semicircle intercepted by wall/road (N84). Possible enclosed depression slightly questionable as it could be as a result of excavation for N84 road construction
<b>Site photo</b>

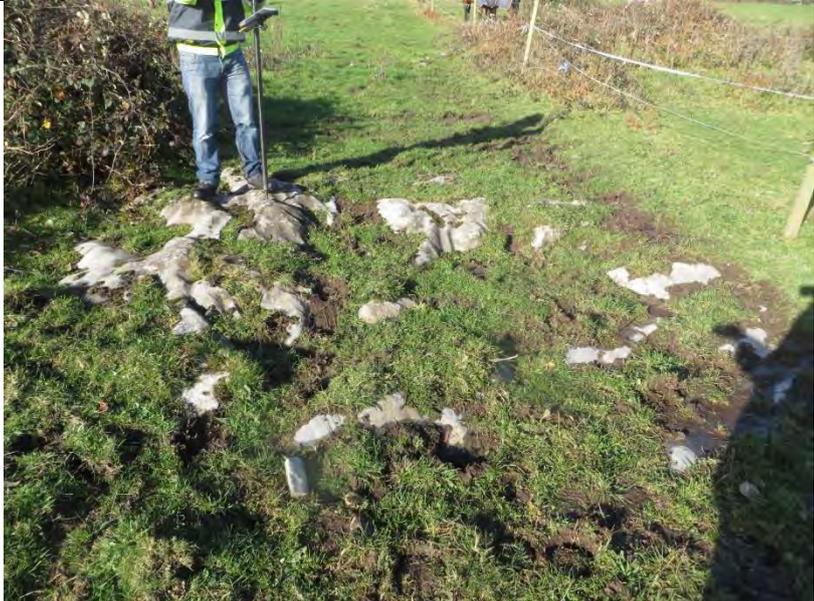
<p>The map shows a residential area with roads and buildings. A red circle highlights a specific location. An information window is overlaid on the map, displaying details for 'Karst Landforms'.</p>
<b>Field survey date</b>	14/11/2014
<b>Field survey status</b>	Confirmed
<b>Water present</b>	No
<b>Ground level elevation</b>	44.19 mAOD
<b>Additional Information</b>	Area of superficial solution features noted by GSI database but not very obvious in field. Some rock visible with solution erosion, see photo.
<b>Site photos</b>

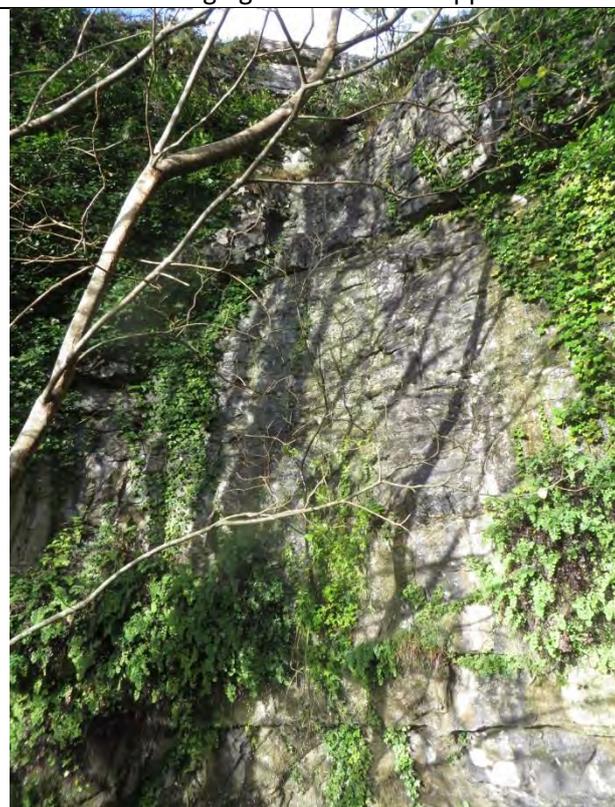
<b>Field survey date</b>	14/11/2014
<b>Field survey status</b>	Confirmed
<b>Water present</b>	Yes Electrical conductivity: 490 uS/cm Temperature: 12 °C pH: 8.23
<b>Additional Information</b>	Feature is located in old quarry. Water is discharging from fractures approx. 5m above ground level.
<b>Site photos</b>

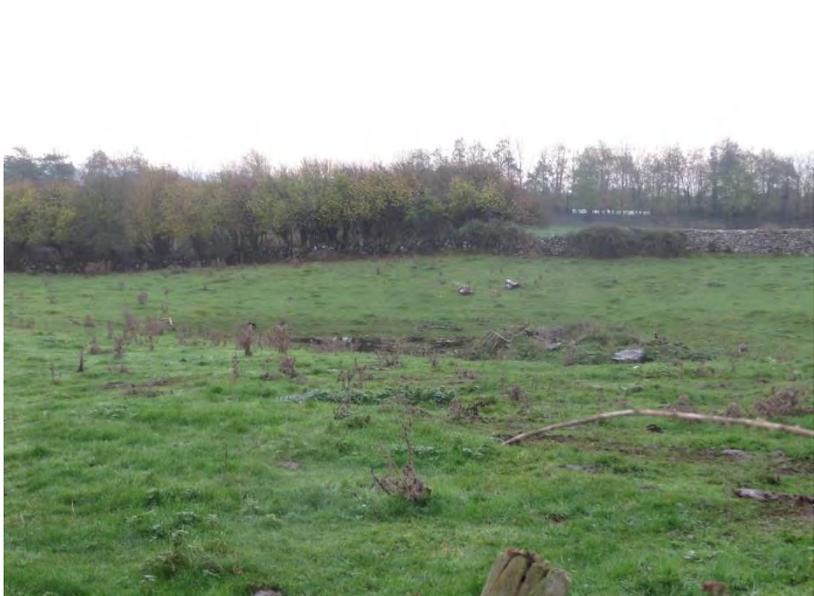
<b>Field survey date</b>	18/11/2014
<b>Field survey status</b>	Confirmed
<b>Water present</b>	Yes No water quality analysis recorded
<b>Additional Information</b>	Farmer noted that the depression fills with water
<b>Site photos</b>

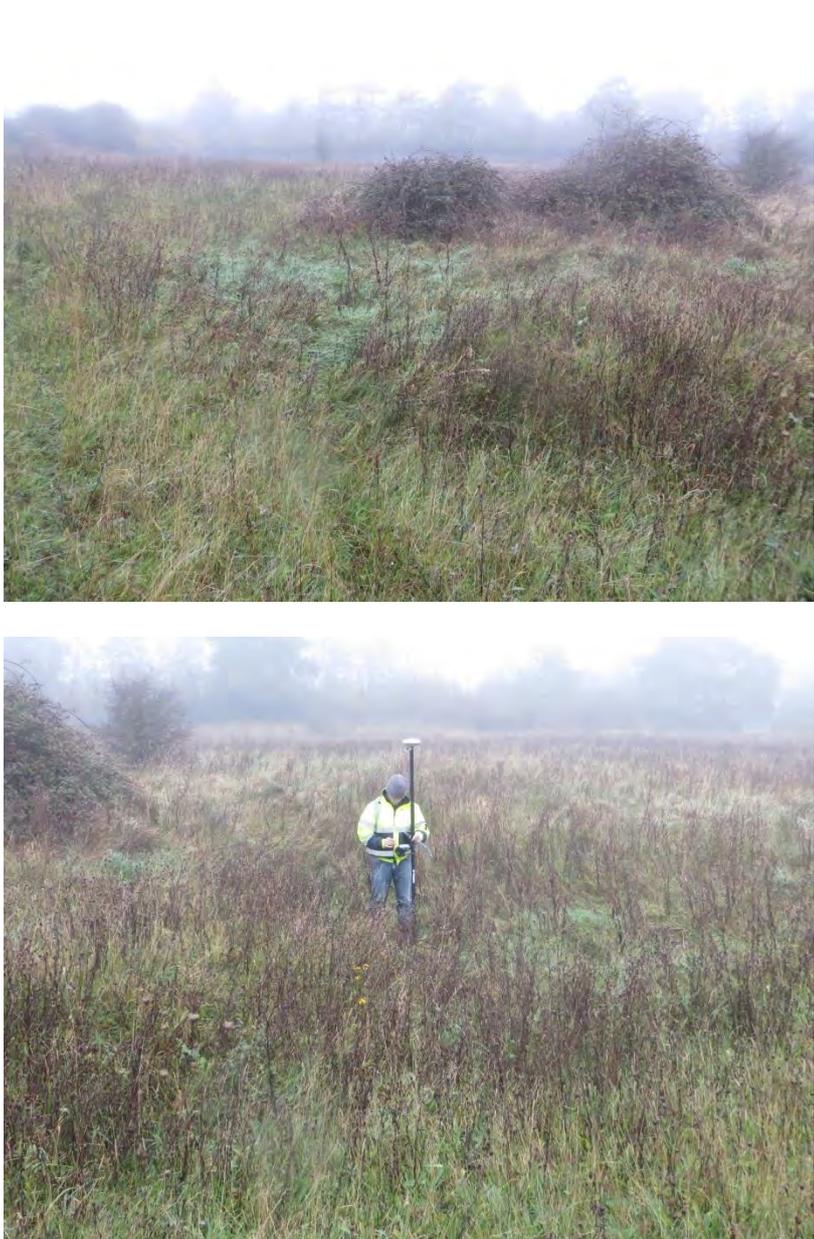
<b>Feature ID</b>	<b>K202</b>
<b>Feature type</b>	Enclosed depression
<b>Coordinates</b>	536033, 726313
<b>Source</b>	Field survey
<b>Field survey date</b>	23/11/2014
<b>Field survey status</b>	Confirmed
<b>Water present</b>	No
<b>Additional Information</b>	Very shallow enclosed depression Approx. 20m diameter
<b>Site photos</b>
