A Survey of Selected Rivers for the Galway City Transport Project with Potential for Margaritifera (Moorkens, 2014a)

A SURVEY OF SELECTED RIVERS FOR THE GALWAY CITY TRANSPORT PROJECT WITH POTENTIAL FOR *MARGARITIFERA*

September 2014

Evelyn A. Moorkens

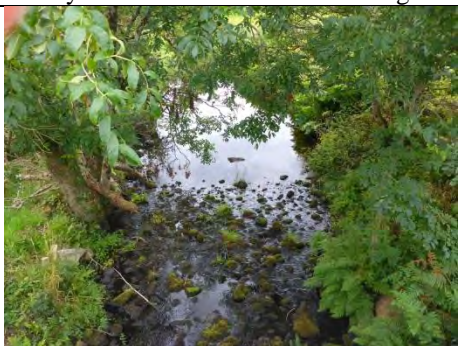
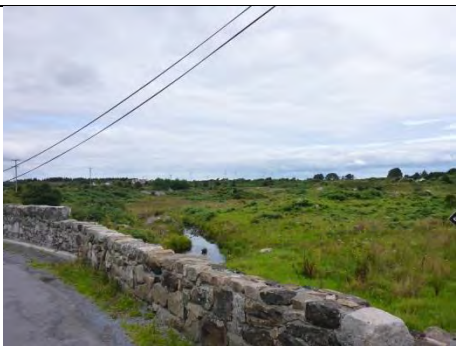
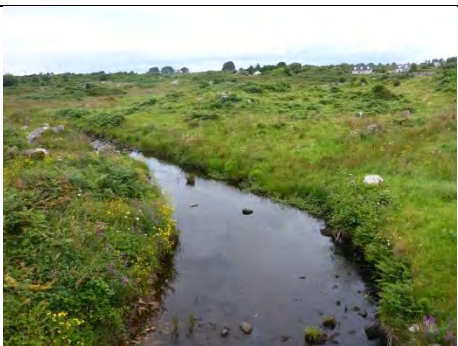
Site 3		Bridge recently remortared. Very shallow and almost dry d/s of bridge. Upstream the habitat is in very poor condition with filamentous algae throughout. Highly disturbed environment with wind turbines, high density housing, peat cutting, high nutrients, boulders removed from riverbed.	
Lough Inch River			
M18924 23962 at bridge			
Surveyed 100m u/s and 25m d/s bridge

Downstream of bridge		Upstream of bridge	Upstream of bridge
Site 4		River very dry at bridge with very little flow. Filamentous algae covering to substrate. Habitat tunnelled upstream.	
Lough Inch River			
M19199 24101 at bridge			
Surveyed 50m u/s and 50m d/s bridge

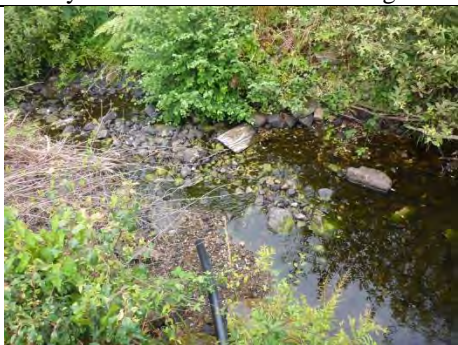
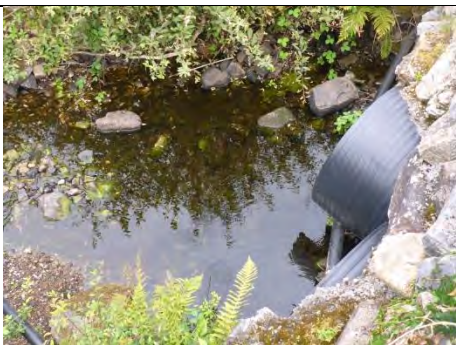
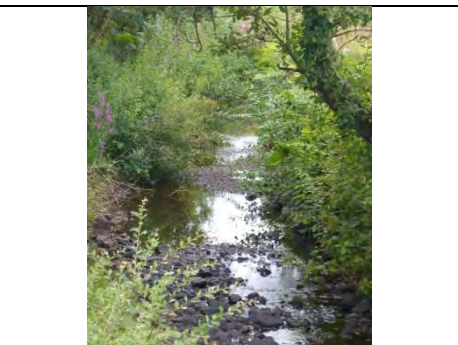
Downstream of bridge		Downstream of bridge	Upstream of bridge
Site 5		Cattle access area with very muddy poached banks and muddy water. Small gorge upstream created by granite outcrops. Solid overhanging woodland both sides.	
Lough Inch River

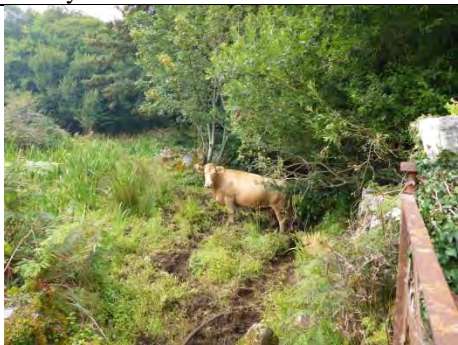
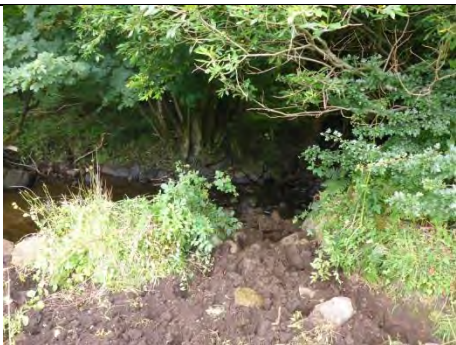
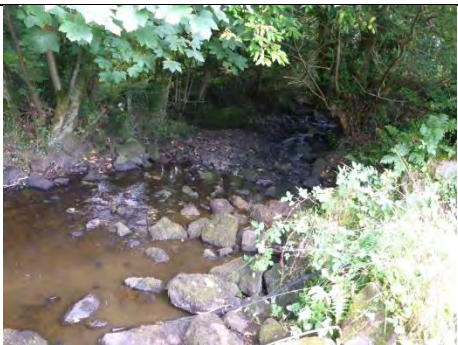
Cattle access to stream		Heavily poached banks	Turbid water resulting from cattle access

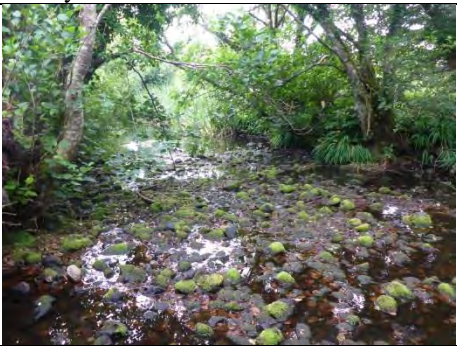
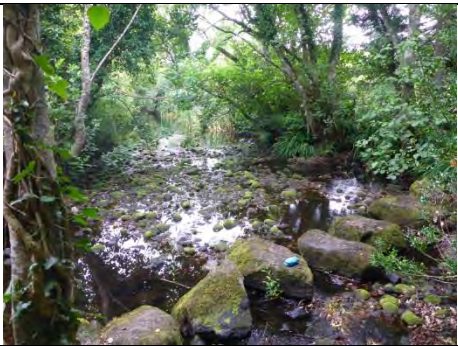
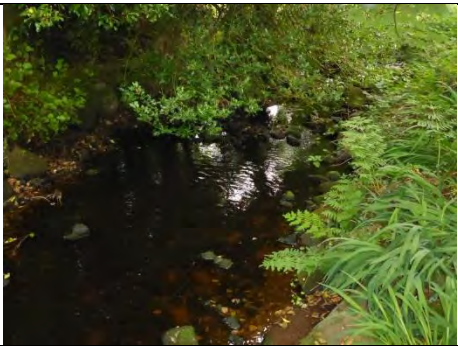
Site 6	Rocky boulder crossing, dry and widened (may be old ford). Dry mossy rocks and <i>Sparganium</i> stands downstream	
Lough Inch River		
M18874 23799		
Surveyed local area

View downstream	View downstream	View upstream

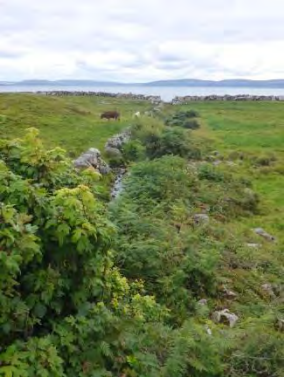
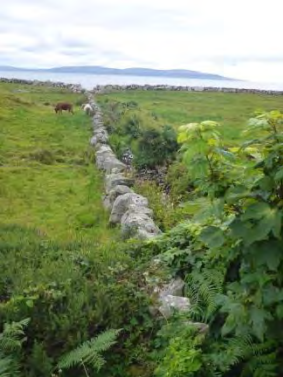
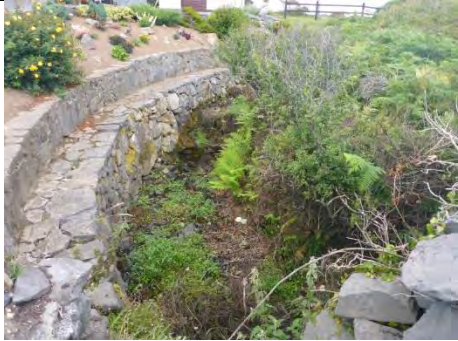
Site 7	Generally shaded habitats with scrub. Very little flow or depth of water. Mixed substrates, some places with mix of gravels and cobble. Overall, very little potential for mussels.
Lough Inch River	
M19295 24099	
Surveyed for c. 300m u/s

Site B	Temporary stream, runs dry, no <i>Margaritifera</i> habitat	
Small stream		
M20060 22752

View downstream	View downstream	View upstream

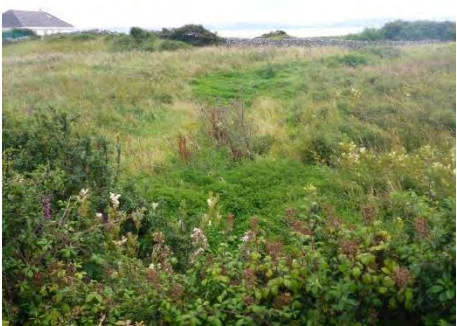
View downstream of main road

Site D	Stream located on map at M21555 22629 must be culverted off but so temporary it is not evident entering the sea at any stage. However, there is a swampy habitat with <i>Berula</i> and some standing water on the sea side of the road. Upstream it is all absorbed in gardens.	
Small stream		
M21555 22629

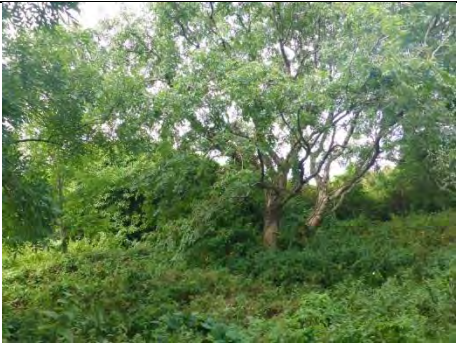
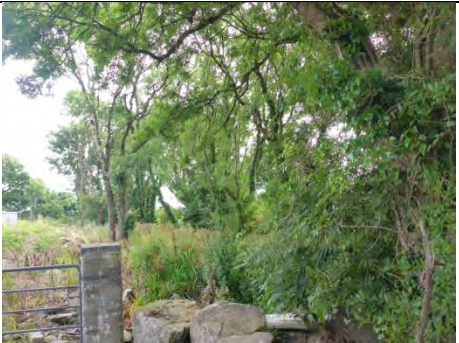
View upstream	View downstream

Site E	Old tree line marks where the stream was. It is now dry and absorbed into the surrounding land through drainage. No <i>Margaritifera</i> habitat	
Small stream		
M22088 23187

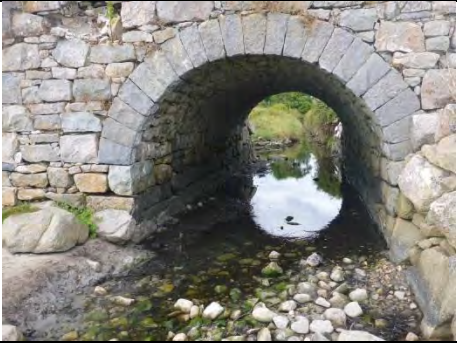
Beneath bridge

Site G	At the quay in Barna, tidal influence, no habitat	
Trusca Sstream		
M23265 22735

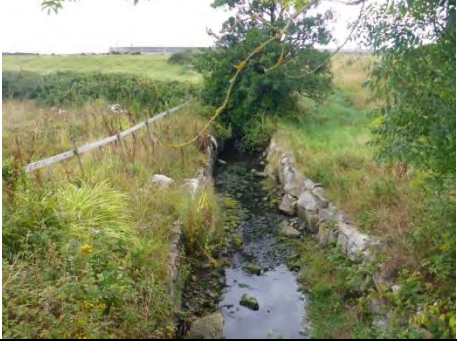
View downstream

Site H	Too small and shallow for <i>Margaritifera</i> , dense filamentous algae	
Trusca Stream		
M23243 22814

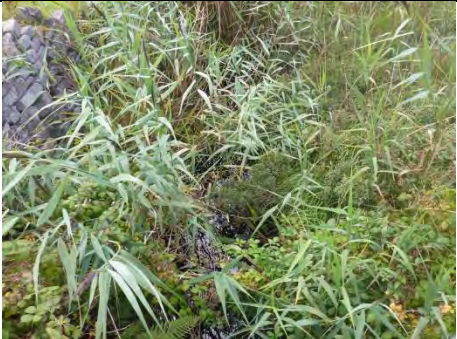
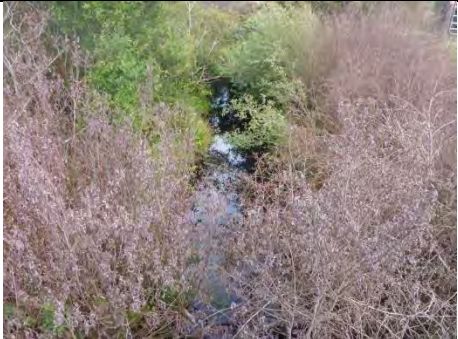
View downstream	View upstream

Site J	Very low flowing water in flat area in reed bed. No <i>Margaritifera</i> habitat	
An Sruthan Dubh		
M22459 27033

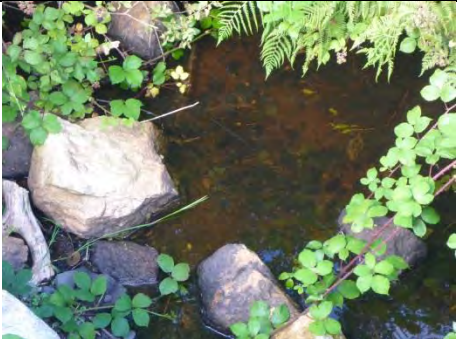
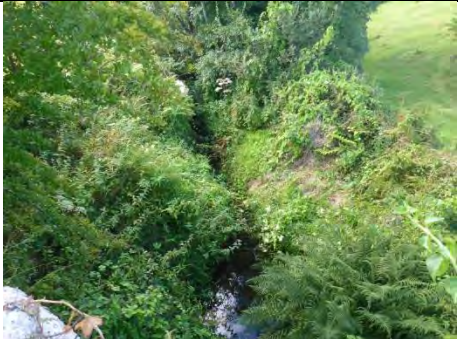
Site K	Good gravel substrate but no significant flow and very tunnelled. No <i>Margaritifera</i> habitat	
An Sruthan Dubh		
M23477 26284

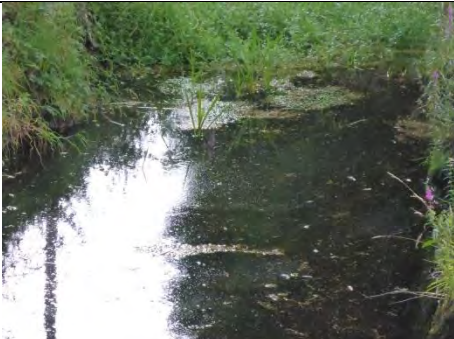
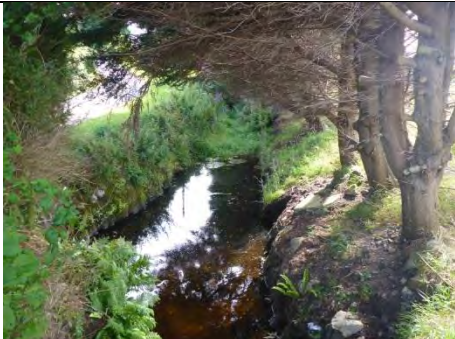
Site M	Larger water body but slow flowing and highly silted, narrow and tunnelled upstream. No <i>Margaritifera</i> habitat	
Barna stream upper branch		
M24369 26282

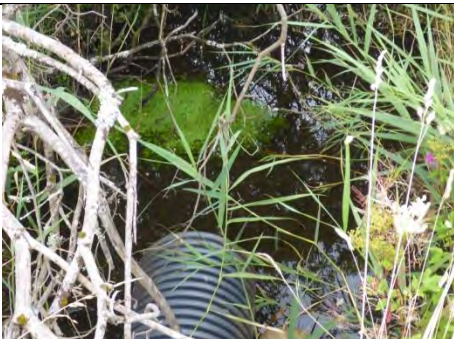
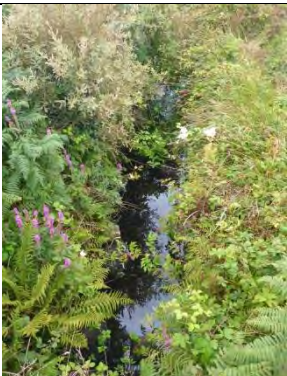
Site O	Tunnelled, overgrown, very little flow, <i>Callitriche</i> , sandbags, culverted pipe. Narrowed downstream, water with grey tinge	
Barna Stream main channel		
M25346 26206

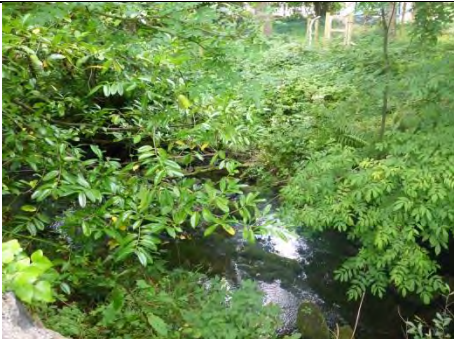
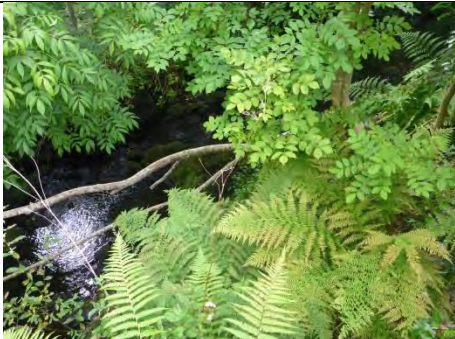
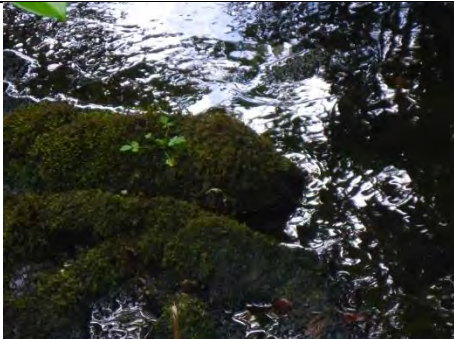
Site P	Good flow with mossy rocks in stream, good boulder and gravel mixed substrate. Tree-lined banks, but lots of new housing estates nearby. Rather shallow, mostly less than 20cm deep but with flow where gradient is good. Some potential but no mussels found.		
Barna Stream main channel			
M24644 23946

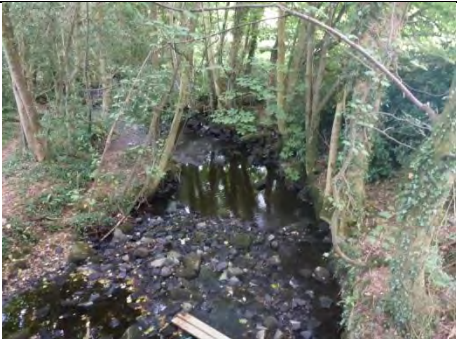
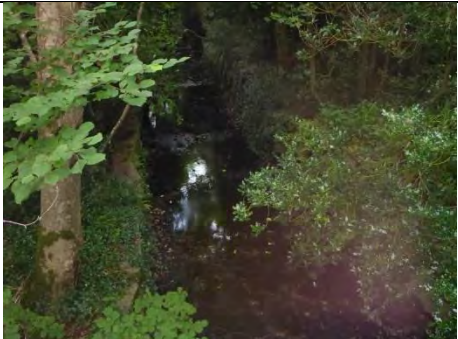
Site Q	Near roadbridge. Still good substrate and some flow in places, tree lined but very shallow	
Barna Stream main channel		
M24750 23794
