Appendix 15.5
Preliminary Bat Roost
Assessment – Trees

RPS Ltd. were commissioned by Meath County Council to undertake a preliminary roost assessment (PRA) of trees for bats within the proposed N2 bypass route. Surveys were carried out by suitably qualified Ecologists, holding a bat roost disturbance licence (DER/BAT 2020-44).

Table 37. Tree features suitable for Roosting Bats identified during the Preliminary Ground Level Roost Assessment

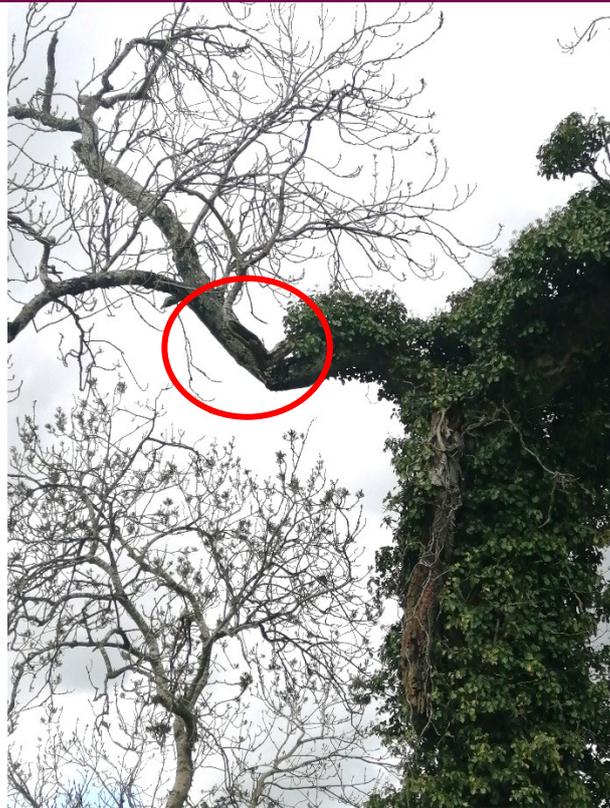
Tree Code	Tree Species	Feature Location and Description	Suitability
BT12	Ash	Two features identified. Mature Ash tree. (i) Facing north, the first feature is SW facing. The first trunk facing east has a small subsidiary branch with large scar.	Moderate

- **Tree of moderate bat roost potential:** *Further surveys required.* If a tree of moderate bat roost potential is required to be felled, then bat presence/absence (emergence/re-entry) surveys are required to expand on the findings of the PRA. These presence/absence surveys should, at a minimum, include:

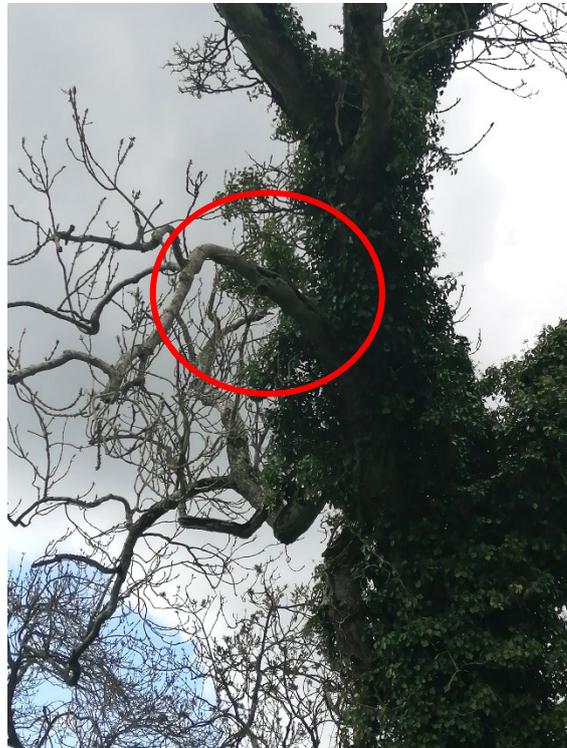
(ii) Facing northwest, the second feature is southeast facing. Find the first trunk facing downward on this side. Large tear/knot hole.

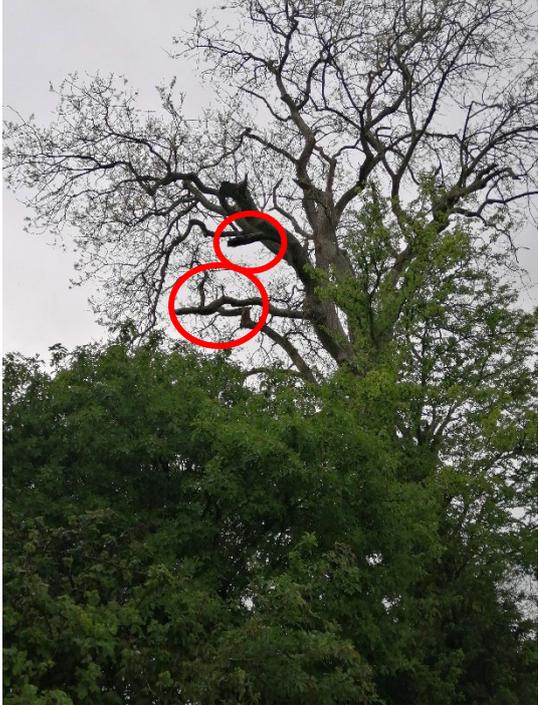
BT17	Ash	Five moderate features on very mature ash. (Note: Features (i) and (ii), and Moderate features (iii) and (iv) can be grouped together for survey if required as they are in close proximity to each other). (i) Downward south facing branch break. Standing in a north-eastern direction, follow the main trunk up c.8m and follow the first branch facing	
------	-----	---	--

Tree Code	Tree Species	Feature Location and Description	Suitability
		<p>directly south. At the end of this branch it splits into two- the lower and smaller of these two branches is the moderate feature.</p> <p>(ii) Similar to feature (i). Branch breaking and bark peeling. The feature is located c. 2m below and behind the first feature.</p>

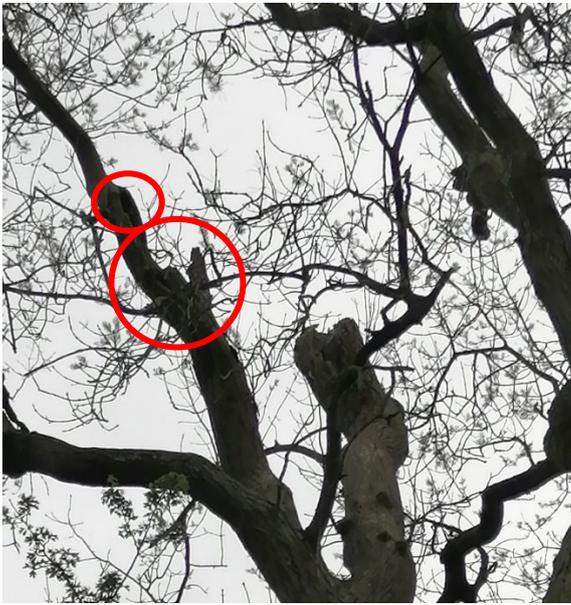
<p>(iii) Facing in a southwestern direction. The feature is facing directly north on the apical/main centre branch of the trunk. Knot hole feature located at tip of branch.</p> <p>(iv) Directly below feature (ii). Bark peeling.</p>

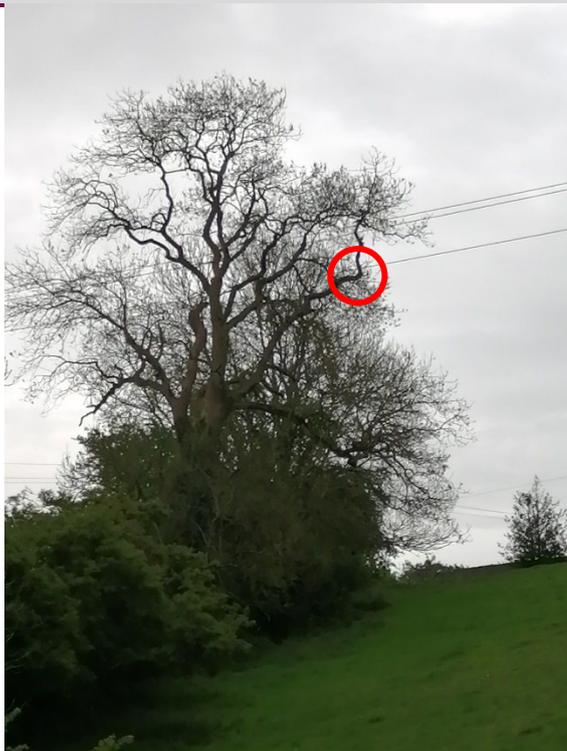
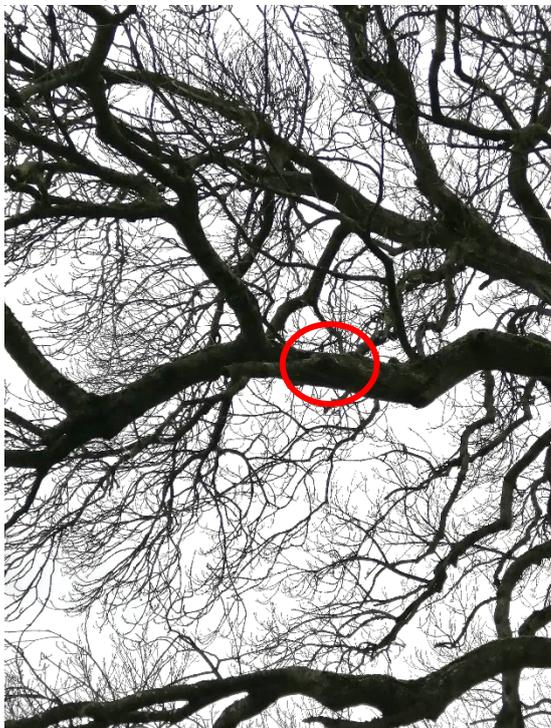
Tree Code	Tree Species	Feature Location and Description	Suitability
BT18		<p data-bbox="478 1019 670 1052">Two low features.</p> <p data-bbox="478 1052 1284 1142">(i) Facing southeast, first branch facing northeast splits into three. The most easterly branch of these has a very small knot hole around three quarters of the way down the branch. The feature is on a small finger-like branch.</p>

<p data-bbox="478 1870 1284 1960">(ii) Facing northeast, the branch is facing west. The first branch on this side splits into two, The lower of these two branches has a small branch break/split.</p>	Low

- **Tree of low bat roost potential:** *No further survey is required.* If a tree of low bat roost potential is required to be felled then soft felling is recommended, where:

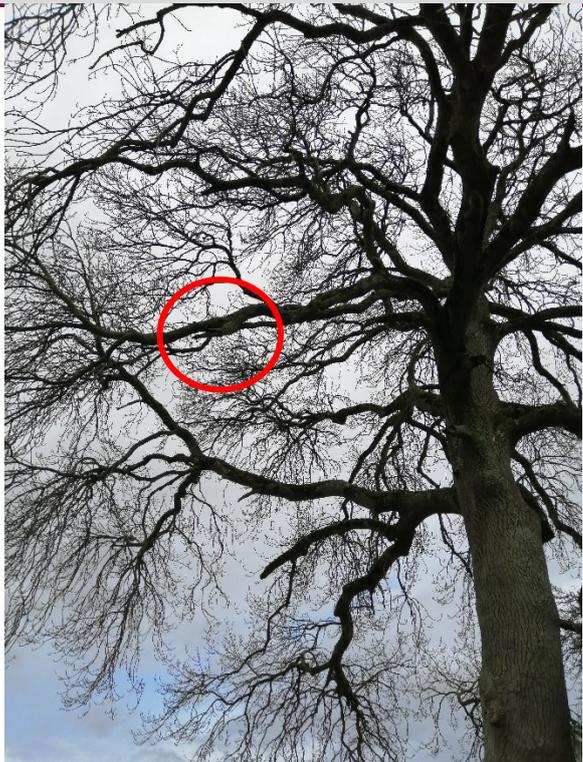
BT28	Oak	<p>Two features identified. Mature Oak tree located along the N51.</p> <p>(i) When standing in the field facing the N51, stand in a NW direction and the feature is facing SE. Feature is located c.1.5m above the hedgerow. It is the first downward facing trunk with knot hole hollow on SE side of tree.</p>	Moderate

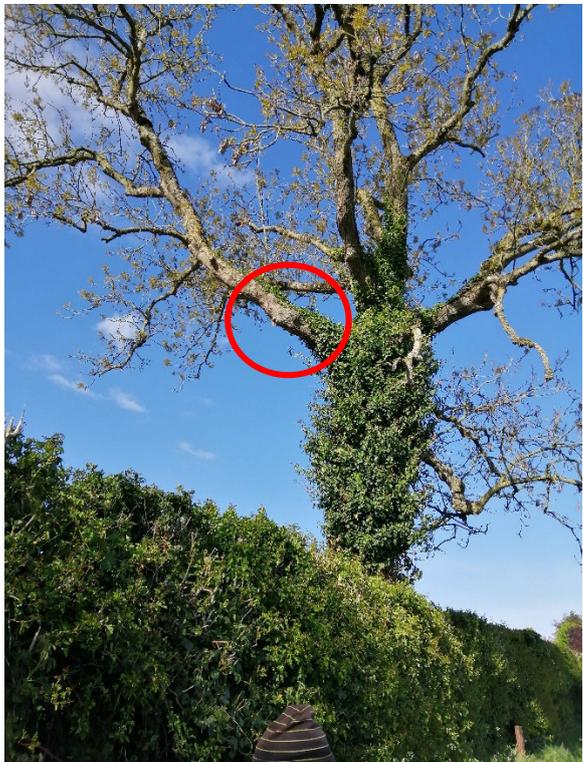
<p>(ii) When standing in the field facing the N51, stand in a NE direction and the feature is facing NW and juts out over the road slightly. Knot hole located on the first NW facing branch. Located 6m from the ground.</p>

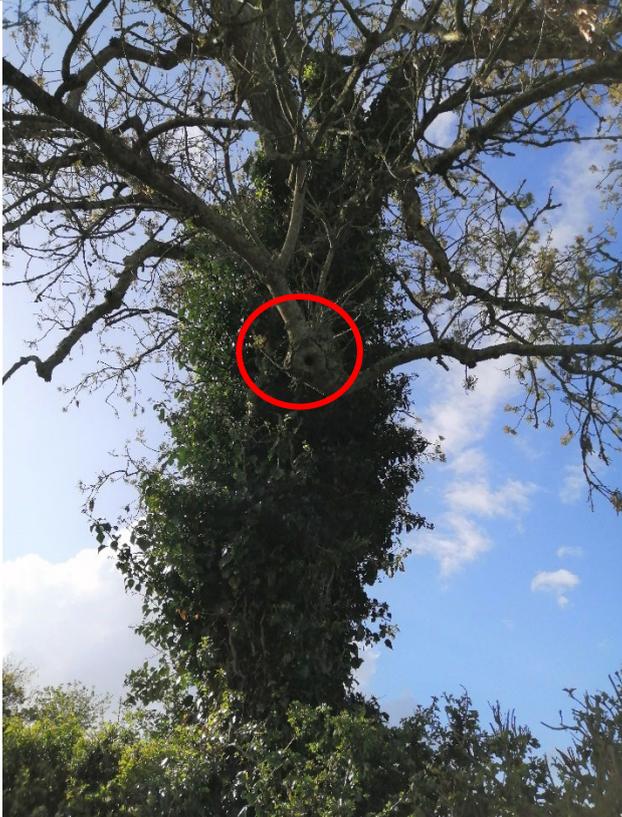
<p data-bbox="480 1093 1289 1227">East facing feature standing at base of tree facing west. The first south facing branch has a stump/branch break at its base. The feature is horizontally positioned c.4m from the ground. Other low features have contributed to this tree having moderate potential e.g. ivy cover and splitting bark.</p>	Moderate
BT37	Ash	<p data-bbox="480 1240 1289 1323">Northwest facing feature. Standing looking at tree and facing southeast. The feature is located c. 6m from the ground on the main trunk. Large knot hole.</p> <p data-bbox="480 1330 1289 1384">Orientated southwest with potential staining at the base of the first east facing branch. Obscured by flowering sycamore. Very difficult to see.</p>	Moderate

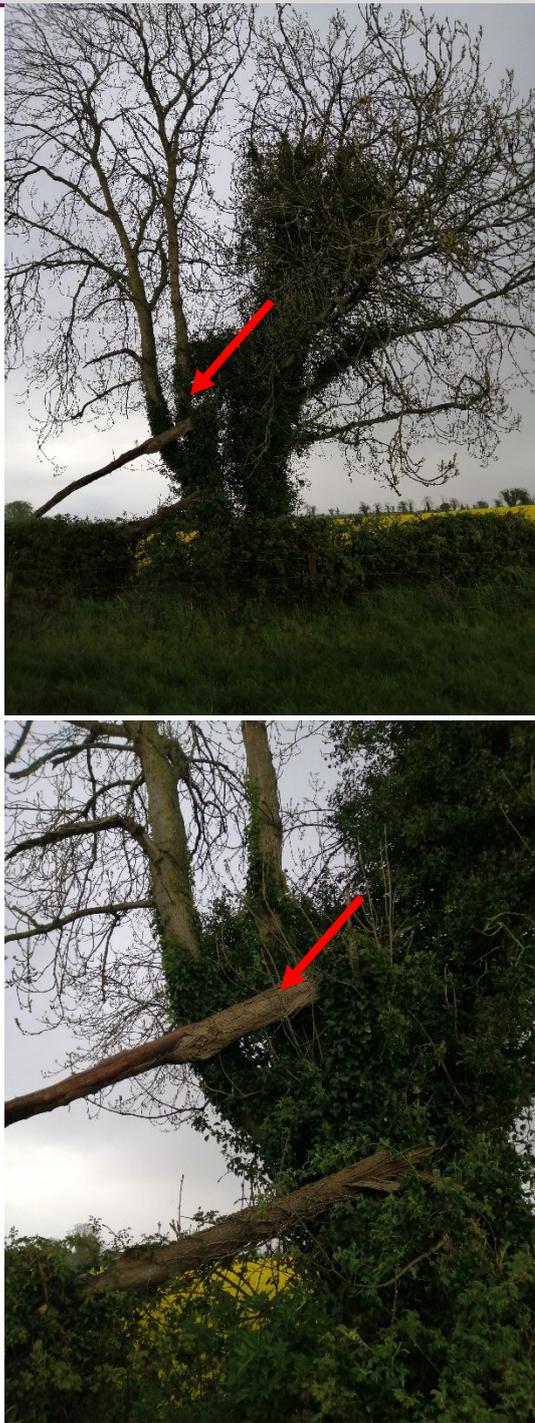
<p data-bbox="478 1691 1276 1803">Locate 30m south of BT35 within small, wooded patch between fields. Branch of Scots pine has broken and rooted itself into the ground making it look like a separate tree. Facing south, it is the first branch break facing northwest c.4m from the ground. Excessive splitting and breaking.</p>	Low

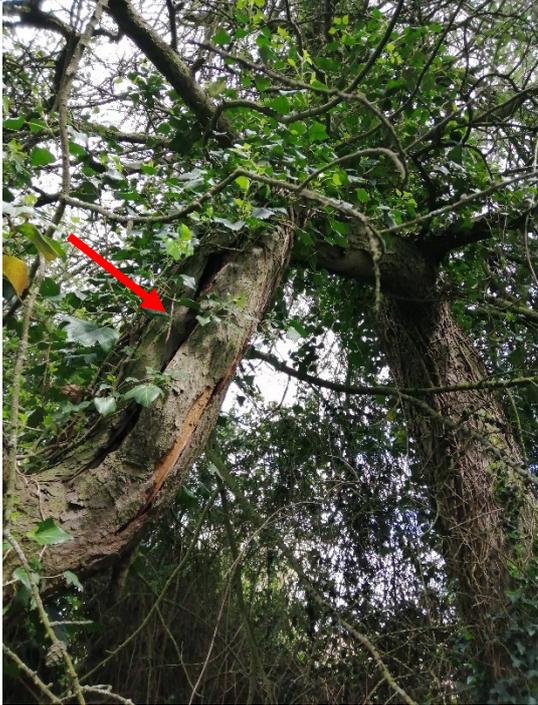
<p data-bbox="480 981 1281 1088">Larch tree with stumped crown. Crown has potential for good features they are just no visible as they are obscured. Branch break also present. Standing in a south-westerly direction, the feature is east facing and has clearly fallen from crown of tree.</p>	Low
BT42	Ash

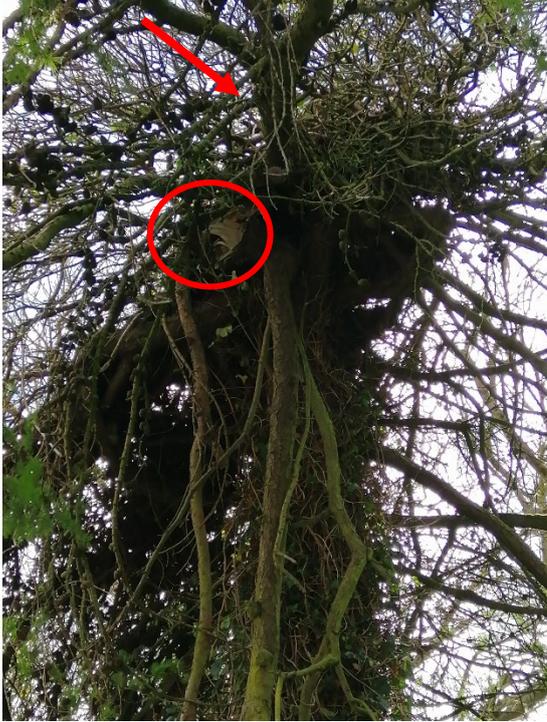
<p data-bbox="480 1832 639 1859">Dead thick ivy.</p>	Low (ivy)

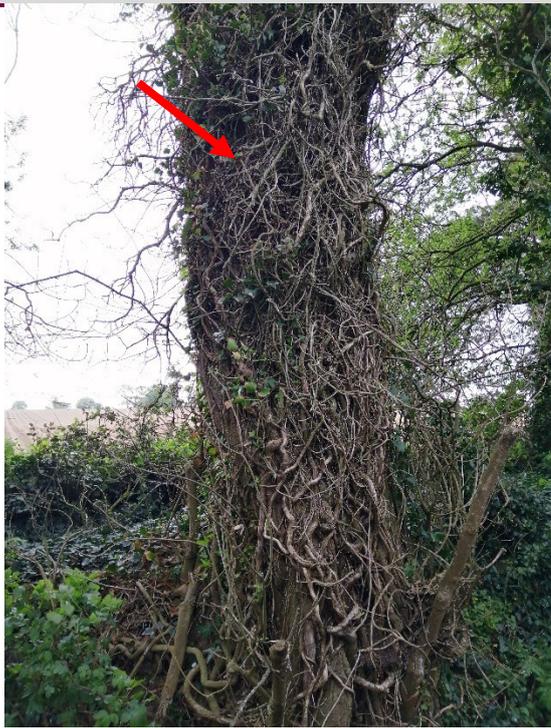
<p>Thick ivy. Note: All of the Scots pine and larch trees south of BT43 should be soft felled.</p>	Low (ivy)
BT44	Ash

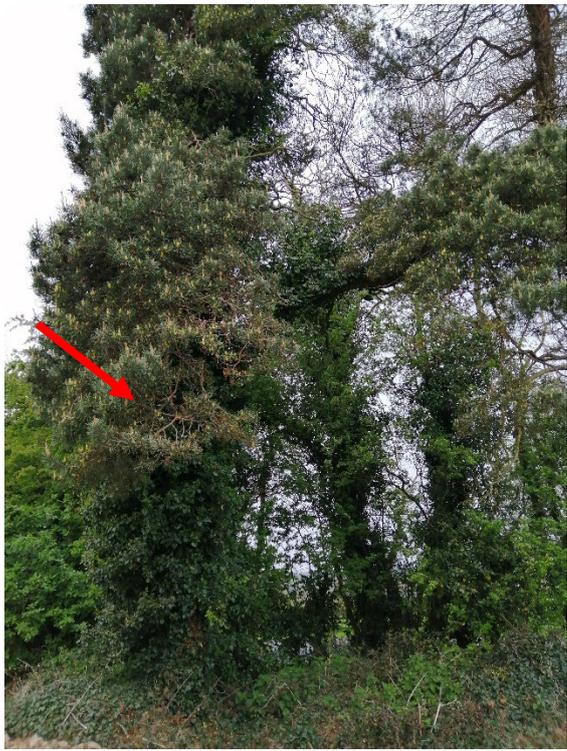
<p>Two moderate features.</p> <p>(i) When facing north toward the Boyne the feature is southwest facing. The branch pointing toward you (south facing), there is a large bark tear with significant potential for upward shelter. The tear is close to the base of the branch.</p> <p>(ii) On the same branch as feature (ii), follow the branch to its tip where there is a large branch break with open hole. Good potential for shelter.</p>	Moderate

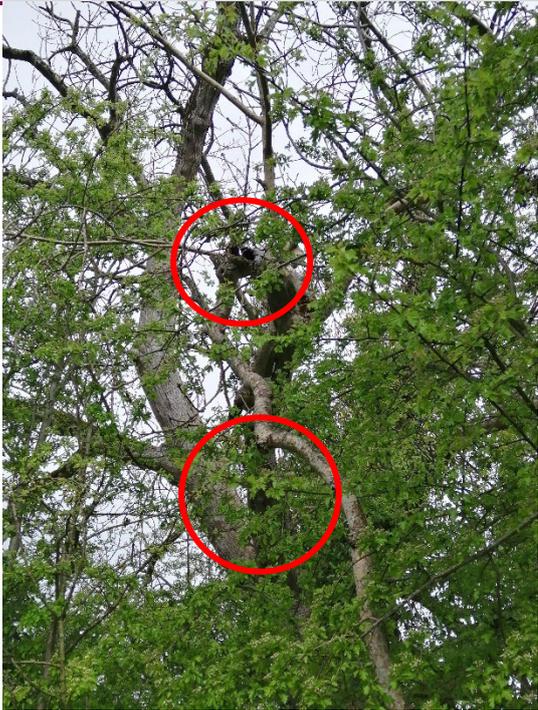
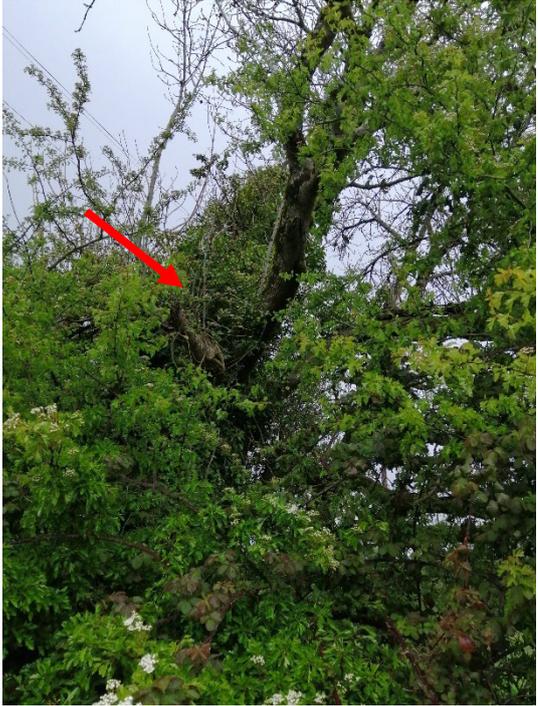
Tree Code	Tree Species	Feature Location and Description	Suitability
BT45	Ash	Heavy ivy coverage and located below electricity line along the towpath.	Low (ivy)
BT46 BT47 BT48	Scots Pine	Heavy ivy coverage with dead ivy concentrated at the crown of the tree. However, this tree is heavily managed and cut back on its west side. Features obscured by ivy, however, may have crack and break features.	Low (ivy)

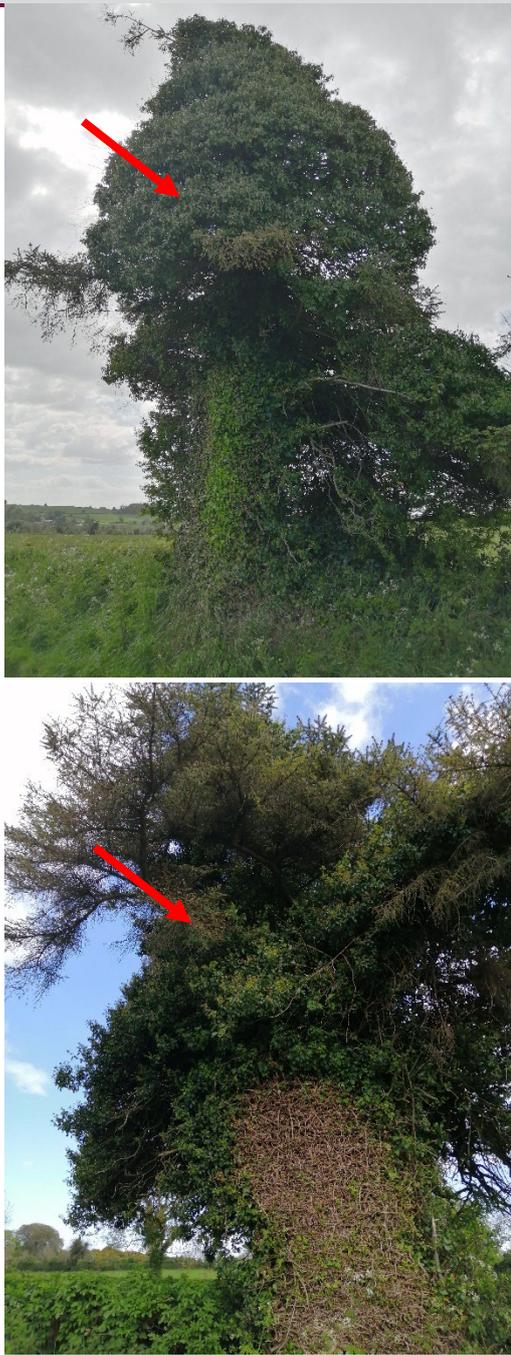
<p data-bbox="478 1624 1284 1736">Thick ivy coverage. Looks like two separate trees close together at first glance. Potential for shelter between thick ivy branching. Tree is located directly opposite open wooded patch on west side of track. First ash tree on left hand side of driveway.</p>	Low (ivy)

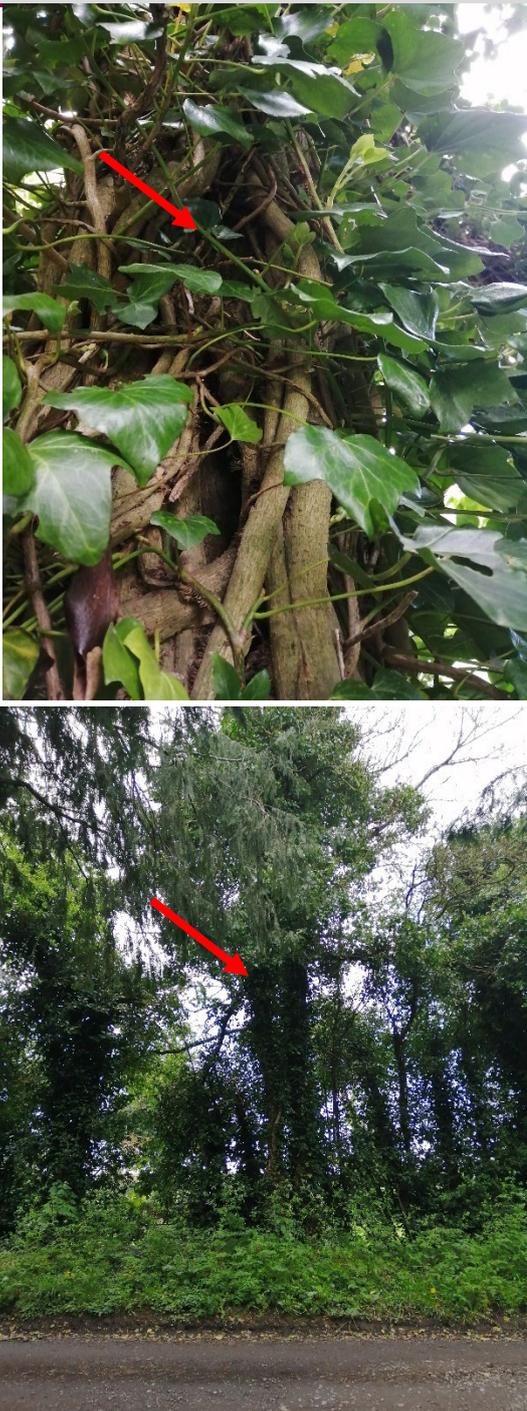
<p>Fifth hawthorn on left hand side (east side of track). Broken branch and hawthorn tree is leaning over it. Has fallen from tree with two to three bark holes.</p>	Low

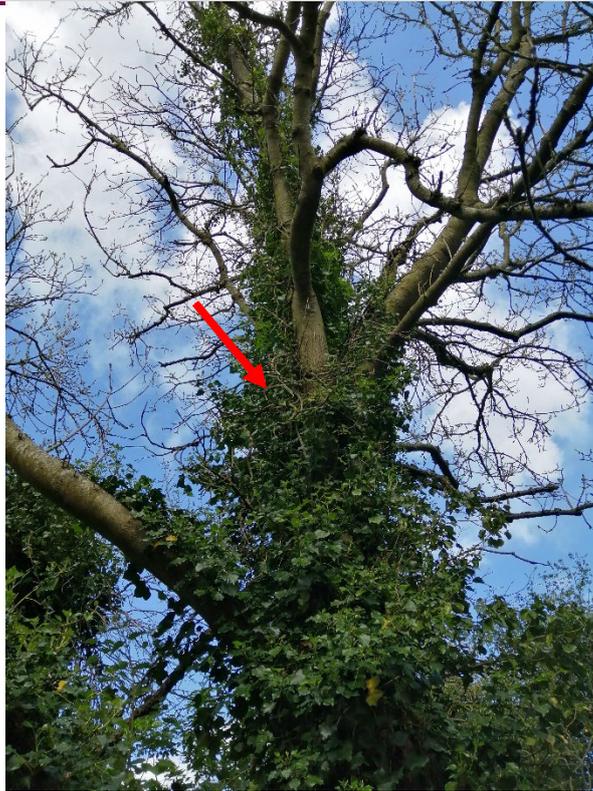
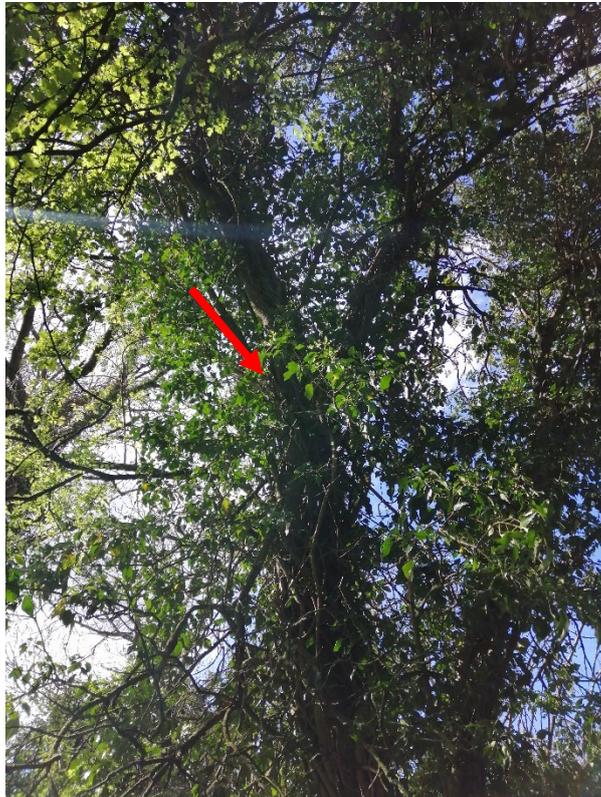
Tree Code	Tree Species	Feature Location and Description	Suitability
BT53	Hawthorn	Mature hawthorn on southeast corner of building opposite Ledwidge Museum. Thick ivy.	Low
BT54	Ash	Mature Ash located in the northwest corner of the building identified with bat roost potential opposite Ledwidge Museum.	Low

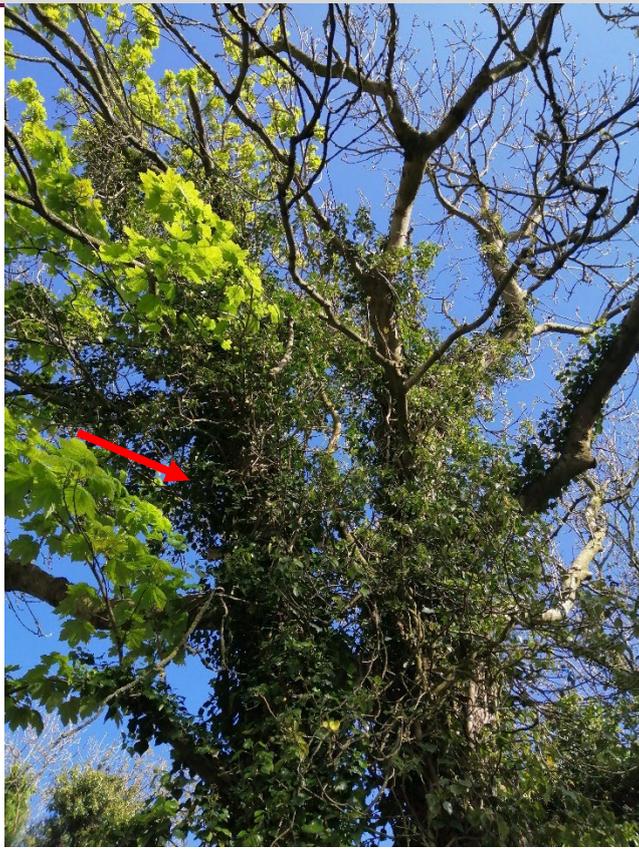
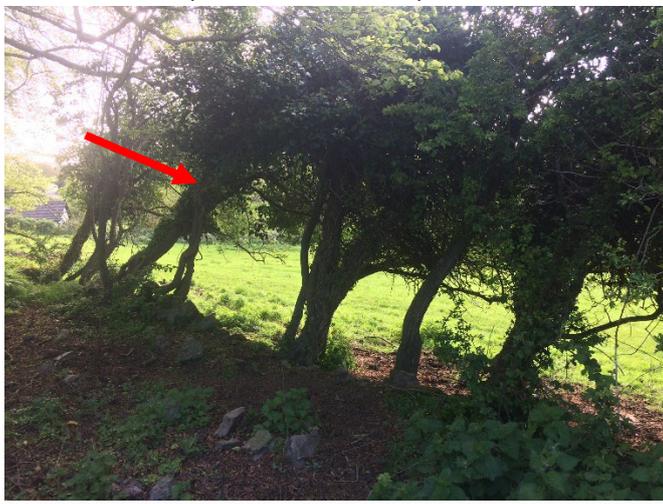
Tree Code	Tree Species	Feature Location and Description	Suitability
BT55	Hawthorn	All hawthorns on perimeter of wooded patch to be soft felled.	Low
BT56	Hawthorn	Thick ivy.	Low (ivy)
BT57	Hawthorn	Thick ivy.	Low (ivy)

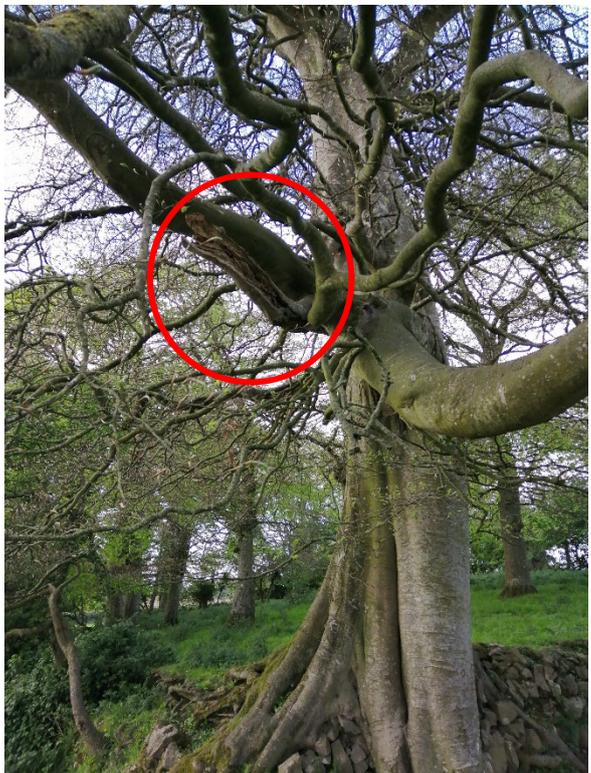
Tree Code	Tree Species	Feature Location and Description	Suitability
BT58	Beech	<p>Mature beech with two features.</p> <p>(i) Standing north, the feature is facing southwest. Broken branch/split. Follow the first branch in front of you c. 2m from the ground, this branch splits into two and in between this branch split there is a middle broken and shorter branch.</p>	Low

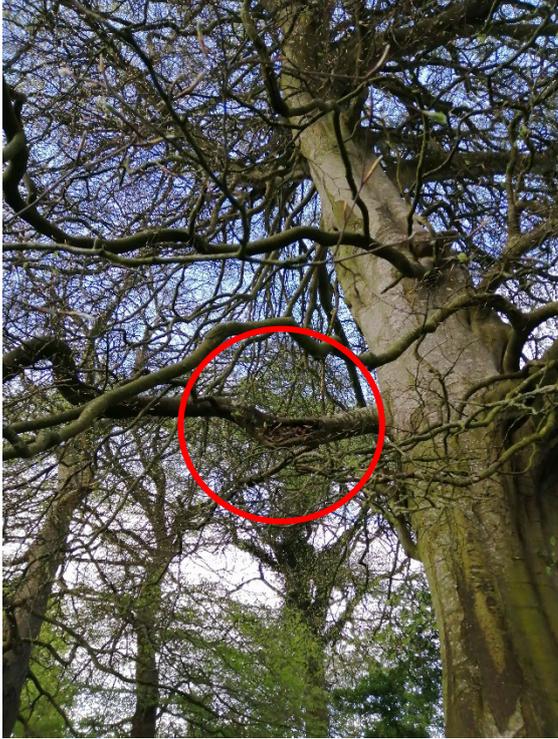
<p>The image shows a close-up of a beech tree trunk with several large, gnarled branches. A red circle highlights a specific feature on one of the branches, which appears to be a broken or split section. The tree is situated in a grassy area with other trees in the background.</p>	
		<p>(ii) Standing in a northwest direction. The second feature is located adjacent to feature (i). The feature is an elongated open knot hole pointing</p>

Tree Code	Tree Species	Feature Location and Description	Suitability
		<p>in a southwest direction and is the first branch pointing south located c. 4,5m from the ground.</p>

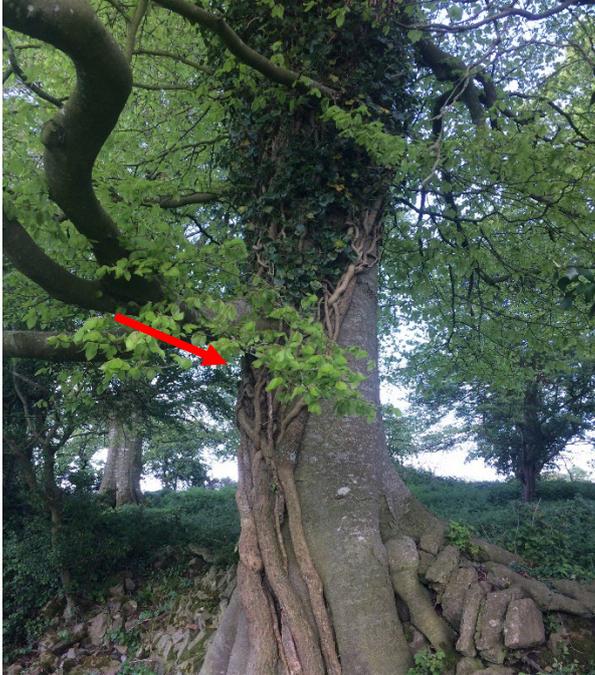
BT59	Beech	<p>Two features identified. (i) Branch tear/rotting. Standing in a eastern direction the feature is south facing and is located c. 10m from the ground. (ii) Ivy coverage.</p>	Low

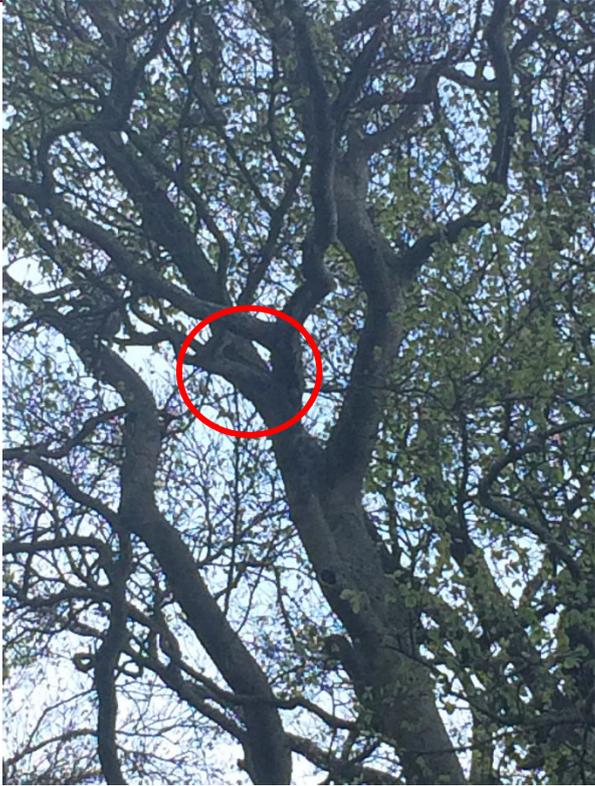
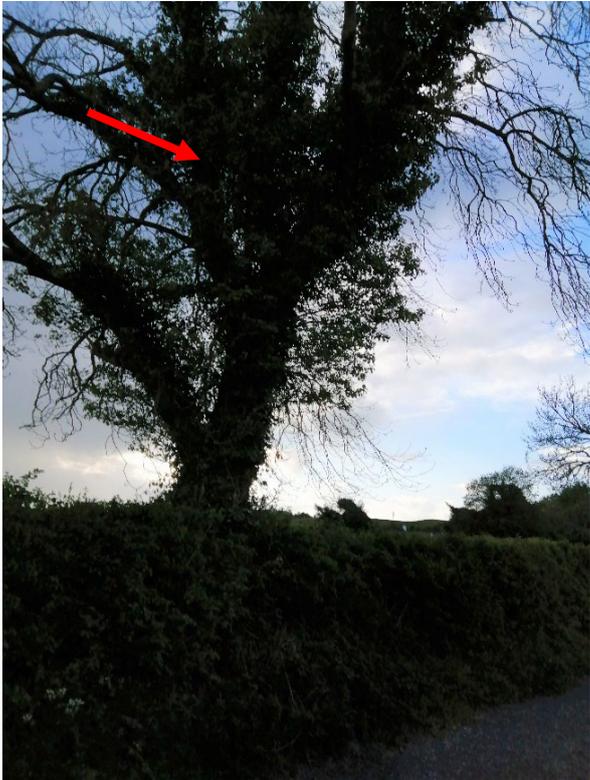
Tree Code	Tree Species	Feature Location and Description	Suitability
BT60	Ash	Thick ivy.	Low (ivy)
BT61	Beech	Two broken branches. Standing in a northwest direction the feature is southeast facing. Both broken branches are located on the first east facing branch.	Low
BT62.1 BT62.2	Ash	Thick Ivy.	Low (ivy)

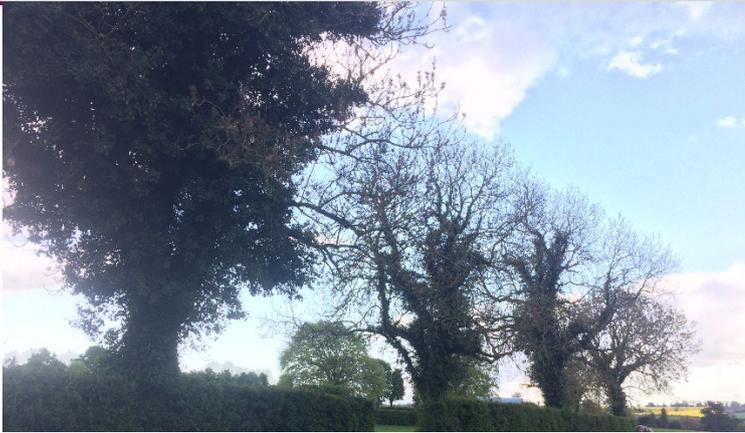
Tree Code	Tree Species	Feature Location and Description	Suitability
BT62.3 BT62.4

BT63	Ash	Two features identified (i)Knot/Hole. As standing west, this feature is facing east. Follow the first trunk on the RHS (southern side) that splits into two. There is a branch that goes northwest from this trunk. At the base of the branch is a knot/hole. Note: there is also a feature located approx. 1m above this knot/hole on the same branch, but it does not have any bat potential.	Low
BT64	Ash	Four features identified. (i) Broken Branch. As standing facing west, this feature is facing southwest. It is the first broken branch facing back. It is broken at a right angle (ii) Knot/Hole. On the same branch as feature 1, there are two holes approx. 6m above ground level. (iii) Knot/Hole. As facing west, the third trunk (e.g. 2 above feature 1) breaks into many branches with two branches facing northwest. The lower of these two branches has two open knots/holes approx. 1m apart. (iv) Knot/Hole. As facing west, the fourth major trunk up from the bottom, located approx. 3.5m above the third trunk. Where this trunk breaks into two there is a knot/hole on the west facing branch.	Low

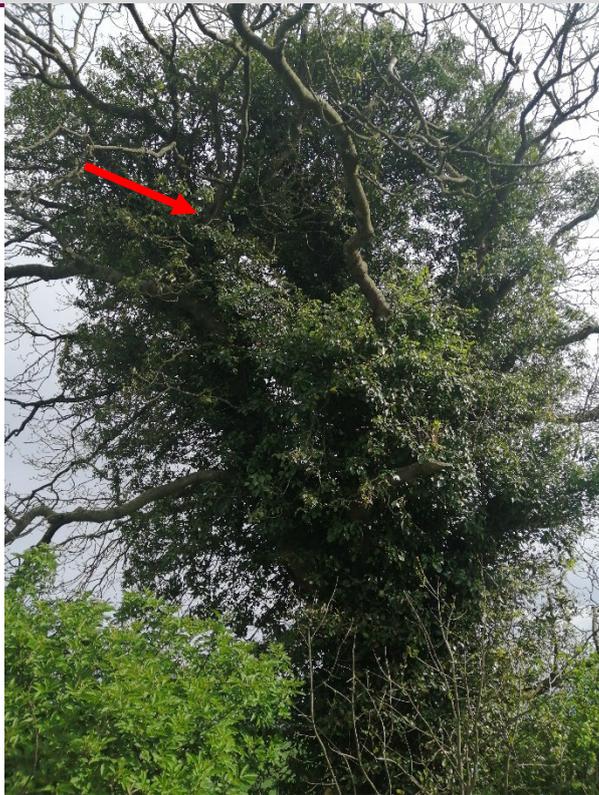
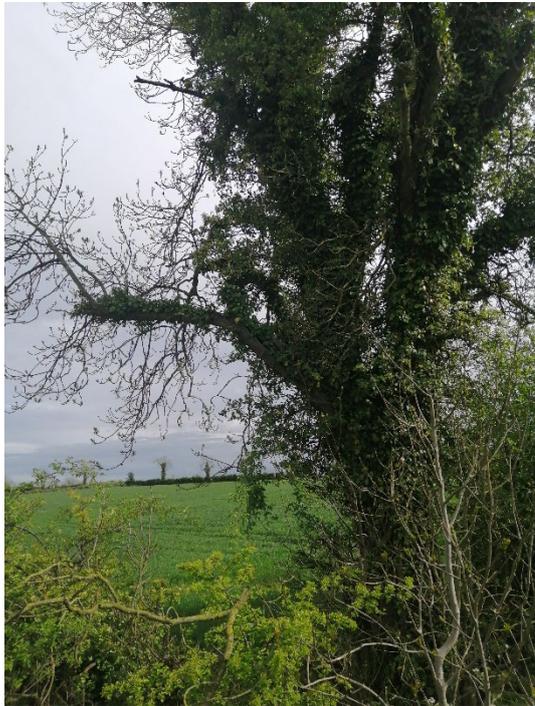
Tree Code	Tree Species	Feature Location and Description	Suitability
BT66	Ash	Branch break/tear	Low
BT67	Ash		Low (ivy)
