# Appendix 2

## Submission on rElAR

Ref: -QD05E.323037

This report examines and critically assesses the rEIAR submitted by Patrick McCaffrey & Sons Ltd (hereafter McCaffreys) and the impact of the quarry on local residents, landowners, the environment, quality of life, human health, property, health and safety. Deficiencies and shortcomings in the rEIAR are identified.

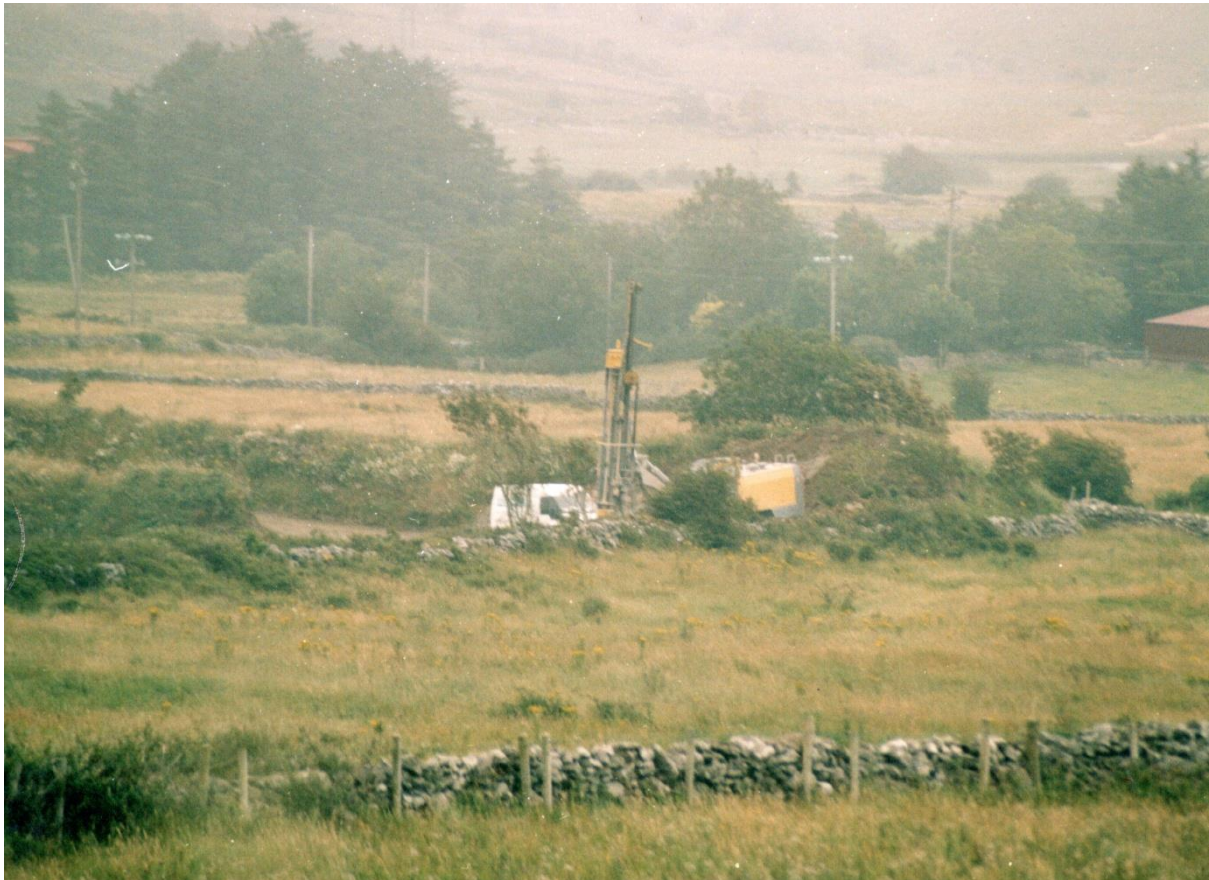
Figure 3: Drilling machine in-place preparing the rock to blast above the nesting site of the peregrine falcon in the southwest corner of the 'South Quarry'

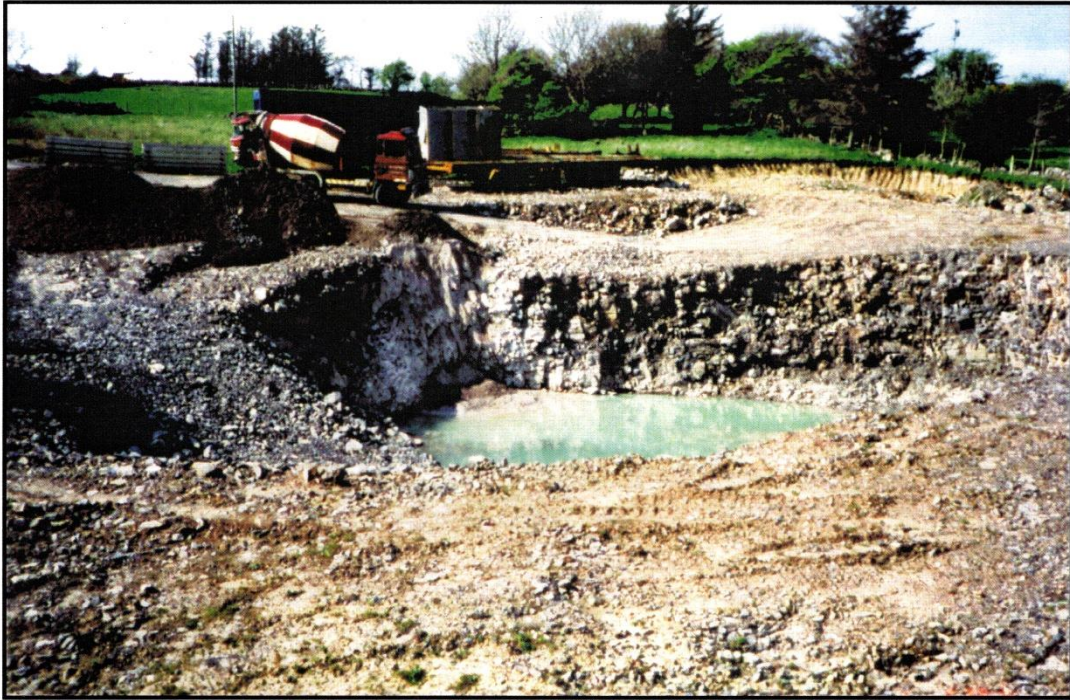
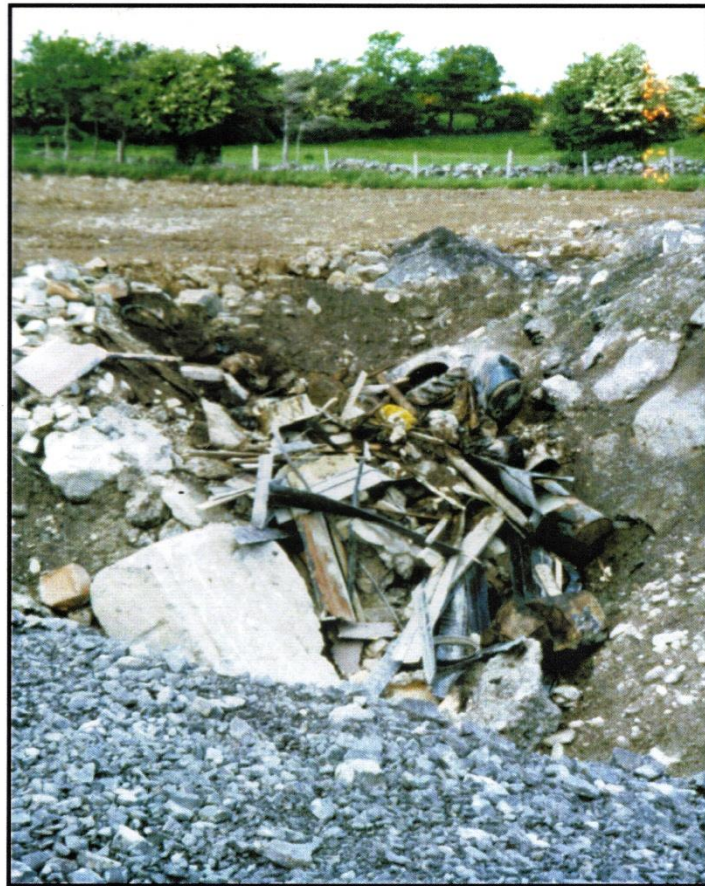
Quarry No. 3.

No consideration is given in the rEIAR to the remediation of the on-site landfill. McCaffreys had opened yet another unauthorised quarry in January 1999, this time in the fields to the east of the public right-of-way through the quarry. Complaints from local residents ultimately led to a threat of enforcement action by the Donegal County Council Planning Department. This threat later resulted in McCaffrey's 01/106 planning application to Donegal County Council. However, the quarry excavation that McCaffreys had blasted (north east of the quarry office – identified as Quarry 3 in the KT Cullen & Co report - was backfilled with rubbish and scrap from around the quarry as shown in Figure 4 below and in Appendix 2.3. (Appendix 2.3 contains a report by KT Cullen & Co. Ltd that investigated planning, environmental compliance and general nuisance associated with McCaffrey's quarry). This landfill is a long-term environmental hazard that should have been thoroughly investigated in the rEIAR, particularly given the local hydrology and the proximity of public water supply at Lough Gorman (please see Section 8 Water in this report). I would have expected to see fully-developed proposals for its remediation but it is not even mentioned in the rEIAR.

Figure 4: Waste material dumped in on-site landfill (taken from Appendix 2.3)

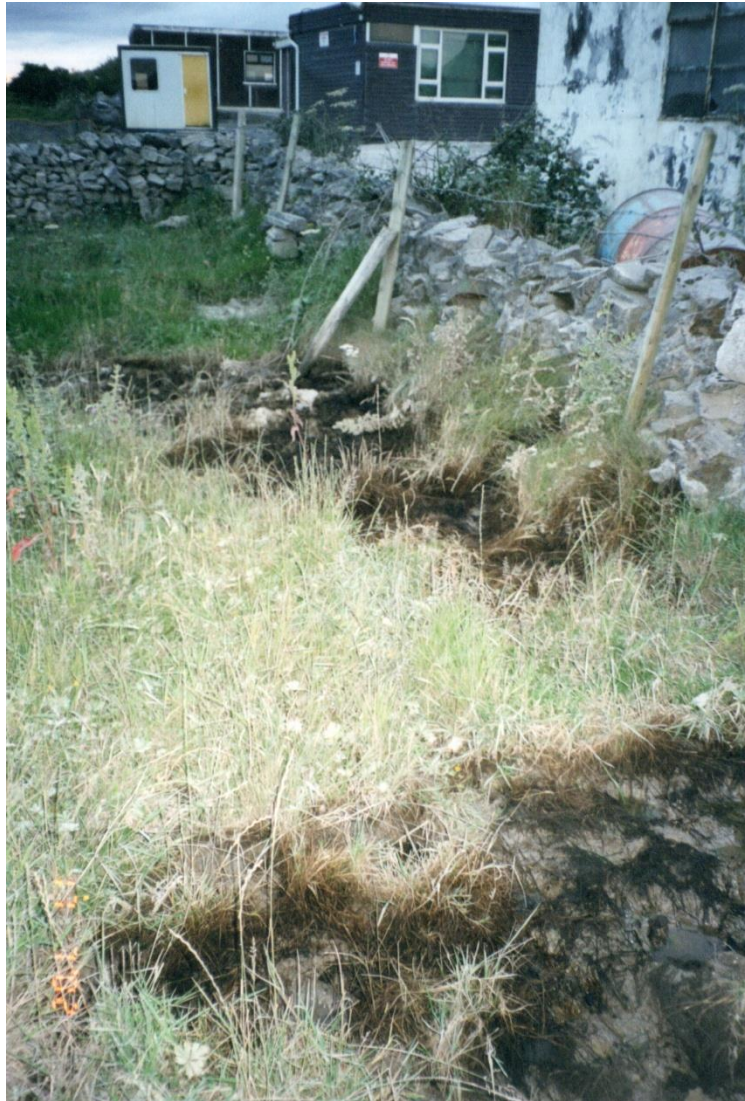
Figure 5: Contamination of farmland by run-off from McCaffrey's Quarry.

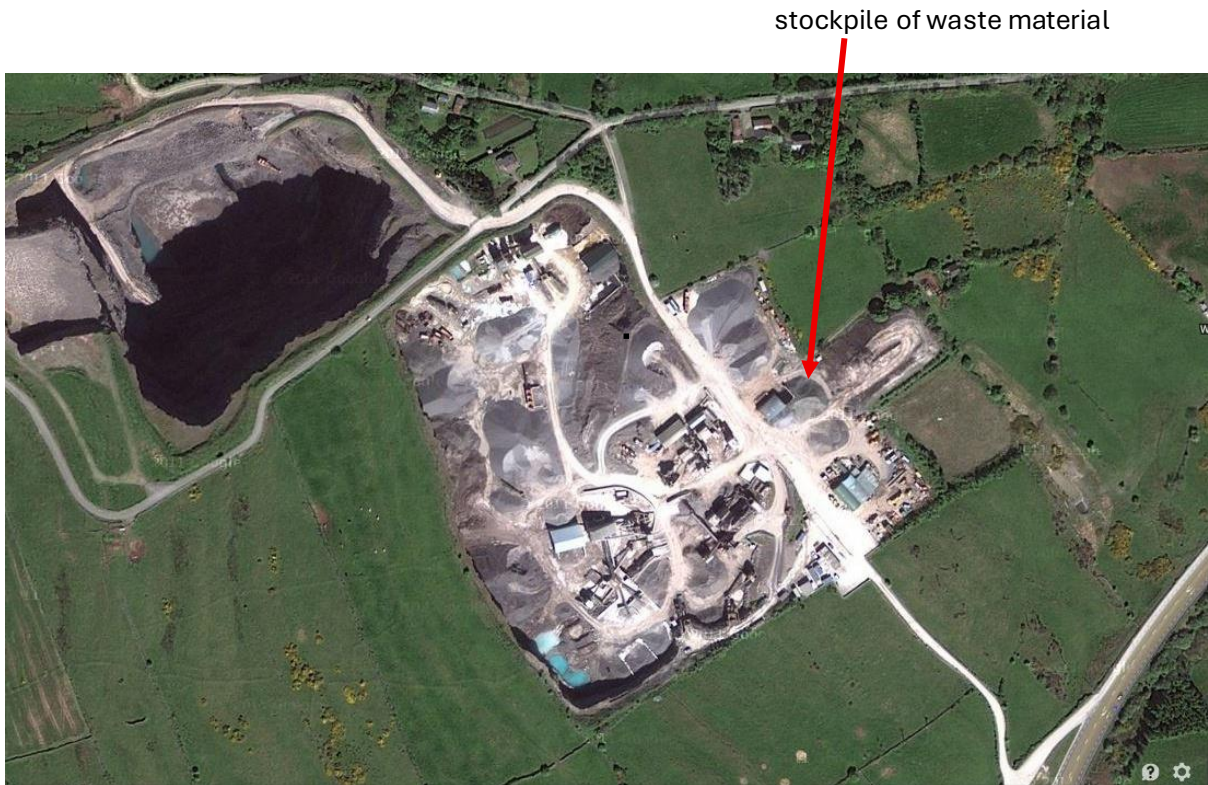
Figure 6: 2010 Google Earth Map showing stockpile of waste material to east of access road through south quarry

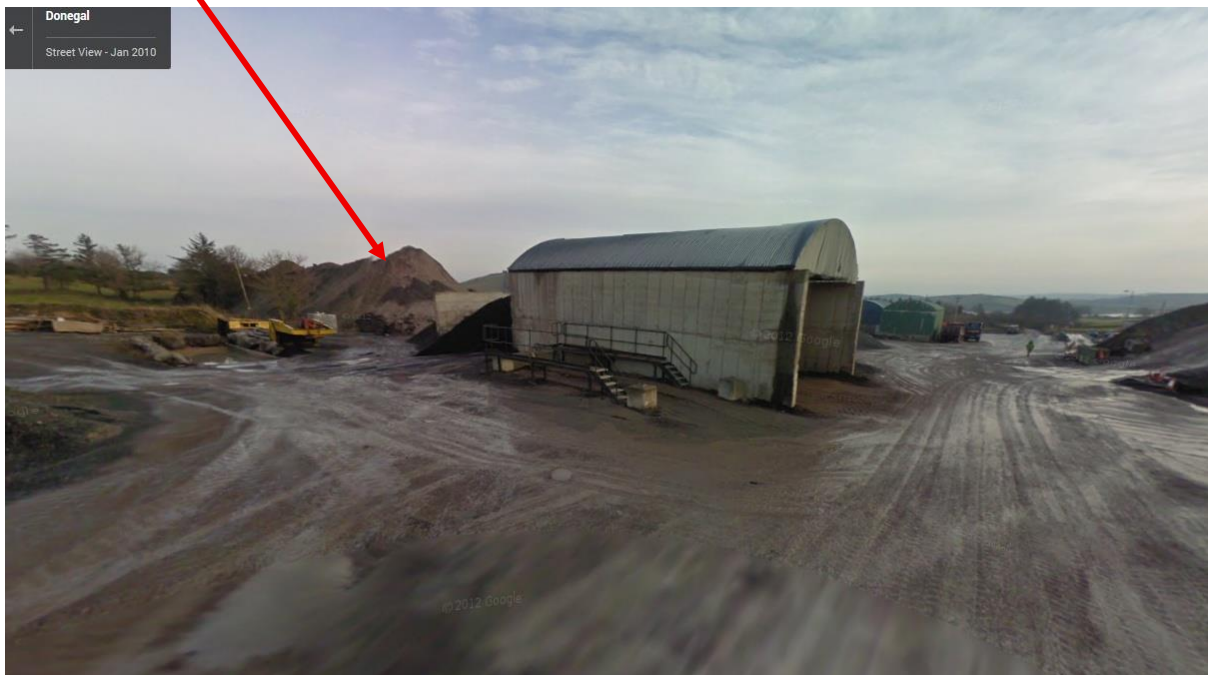
waste material to rear of shed

Figure 7: Google Earth photograph of stockpile of waste material to the rear of quarry storage shed

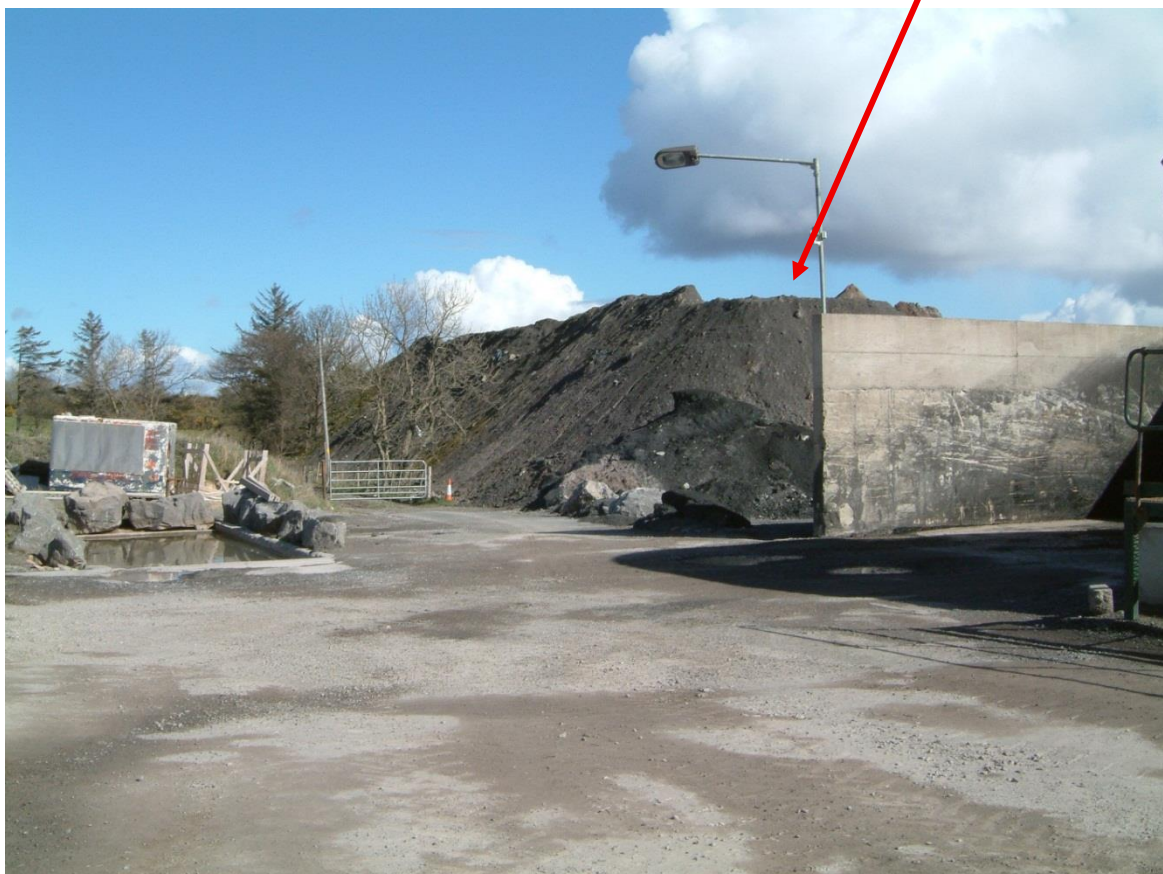
Figure 8: View of stockpile of waste material taken from publicly accessible road - March 2012

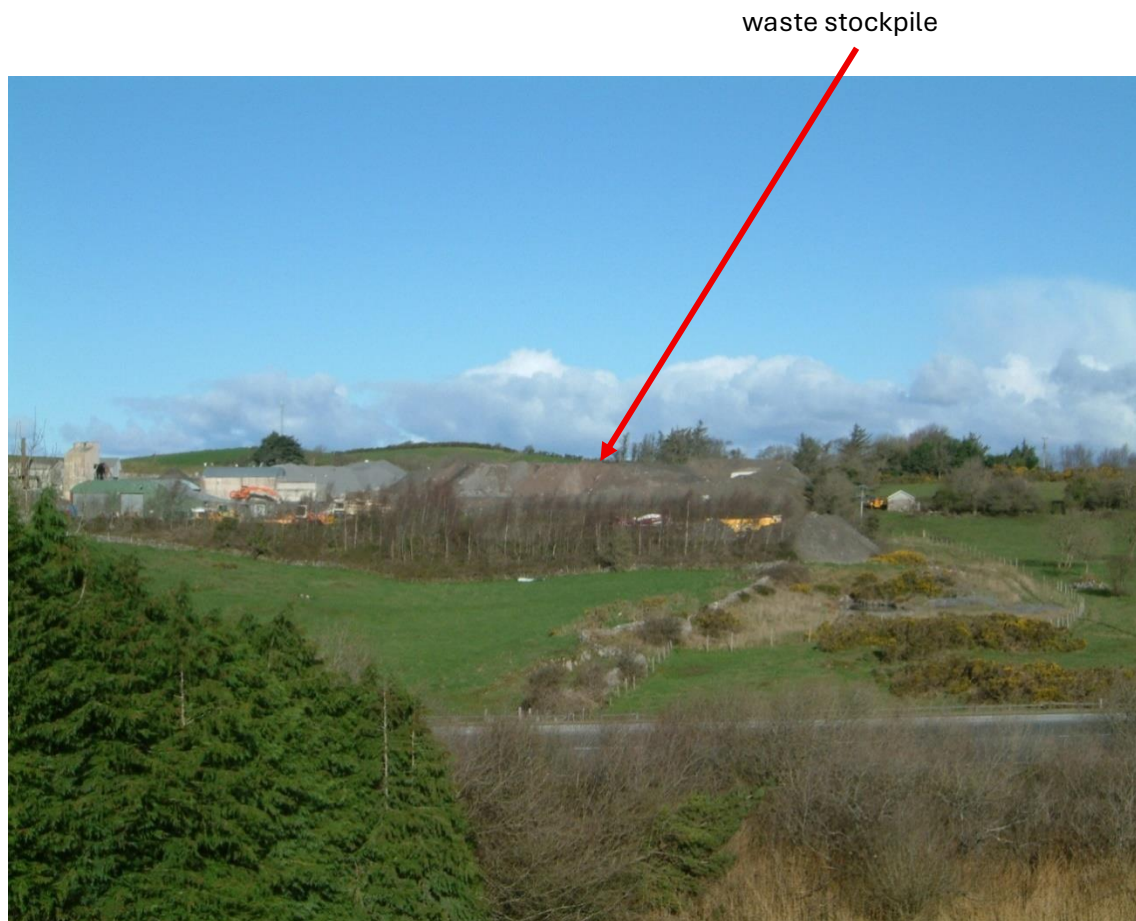
Figure 9: View of waste stockpile taken from lands to south east - March 2012

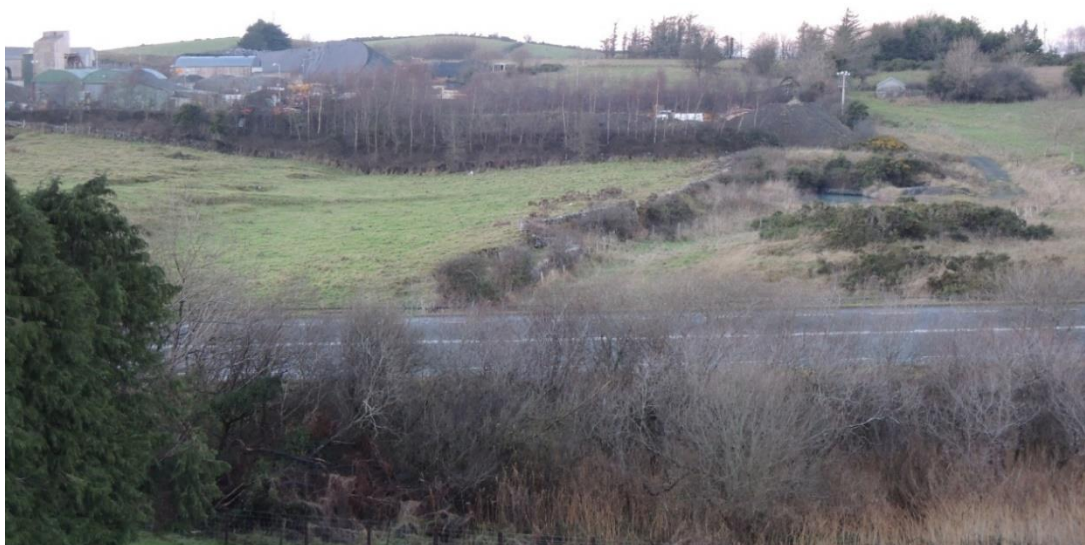
Figure 10: Same view as photograph above showing stockpile removed – January 2015

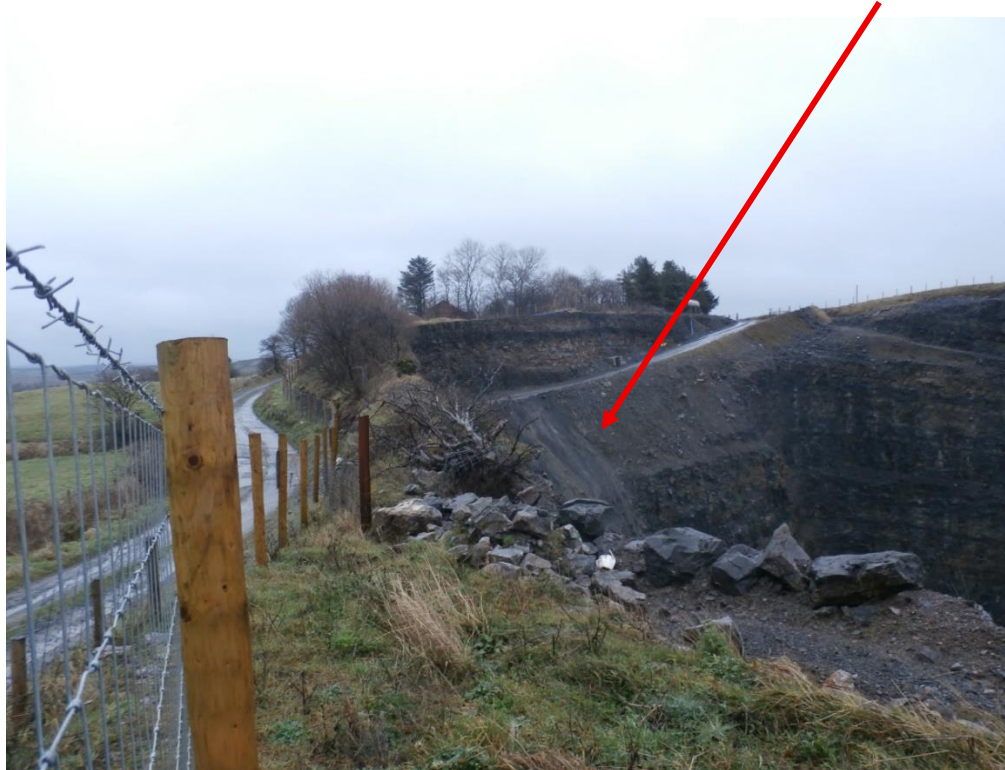
evidence of fresh quarry waste material being dumped January 2015

Figure 11: Photograph from 07<sup>th</sup> January 2015 showing evidence of waste material dumped over face of north quarry

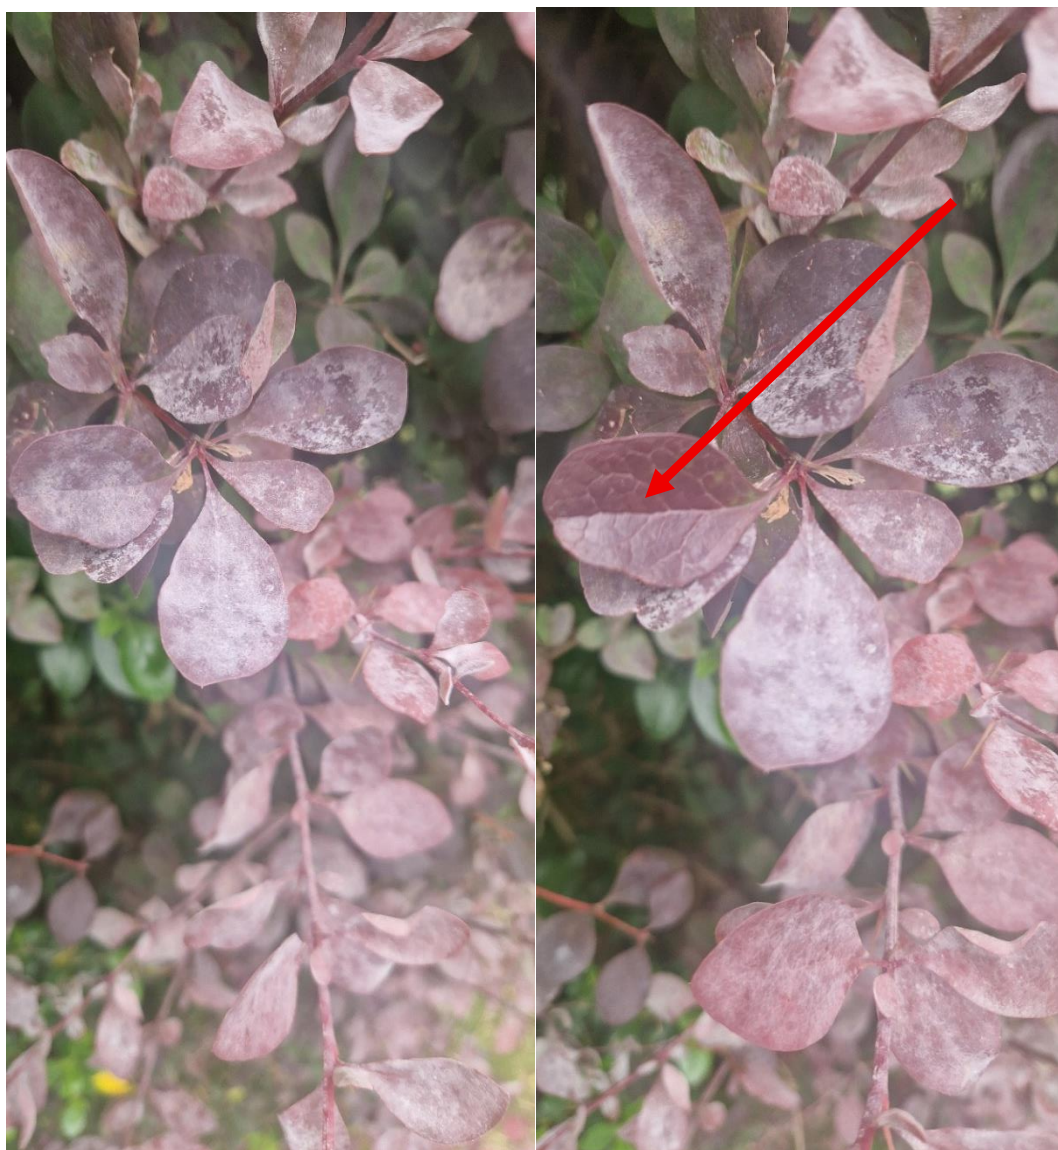
Pollution in the form of dust and noxious fumes has been, and still is, a serious problem at my residence (SR04 in the rEIAR) and around my farm. Grass and plants around the farm, cars, machinery, house windows are frequently coated in lime dust from the quarry and quarry vehicles. As an illustration of this, I have included in Figure 12 two pictures taken on 31<sup>st</sup> July 2025 showing the leaves of a shrub in my garden coated in dust from the quarry. In one of the pictures, the dust has been wiped off one of the leaves for comparison. Other examples are provided in Figures 13 and 14. This pollution has been and is a regular occurrence.

Figure 12: Dust deposition on a shrub at my residence (SR04) with dust wiped off one leaf for comparison 31<sup>st</sup> July 2025

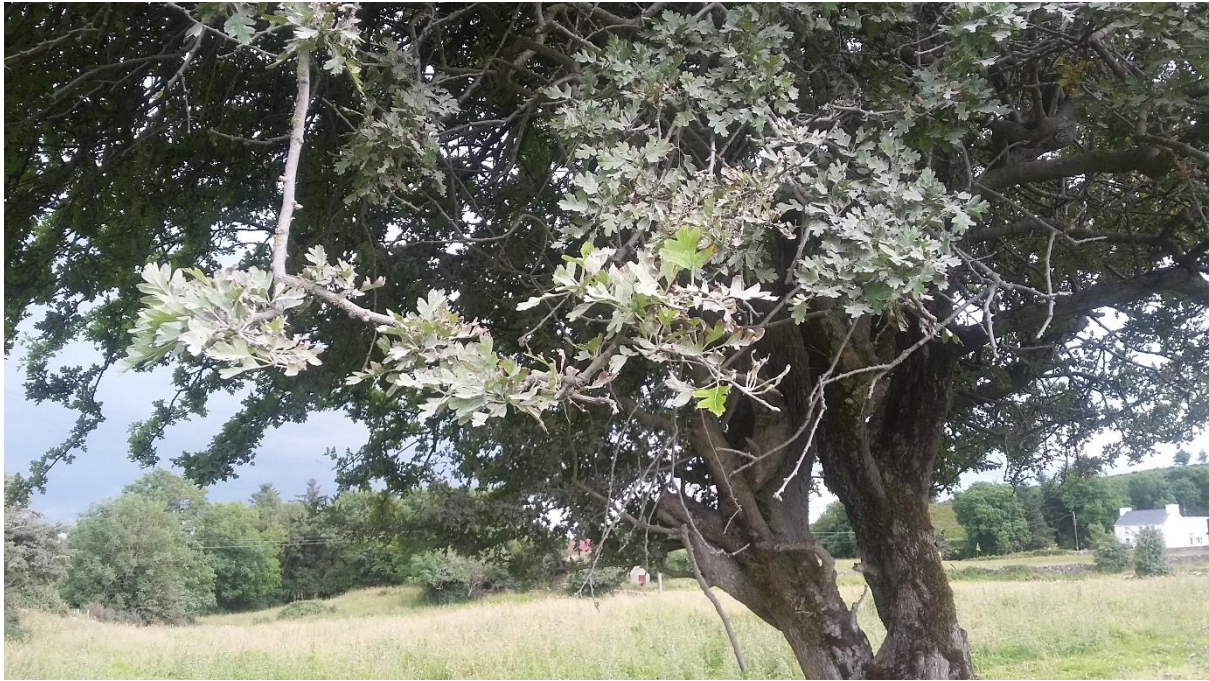
Figure 13: Example heavy deposition of dust on leaves of a hawthorn tree located on my lands approx. 125m south of quarry perimeter

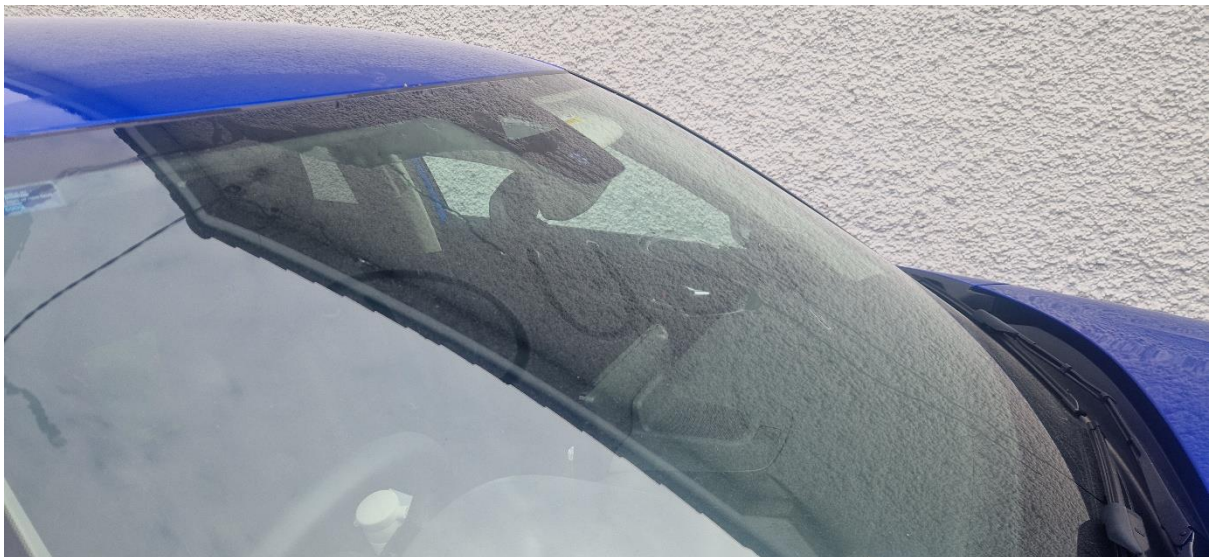
Figure 14 taken on 23<sup>rd</sup> July 2025 shows dust deposition from the quarry on the windscreen of my car.

Figure 14: Dust deposition on my car at my residence – SR04 (23/07/2025)

This type of deposition is a regularly repeated on the windows of my house. Problems with dust pollution from the quarry have persisted for years and McCaffreys appear to be either disinterested or unable to address and solve this persistent nuisance.

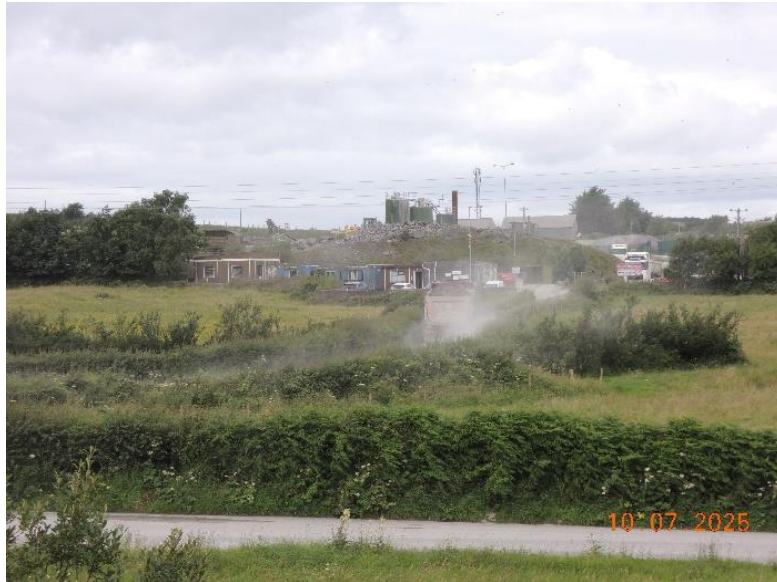
Figure15: Traffic generated dust pollution (10<sup>th</sup> July 2025)

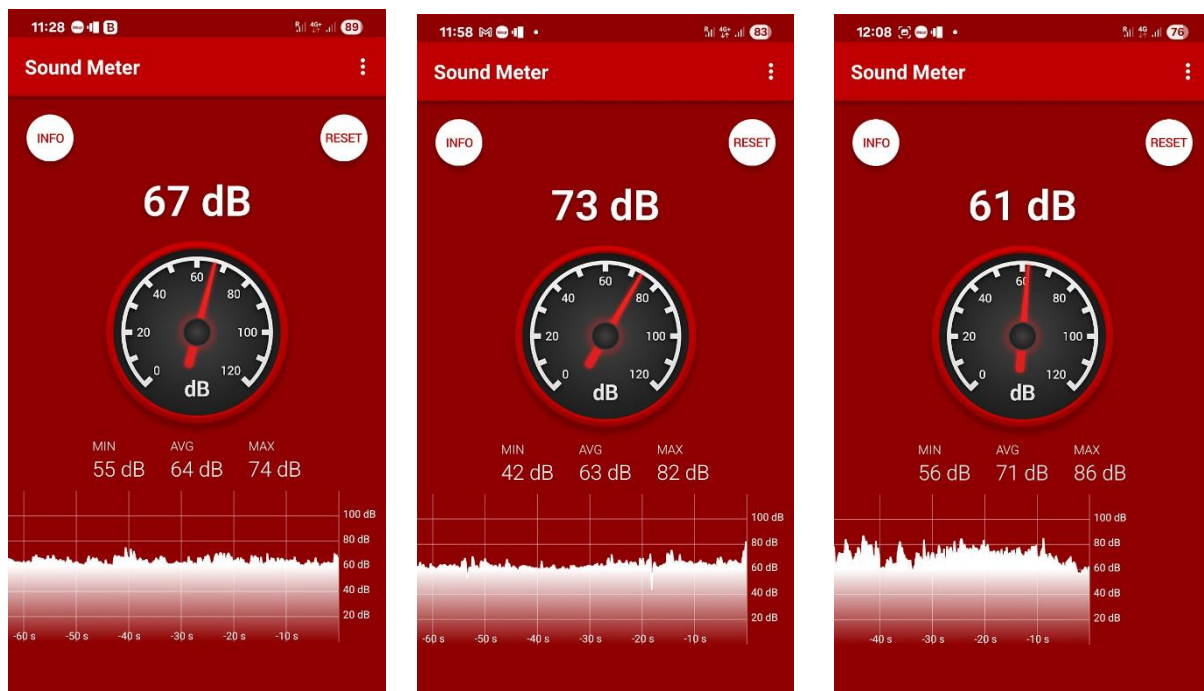
On 21<sup>st</sup> August 2025, using a smartphone app, I made a series of noise measurements near the site boundary at N1 (see Figure 19 above for location). Weather conditions were dry, overcast and calm. The readings revealed average noise readings ranging from 63dB(A) to 71 dB(A) during the measurement period, with peak reading of 86 dB(A), as shown in Figure 20.

Figure 20: Sound levels outside site boundary at N1 (21<sup>st</sup> August 2025)

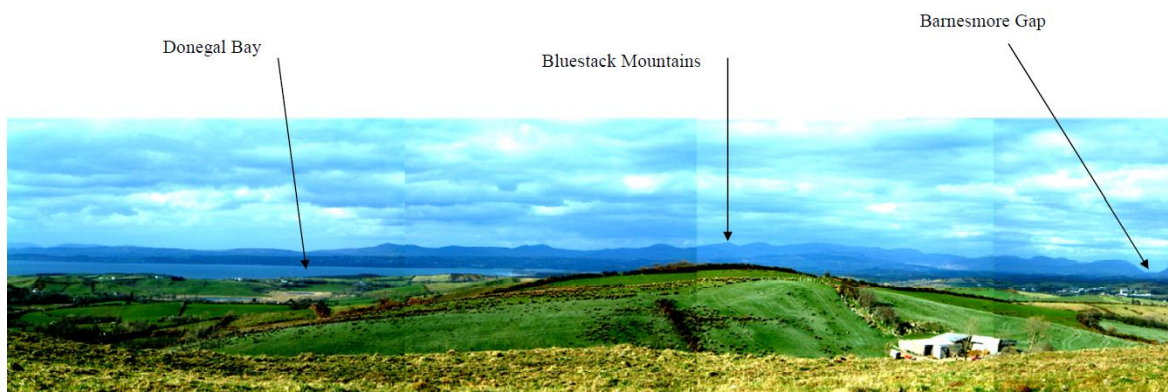
The picture presents a beautiful panoramic view over Donegal Bay, from Slieve League across the Bluestacks, through the beautiful rolling drumlin country of south Donegal to Barnesmore Gap and onto Co. Tyrone. This picture was taken in 2003, before McCaffreys began yet more unauthorised expansion to the quarry in 2007. The foreground is now blasted away and has an ugly fence damaging the view.

Figure 21: Views taken from point between VP3 and VP4

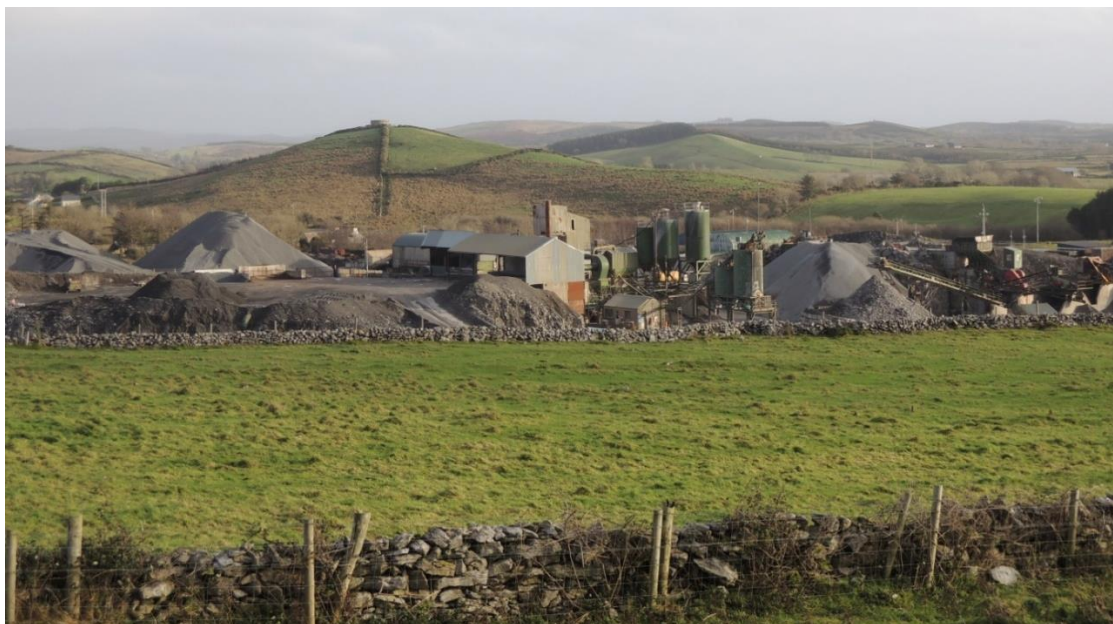
Figure 24: The south quarry pictured from VP4

The contrast in these two pictures speaks volumes about the very negative visual impact the quarry has on the landscape. For the rEIAR to describe the significance of the effect of the quarry on the landscape as 'Slight-imperceptible' speaks of a very dubious quality of assessment by the applicant. Their assessment just does not stand up to any degree of serious objective scrutiny.

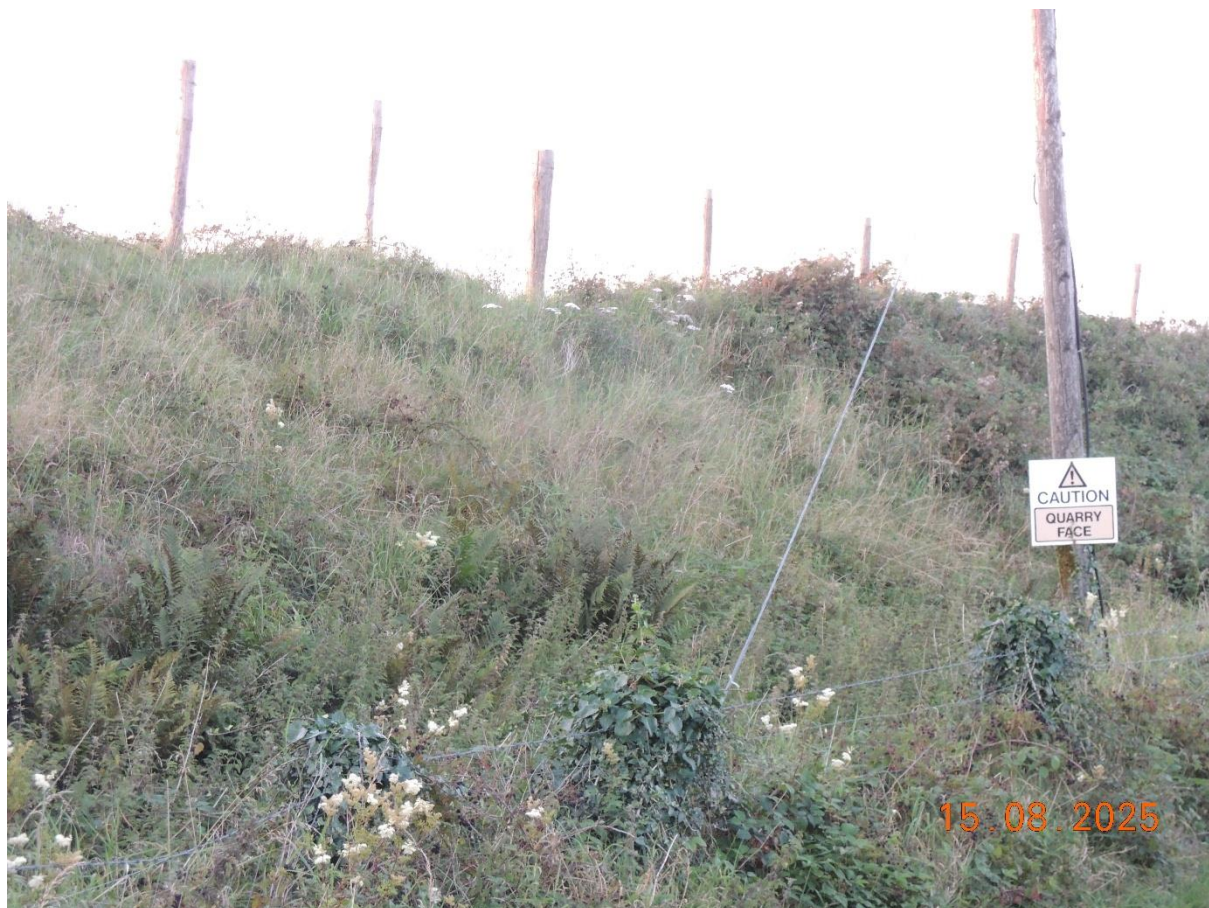
These ugly berms are not a natural feature in the landscape and create an impression of driving through a tunnel.

Figure 25: Berm on north western side of L7265 blocking views

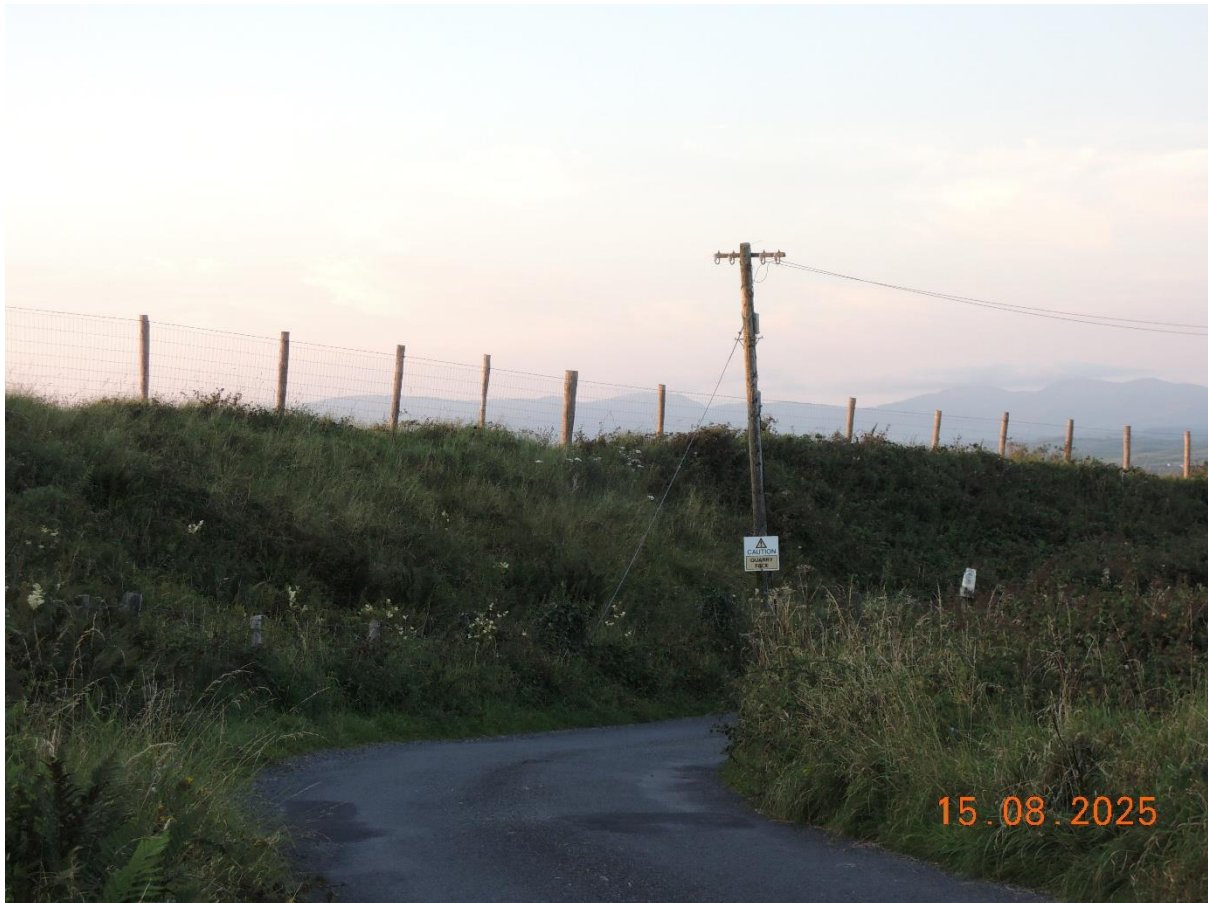
Figure 26: A glimpse over the top of the berm of the view that is blocked

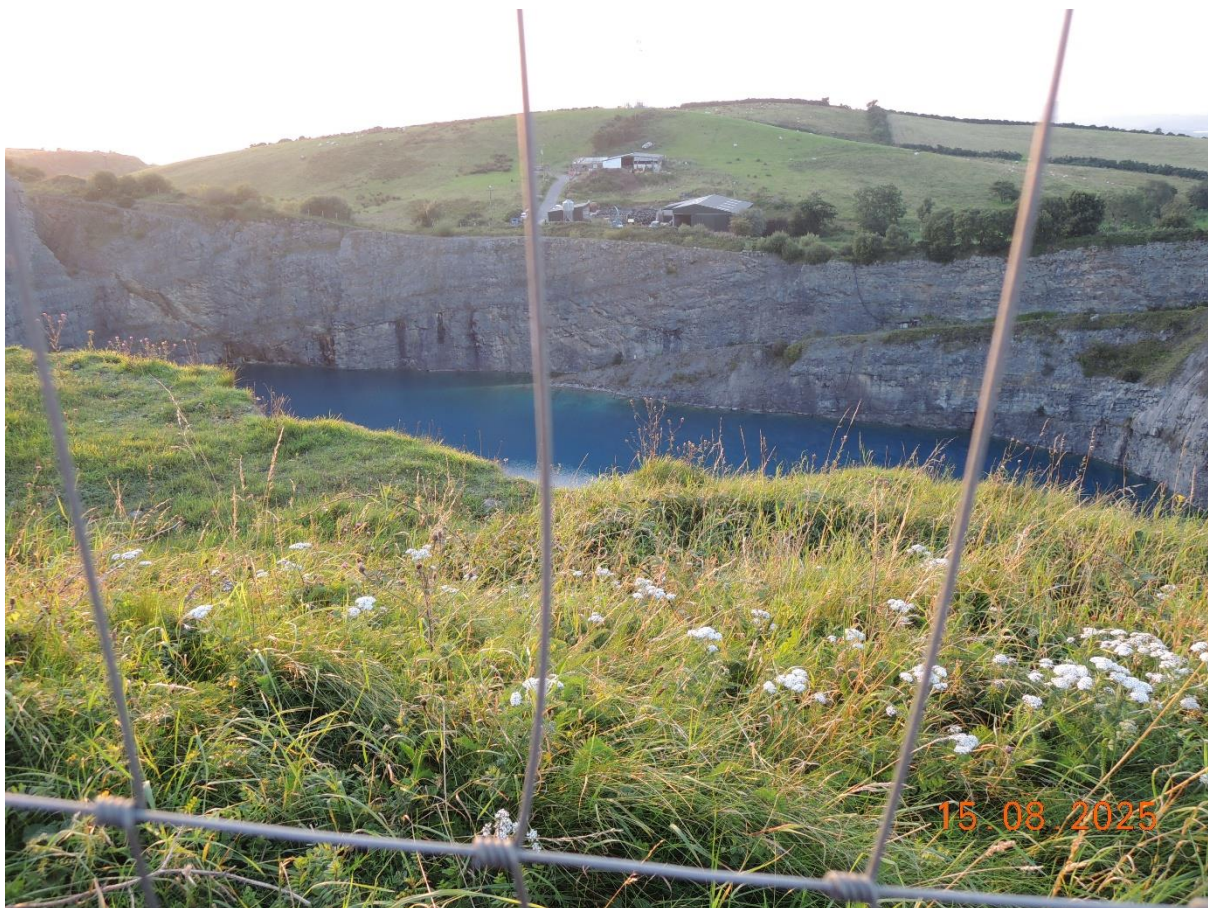
Figure 27: Inner face of berm sloping towards cliff edge

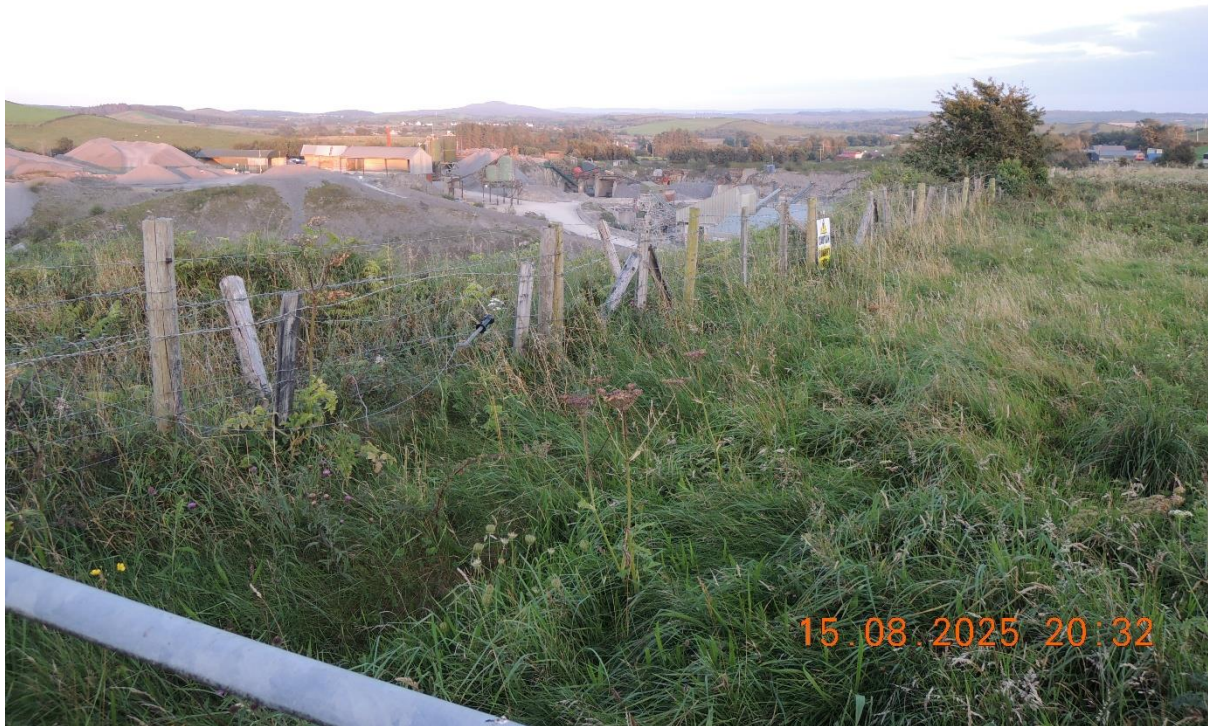
It should be noted that the fence around the south quarry is only 1m in height, and the side on the southern side of the perimeter is not fenced at all by McCaffreys (see Figure 28).

Figure 28: A one meter high fence runs along part of the south quarry perimeter

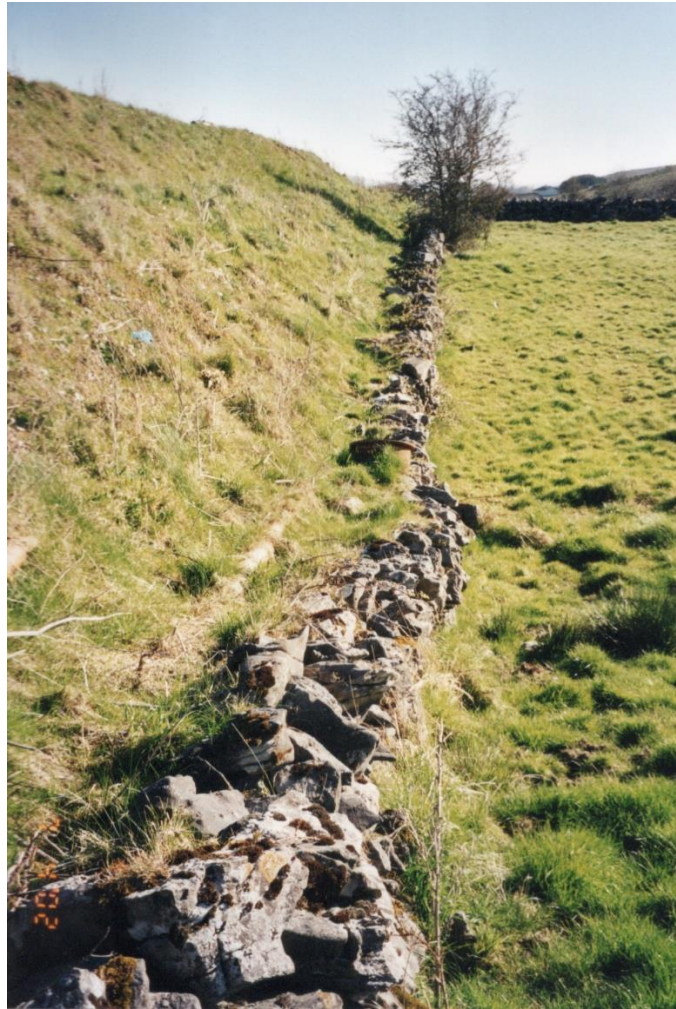
Figure 29: Partial collapse and push-back of our drystone walls caused by McCaffrey's creation of the berm (pictured in 2002, looking north-eastwards). Machinery yards are now located on the other side of this berm to the left.

Also shown in this picture is the pipe that McCaffreys used at that time to pump water out of the base of the south quarry, repeatedly flooding our fields. This water leached into the bedrock and sprung up in our fields close to Lough Gorman.

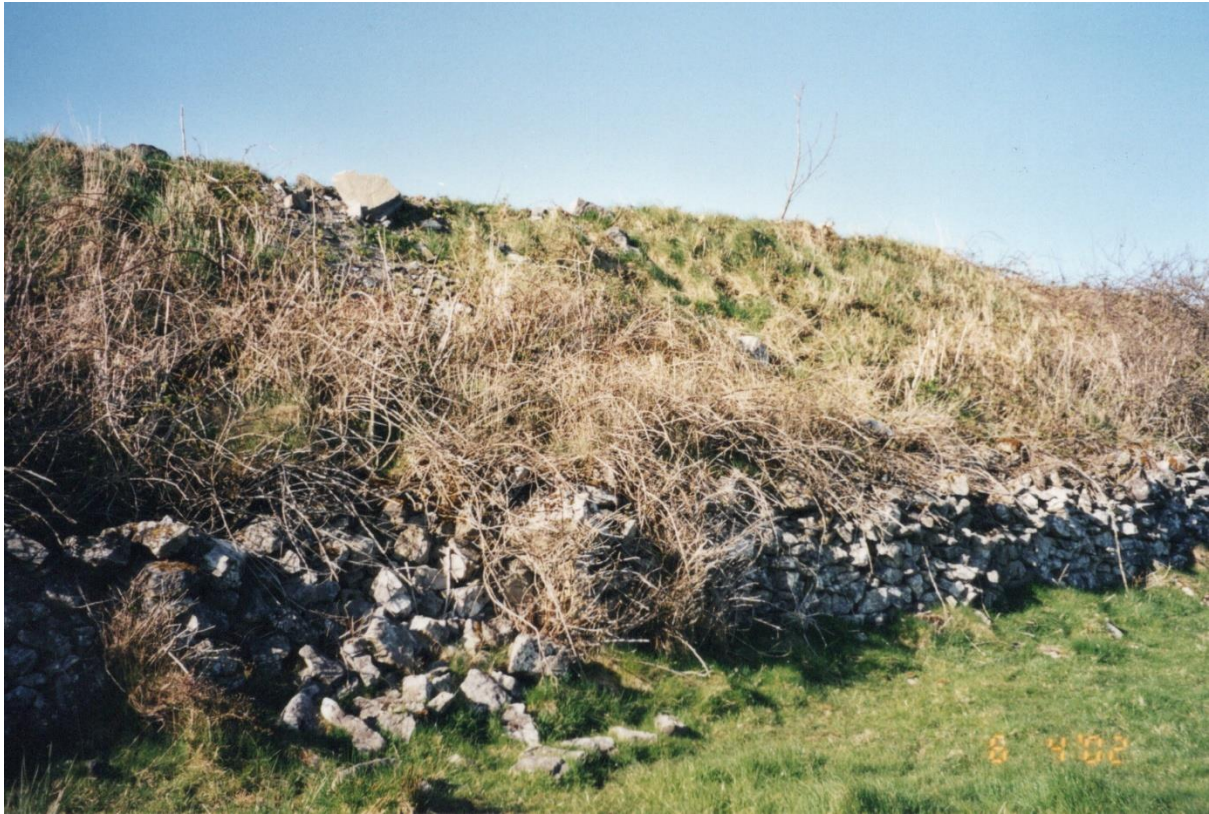
Figure 30: Damage to our drystone walls along the boundary of the South Quarry (pictured 2002) at a location to the west of the road to the quarry. Besides the very significant damage to these drystone walls, it also created the problem for running the farm as McCaffrey's actions resulted in the fields no longer being stockproof.

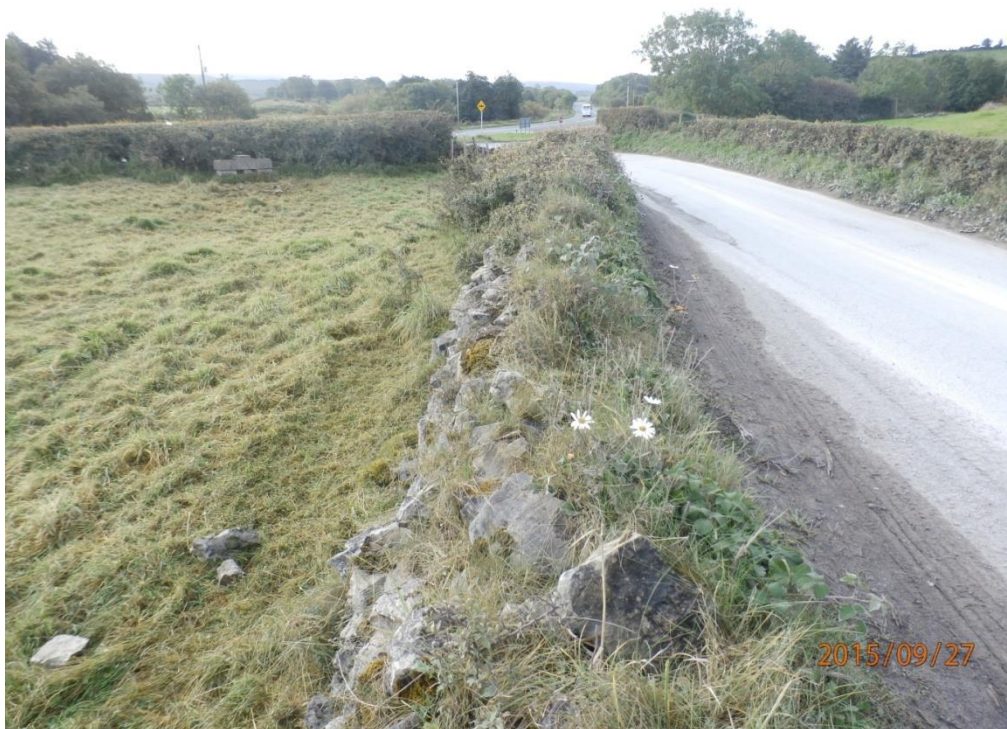
Traffic to and from the quarry has pushed back my drystone walls along the length of the road. This traffic is composed mainly of quarry vehicles. The quarry operator has raised the height of the access road by approximately 600mm. This has widened the road and put additional weight against the drystone walls, which are subject to collapse (Figures 32, 33 and 34). This is particularly hazardous as the lands are adjoining the heavily trafficked N15 and any farm animals that escape pose a serious traffic hazard. The road is substandard in width and design for such heavy traffic. Lorries going to and from the quarry have been increasing in size and loading tonnage over the years. The road was originally a narrow rural road similar to the other end of the road where it joins the L7265, as shown in Figure 35.

Figure 32: Quarry operator has raised access road by 600mm putting additional weight on drystone field walls
