# Appendix 2

## Submission on rElAR

Ref: -QD05E.323037

This report examines and critically assesses the rEIAR submitted by Patrick McCaffrey & Sons Ltd (hereafter McCaffreys) and the impact of the quarry on local residents, landowners, the environment, quality of life, human health, property, health and safety. Deficiencies and shortcomings in the rEIAR are identified.

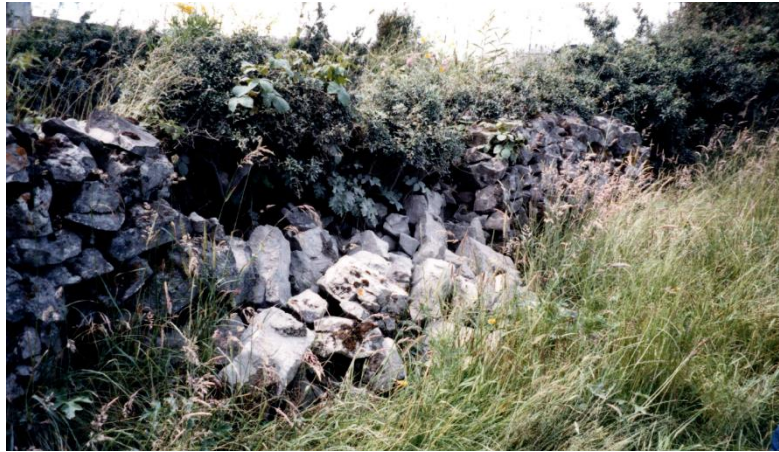
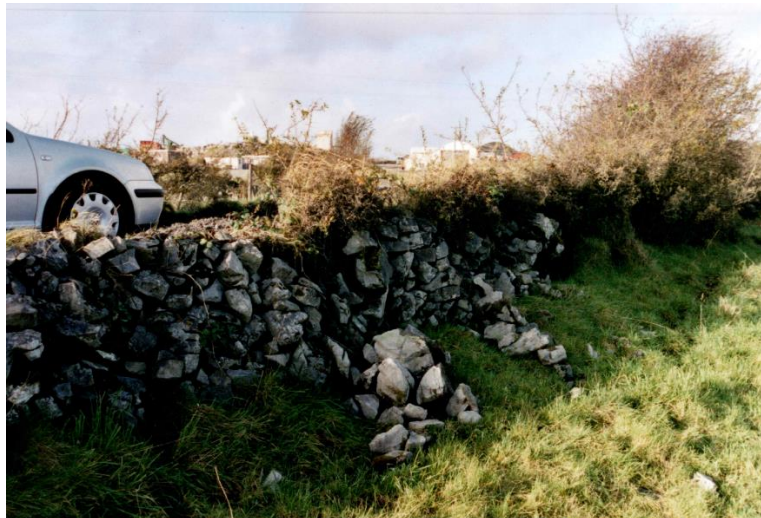
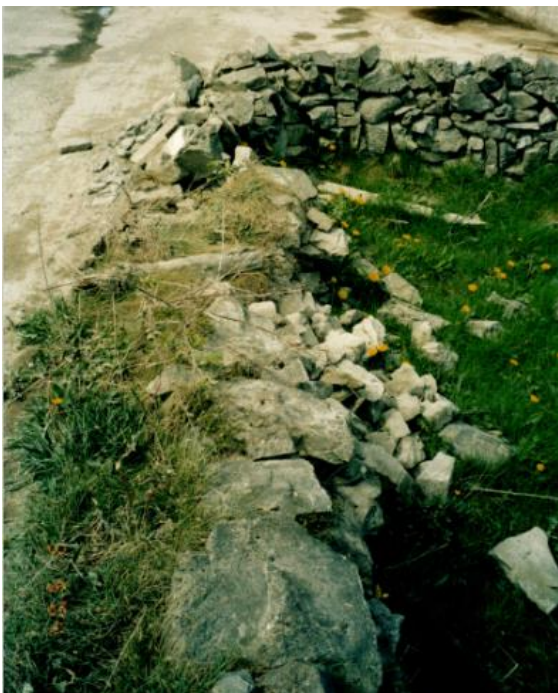
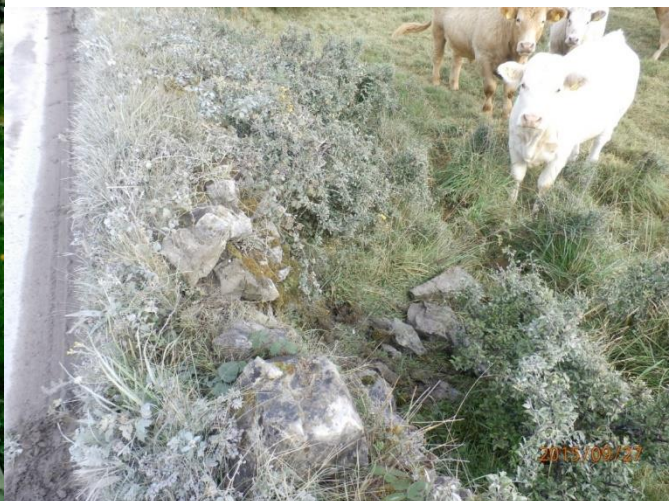
Figure 33: Damage to drystone walls with stones falling into field creating hazard of cattle escaping

McCaffreys do not accept that the damage to my drystone walls from quarry traffic is their responsibility and it has been left to me to repair them myself.

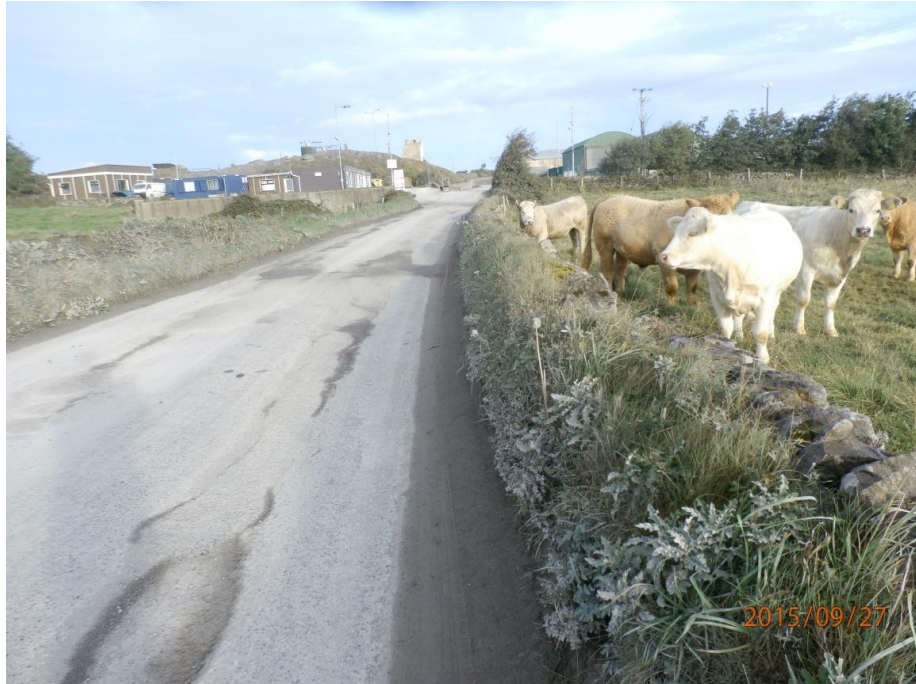
Figure 34: Access road through my lands is substandard in width for quarry traffic

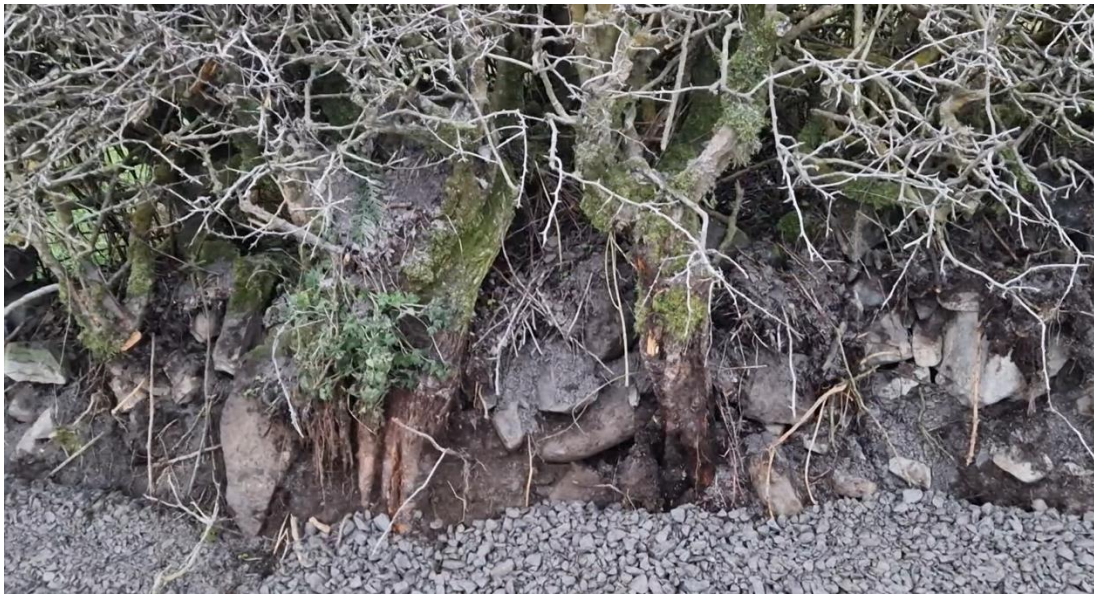
Figure 37: Removal of roadside grass margin, damage to my hedge and drystone wall

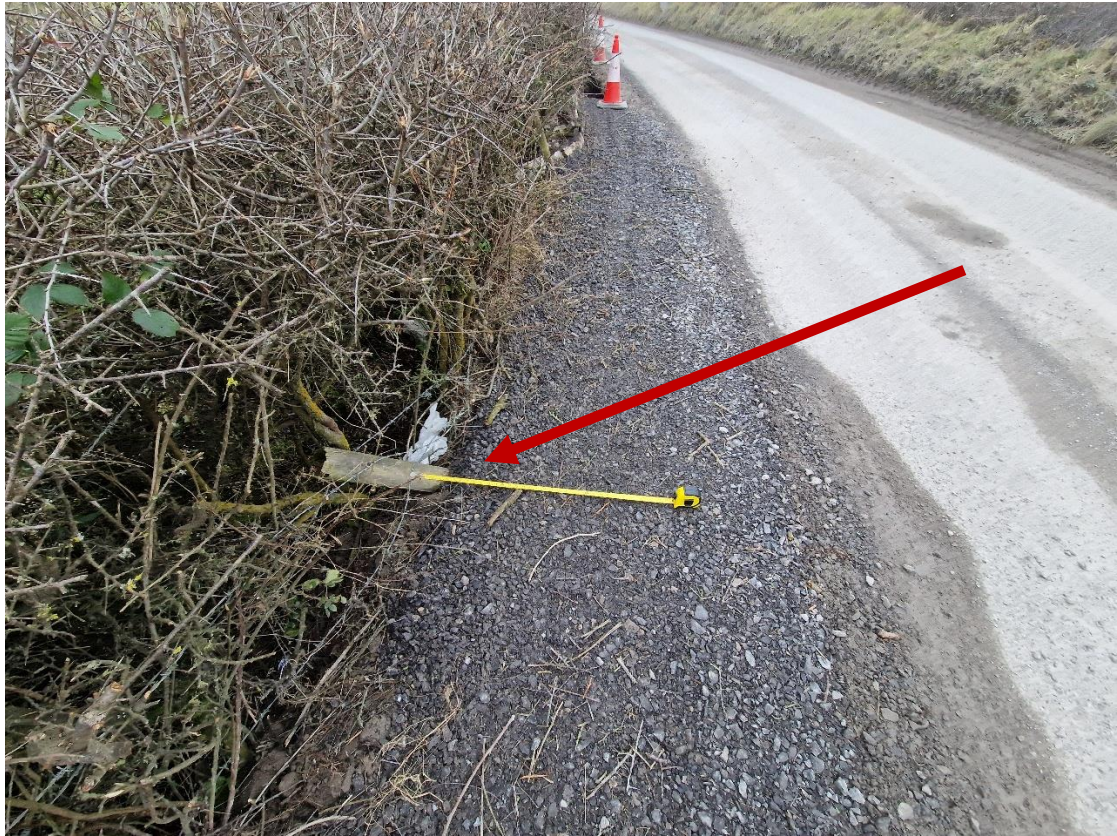
Figure 38: Encroachment onto my property, damage to roadside hedge and flattening of barbed wire fence (arrow shows previous upright fence post flattened and partly covered by road filling)  
January 2024

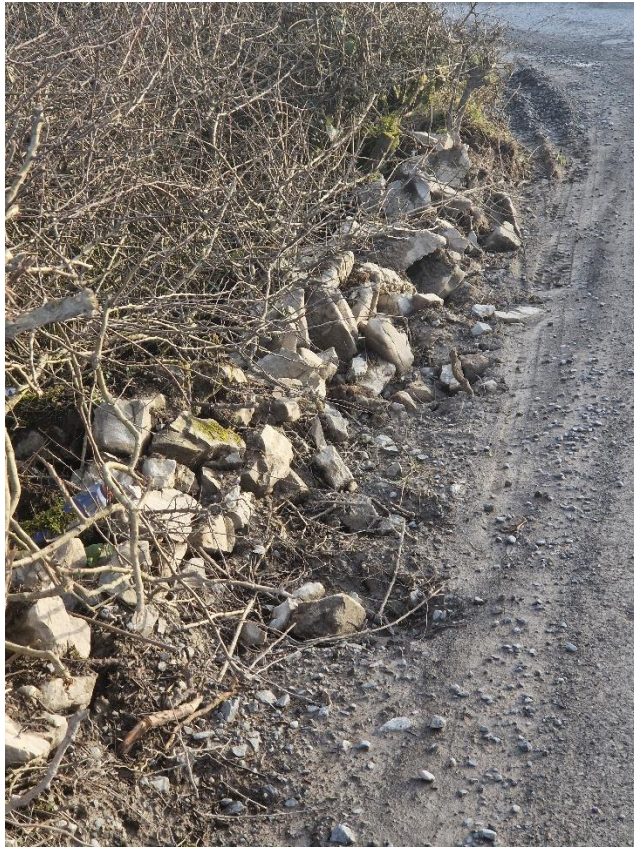
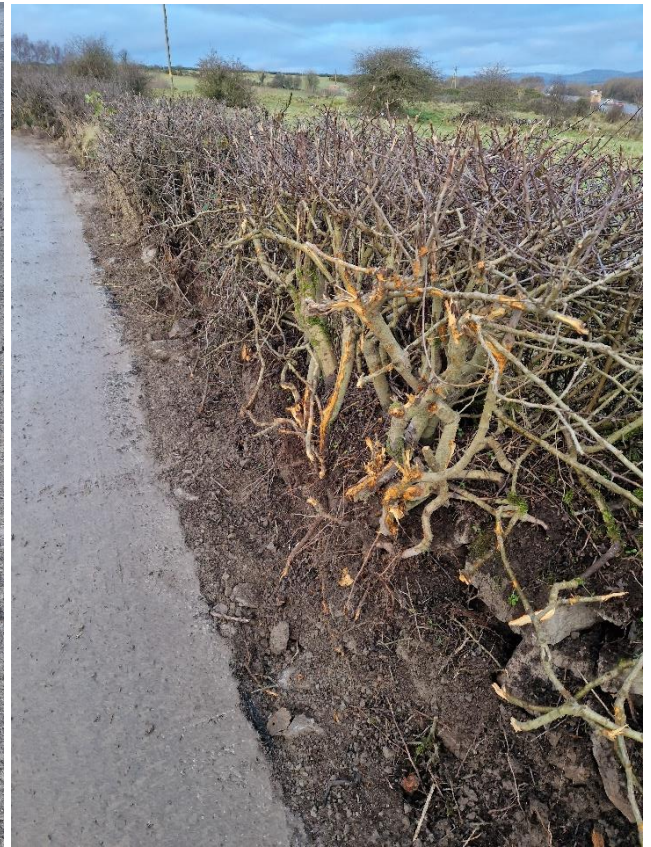
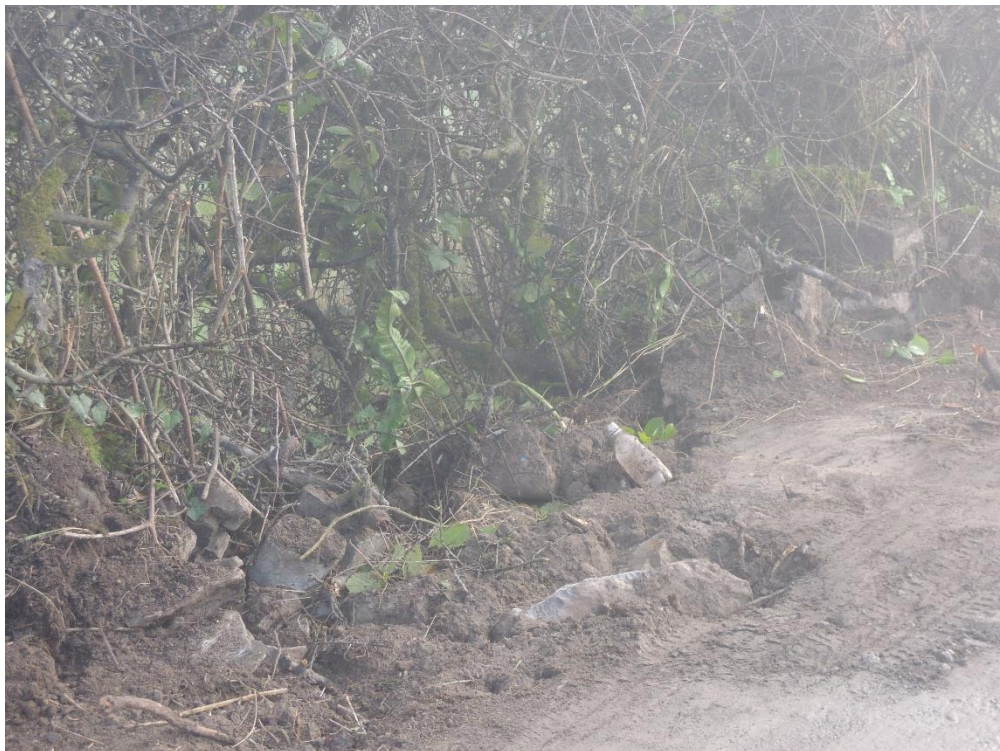
Figure 39: Destruction of boundary drystone walls and hedging, removal of roadside grass margin (January 2024)

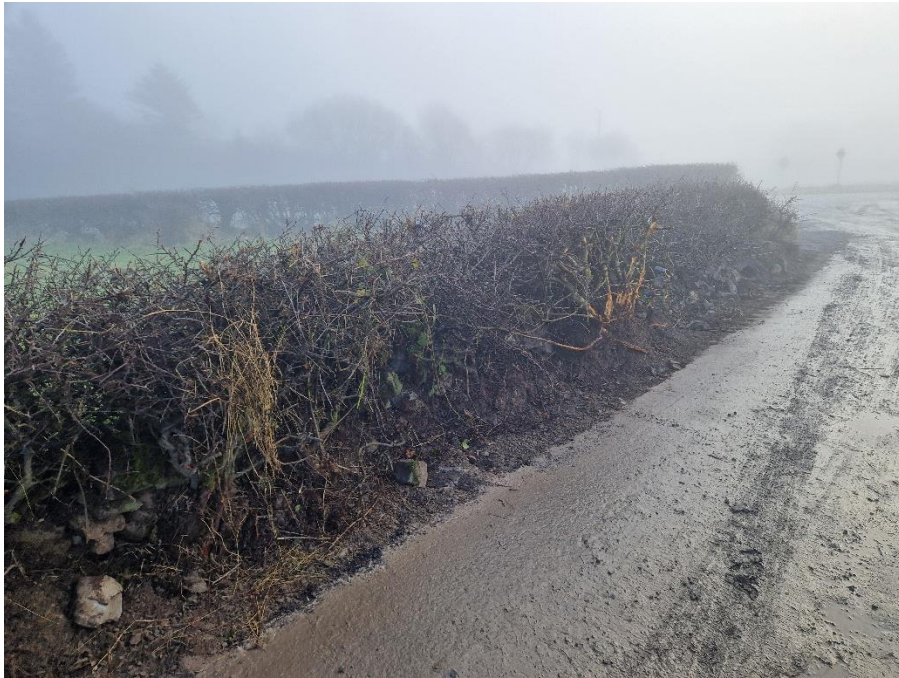
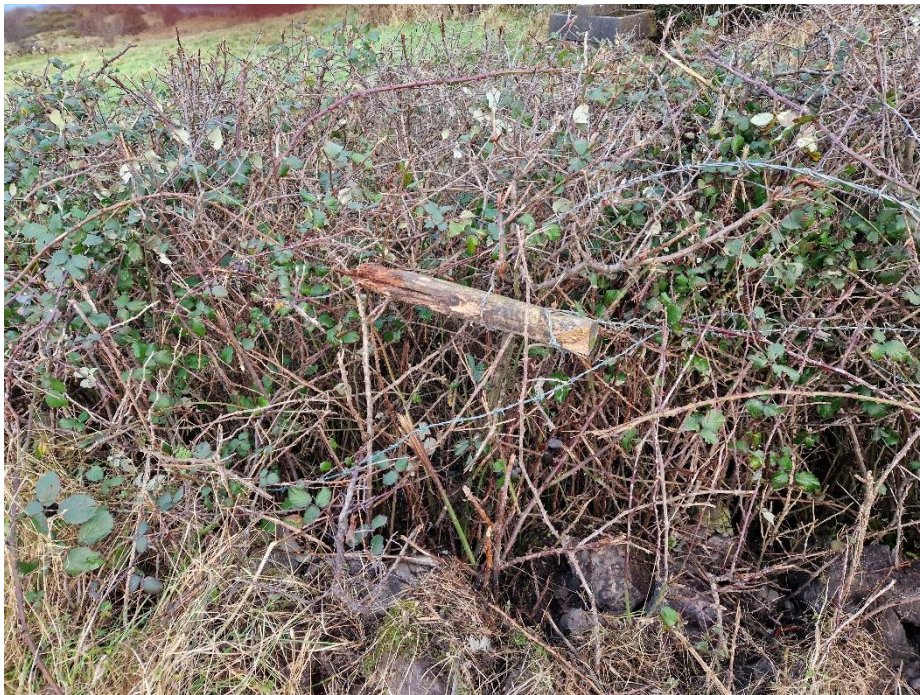
Figure 40: Other images of damage to my roadside property near the junction (January 2024)

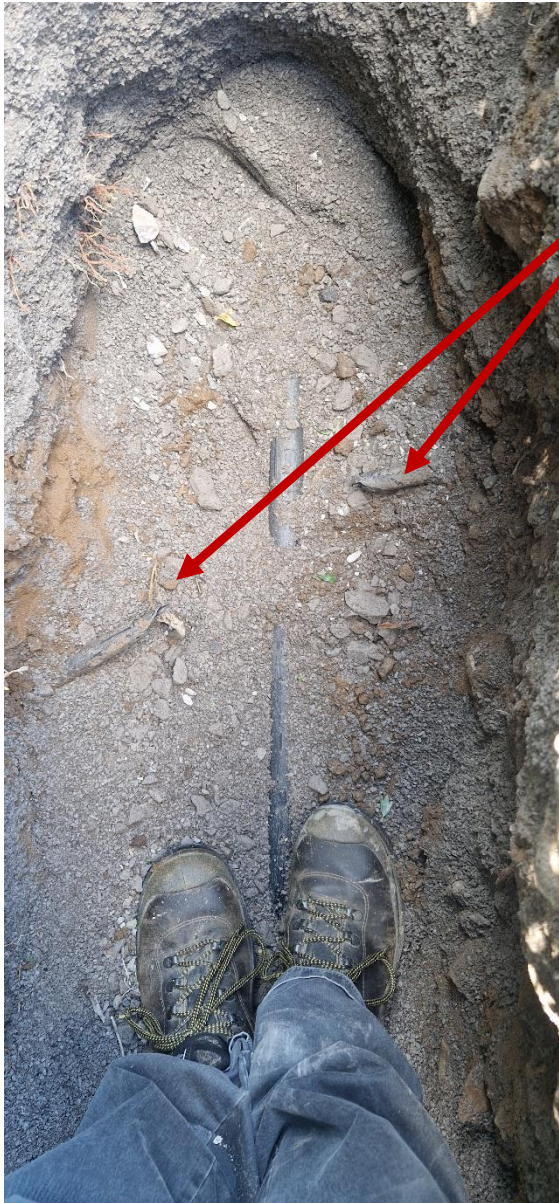
Figure 41

My farm water supply pipe cut by McCaffrey's by their water pipe laying.

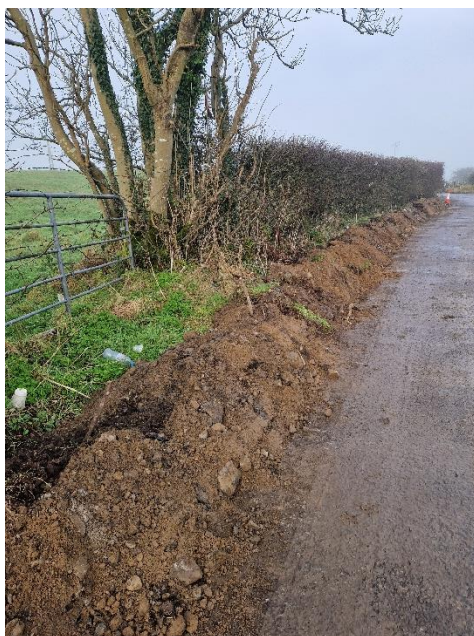
Figure 43: Waste material and spoil from McCaffrey's activities were dumped along my hedge and blocking access to my field at this gate.

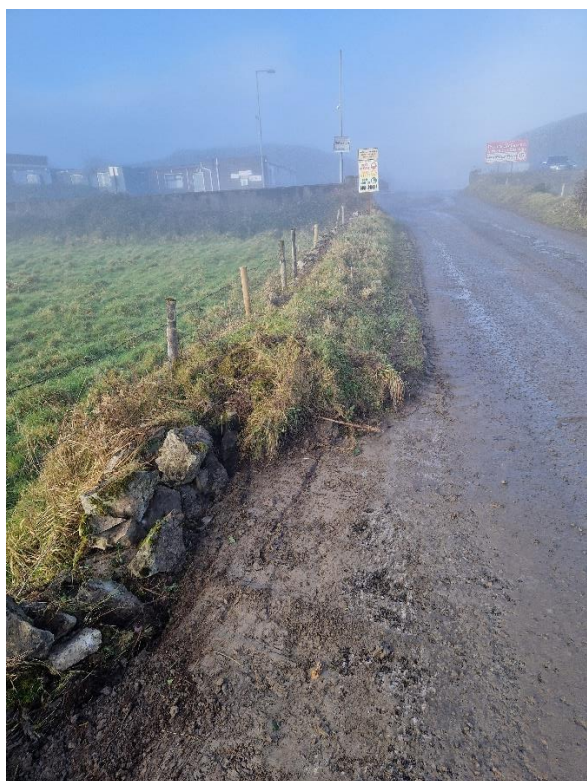
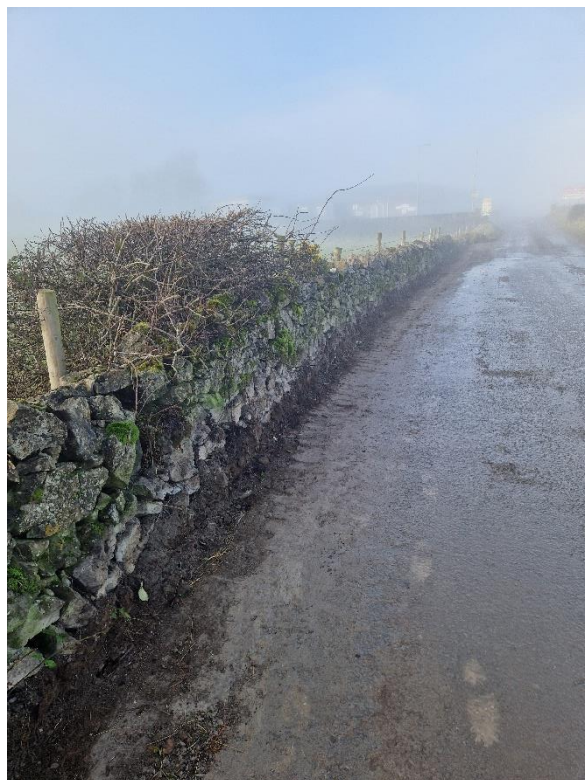
Figure 44: Removal of my roadside grass margins
