- **Appendix 6.3 Hedgerow Impact Study**

BENCHMARK HEDGEROW STUDIES

Client:	EirGrid Plc
Project:	North South 400kV Interconnection Development
Title:	Benchmark Hedgerow Studies

PROJECT NUMBER: 6504				DOCUMENT REF: 6504_A			
Revision	Description & Rationale	Originated	Date	Checked	Date	Authorised	Date
A	FINAL	RM	020911	MH	020911	DG	020911
TOBIN Consulting Engineers

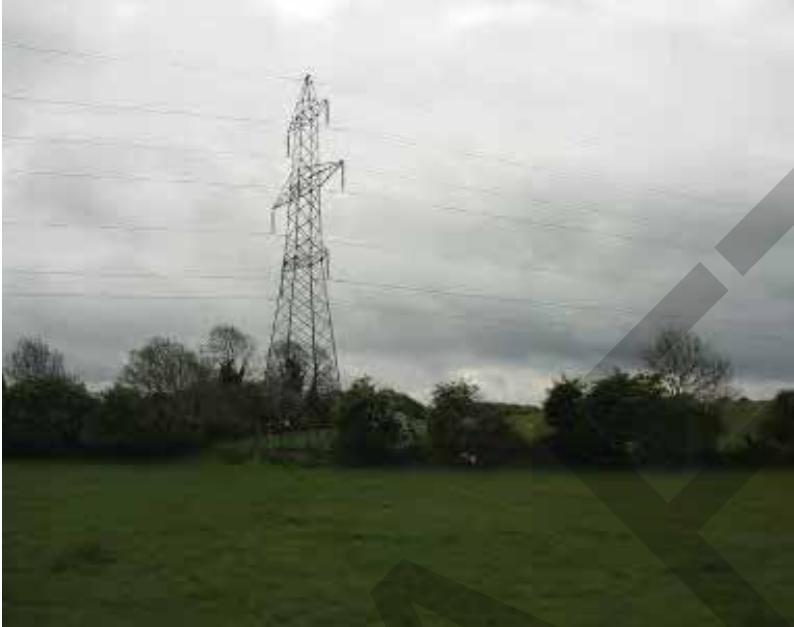
<p>Moderate value Hedgerow with section completely removed at 7m wide gap where tower located</p>
13

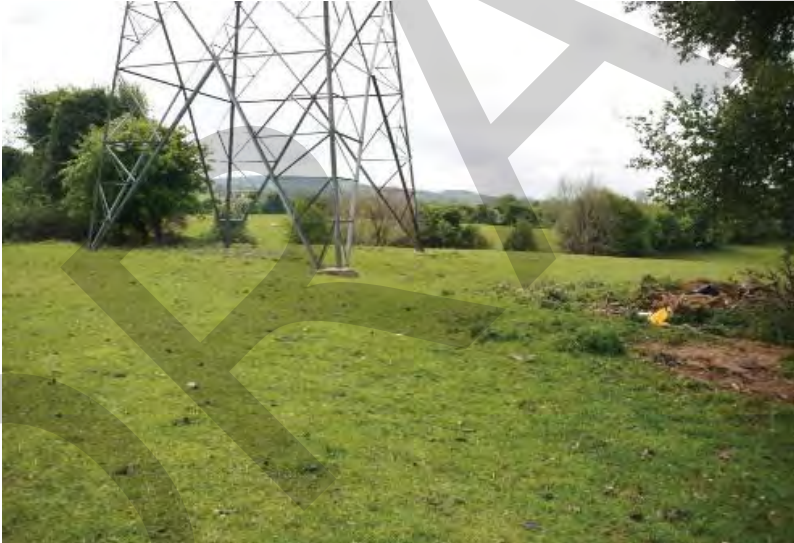
<p>Hedgerow completely removed at 25m wide gap where intermediate tower located. No reinstatement</p>

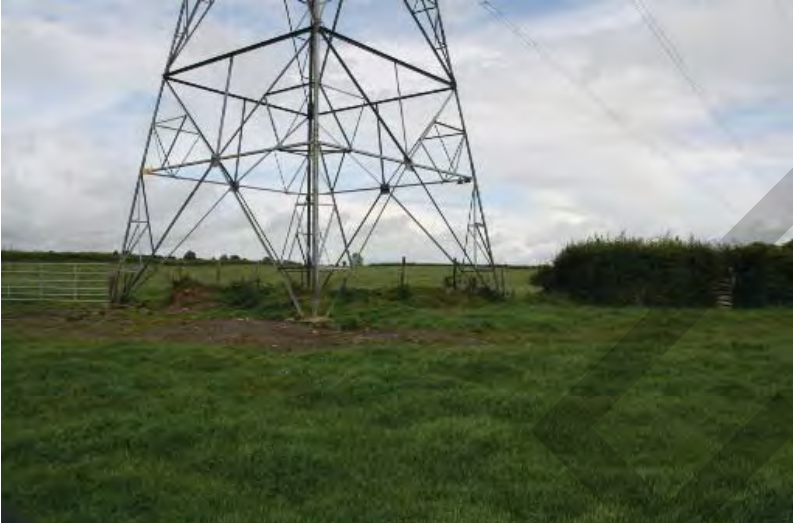
37	Intermediate	Livestock	20m of hedgerow permanently removed under tower.	hedgerow either side of tower is managed and species poor (hawthorn dominated)	None close to tower	Low	Loss of woody hedgerow species as 20m of hedgerow permanently removed under tower. No recovery/reinstatement
38	Intermediate	Livestock (meadows)	20 - 30m of hedgerow permanently removed under tower. (Includes an access track). The tower is located at the meeting point 3 hedgerows meaning larger impact.	Robust unmanaged narrow species rich (woody and ground flora) hedgerow. Species include alder, spindle, rose, blackthorn, hazel, hawthorn, ivy and holly. hedgerow is located on a townland boundary	Birds include common passerines.	High	Loss of woody hedgerow species as 20 - 30m of hedgerow permanently removed under tower. (Including an access track).
39	Intermediate	Livestock (meadows)	Hedgerow at tower location dominated by pioneer woody species of disturbed ground. Tower means hedgerow wider at this location	Species rich hedgerow either side of tower (willow, ash, hazel, ivy, blackthorn, gorse, hawthorn and elder)	Birds include common passerines.	High	Change in hedgerow plant community at tower location includes pioneer woody species of disturbed ground. Hedgerow wider at tower location

<p>20m of hedgerow permanently removed under tower.</p>
38

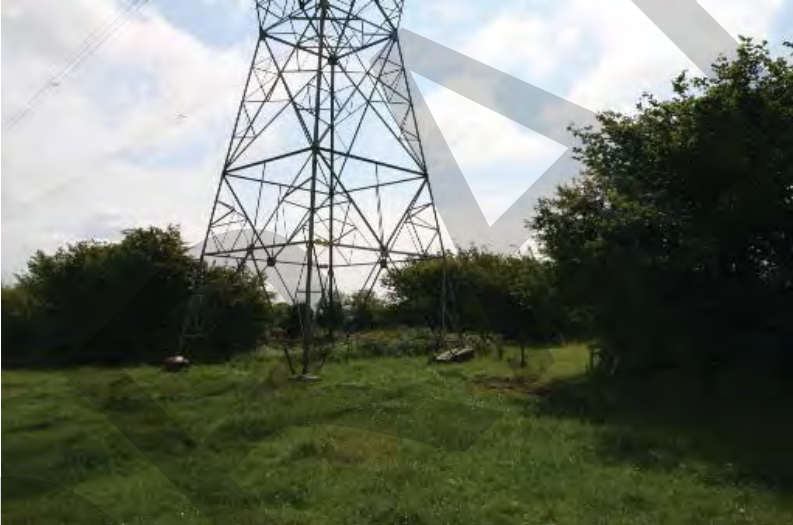
<p>Intermediate tower in gap where hedgerow permanently removed and access track retained. High value species rich hedgerow either side.</p>
39

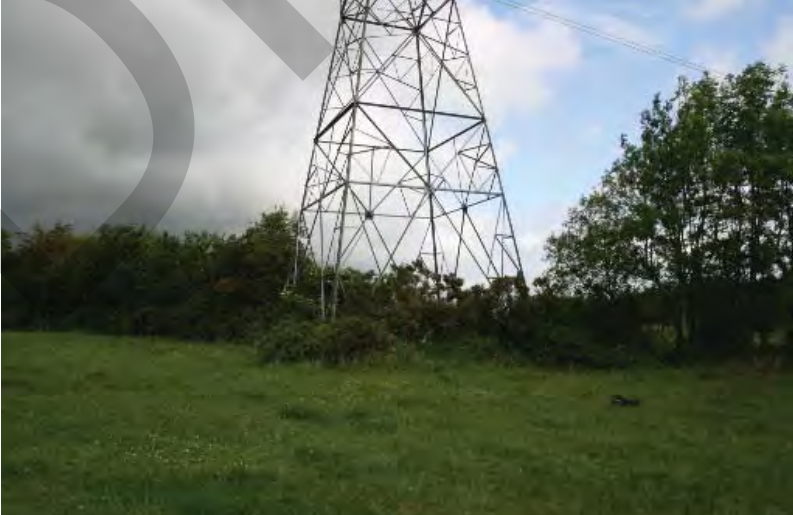
<p>Intermediate tower with disturbed ground species (gorse, bramble) dominating tower gap. High value hedgerow either side of tower has different woody vegetation to that under tower</p>
