- **Appendix 6.3 Hedgerow Impact Study**

# BENCHMARK HEDGEROW STUDIES

SEPTEMBER 2011

<b>Client:</b>	EirGrid Plc
<b>Project:</b>	North South 400kV Interconnection Development
<b>Title:</b>	Benchmark Hedgerow Studies

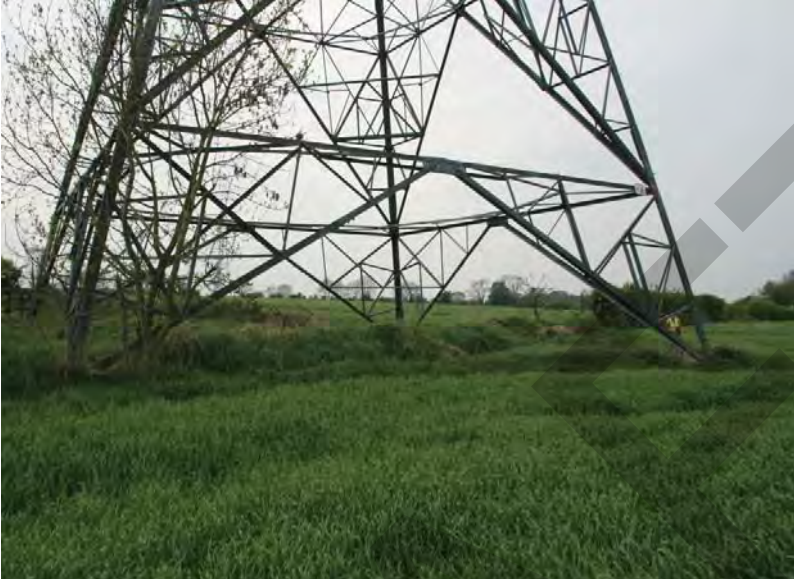
Location Tower Nos.	Plate	Description
1

Location Tower Nos.	Tower Type	Land use	General description hedgerow at tower location	General Description of hedgerow either side of tower location	Fauna describe (all)	NRA Evaluation hedgerow overall	Description of differences at tower location relative to either side of tower
1	Angle	Arable	80M of hedgerow permanently removed as tower located at the meeting point of 3 hedgerows. No recovery noted. Grassy verge species present which are indicators of species poor neutral grassland habitat.	Robust species poor Managed hedgerow on bank. Woody species include hawthorn (dominant) and ash. Climbers incl. Ivy, rose and bramble. No woody ground flora. No ditch. Arable farmland.	Abandoned badger outlier sett at hedgerow to north. Bat survey conducted under tower noted Soprano and Common pipistrelle foraging along existing hedgerow under towers i.e. gap in hedge was not proving to be a barrier. Breeding territorial passerines birds noted including yellowhammer and blackbird nest near tower.	Low	Significant gap at tower location as hedge gone

<p>Angle tower with entire hedge removed and no significant recovery. Note existing managed hedgerow in background. This tower is located at the junction of 2 "low value" hedgerows.</p>
2

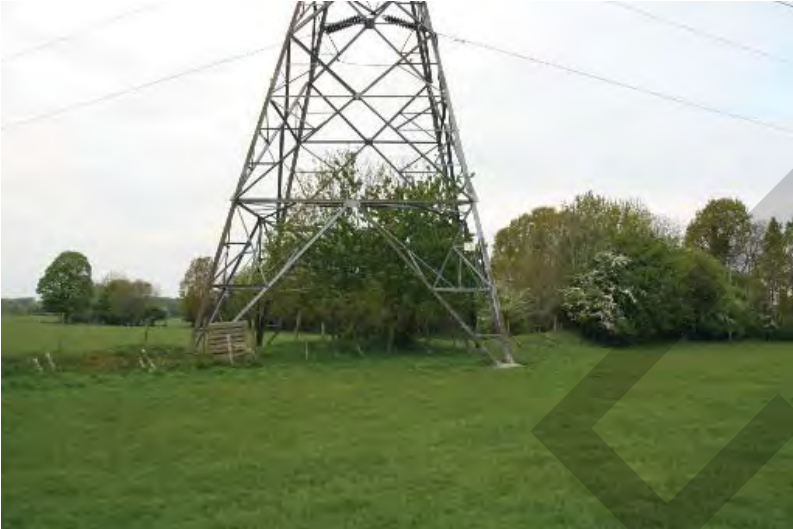
Location Tower Nos.	Plate	Description
10

<p>Intermediate tower with limited woody vegetation recovery. Some woody vegetation was pollarded rather than completely removed during construction.</p> <p>Hedgerow either side has low evaluation and is heavily grazed by sheep preventing recovery/ re-establishment.</p>
11

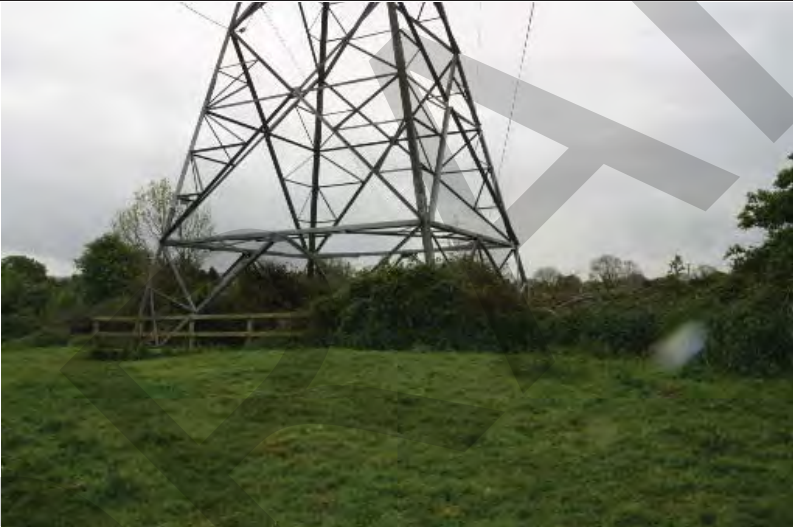
11	Angle	Livestock	Tower base surrounded by wood fence. Hedgerow (30m) replaced by bramble thicket.	Species poor hawthorn and elder unmanaged hedgerow. Damaged cattle. Some woodland ground flora. Livestock	Rabbits, passerines	Moderate	Loss of woody hedgerow species at tower location. Dense brambles maintain connectivity
12	Intermediate	Livestock	Hedgerow completely removed at 7m wide gap.	Species poor (rose, ivy, bramble, ash hawthorn) some woodland flora (e.g. viola, primula). Long term managed. Damaged by cattle.	Rabbits, passerines. No bat activity noted in this area during survey.	Moderate	Loss of woody hedgerow species at tower location.

<p>Moderate value hedgerow. Tower base surrounded by wood fence. Hedgerow (30m) replaced by bramble thicket. Note fencing, to keep livestock out, allows some woody vegetation to re-establish</p>

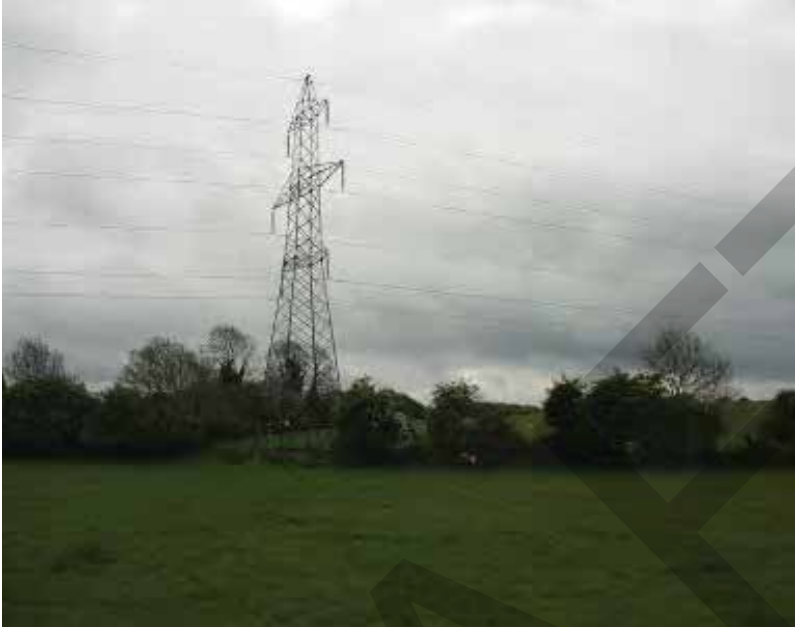
Location Tower Nos.	Plate	Description
12

<p>Moderate value Hedgerow with section completely removed at 7m wide gap where tower located</p>
13

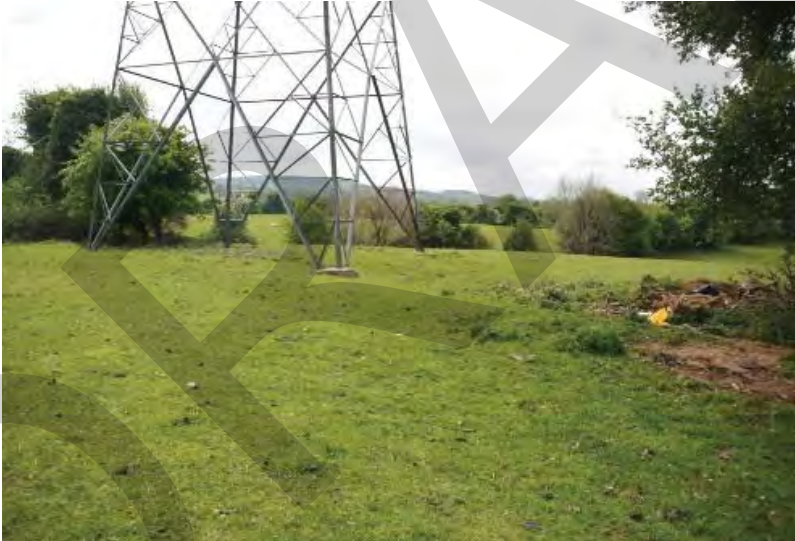
<p>Hedgerow completely removed at 25m wide gap where intermediate tower located. No reinstatement</p>

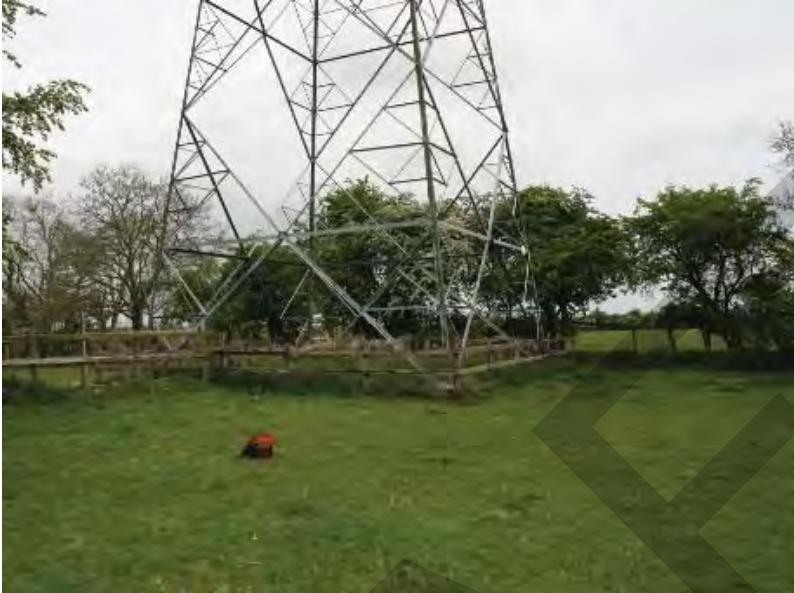
Location Tower Nos.	Plate	Description
14

<p>Hedgerow completely removed at 12 m wide gap where intermediate tower located. No reinstatement. Fenced off</p>
17

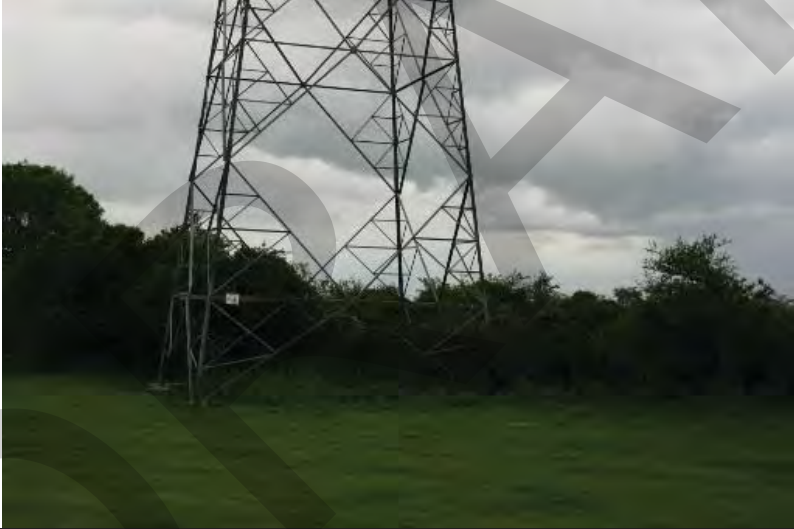
17	Intermediate	Arable	Re-establishment gorse, ivy, elder, hawthorn, blackthorn and bramble thicket under tower	Unmanaged hedgerow dominated by hawthorn, elder, ash and gorse. Grazed sheep, agricultural weeds at field layer. Arable	None	Moderate	Change in dominant woody vegetation with establishment of relatively vigorous pioneer woody plant growth under tower. Hedgerow connectivity retained.
22	Angle	Arable	Re-establishment of hazel, ivy, elder, hawthorn, blackthorn and bramble thicket under tower. Notably hedgerow and rank grassland wider at tower location	Unmanaged dense relatively species rich hedgerow. Some large mature standards present. Agricultural and plant verge species predominate ground flora. Arable	Rabbit, passerines	Moderate	No real difference besides trimming. Re-establishment of hazel, ivy, elder, hawthorn, blackthorn and bramble thicket under tower. Notably hedgerow and rank grassland wider at tower location

<p>Hedgerow connectivity retained at gap where tower straddles low hedgerow. Change in dominant woody vegetation with establishment of relatively vigorous pioneer woody plant growth under tower.</p>
22

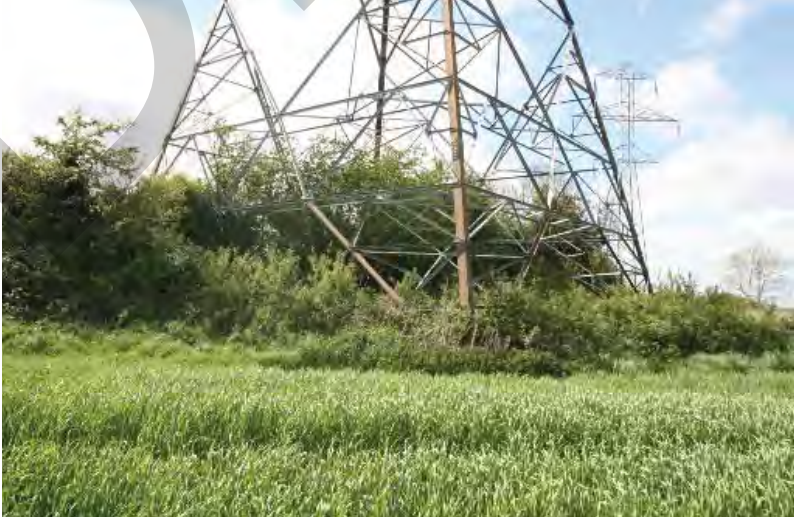
<p>Moderate value hedgerow. No real difference under tower besides trimming. Re-establishment of hazel, ivy, elder, hawthorn, blackthorn and bramble thicket under tower. Notably hedgerow and rank grassland wider at tower location</p>

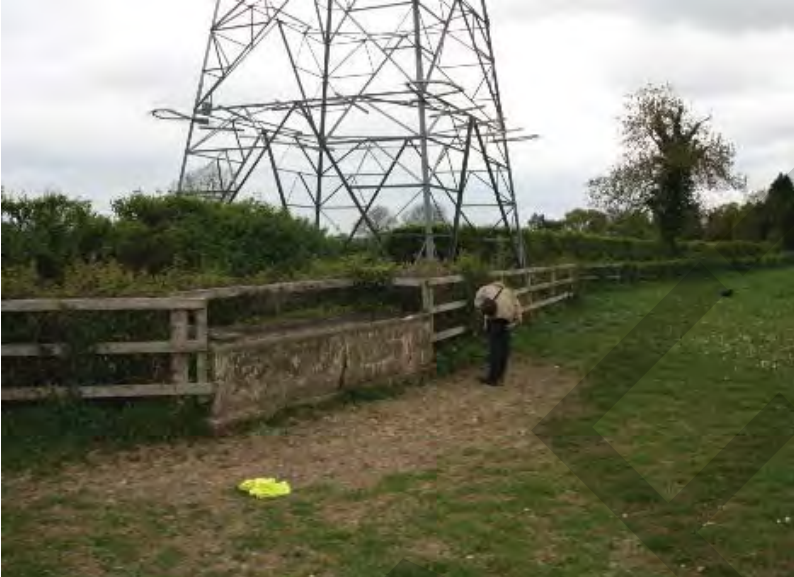
Location Tower Nos.	Plate	Description
25

25	Intermediate	Livestock	7m gap with main woody vegetation (hawthorn) gone. Dense briars as fenced off. Fenced at tower location means remnant hedgerow wider than surrounding at tower location.	Managed (trimmed) species rich (woody) hedgerow.	Rabbit, passerines (including yellowhammer)	Moderate	Loss of woody hedgerow species at 7 m gap with no significant hedgerow re-establishment
29	Intermediate	Livestock (meadows)	Tower straddles low managed hedgerow. Hedgerow structure largely retained	Relatively species poor (woody) managed hedgerow. Agricultural weeds (ground flora).	Passerines (including yellowhammer)	Low	No significant impact - hedge re-established/ not completely cleared

<p>Moderate value hedgerow. Loss of woody hedgerow species at 7 m gap with no significant hedgerow re-establishment</p>
29

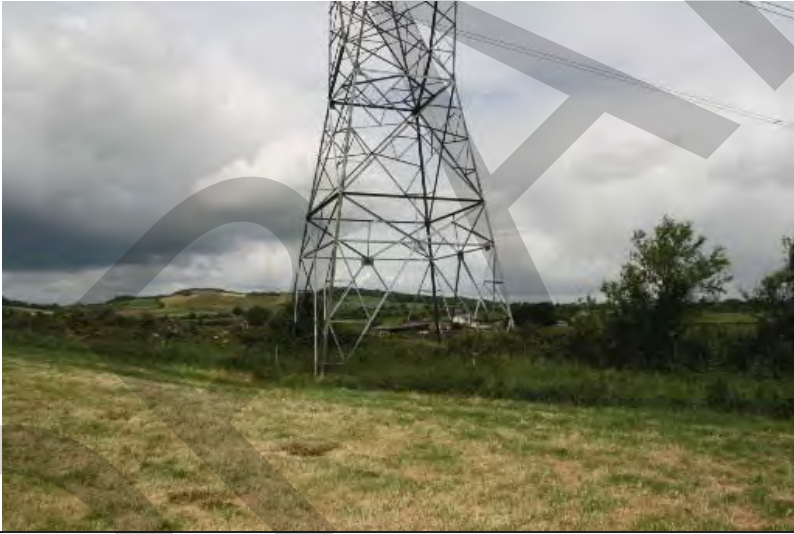
<p>Tower straddles a low managed hedgerow. Hedgerow structure largely retained</p>
33

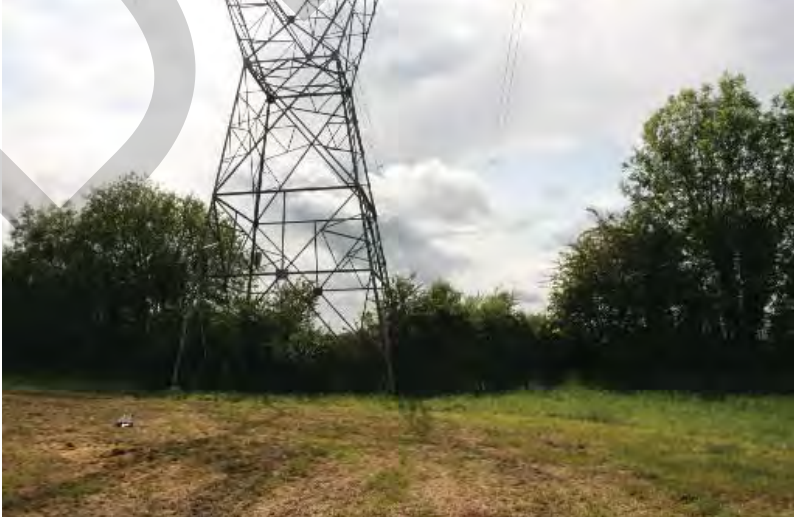
<p>Intermediate tower straddling retained "High" value hedgerow. Note height of hedgerow below line (c.a. 3 – 4m) which is much lower than hedgerow either side.</p>

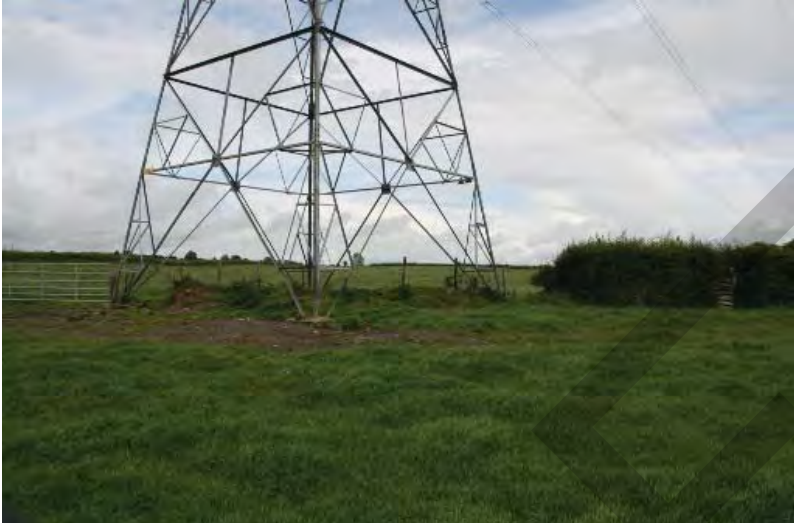
Location Tower Nos.	Plate	Description
37

37	Intermediate	Livestock	20m of hedgerow permanently removed under tower.	hedgerow either side of tower is managed and species poor (hawthorn dominated)	None close to tower	Low	Loss of woody hedgerow species as 20m of hedgerow permanently removed under tower. No recovery/reinstatement
38	Intermediate	Livestock (meadows)	20 - 30m of hedgerow permanently removed under tower. (Includes an access track). The tower is located at the meeting point 3 hedgerows meaning larger impact.	Robust unmanaged narrow species rich (woody and ground flora) hedgerow. Species include alder, spindle, rose, blackthorn, hazel, hawthorn, ivy and holly. hedgerow is located on a townland boundary	Birds include common passerines.	High	Loss of woody hedgerow species as 20 - 30m of hedgerow permanently removed under tower. (Including an access track).
39	Intermediate	Livestock (meadows)	Hedgerow at tower location dominated by pioneer woody species of disturbed ground. Tower means hedgerow wider at this location	Species rich hedgerow either side of tower (willow, ash, hazel, ivy, blackthorn, gorse, hawthorn and elder)	Birds include common passerines.	High	Change in hedgerow plant community at tower location includes pioneer woody species of disturbed ground. Hedgerow wider at tower location

<p>20m of hedgerow permanently removed under tower.</p>
38

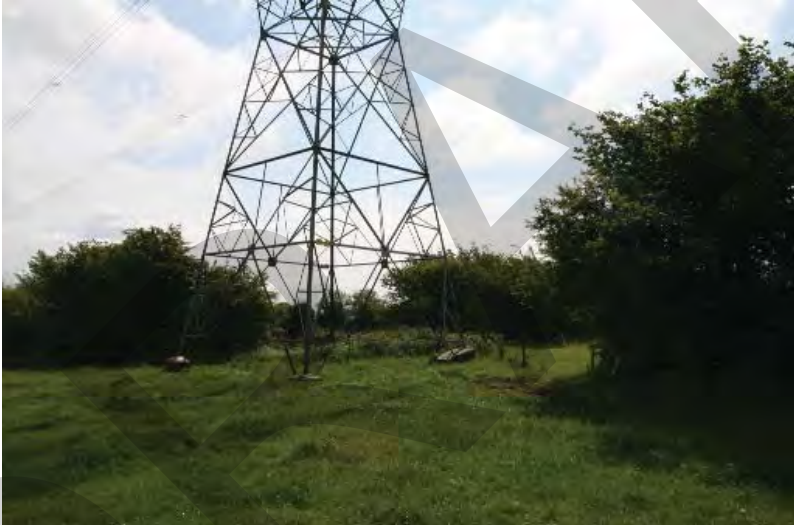
<p>Intermediate tower in gap where hedgerow permanently removed and access track retained. High value species rich hedgerow either side.</p>
39

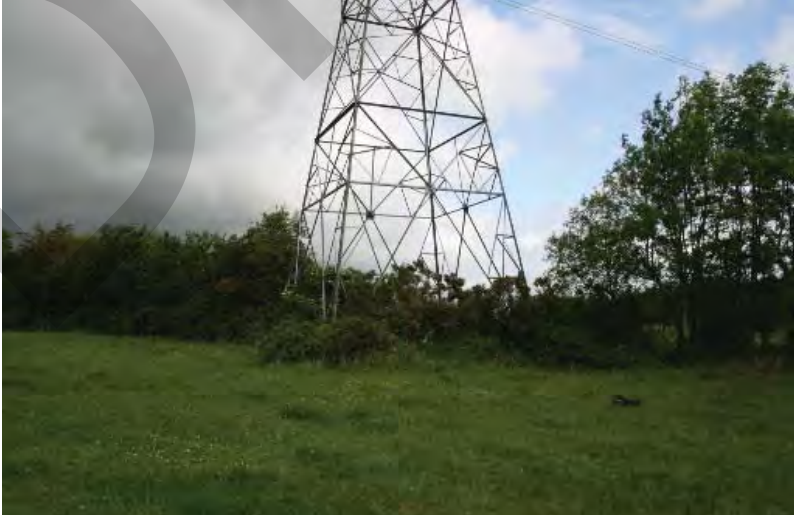
<p>Intermediate tower with disturbed ground species (gorse, bramble) dominating tower gap. High value hedgerow either side of tower has different woody vegetation to that under tower</p>

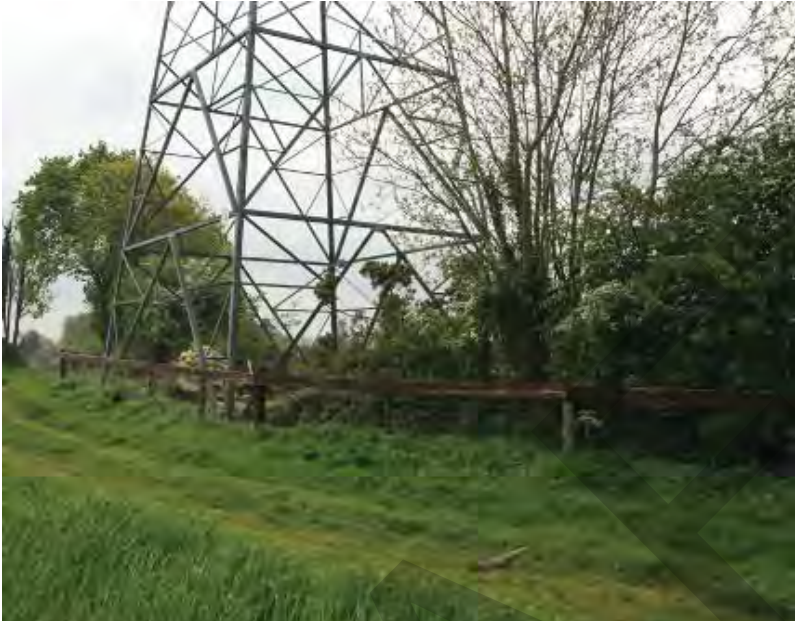
Location Tower Nos.	Plate	Description
40

<p>Hedgerow effectively gone at tower location (c.a. 10m). Low bramble and gorse at tower base. No taller woody vegetation compared to hedgerow either side.</p>
